**MINERALS PROGRAM INSPECTION REPORT**  
**PHONE: (303) 866-3567**

<b>MINE NAME:</b> Cresson Project	<b>MINE/PROSPECTING ID#:</b> M-1980-244	<b>MINERAL:</b> Gold and silver	<b>COUNTY:</b> Teller
<b>INSPECTION TYPE:</b> Monitoring	<b>WEATHER:</b> Clear	<b>INSP. DATE:</b> August 20, 2025	<b>INSP. TIME:</b> 09:30
<b>OPERATOR:</b> Cripple Creek & Victor Gold Mining Company	<b>OPERATOR REPRESENTATIVE:</b> Paulina Berrela	<b>TYPE OF OPERATION:</b> 112d-3 - Designated Mining Operation	
<b>REASON FOR INSPECTION:</b> Normal I&E Program	<b>BOND CALCULATION TYPE:</b> Complete Bond	<b>BOND AMOUNT:</b> \$319,158,980.00	
<b>DATE OF COMPLAINT:</b> NA	<b>POST INSP. CONTACTS:</b> None	<b>JOINT INSP. AGENCY:</b> None	
<b>INSPECTOR(S):</b> Ben Hammar	<b>INSPECTOR'S SIGNATURE:</b>

## **OBSERVATIONS**

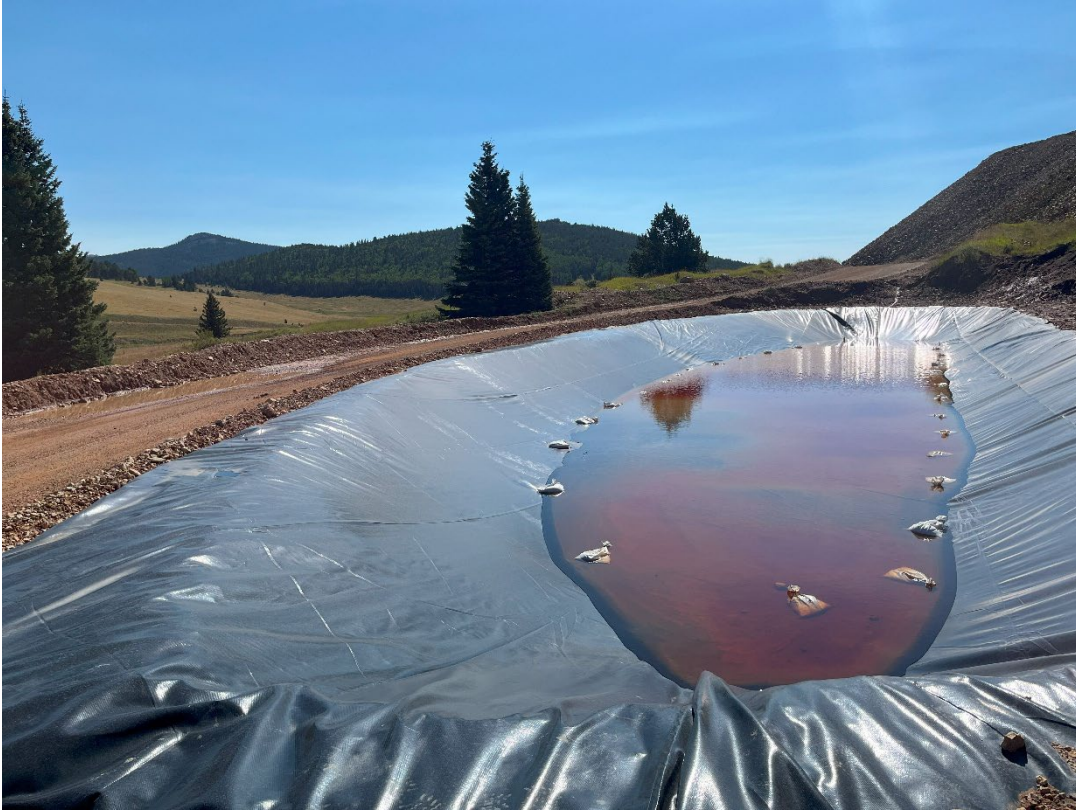
The Division inspected seep areas 1-5 as part of this inspection, and all construction of the collection improvements had been completed approximately 2 weeks prior to this inspection. All seep areas held water at the time of inspection, and seeps 5, 3/4, and 1 had signs of active solution drainage. Seep 2 was clear and appeared to only contain rainfall collection.

Photo 1: Seep collection area 5 facing east. Note the red-colored process water.

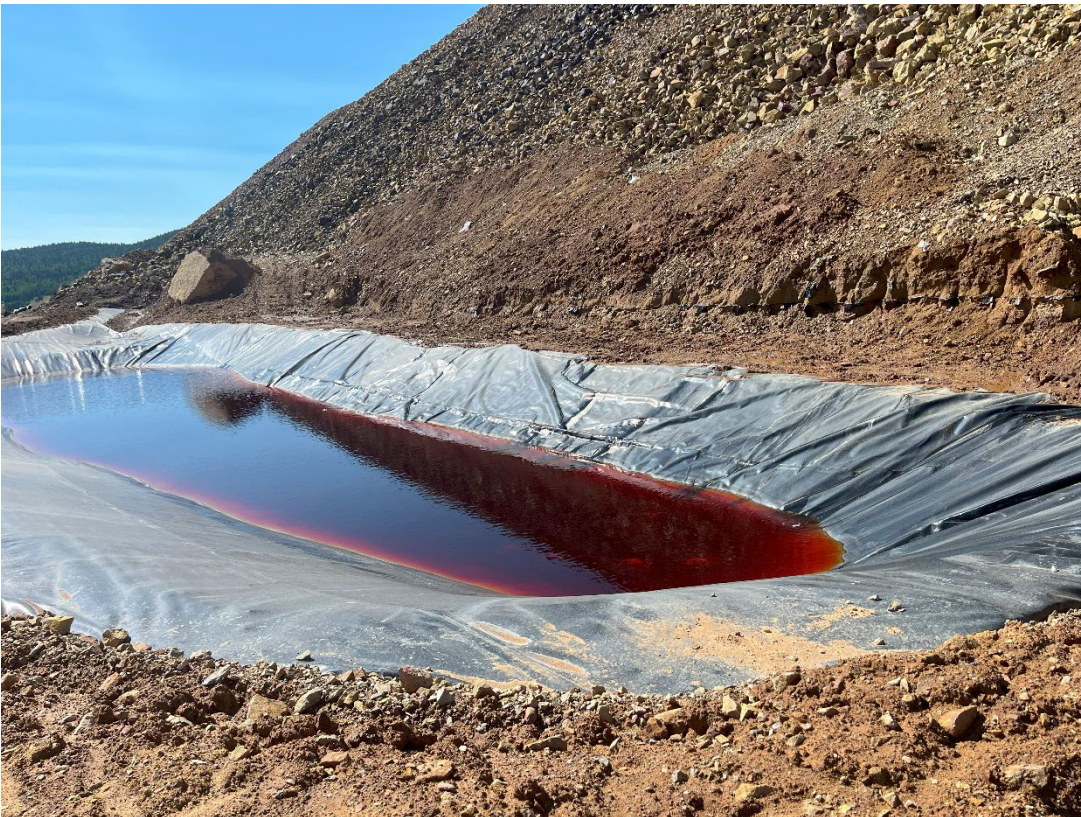
Photo 2: Seep collection area 2, with affected process water.

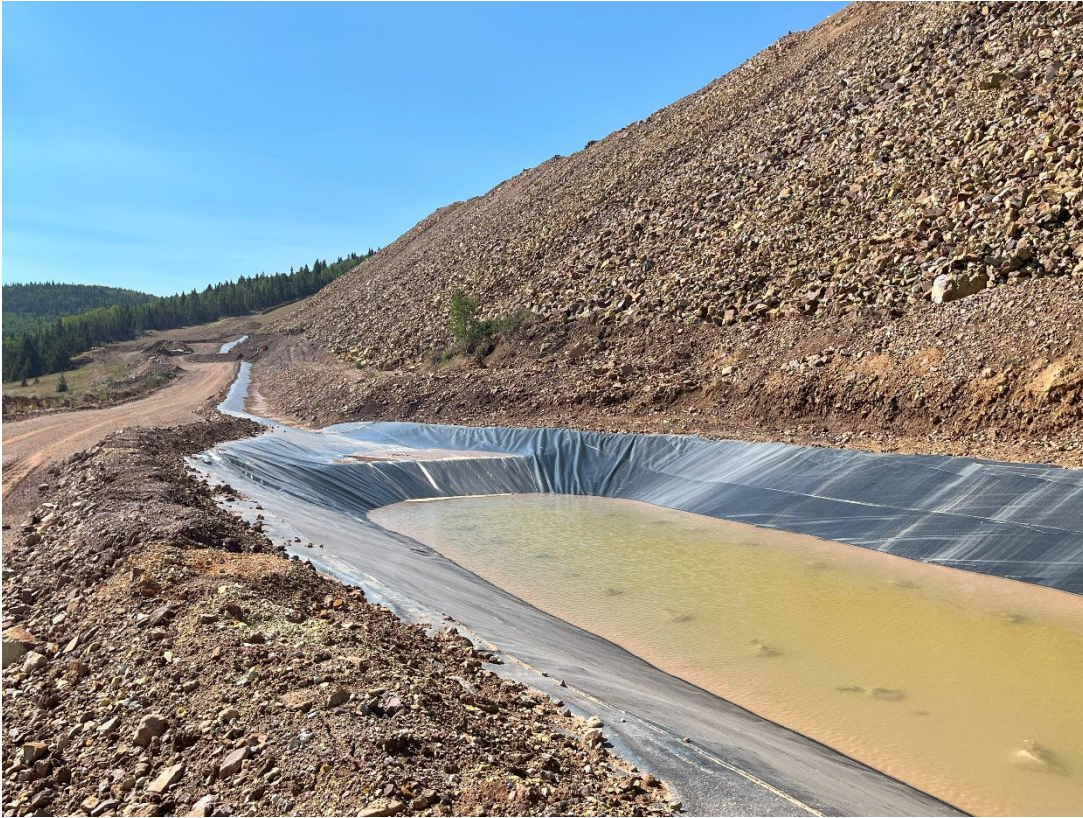
Photo 3: Seep 3/4. Note little to no process water from seepage appears to be contained within it at the time of inspection.

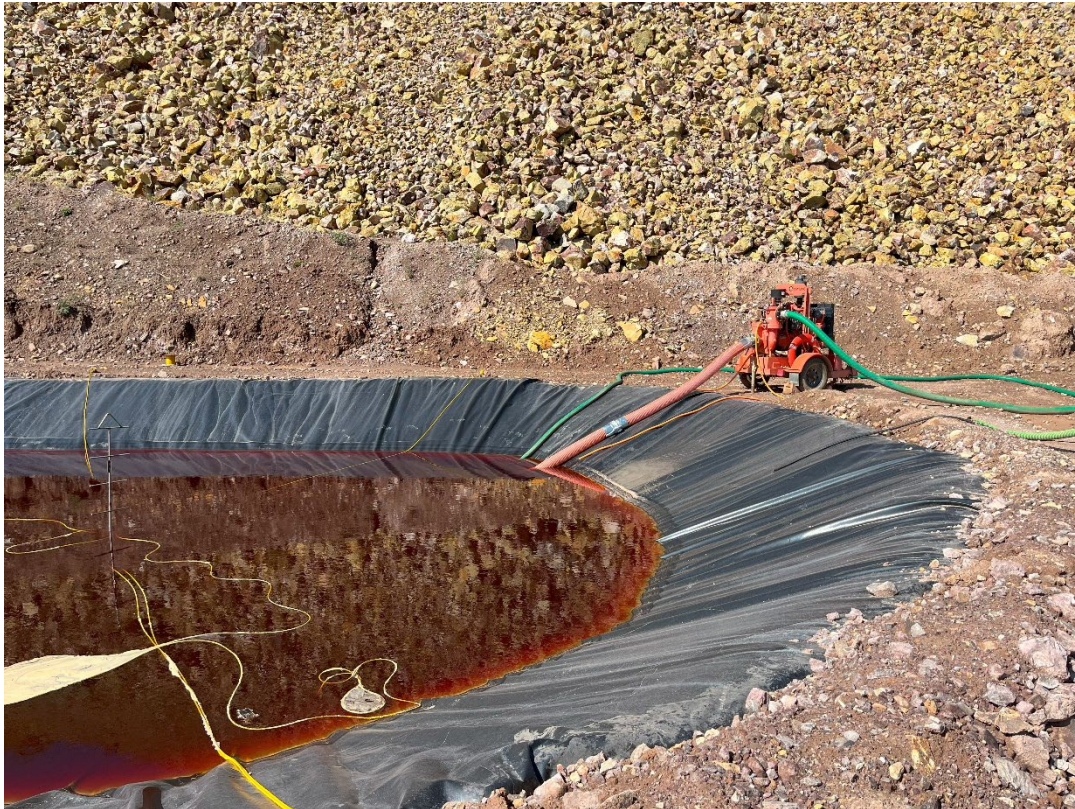
Pumping activities took place within a few hours of inspection, and per the operator representative occur regularly. According to the operator a final report detailing the completed seep improvements will be sent to the Division shortly after this inspection. Photos of the complete improvements are shown in photos 1-4.

Photo 4: Seep 1 with pump. Per the operator pumping activities had occurred close to the time of inspection.

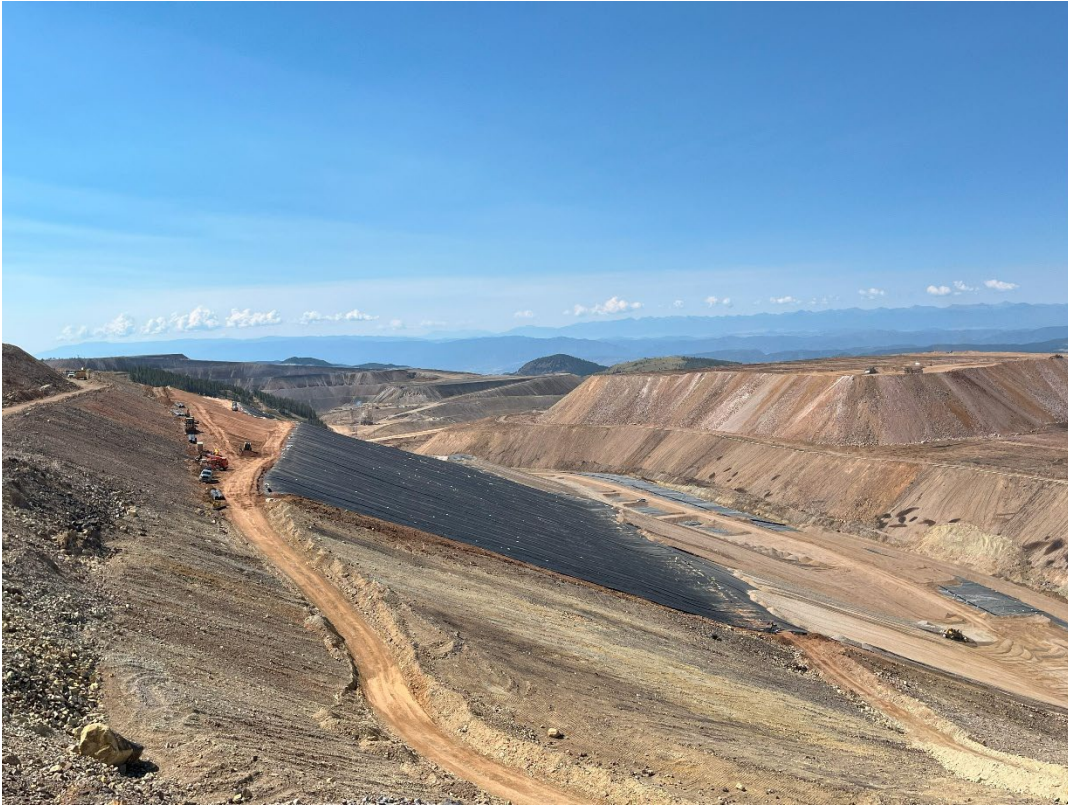
Photo 5: Overlook of VLF2 expansion.

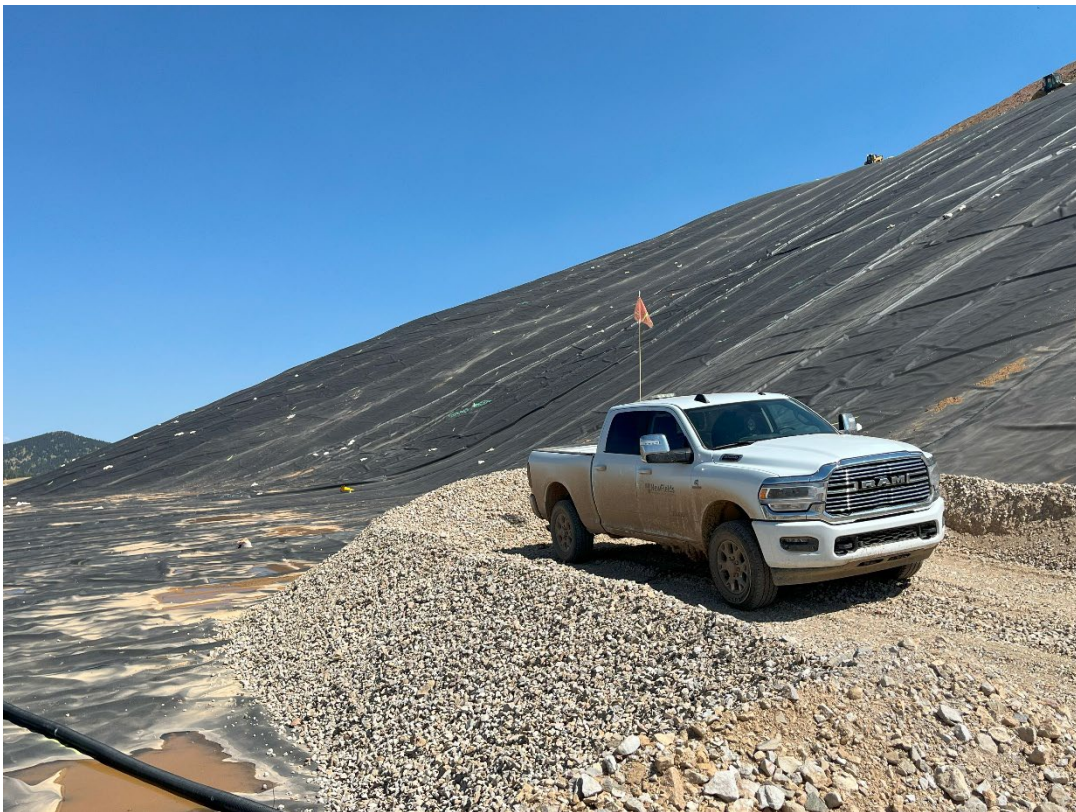
Photo 6: Newfields truck located near the current liner installation area.

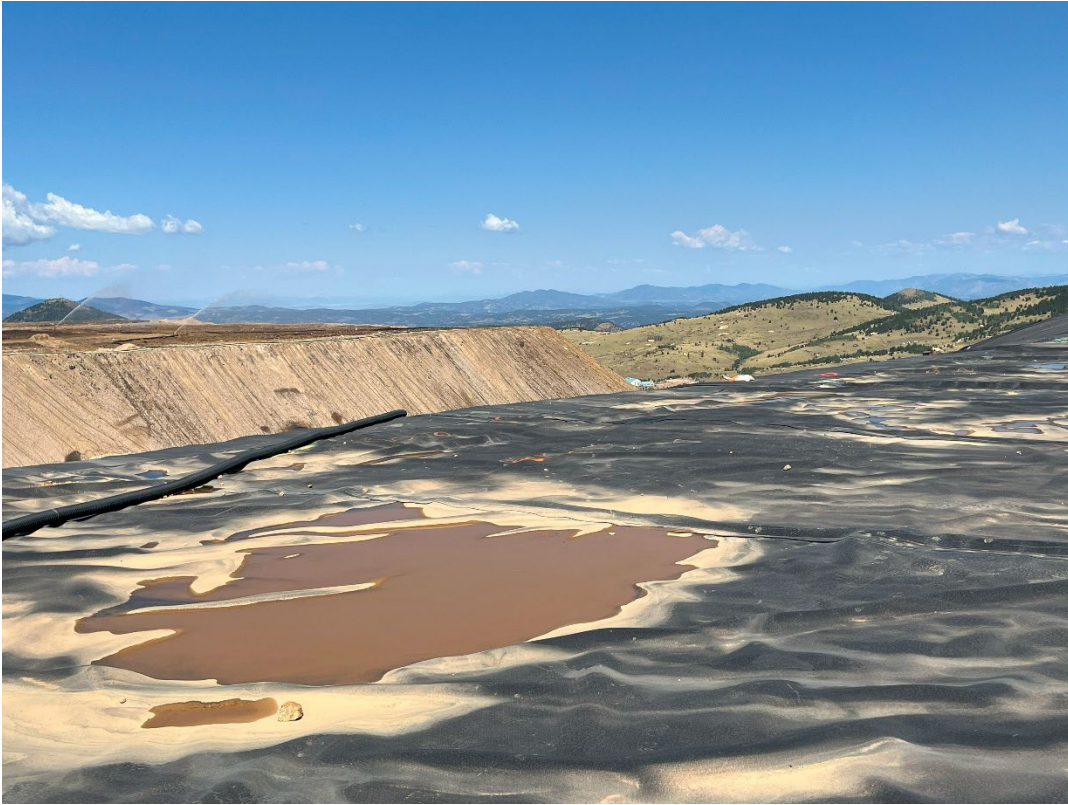
Liner installation and Drain Cover Fill (DCF) placement was also observed during this inspection with an operator and Newfields representative. During this inspection the second bench area was being lined and covered with material. This area and the area immediately upgradient were stated to be expected to be completed within a few days following this inspection.

Photo 7: Recently installed liner area. Note minor ponding due to recent rainfall.

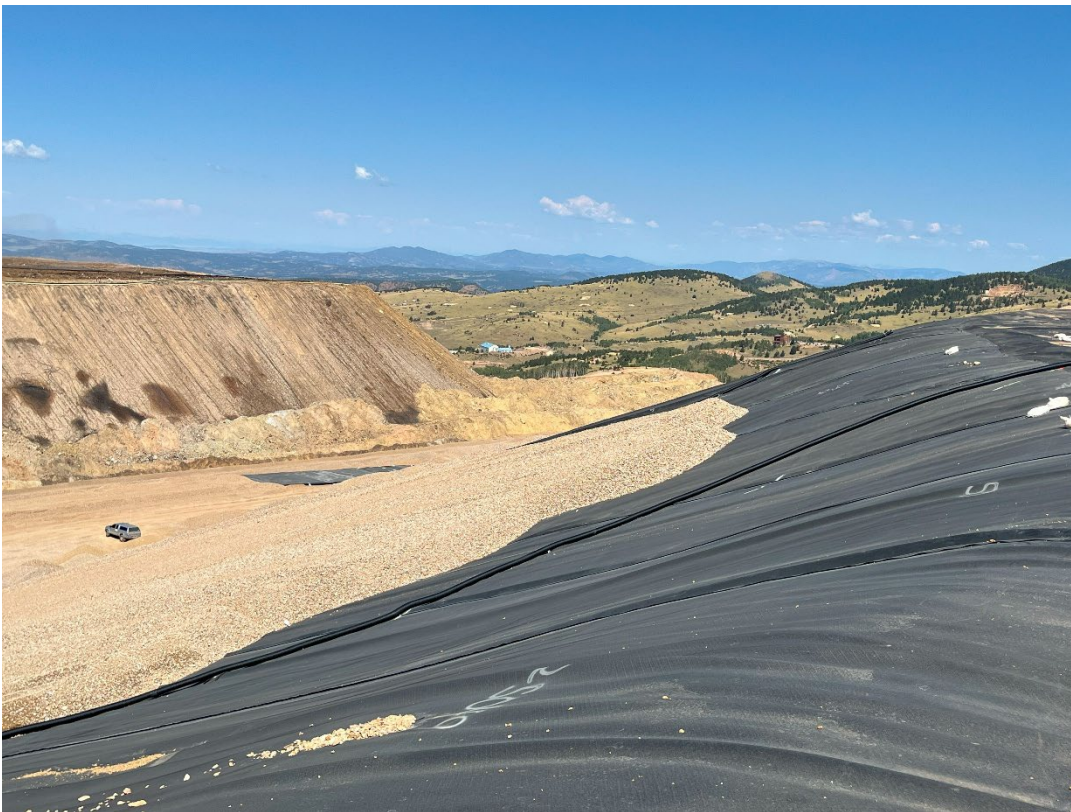
Photo 8: Recent DCF placement areas.

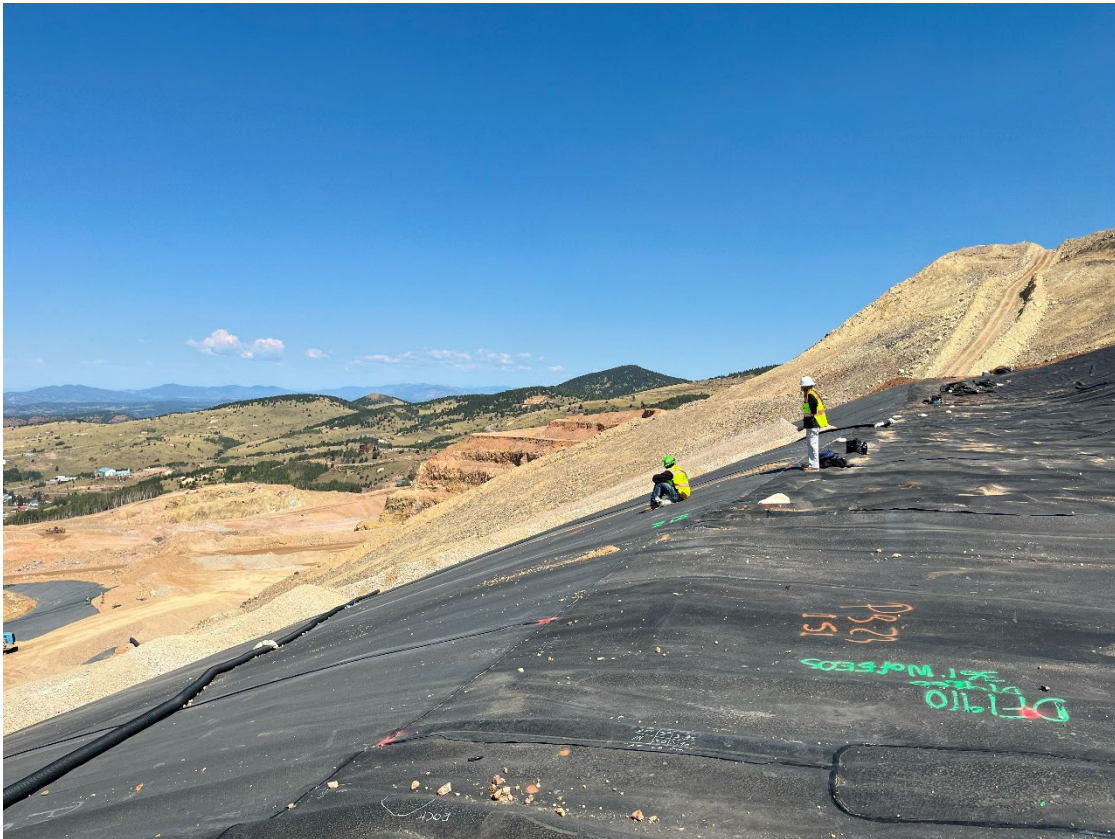
stacking are still in development, and the proposed relocation of the haul road for this area have not been decided upon at the time of inspection. A Newfields representative was observed performing QA duties at the time of inspection.

Photo 9: Newfields representatives performing QA monitoring of liner install.

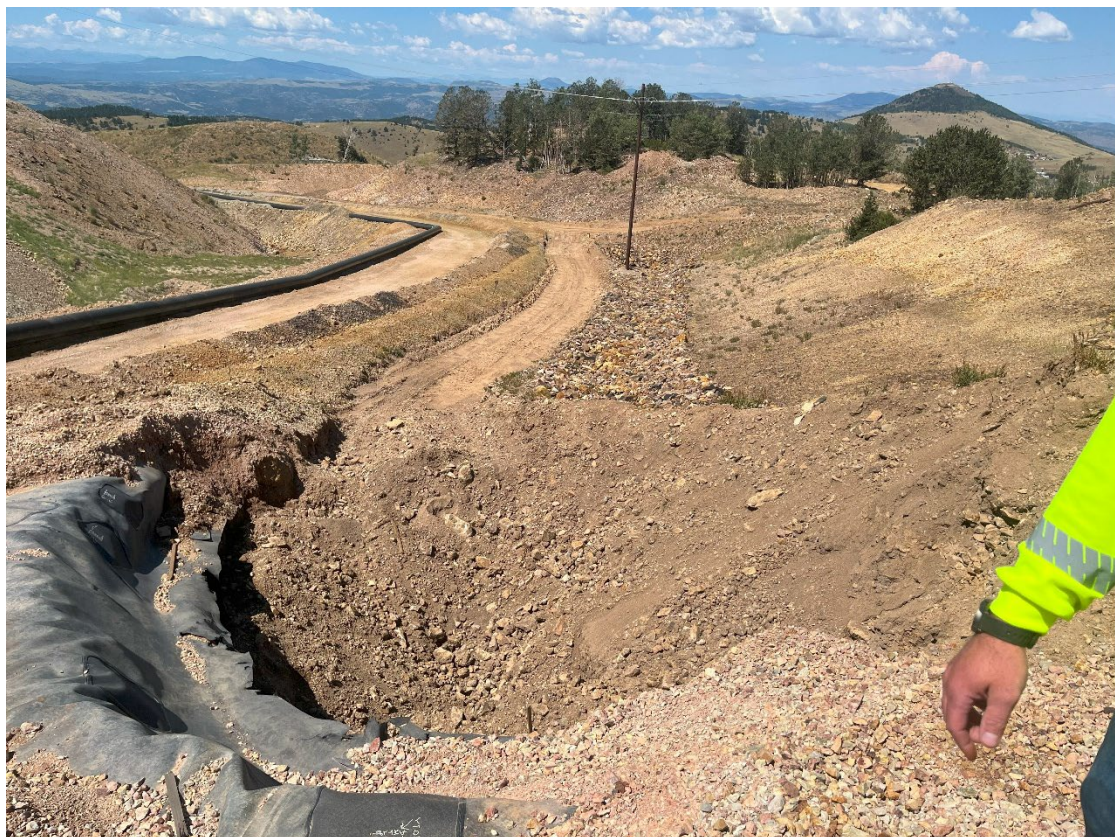
The recent spill site was observed during this inspection, which according to the operator was caused by surface flow from areas of the VLF2 stacked ore areas. Contaminated soils were found in the central contaminated area up to the maximum depth of sampling, and further excavation of affected soils were stopped due to the potential to damage the liner.

At the time of inspection, the operator was awaiting a drilling report to identify the depth of bedrock under the impacted area, and potential preventative mitigation techniques were still being discussed. The previously excavated area has since been backfilled.

Photo 10: Backfilled spill excavation area.
