**MINERALS PROGRAM INSPECTION REPORT**  
**PHONE: (303) 866-3567**

| <b>MINE NAME:</b><br>Tony Mine | <b>MINE/PROSPECTING ID#:</b><br>P-2025-002 | <b>MINERAL:</b><br>Gold and silver | <b>COUNTY:</b><br>Summit |
| <b>INSPECTION TYPE:</b><br>Monitoring | <b>WEATHER:</b> Clear | <b>INSP. DATE:</b><br>August 28, 2025 | <b>INSP. TIME:</b><br>11:00 |

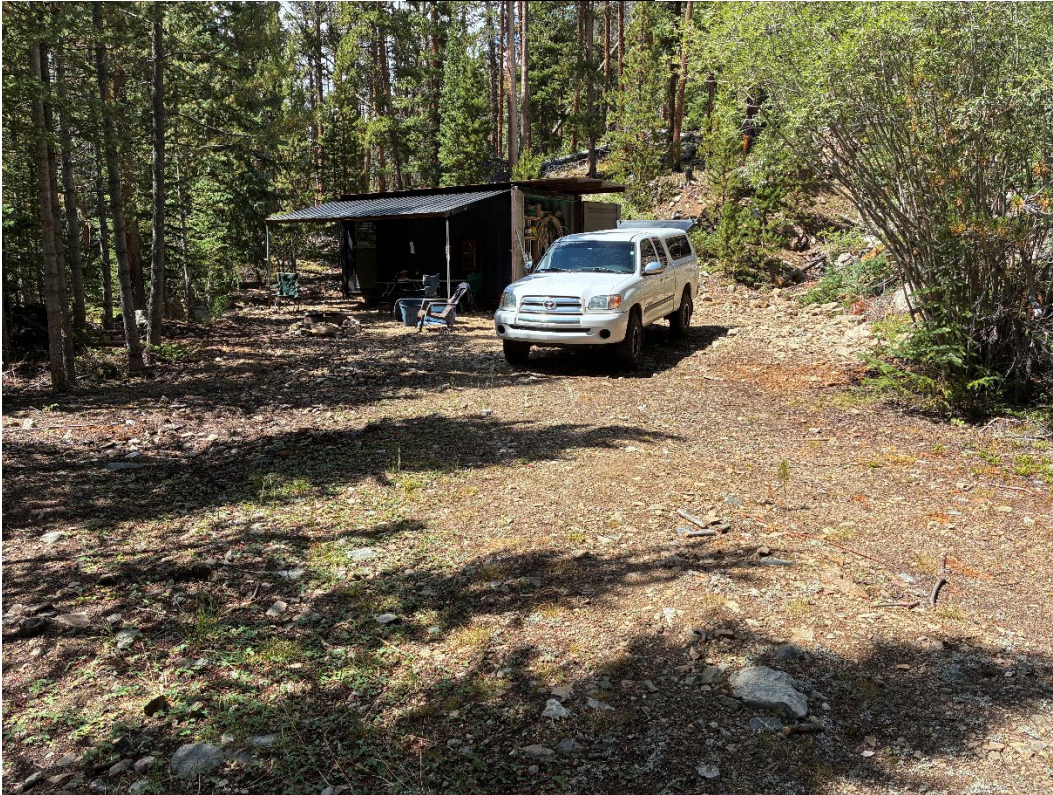
The lower pad contains a portable Conex box, leveled on wood timbers, which serves as a living/bunk area and tool storage (photo 1). To the south of the pad area, a historic tailings pile appears stable with some vegetation (photo 2), but it is not approved for mining, leveling, or any disturbance under the current NOI. Additionally, an old, antique compressor with steel wheels, housed in a makeshift lumber shed, is situated just east of the pad area, having been on-site prior to the current NOI.

Photo 1- Lower pad area with portable Conex box. The collapsed portal to the right, behind the shrub.

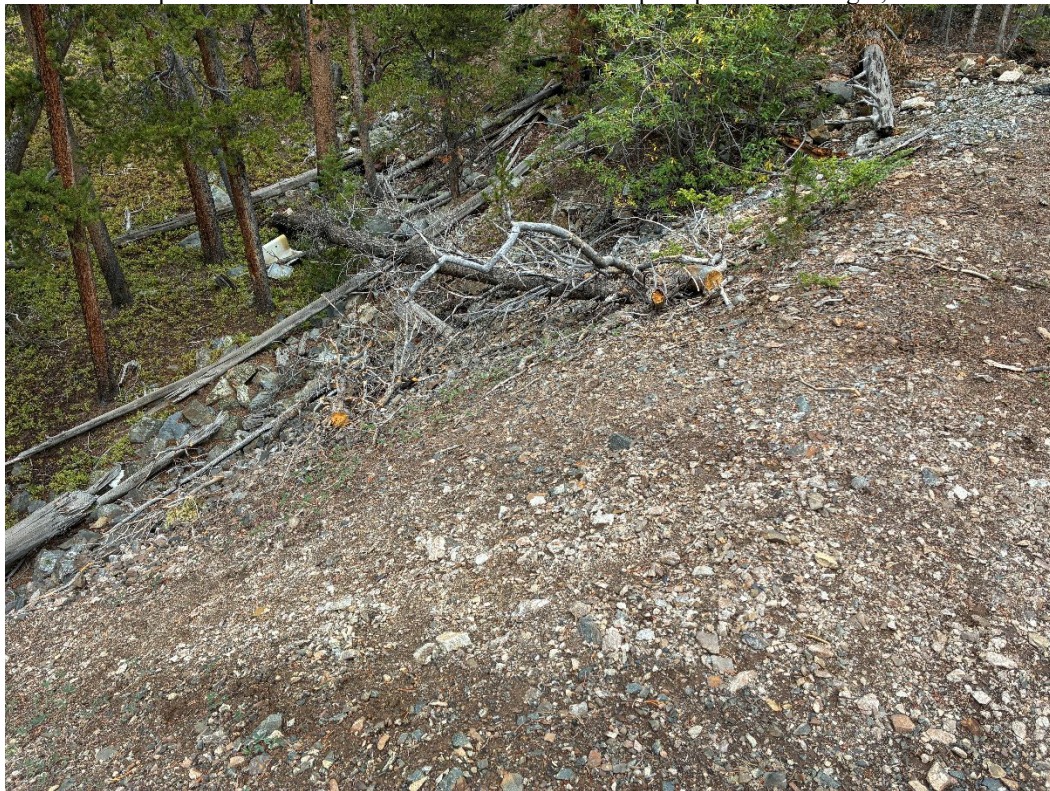
Photo 2- Lower tailings pile

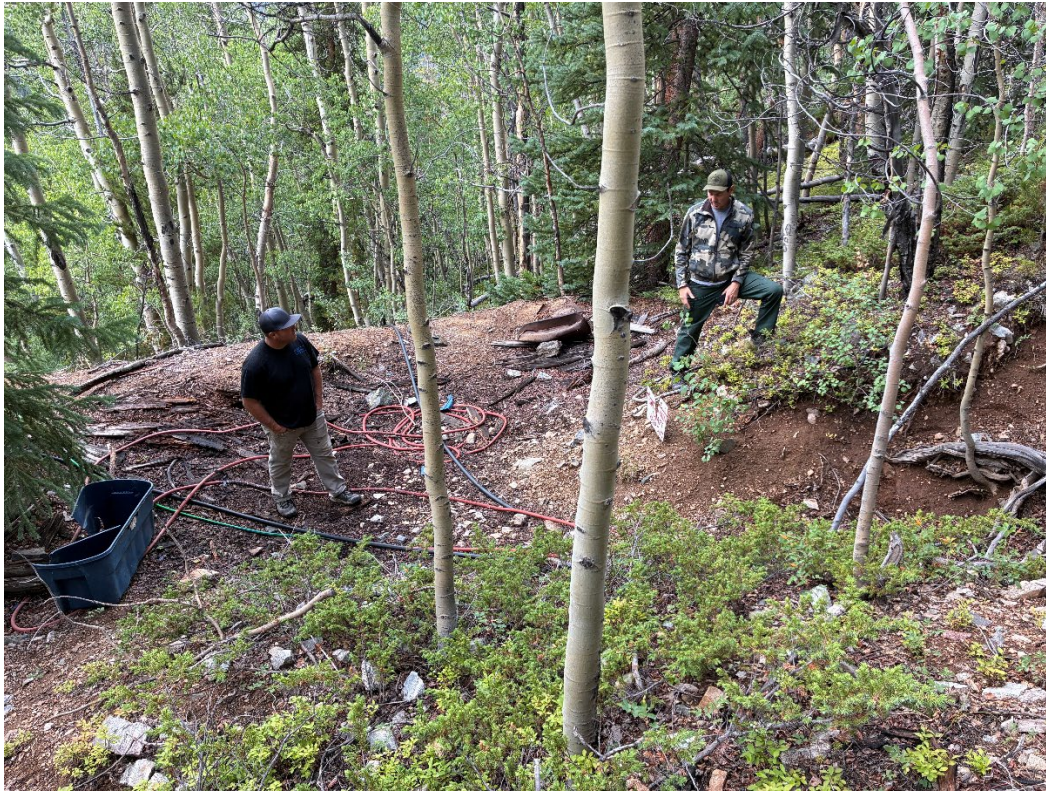
Approximately 30 feet in front of the upper portal (photo 3) lies a small tailings pile (photo 4), which is not approved for disturbance, mining, or expansion under the current NOI. The portal opens into a small rock outcrop (photo 5), where about six inches of water was observed extending back into the mine. A large dirt berm prevents water discharging from the mine, as the current NOI mandates that all water must remain within the mine workings. Mr. Brewer, who is fully aware of this requirement, has removed several old hoses that were previously in place, presumably for water removal.

Photo 3- Upper portal bench area. Tailings pile to the left, portal to the right.

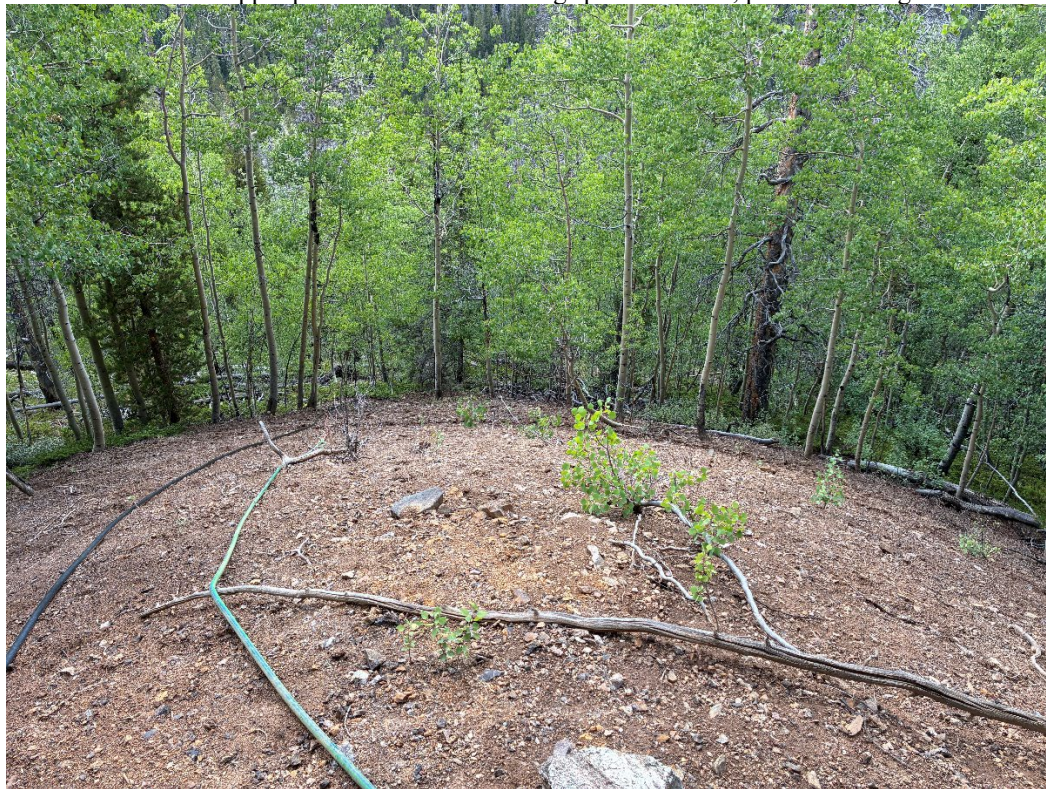
Photo 4- Upper tailings pile.

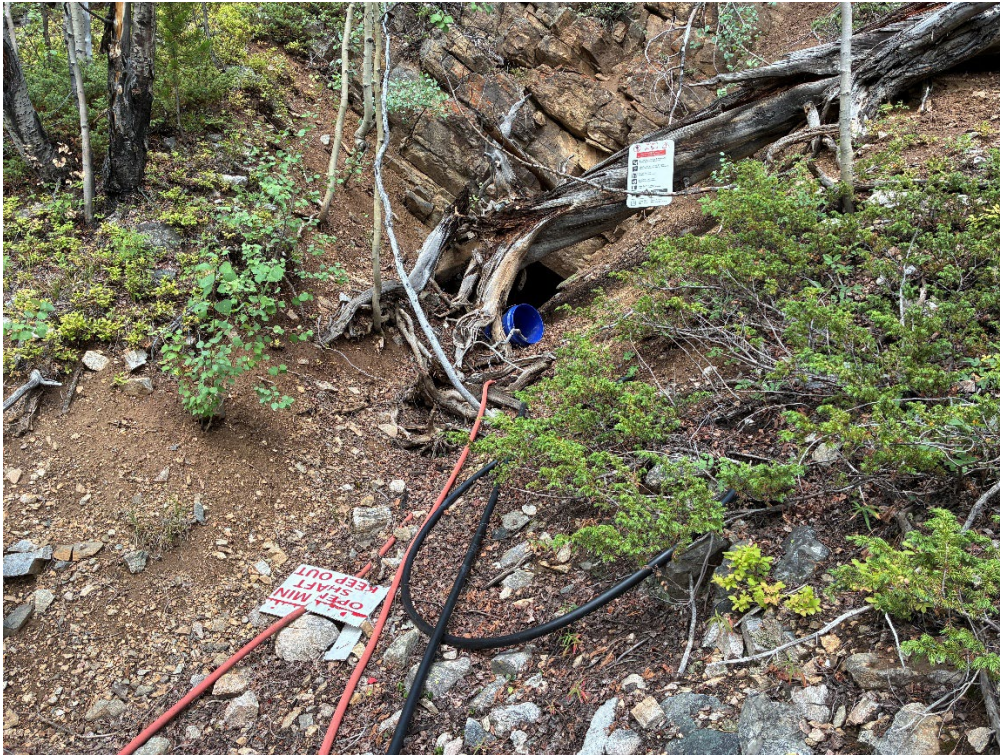
Photo 5- Portal located behind the tree stump. The mound of dirt in front keeps water in the mine.

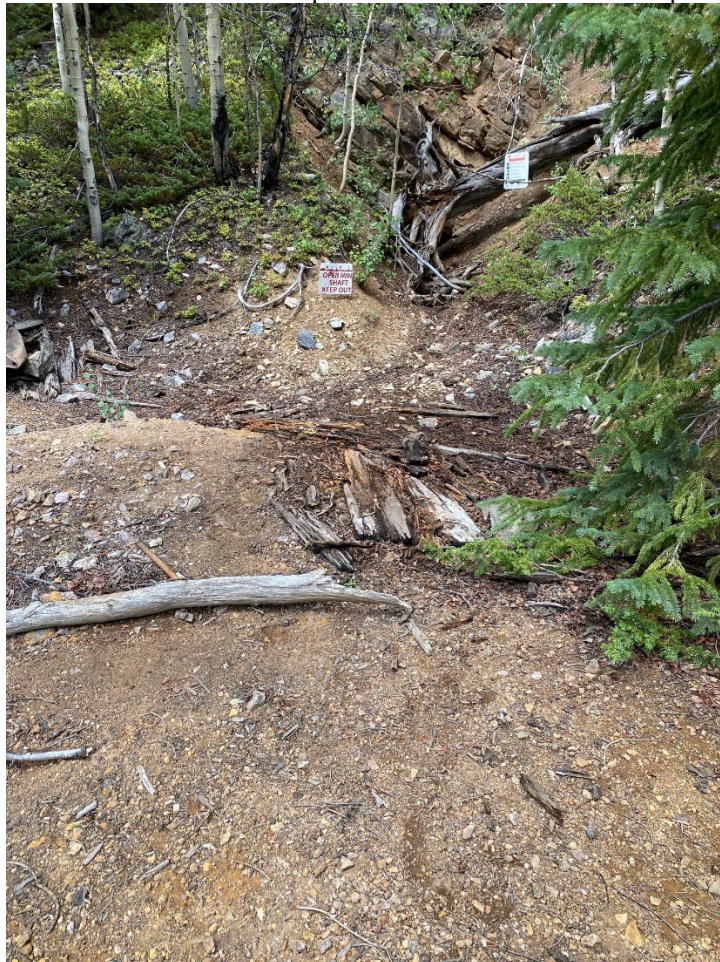
Photo 6- The hoses seen in Photo 3 above have been removed from the upper portal.
