## August Report

Division of Reclamation,  
Mining and Safety

### PERMIT INFORMATION

### INSPECTION INFORMATION

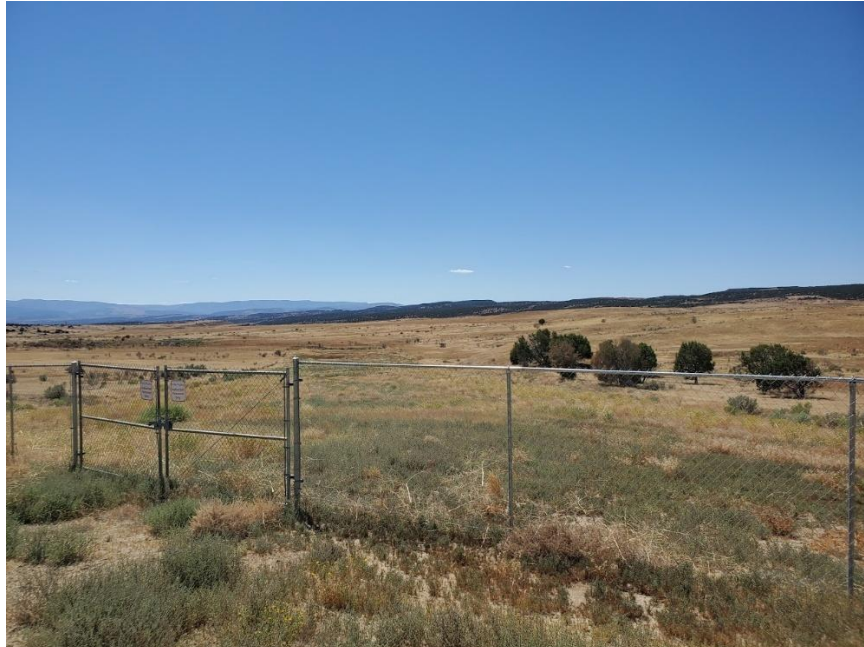
The Halandras Landfill has been backfilled and graded to approximate original contour. No topsoil has been spread on the site. The topsoil pile that remains next to the landfill appears to be of sufficient size to complete reclamation. Volunteer vegetation is growing on the site (Photo 1).

Photo 1: View to the SW of Halandras Landfill.

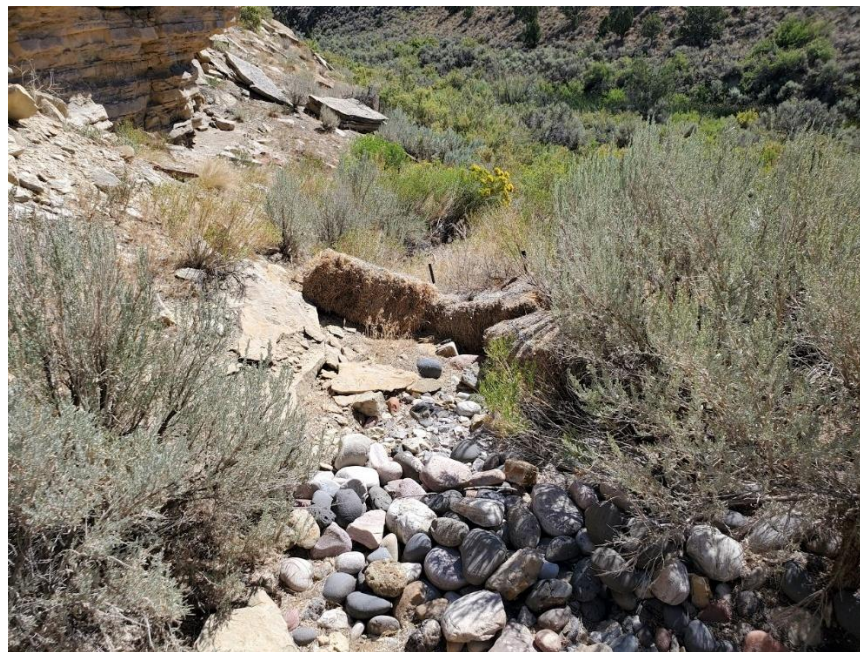
The explosives storage area for the Deserado Mine is located at the southern end of the main facilities area. The storage consists of a pad with a storage bunker for the explosives. The cut and fill slope of the pad was stable with no erosional features. Runoff from the pad is directed to an outlet at the southern end of the pad and passes down a channel through straw bales. The bales appear to be in good condition and functioning as designed (Photo 2).

Photo 2: View to the east of bales that in the drainage of the explosive pad.

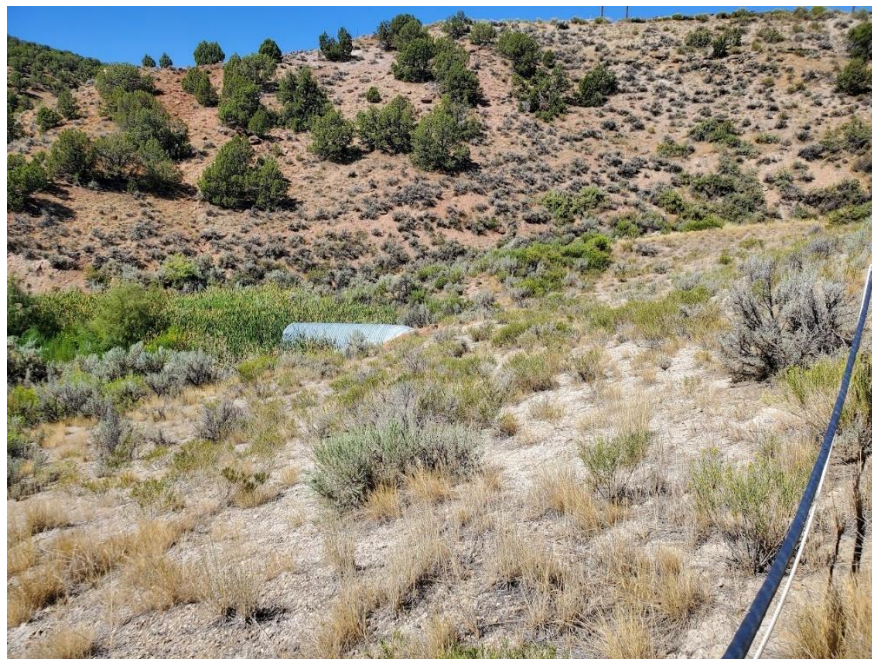
There are three ponds located in the main facilities area: the DP-1 Pond, the PP-1 Pond and the PP-2 Pond. The DP-1 Pond is located on the southern part of the lower facilities bench. DP-1 collects all runoff from the from the three facilities benches. The outlet structure was clear of debris and while the water level in the pond is low it was discharging at the time of inspection. The embankments appear stable with well-established vegetative cover (Photo 3). The emergency spillway has minor amounts of vegetation but is be able to convey water and is well armored. There were no erosional concerns identified. The PP-1 Pond is located on the middle bench of the facilities area near the prep plant. The pond held minor amounts of water and was well below the discharge level (Photo 4). There were no erosion or stability issues identified in the PP-1 Pond. The PP-2 Pond is located on the upper facilities bench. The outlet structure was in good condition with no vegetation obscuring the outlet. The embankments of the pond appear stable and no evidence of slumping or excessive erosion was noted (Photo 5). Water diversion ditches throughout the main facilities area were unobstructed and stable.

Photo 3: View to the southwest of the embankment

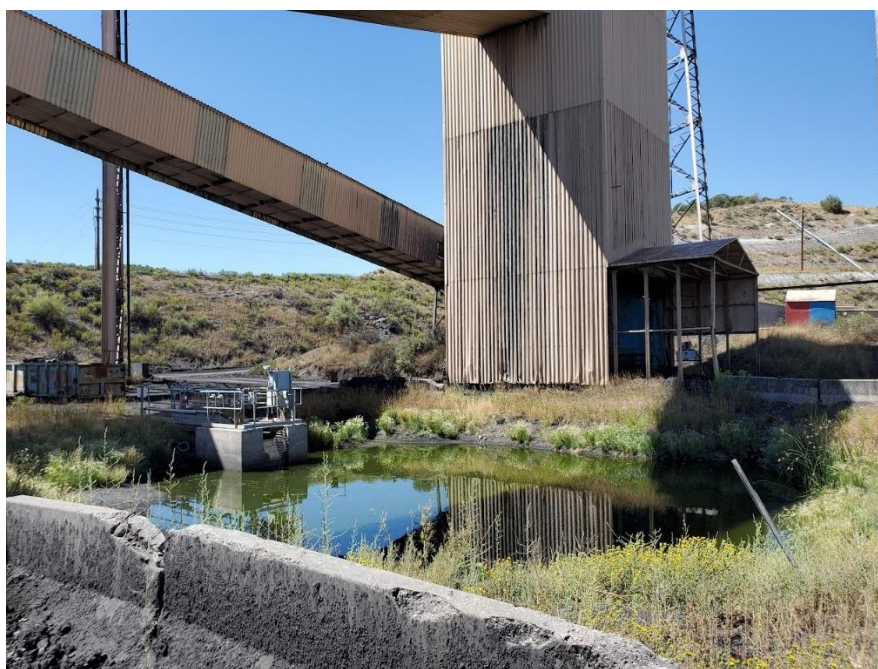
Photo 4: View to the southwest of the PP-1 Pond below the discharge level.

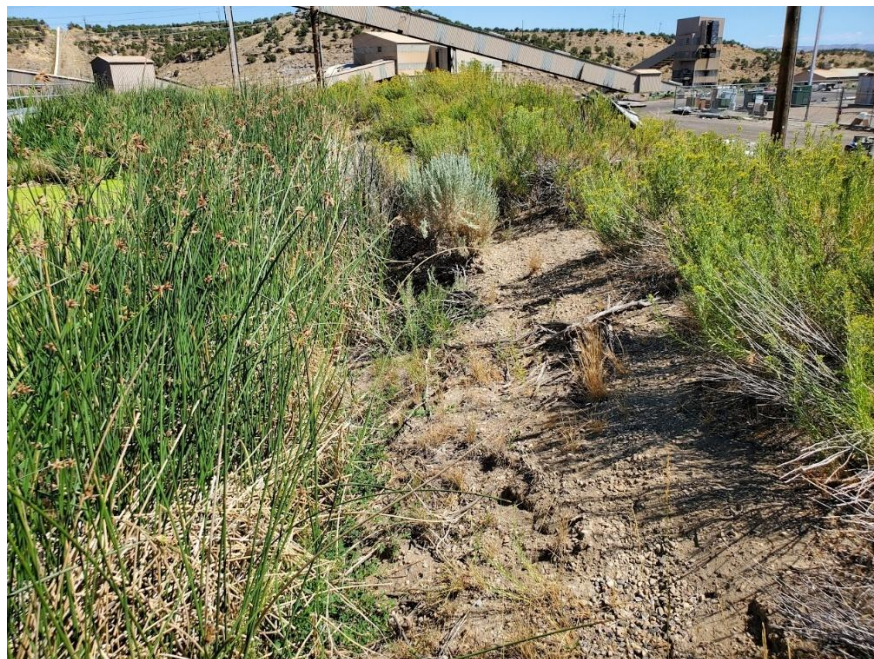
Photo 5: View to the north of the eastern embankment of the PP-2 Pond.

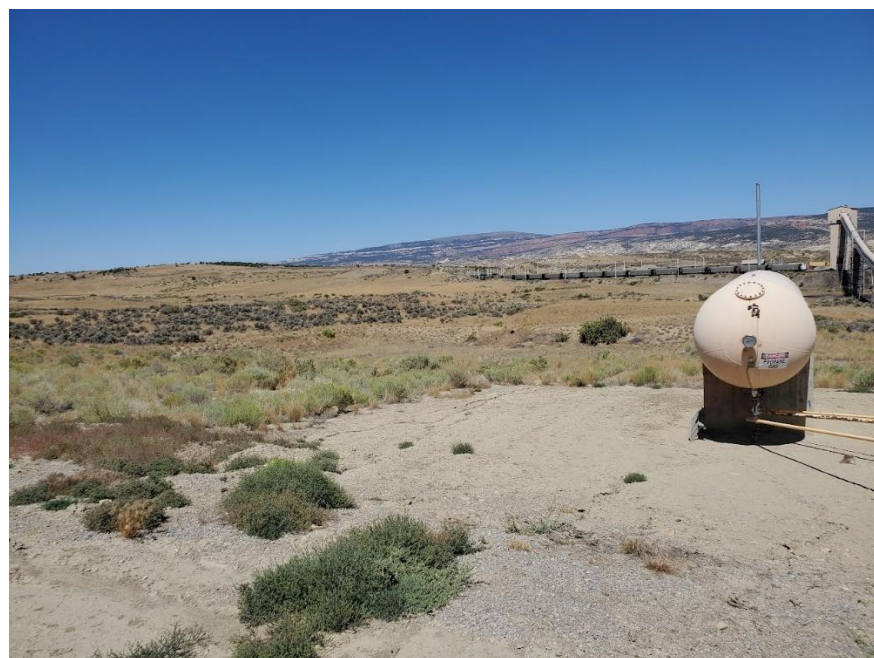
The SS-2 Pond is located at the northwestern base of the Slot Storage Facility. The pond was dry at the time of the inspection. The embankments of the pond were well vegetated and stable with no indications of erosion (Photo 6).

Photo 6: View to the north of the SS-2 Pond.

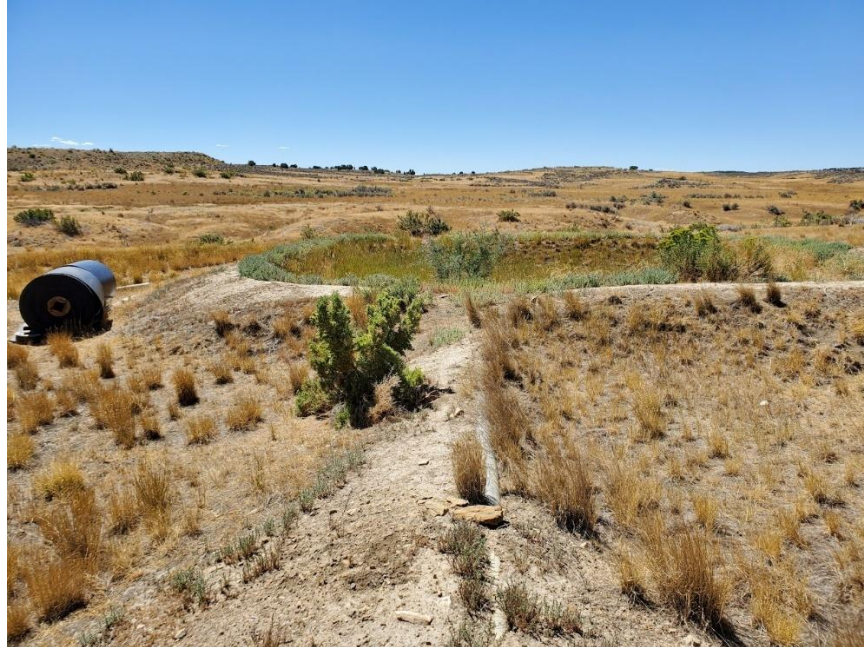
The RS-1 Sump and the RR-1 Pond are located at the south side of the Rail Loadout. The RS-1 Sump was dry at the time of the inspection (Photo 7). The RR-1 Pond was also dry. The embankments of the pond seem stable. The erosion feature on the northern embankment that has been noted in previous inspection reports does not appear to have grown in size (Photo 8). The Rail Loadout Storage South Ditch has minor amounts of vegetative debris but does not appear obstructed and is able to convey water.

Photo 7: View to the south of the rail sump.

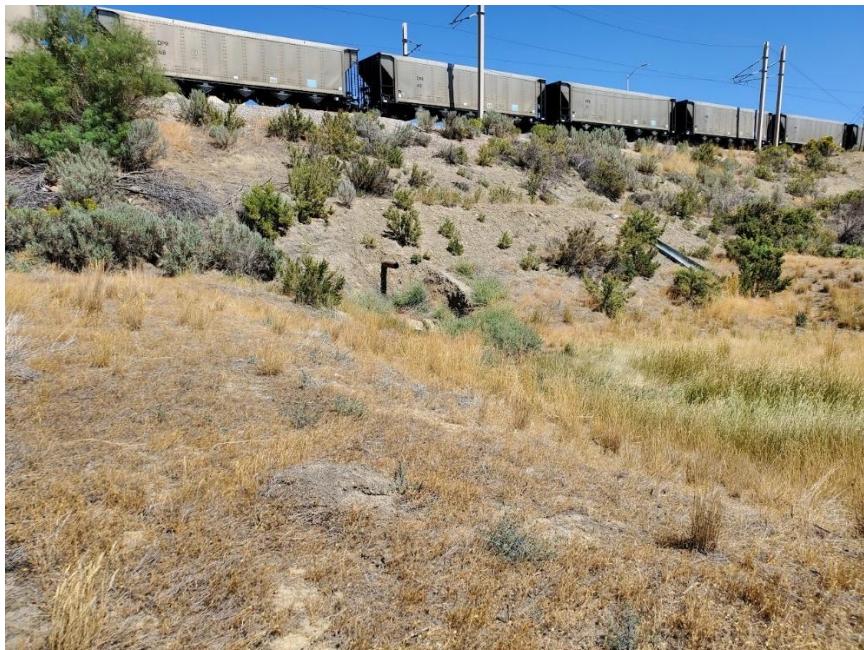
Photo 8: View to the north of the erosion scar on the rail pond. No change since last inspection.

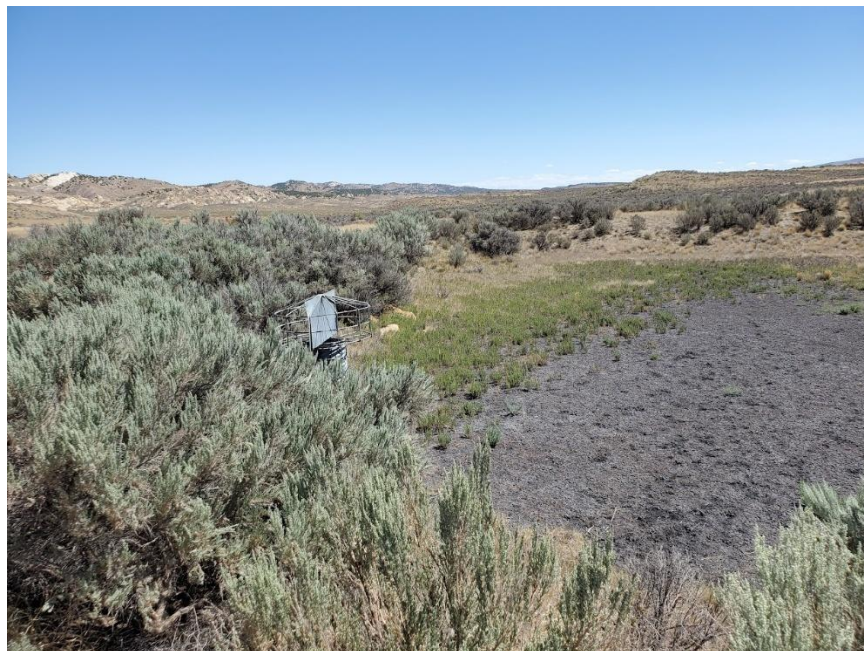
Pond RP-1 is located at the base of the reclaimed RP-1 Refuse Pile. The pond was dry at the time of the inspection. The embankments of the pond were stable with no indications of erosion observed. There were no obstructions in the outlet - the trash rack over the pond's outlet was clean (Photo 9).

Photo 9: View to the east of outlet of RP-1 Pond.

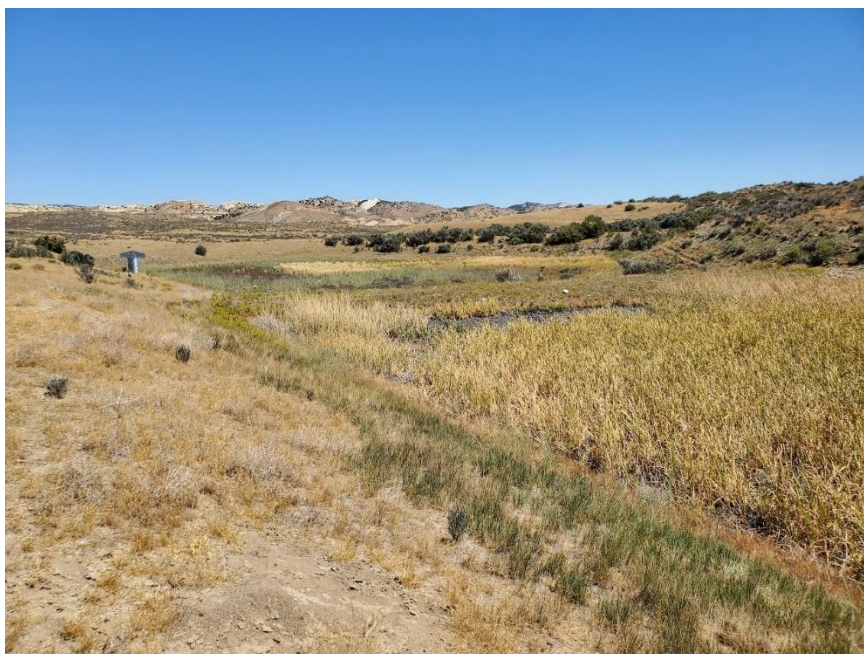
Two ponds are located at the northern base of Refuse Pile RP-2/3/4. The RP -2/3 Pond is located on the pile's northeast corner. The Pond consists of three cells – all of which were dry at the time of the inspection (Photo 10). The channels above the ponds appear clear of debris. No erosional features were noted on the embankments of the conveyance ditches. The trash rack was clear of debris. The RP-4 Pond is located at the northwest base of the pile. The pond was dry during the inspection. The outlet for the RP-4 Pond is capped with a trash rack. The outlet was clear of debris. Animal burrows were noted in the northern embankment of the RP-4 Pond. These burrows were filled during the inspection (Photo 11).

Photo 10: View to the east of the dry RP-2/3 Pond .

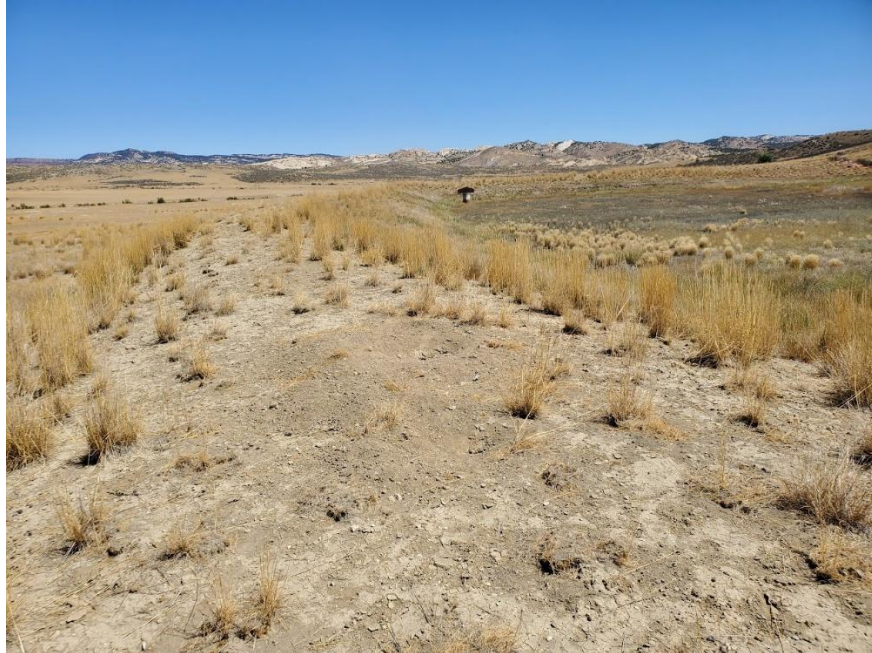
Photo 11: View to the east of burrow on RP-4 embankment.

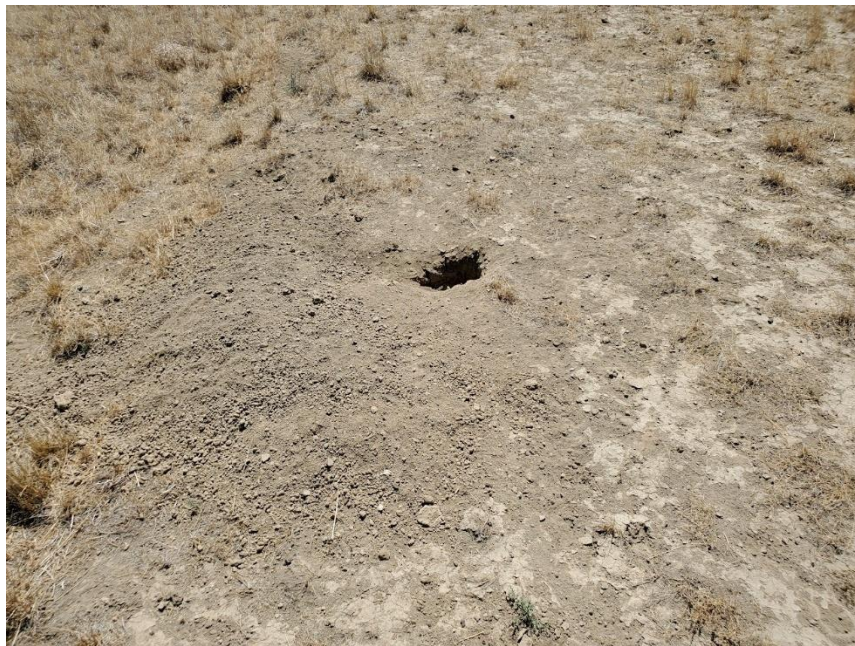
Pond RP-5 is located at the northern base of the RP-5a Refuse Pile. The pond was dry at the time of the inspection. The embankments of the ponds were vegetated and seemed stable. An animal burrow was discovered on the embankment of the pond but was filled during the inspection (Photo 12). The outlet was clear of obstructions.

Photo 12: View to the north of animal burrow in the RP-5 embankment.

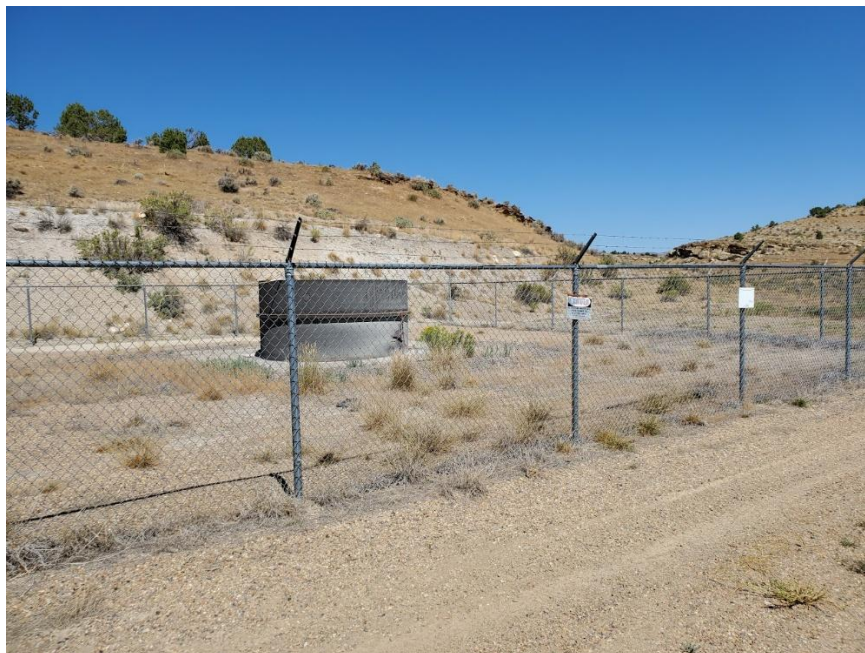
The B Seam Vent Shaft #1 is located north of the main facilities off of the haul road. The pad was stable with no erosional features. The fencing around the shaft to prevent unauthorized entry was in good condition (Photo 13).

Photo 13: View to the north of animal burrow in the RP-5 embankment.

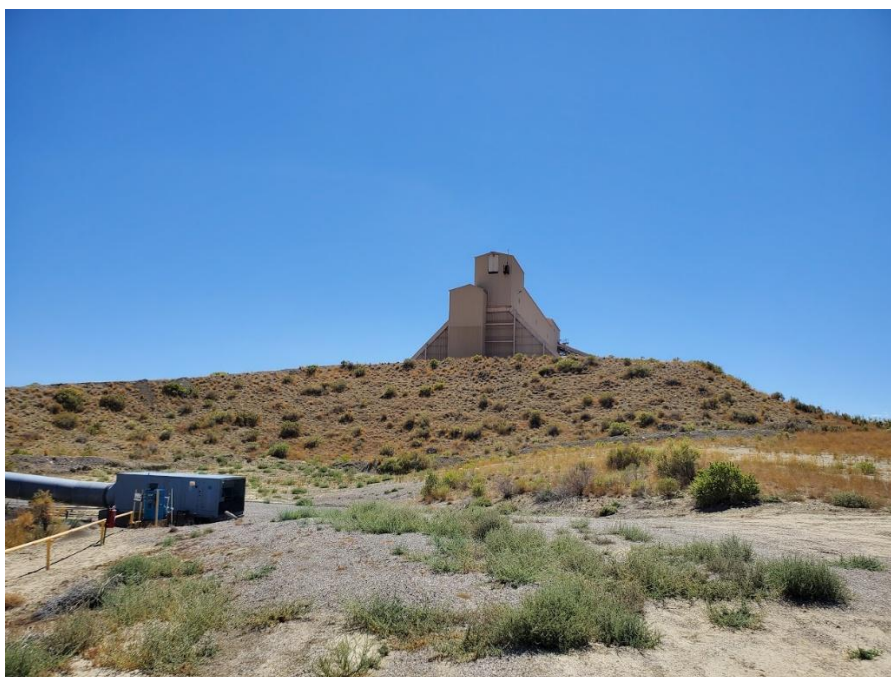
The Slot Storage Facility is located just to the south of the rail loadout. The pad that surrounds the Slot Storage is in good condition with a berm to control erosion. There were no erosional features noted on the embankments below the slot storage building (Photo 14).

Photo 14: View to the north of animal burrow in the RP-5 embankment.

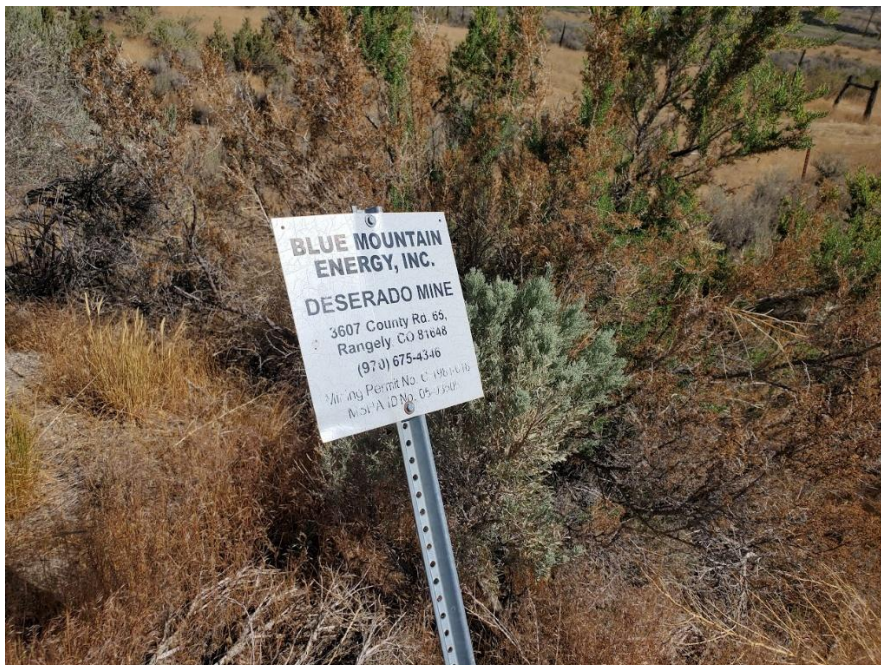
A mine identification sign was observed to be posted on the right-hand side of CR-65 as the county road enters the permit boundary. The sign was placed in an unobstructed location and the text was easily legible. Information on the sign contained the mine permit number, permittee name and contact information (Photo 15).

Photo 15: View to the west of mine ID sign at the permit boundary.
