**MINERALS PROGRAM INSPECTION REPORT**  
**PHONE: (303) 866-3567**

| <b>MINE NAME:</b><br>4406 Alaska, LLC Pit #1 | <b>MINE/PROSPECTING ID#:</b><br>M-2010-036 | <b>MINERAL:</b><br>Clay (general),<br>gravel and sand | <b>COUNTY:</b><br>Phillips |
| <b>INSPECTION TYPE:</b><br>Surety-Related Inspection | <b>WEATHER:</b><br>Clear | <b>INSP. DATE:</b><br>August 5, 2025 | <b>INSP. TIME:</b><br>10:30 |

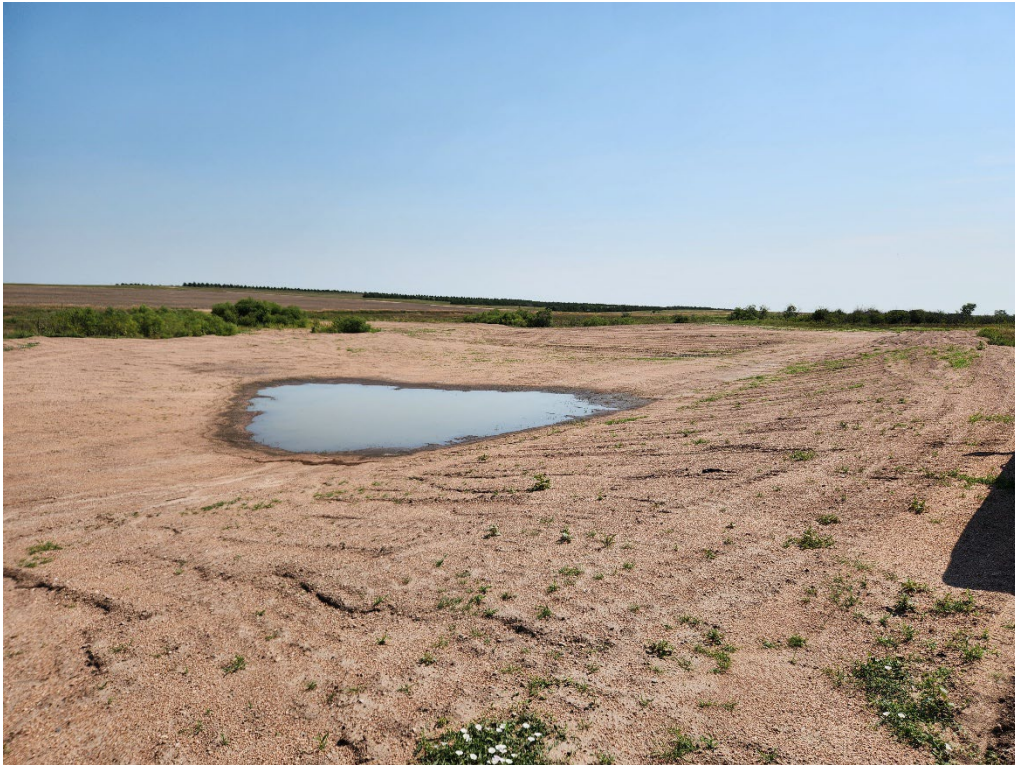
**Photo 1.** Mined area that has been graded, looking northeast.

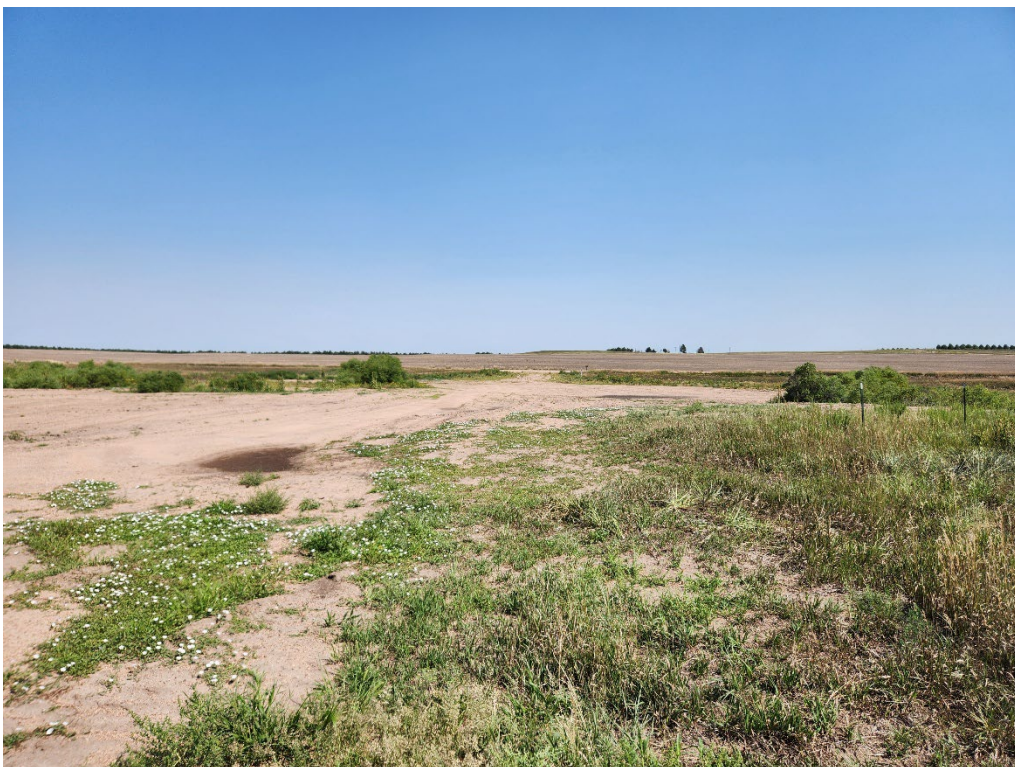
**Photo 2.** Access to mined area, looking north.

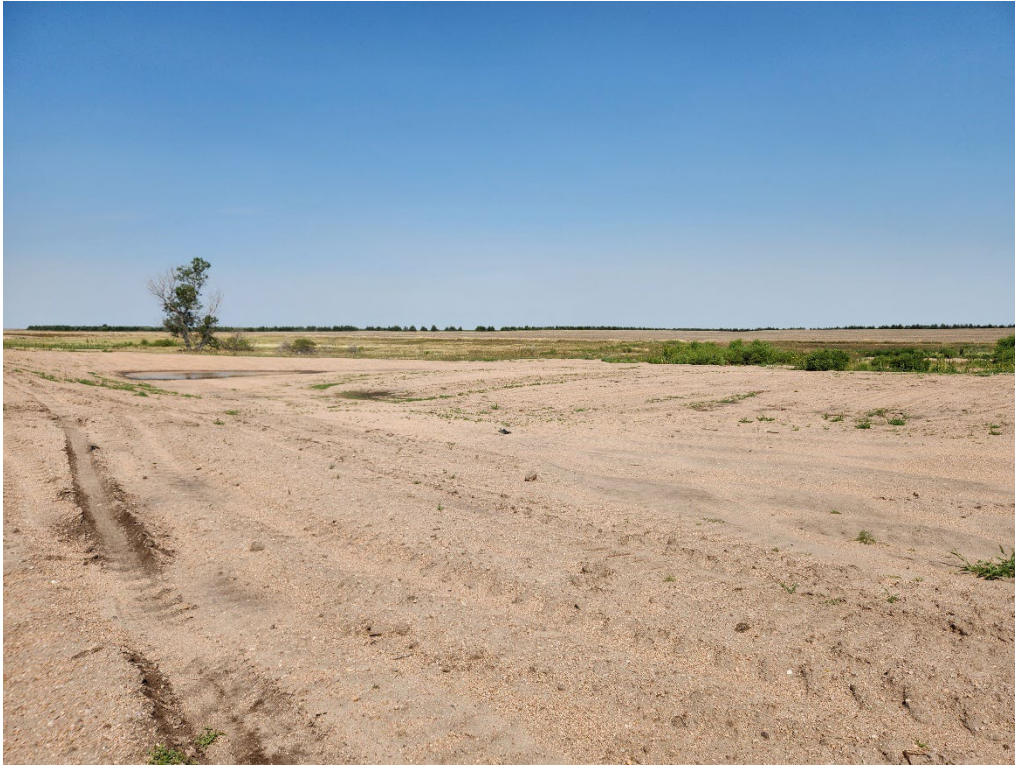
**Photo 3.** Graded pit floor located in the eastern permit area, looking northeast.

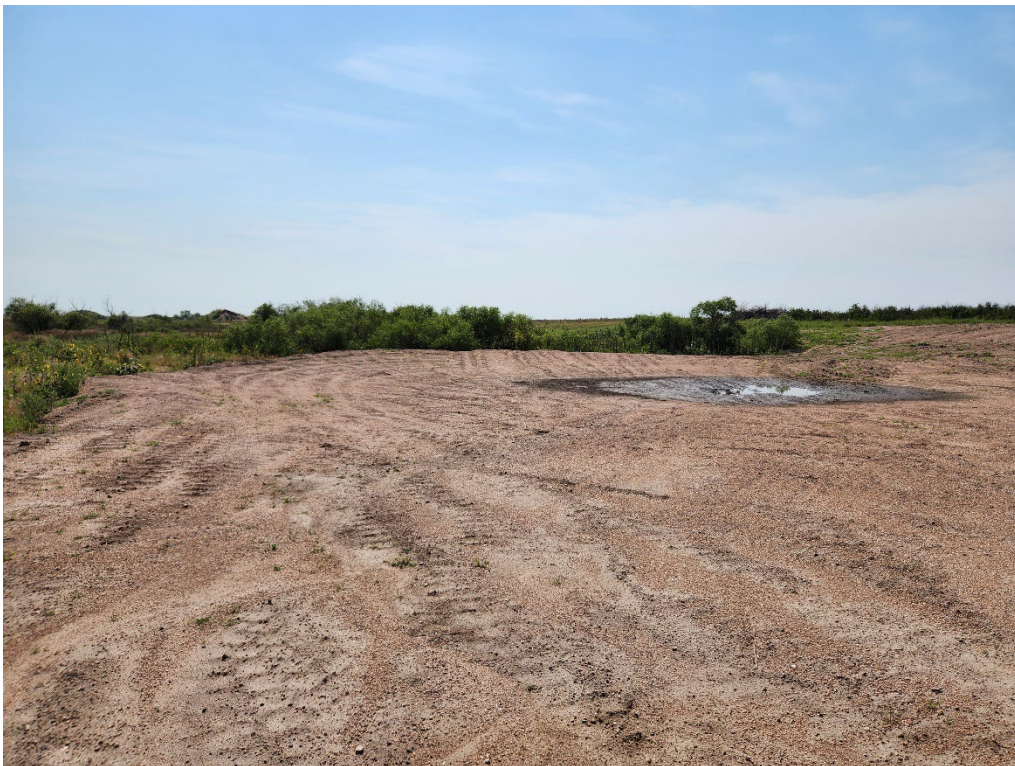
**Photo 4.** Slopes that have been graded to be steeper than 3H:1V, looking south.

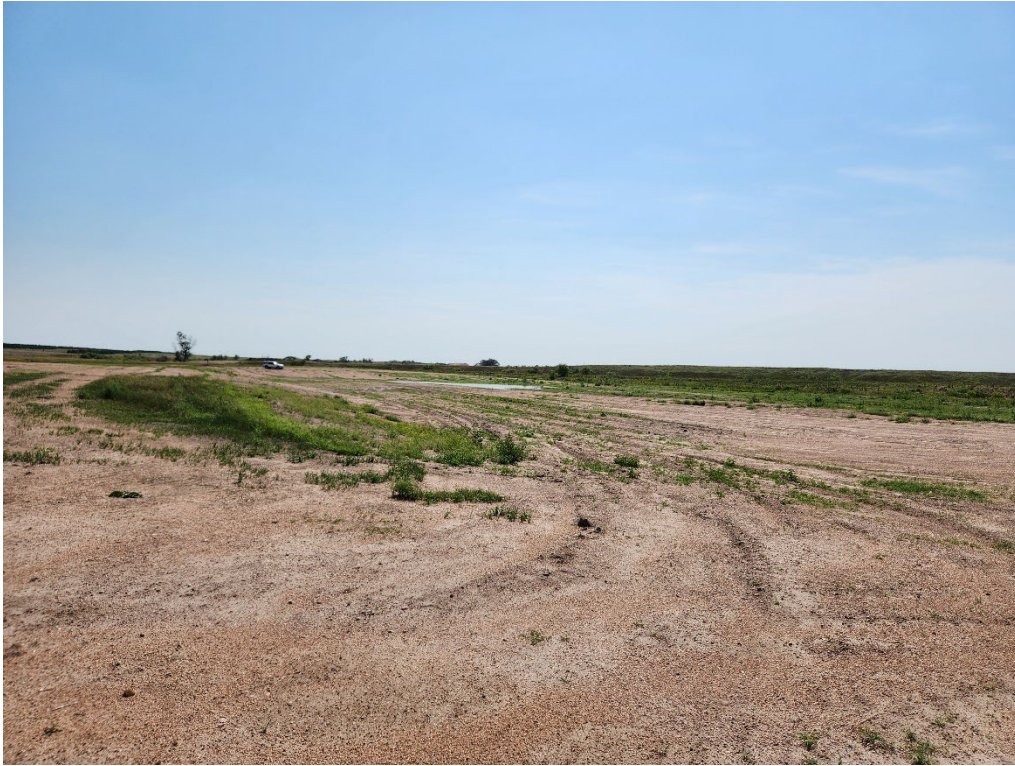
**Photo 5.** Graded pit floor, looking west.

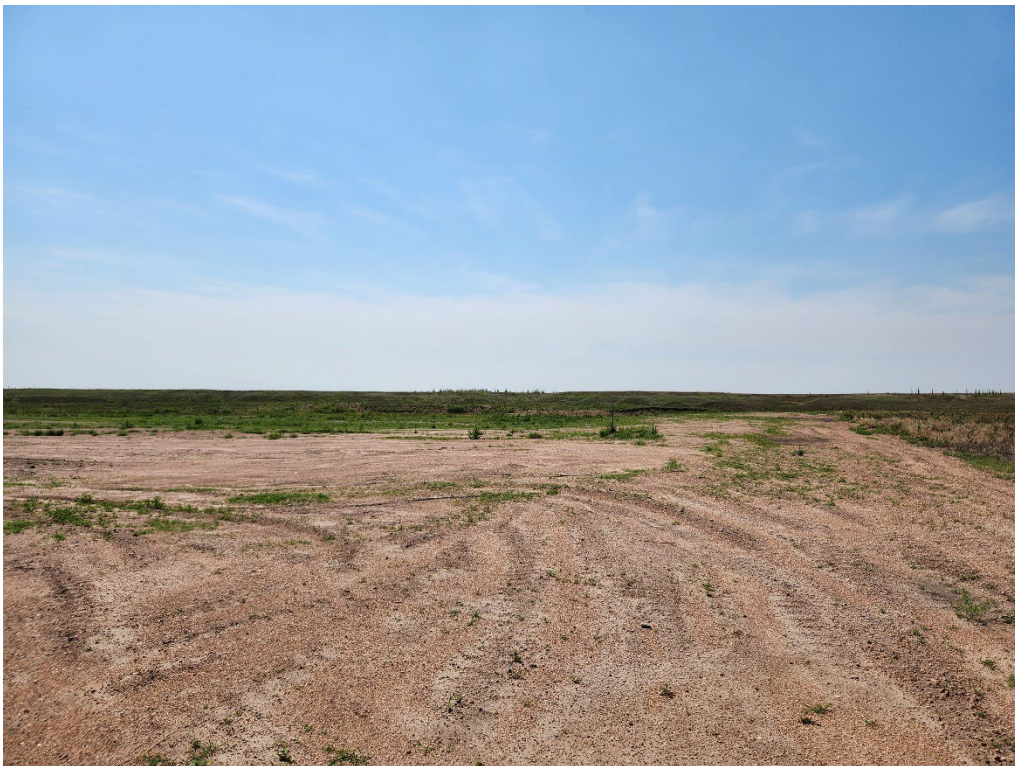
**Photo 6.** Graded edges of the pit floor, looking south.
