## Williams Fork Mines, C-1981-044, Partial Inspection 8/28/2025

## COLORADO

Division of Reclamation,  
Mining and Safety

| <b>Permit Number:</b> C-1981-044<br><b>Mine Name:</b> Williams Fork Mines<br><b>Operator:</b> Moffat County Mining, LLC<br><b>Operator Address:</b><br>Mrs. Miranda Kawcak<br>29515 Routt County Road #27<br>Oak Creek, CO 80467 | <b>County:</b> Moffat<br><b>Operation Type:</b> Underground<br><b>Permit Status:</b> Active<br><b>Ownership:</b> Private |

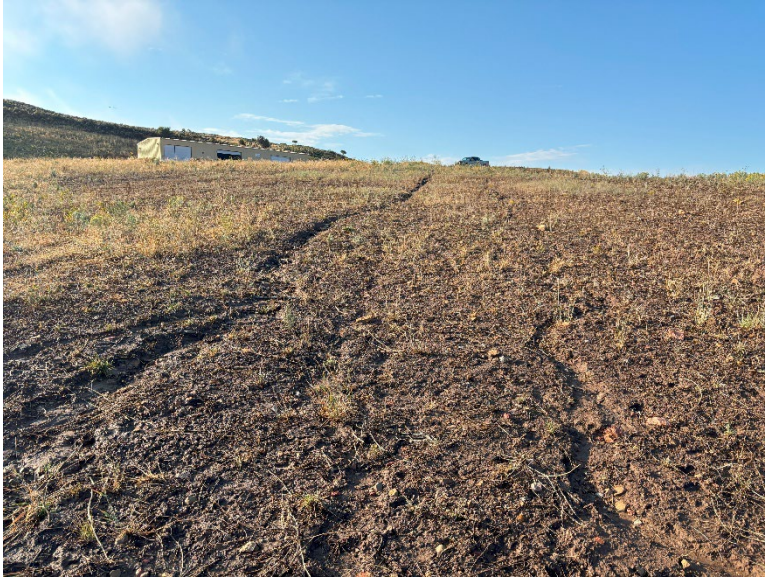
The #5A Portal Area was observed. The slope above impoundment 5A-P1 has a few rills beginning to form where the vegetation is not well established. SPL will need to monitor this area and conduct repairs if necessary. It should be noted there had been significant rainfall in the area prior to the inspection.

Figure 1. Slope above pond 5A-P1. Rills observed.

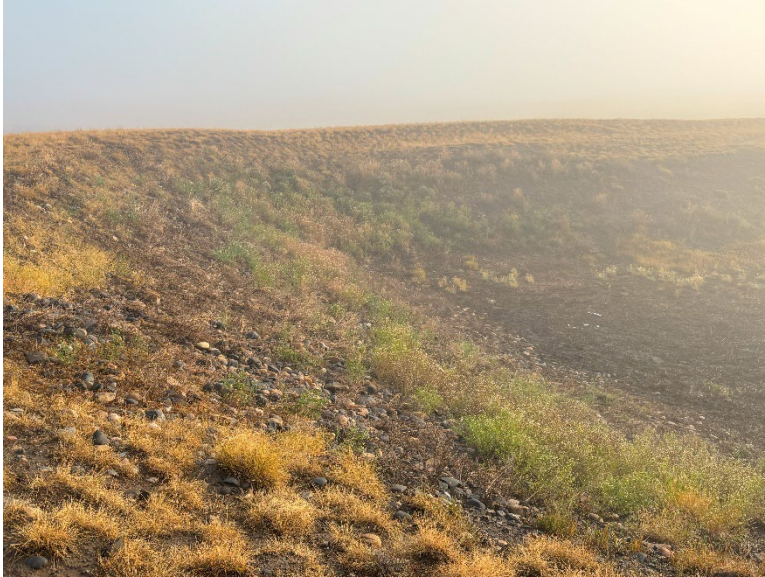
Impoundment 9-P1 was observed. The pond was dry. **The embankment was stable, but a large patch of knapweed was observed on the interior pond slopes. SPL will need to treat this area with a appropriate herbicide.**

*Figure 2. Impoundment 9-P1. Knapweed observed on interior pond slopes.*

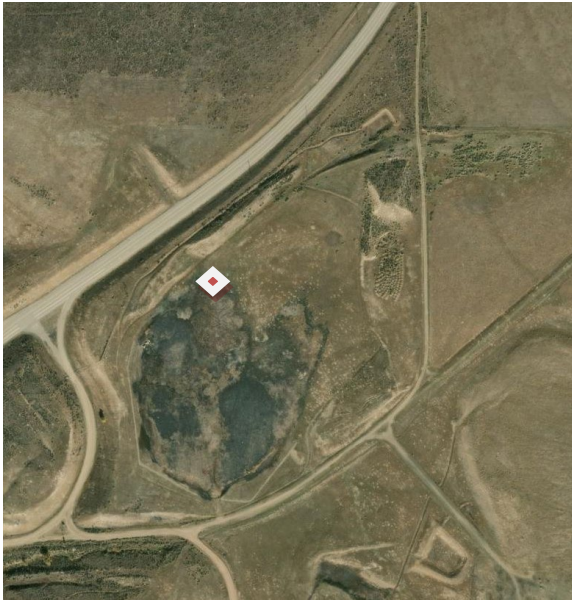
The coal refuse disposal area was observed. This area was stable and vegetated. **A patch of knapweed was observed near the northeast end of the pile (see the figure below for the location of the knapweed patch). This area will need to be treated with an appropriate herbicide.**

*Figure 3. Knapweed patch location*

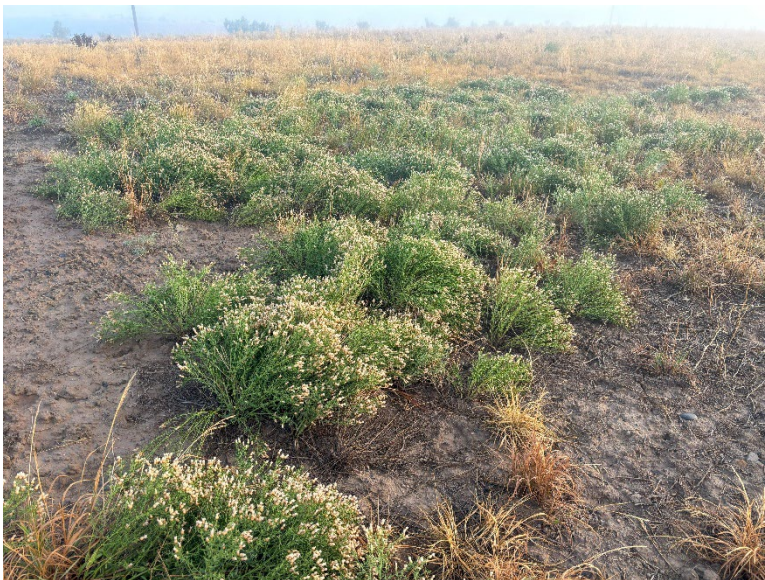
*Figure 4. Knapweed patch on Coal Refuse Area.*

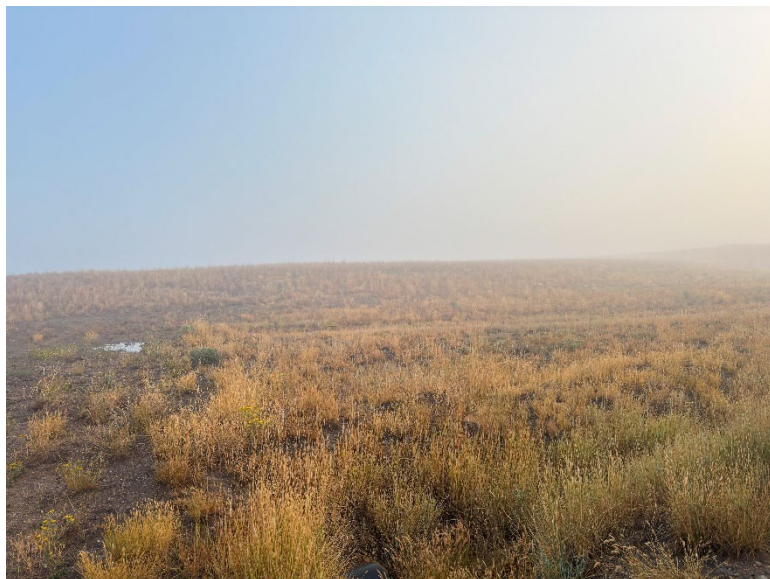
*Figure 5. Coal Refuse Pile from southwest end looking northeast.*

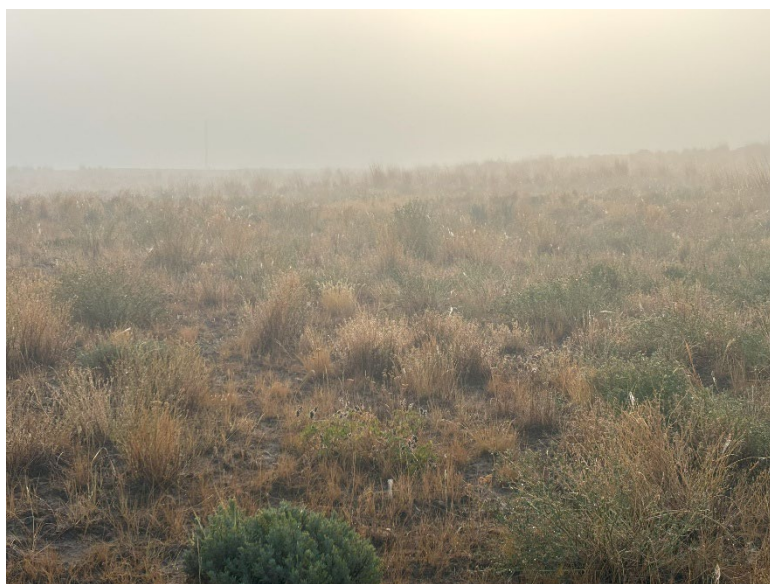
The No. 9 Portal refuse area was observed. This area was stable and vegetated.

*Figure 6. No. 9 Portal Area*

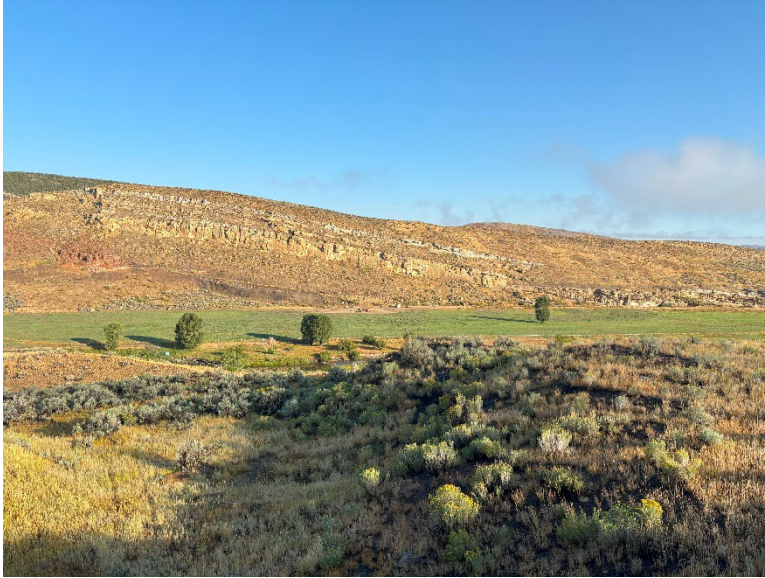
The former facilities area on the west side of the Williams Fork River was observed. The reclamation of this area appears to be progressing well, and the area is actively being utilized to produce hay. Equipment was observed onsite to facilitate the hay operation, and a stack of hay bales was observed.

*Figure 7. Bottom area - reclaimed facilities area being used for hay production.*

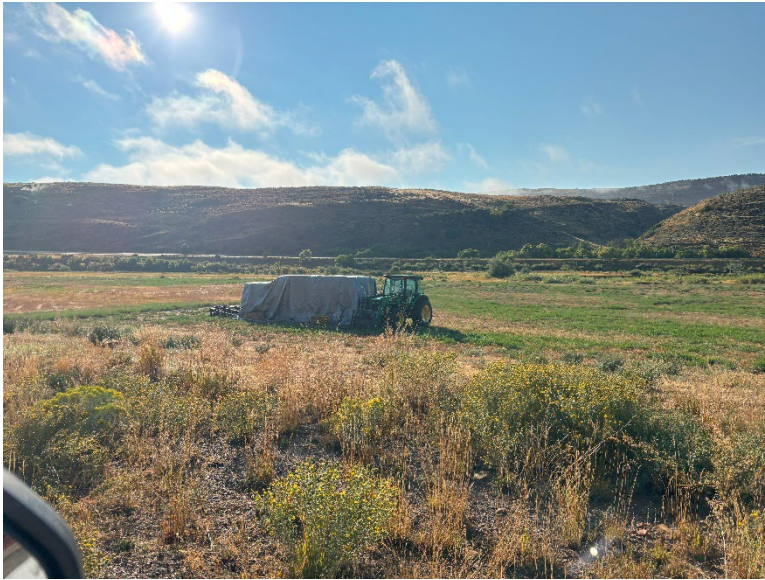
*Figure 8. Hay bales covered with tarp, stored on bottomland area where former facilities used to be located.*

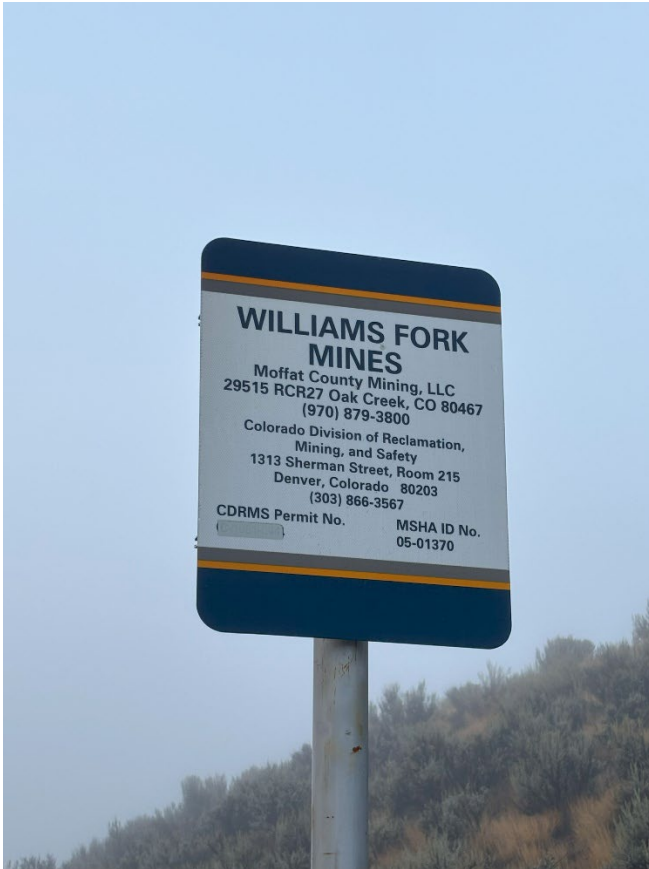
The mine identification sign was observed at the entrance to the east side of the site from Highway 13 adjacent to the refuse pile. The DRMS permit number was faded and nearly unreadable. SPL will need to repair the sign so that the DRMS permit number is legible.

*Figure 9. Mine entrance sign with faded DRMS permit number.*
