**MINERALS PROGRAM INSPECTION REPORT**  
**PHONE: (303) 866-3567**

| <b>MINE NAME:</b><br>Burton Pit | <b>MINE/PROSPECTING ID#:</b><br>M-1987-013 | <b>MINERAL:</b><br>Sand and gravel | <b>COUNTY:</b><br>Rio Grande |
| <b>INSPECTION TYPE:</b><br>Monitoring | <b>WEATHER:</b> Clear | <b>INSP. DATE:</b><br>August 25, 2025 | <b>INSP. TIME:</b><br>13:30 |

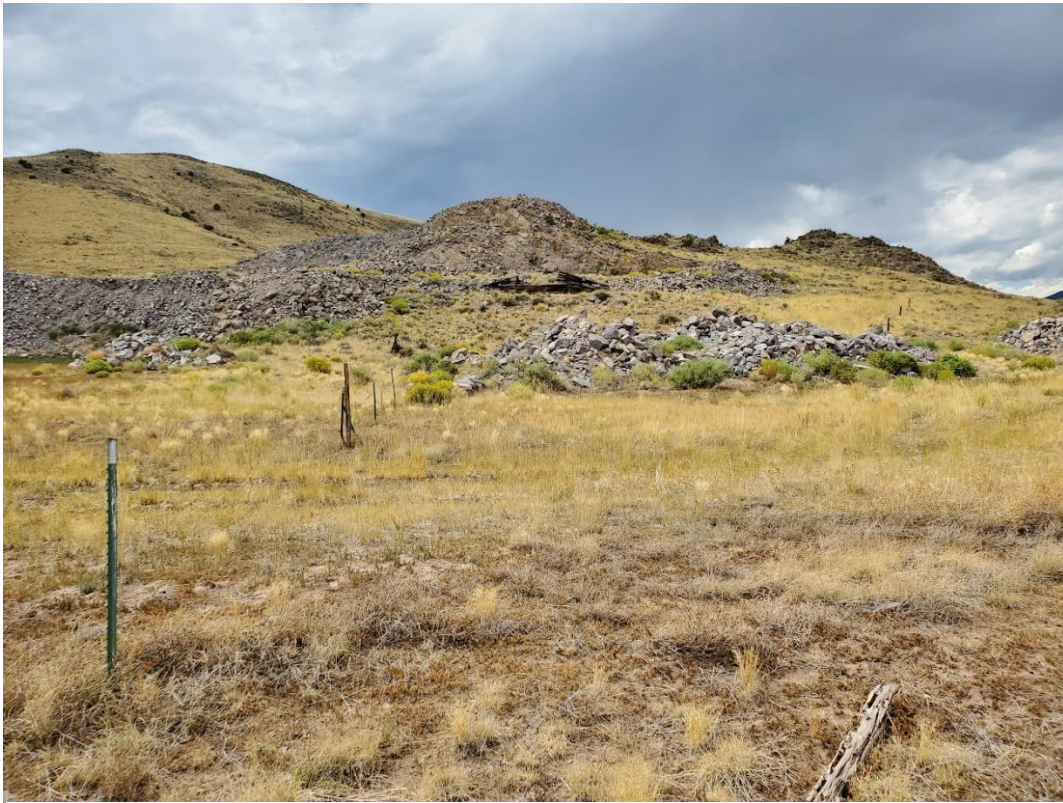
The boundary is marked by t-posts and fence line that are easily distinguishable. The new operator will create a new mine ID sign once the SO process is approved.

Photo 1: View to the west of southern permit boundary.

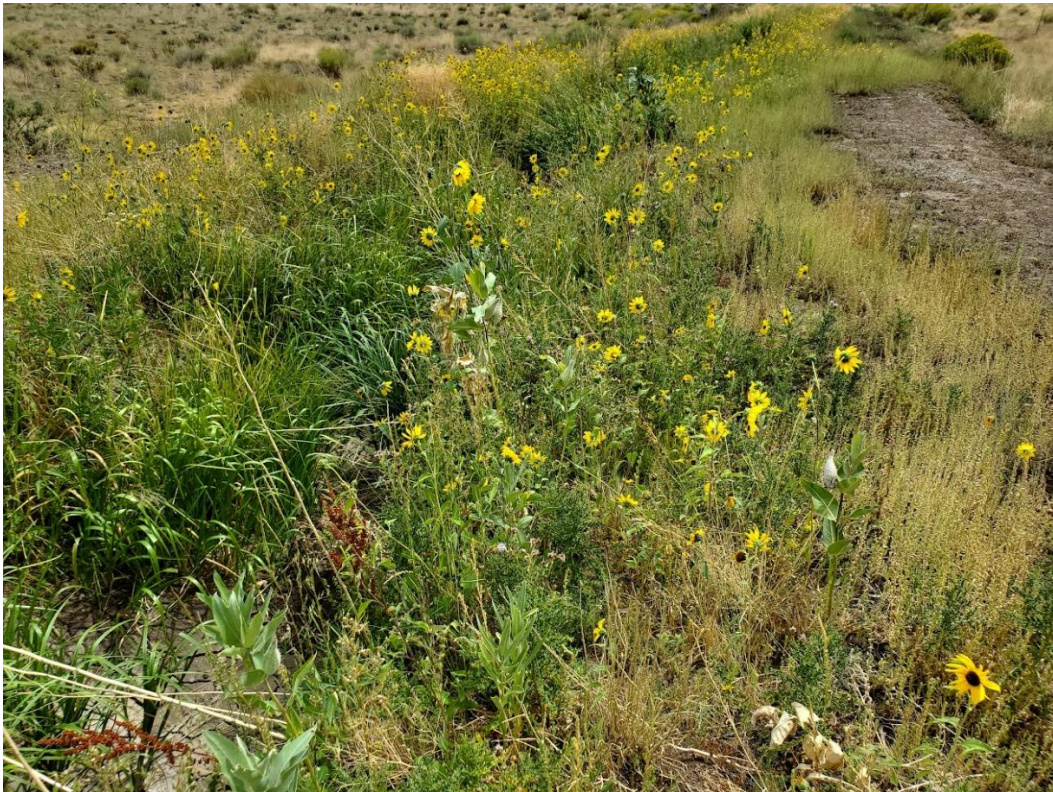
No groundwater has been exposed withing the permit area. The Schuch & Schmidt Ditch runs within 200 feet of the eastern permit boundary. The canal is currently dry. No meteoric water was observed to be impounded within the permit area. No hydrocarbons are stored within the permit area and not evidence of spills were noted during the inspection.

Photo 2: View to the southeast of ditch that runs near the permit boundary.

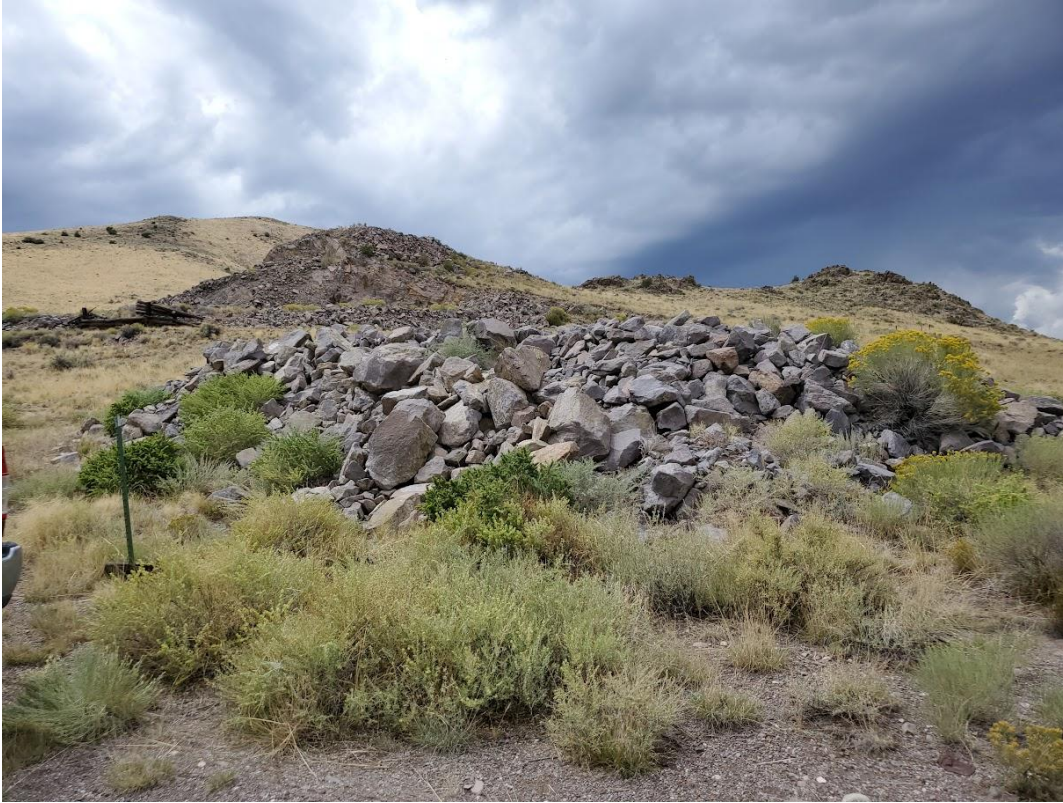
No mining operations are occurring withing the permitted boundary. The permit area was recently reduced to 2 acres. There are historic mining areas in the site as stockpiles of material. The multiple stockpiles can be used as riprap material or crushed into smaller material.

Photo 3: View to the southwest of stockpile and historic mining area.

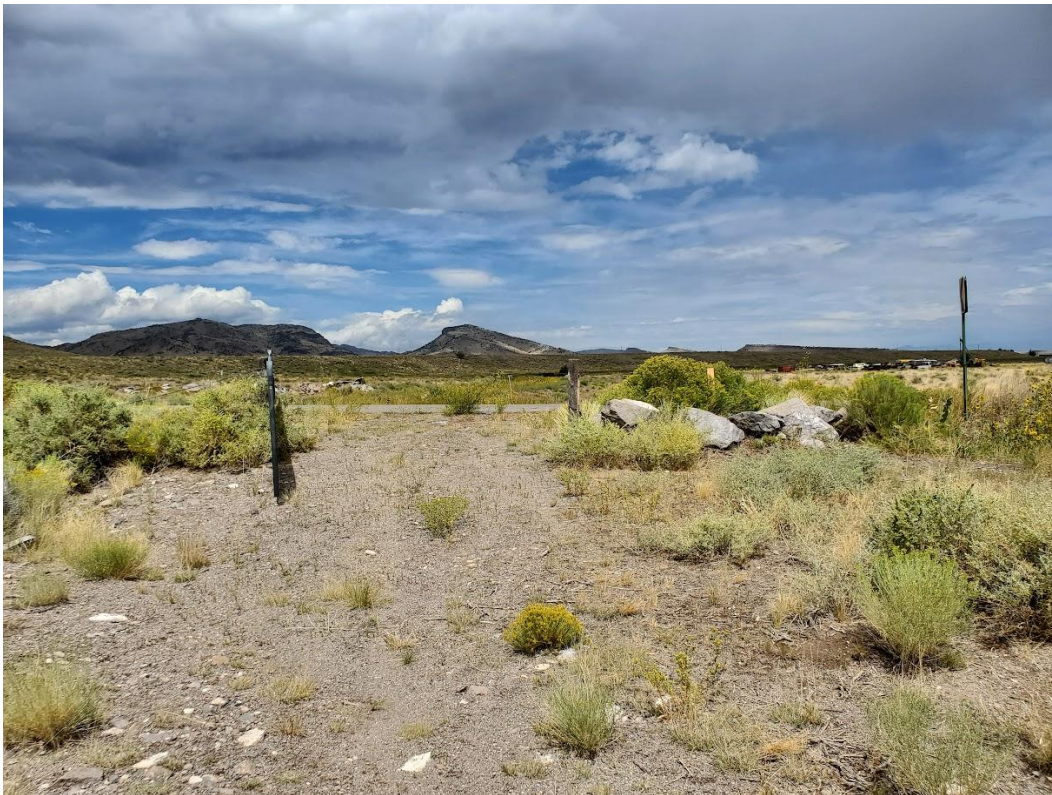
Photo 4: View to the north of the entrance to the site.
