## King Coal Mine, C-1981-035, August Complete Inspection Report

**PERMIT INFORMATION**

**INSPECTION INFORMATION**

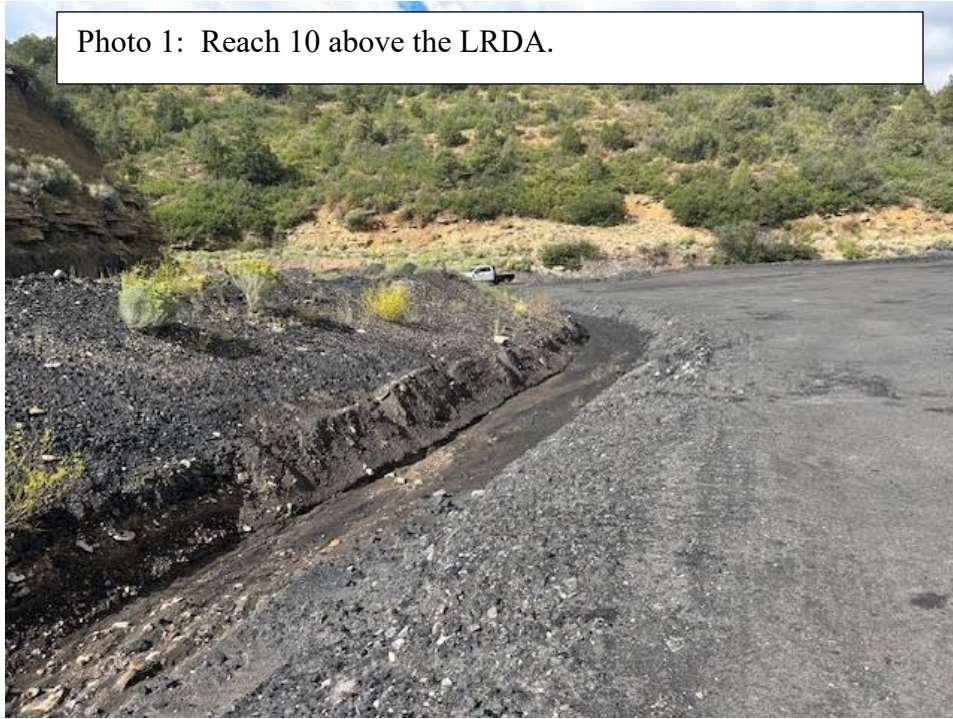
Reach 10 was observed to be clear of debris (Photo 1). The ditch was stable and there were no erosional concerns identified. There was no flow through Reach 10 during the inspection.

Photo 1: Reach 10 above the LRDA.

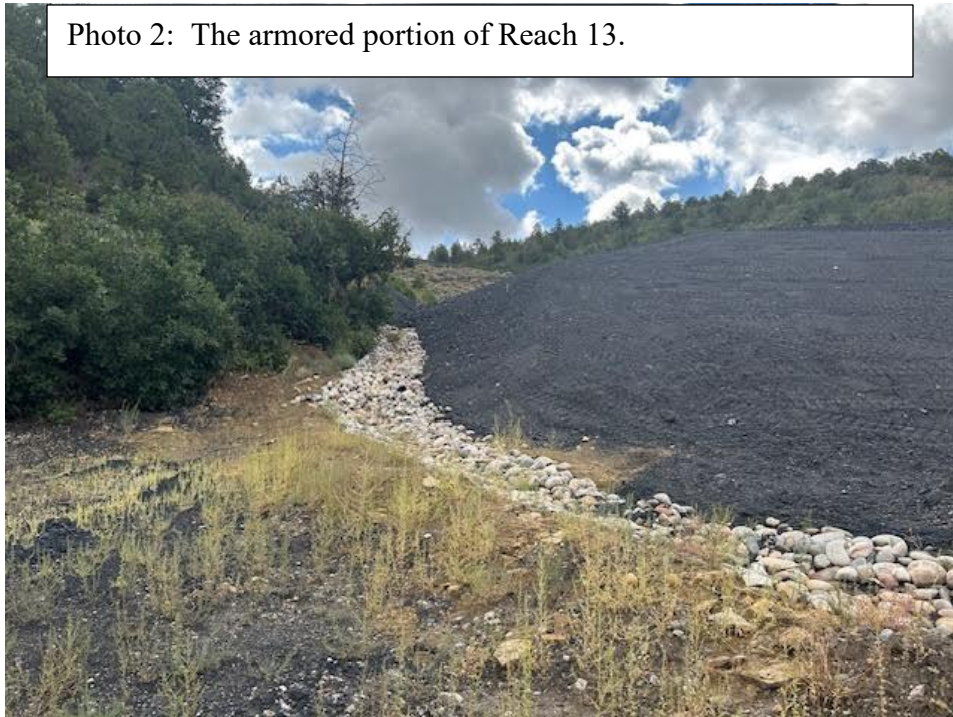
Reach 13 was damp during the inspection. The channel was stable with no erosional concerns noted. The armored portion of the channel along the eastern side of the LRDA was stable and in good repair (Photo 2). The armored portion of the channel connected to the drain inlet was stable and in good condition. The inlet to the drain was clear of debris.

Photo 2: The armored portion of Reach 13.

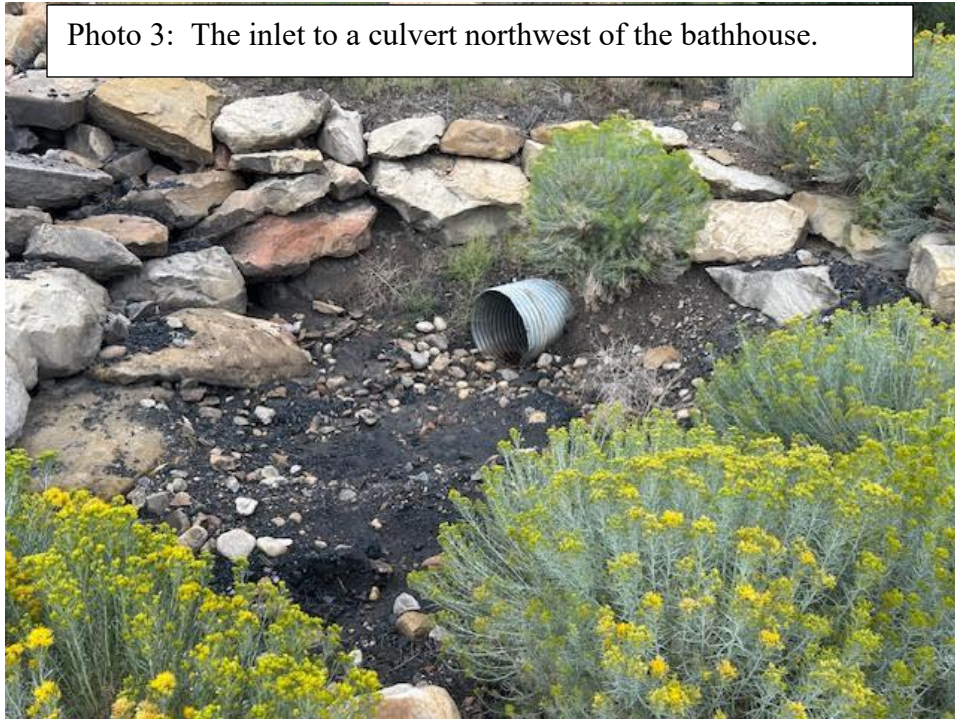
Culverts located within the main facilities pad direct runoff to the east and west sediment ponds. The culverts were clear of debris (Photo 3). There were minimal amounts of sediment deposited at the inlets and outlets of the culverts.

Photo 3: The inlet to a culvert northwest of the bathhouse.

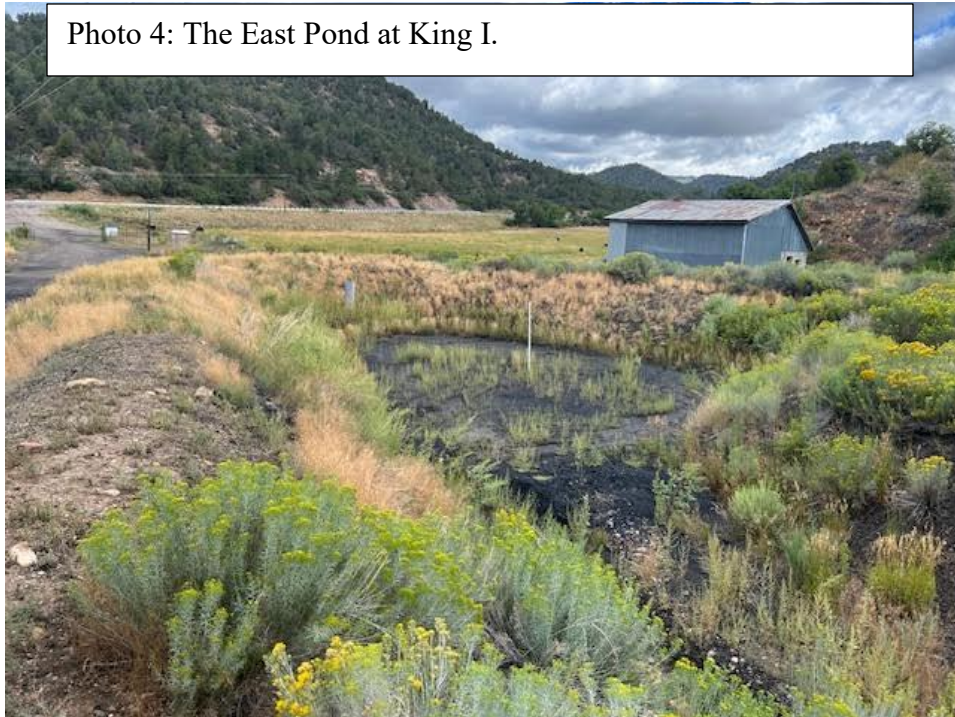
The east pond was mostly damp in the bottom (Photo 4). The culvert inlet for the pond was clear of debris. The outlet for the pond was also clear of blockages. The embankment was stable with vegetative cover. There were erosional features identified.

Photo 4: The East Pond at King I.

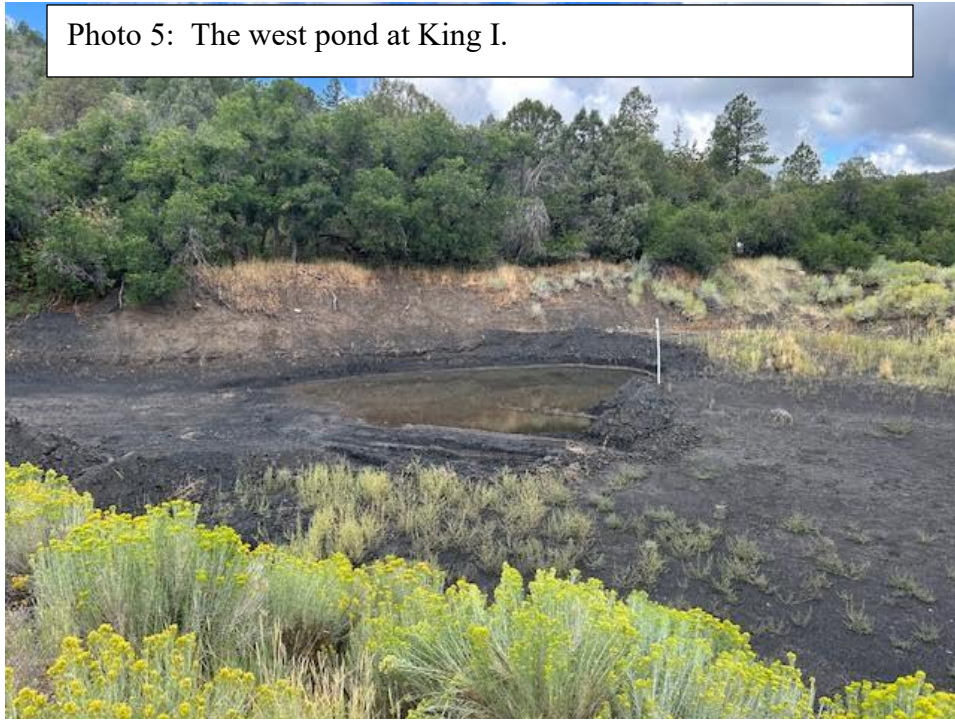
The west pond was holding a small amount of water during the inspection (Photo 5). The water in the pond was below the discharge outlet. The inlet to the pond was damp and clear of debris. The pond's outlet was also clear of obstructions. The embankment was stable with vegetative cover. No erosional features were identified.

Photo 5: The west pond at King I.

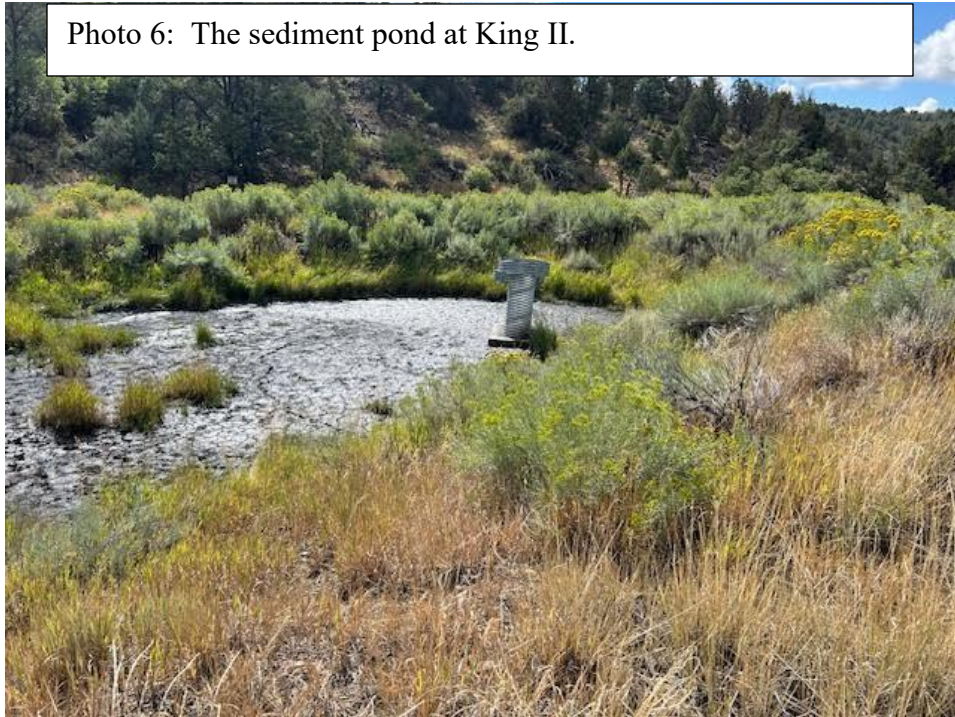
The sediment pond is located on the south end of the King II facilities. At the time of the inspection the sediment pond was holding water. The level of water impounded in the pond was below the primary outlet (Photo 6). The discharge outlet was clear of debris. The embankments were covered with vegetation and stable. No indications of erosion were identified.

Photo 6: The sediment pond at King II.

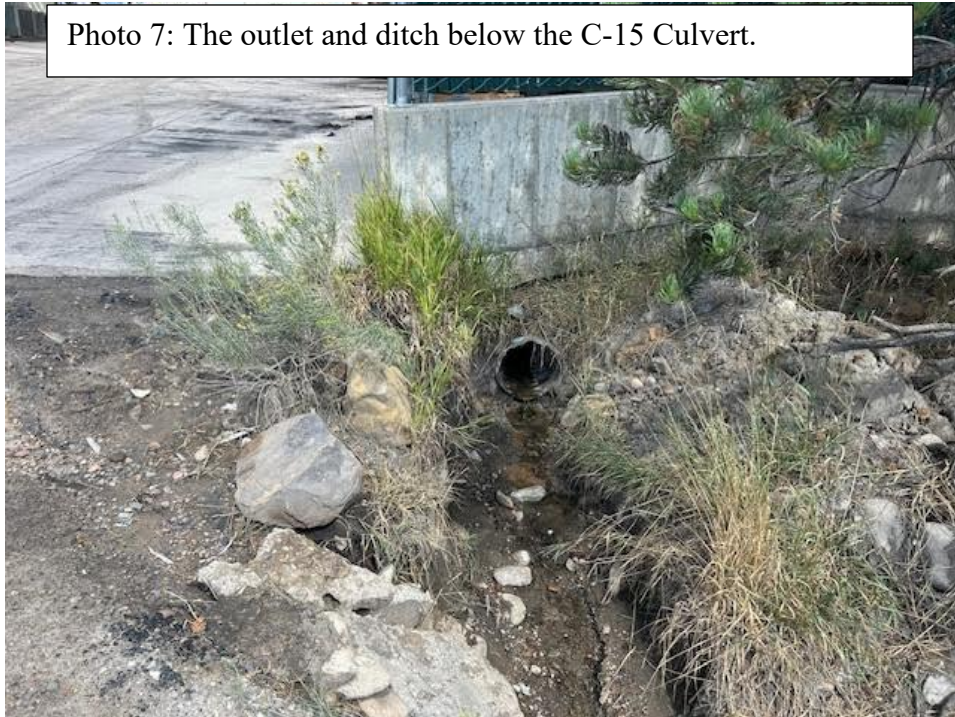
Facilities drainage ditches and associated culverts within the King II area report to the sediment pond. The drainage ditches were conveying water during the inspection. The ditches were noted to be clear of debris (Photo 6 and 7). There were no erosional features or indications of instability. The culvert inlets and outlets throughout

Photo 7: The outlet and ditch below the C-15 Culvert.

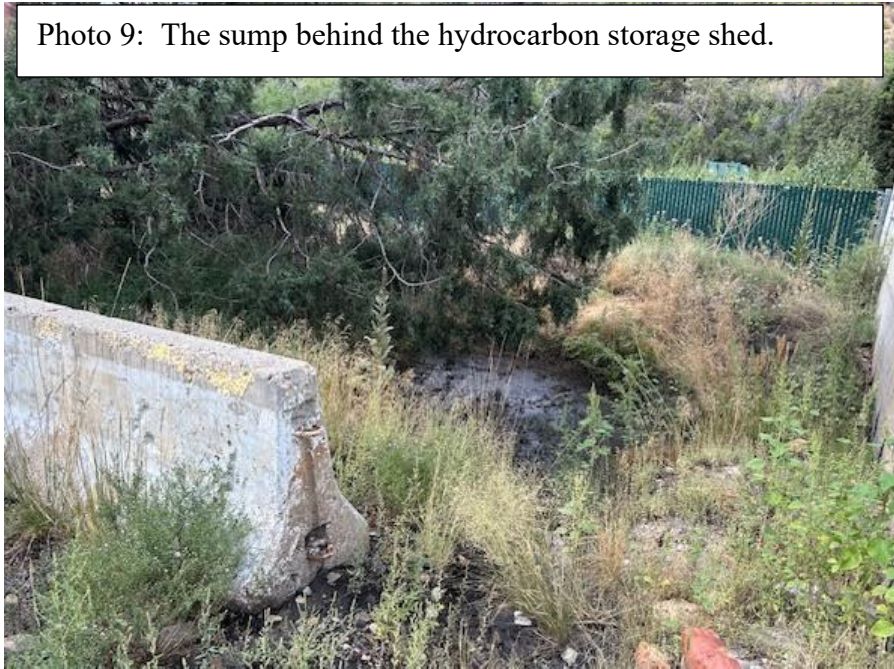
The sump located on the east side of the hydrocarbons/fuel storage shed was damp during the inspection (Photo 9). There were no erosional features or indications of instability observed. The discharge outlet for the sump was clear of debris.

Photo 9: The sump behind the hydrocarbon storage shed.

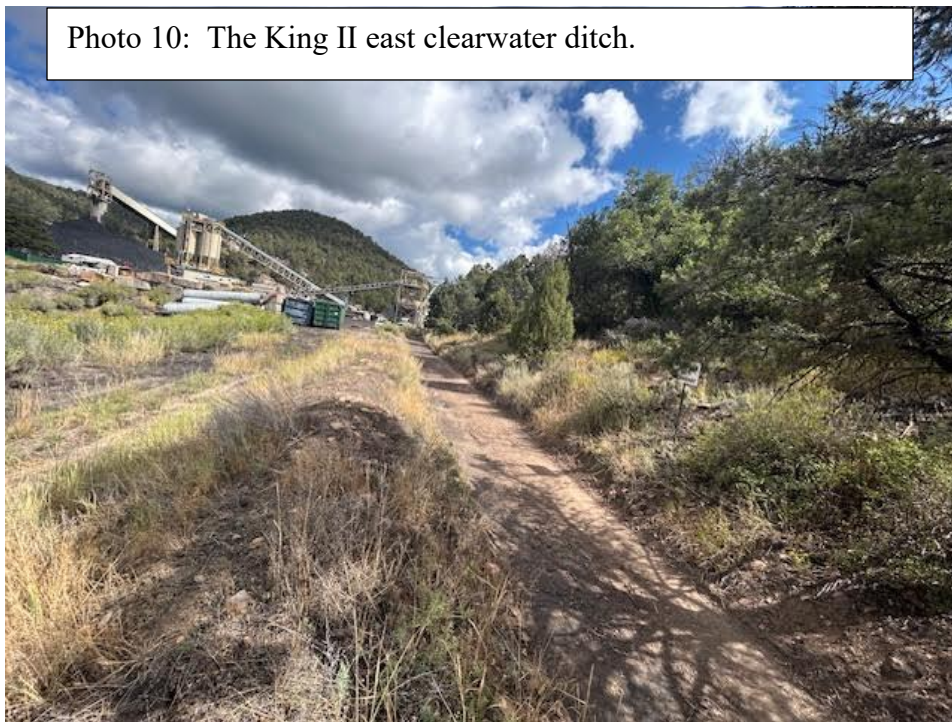
Two clearwater diversion ditches, the east and west clearwater ditches, are located within the King II Facilities. The east clearwater ditch was damp during the inspection (Photo 10). The east ditch was clear of debris. There were no erosional features. The diversion ditch was stable, and the amount of sediment had deposited in the channel was low. The west clearwater diversion starts above the northwest corner of the King II area, turns south along the haul road, and ends near the entrance to the mine site. During the inspection, the west ditch was mostly dry. There were no erosional features observed (Photo 11). The channel was unobstructed and stable.

Photo 10: The King II east clearwater ditch.

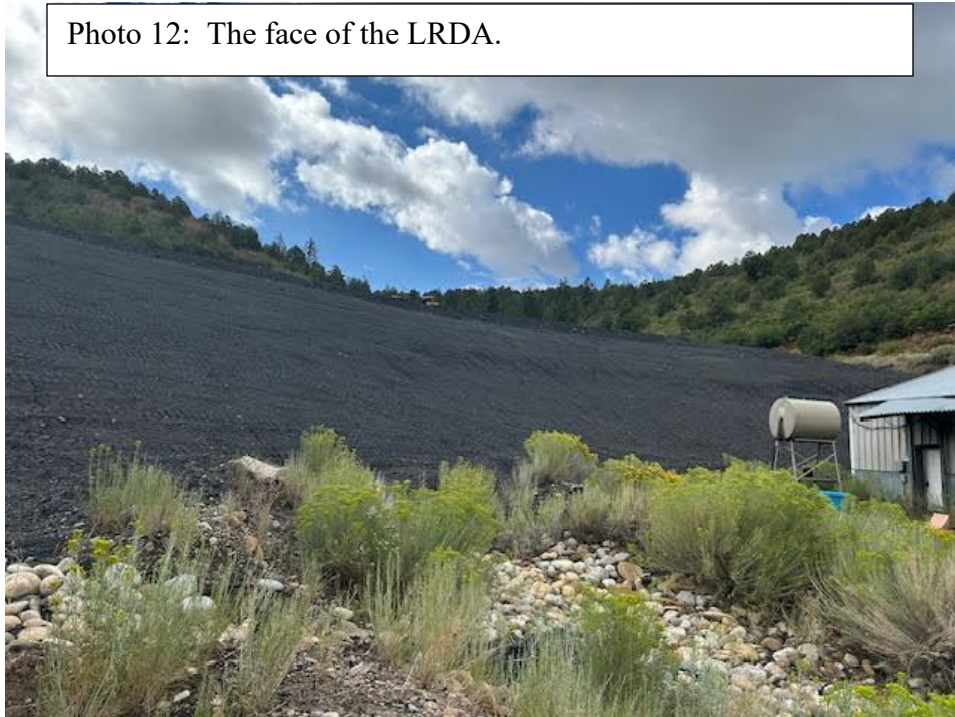
The coal waste piles are located at the King I facilities. The top of the URDA was inaccessible during the inspection due to soft ground conditions. The face of the URDA was stable with no major erosional features. Some minor rills were observed on the face of the pile. The rills have been noted in previous Division inspections and do not appear to impact the stability of the pile. The operator resurfaces the slope when the rills enlarge. The LRDA was also stable during the inspection (Photo 12). There were no erosional features on the face of the pile. A small amount of coal refuse was stockpiled on top of the LRDA (Photo 12). The material will be spread and compacted as spring conditions allow.

Photo 12: The face of the LRDA.

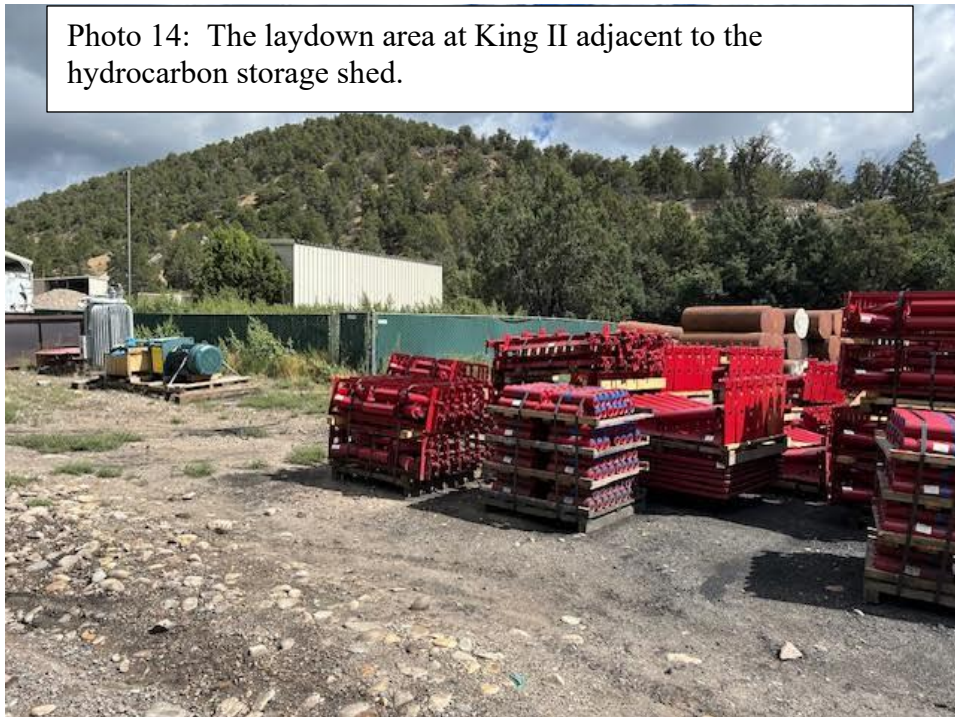
The King II facilities pad was also well kept. Materials were stored in laydown areas (Photos 14 and 15). Trash was kept within the receptacles at the south end of the facilities pad. The hydrocarbon storage shed was

Photo 14: The laydown area at King II adjacent to the hydrocarbon storage shed.

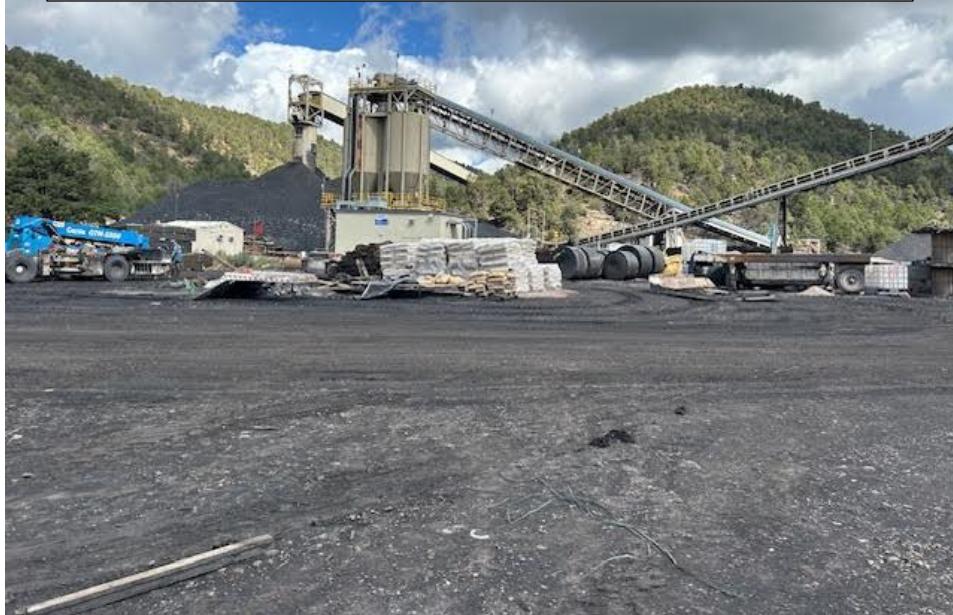
Photo 15: The laydown area north of the King II sediment pond.

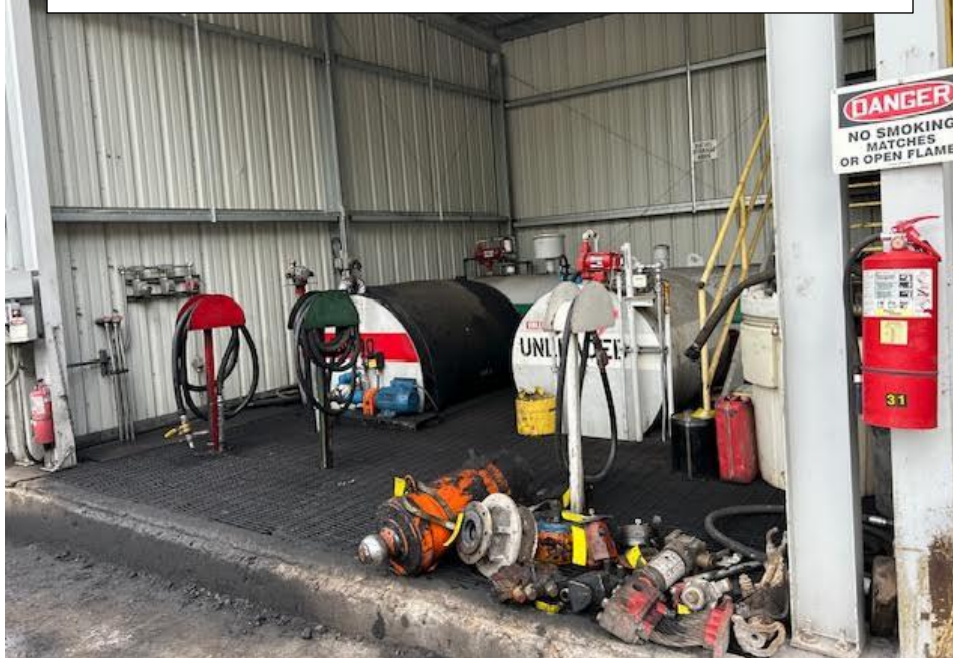
organized. All hydrocarbons were placed within secondary containment (Photo 16). The hillside to the south of Coal Stack #1 was clear of coal fines. The sediment fence installed above the clearwater ditch was in good repair.

Photo 16: The hydrocarbon storage shed.

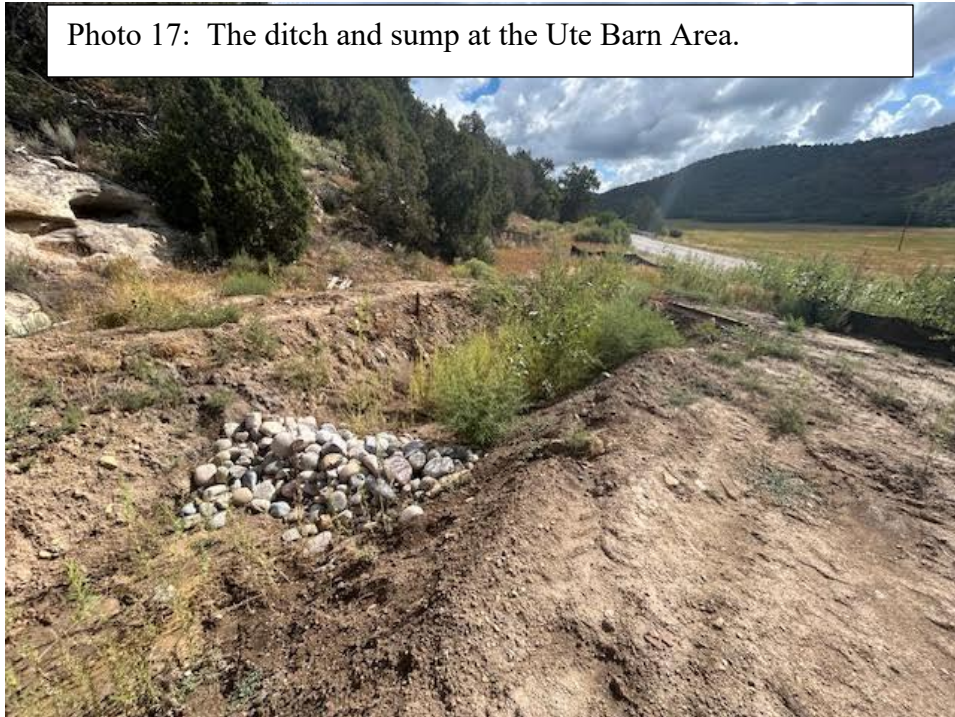
The Ute barn area was observed to be stable. There were no erosional concerns identified. The drainage ditch on the east side was clear of obstructions and sediment (Photo 17). The silt fence at the end of the sump was in good condition. There were no off-site impacts were observed.

Photo 17: The ditch and sump at the Ute Barn Area.

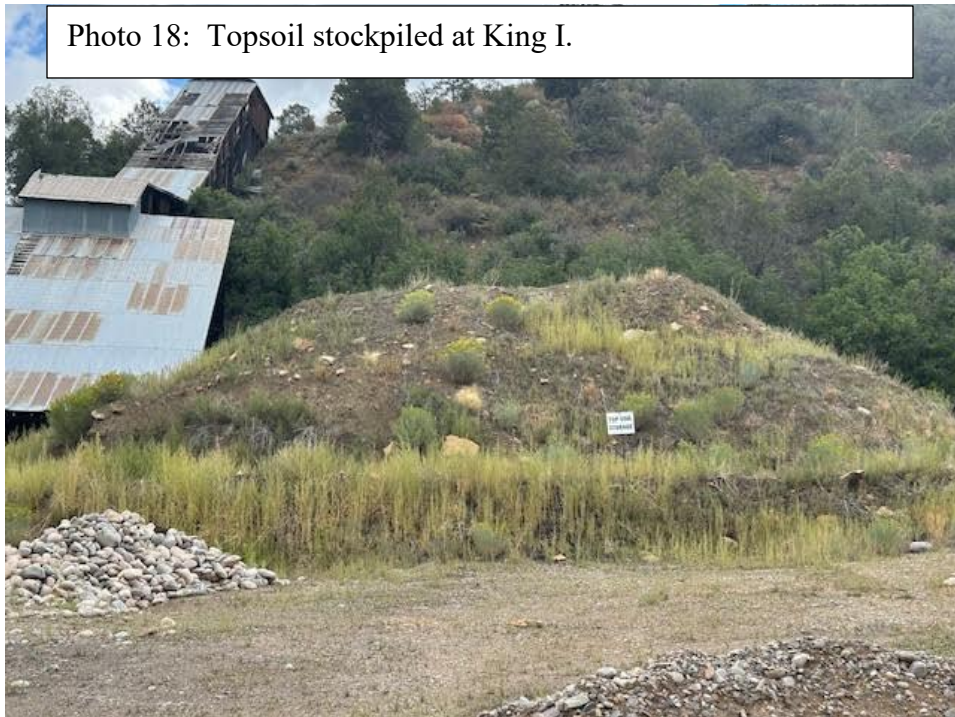
Topsoil stockpiles at the King I facilities were vegetated and stable (Photo 18). No erosional features or the loss of topsoil resources were observed.

Photo 18: Topsoil stockpiled at King I.

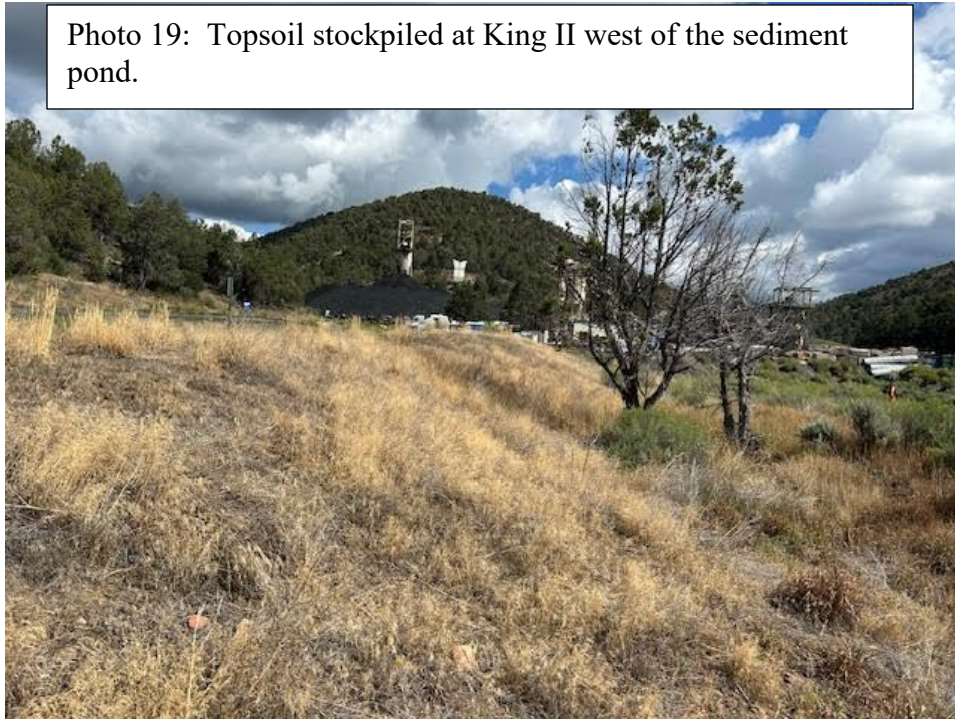
The topsoil stockpiles at the King II facilities area were stable and covered with vegetation. There were no erosional features observed (Photo 19). No loss of topsoil resource had occurred.

Photo 19: Topsoil stockpiled at King II west of the sediment pond.

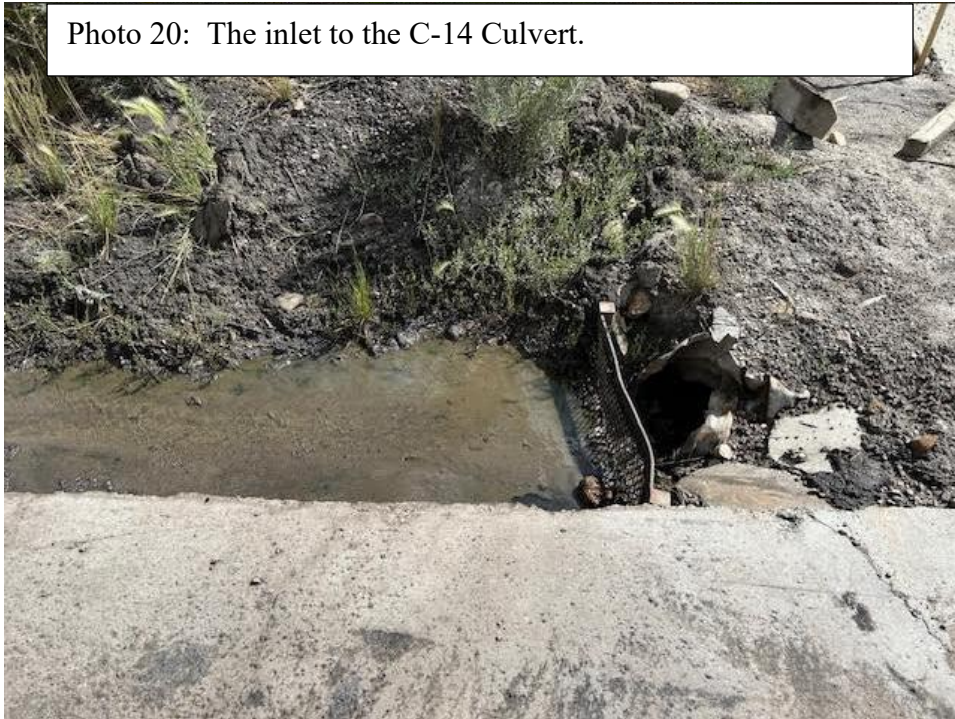
the facilities area were unobstructed. Two culverts, C-14 and C-15, required maintenance (Photo 20 and 21). The metal grates placed in front of the culvert inlets had become partly covered with debris. Both culverts were still functioning during the inspection.

Photo 20: The inlet to the C-14 Culvert.

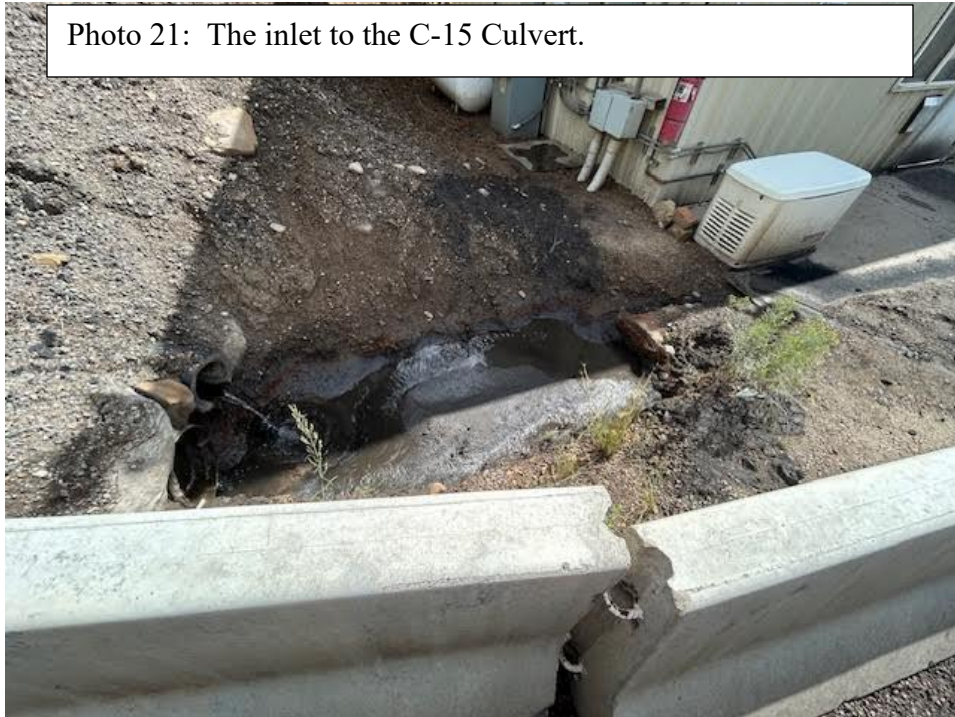
Photo 21: The inlet to the C-15 Culvert.
