**MINERALS PROGRAM INSPECTION REPORT**  
**PHONE: (303) 866-3567**

<b>MINE NAME:</b> Lava Mine	<b>MINE/PROSPECTING ID#:</b> M-2025-040	<b>MINERAL:</b> NA	<b>COUNTY:</b> Conejos
<b>INSPECTION TYPE:</b> Possible Illegal(Unpermitted Operation)	<b>WEATHER:</b> Clear	<b>INSP. DATE:</b> August 25, 2025	<b>INSP. TIME:</b> 13:00
<b>OPERATOR:</b> Red Hill Lava Products, Inc.	<b>OPERATOR REPRESENTATIVE:</b> Brandon Happel	<b>TYPE OF OPERATION:</b> Processing Facility	
<b>REASON FOR INSPECTION:</b> Citizen Complaint	<b>BOND CALCULATION TYPE:</b> None	<b>BOND AMOUNT:</b> NA	
<b>DATE OF COMPLAINT:</b> NA	<b>POST INSP. CONTACTS:</b> None	<b>JOINT INSP. AGENCY:</b> None	
<b>INSPECTOR(S):</b> Chris Girardi	<b>INSPECTOR'S SIGNATURE:</b>

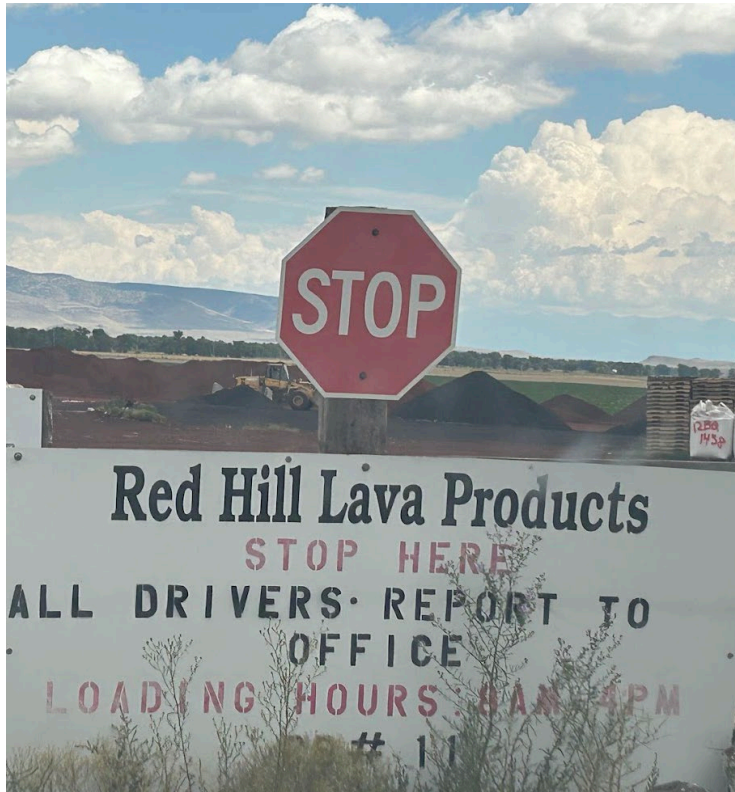
Photo 1: Entrance sign leading to the property, along with stockpiles of material, a wheel loader, and pallets.

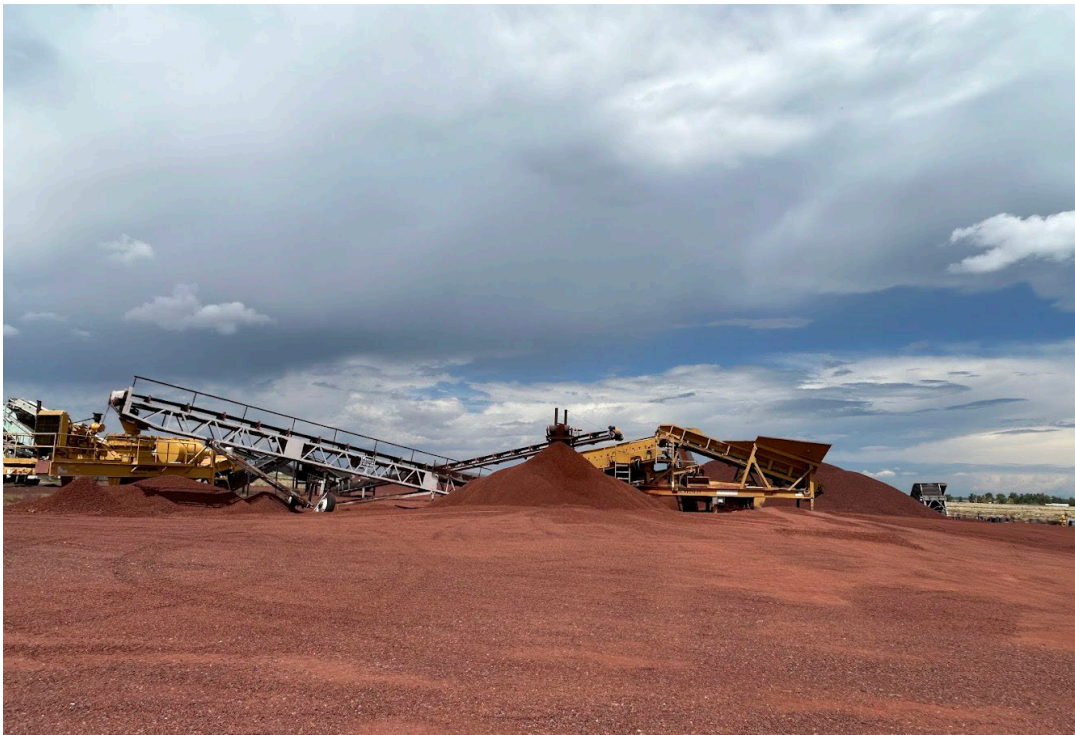
Photo 2: View of the processing area with stockpiles of red volcanic material.

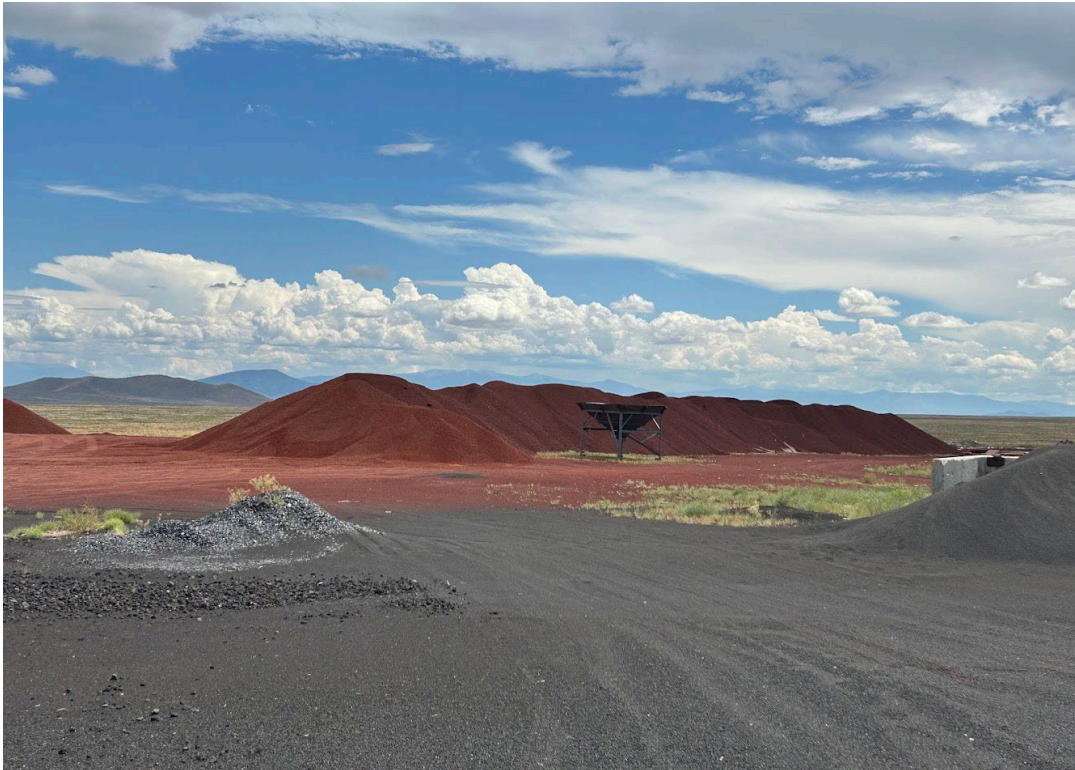
Photo 3: Stockpiles of material and a hopper feeder, facing east.

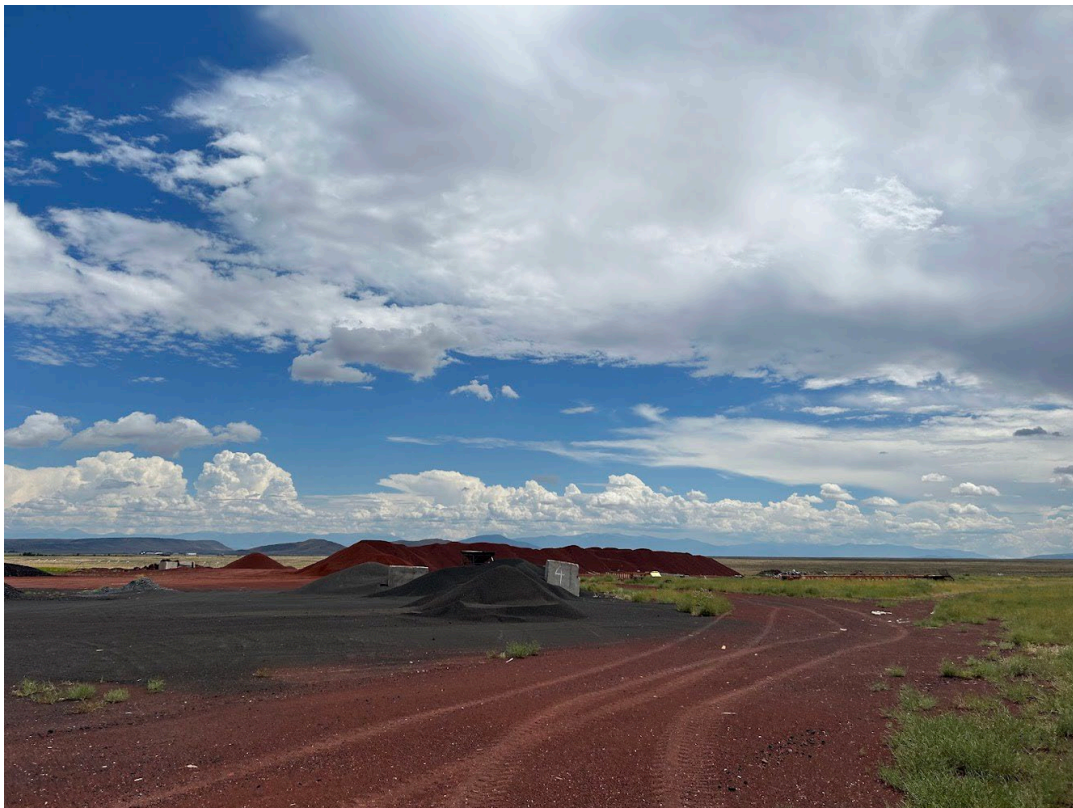
Photo 4: More stockpiles of red and black-colored material, and an equipment yard, facing southeast.

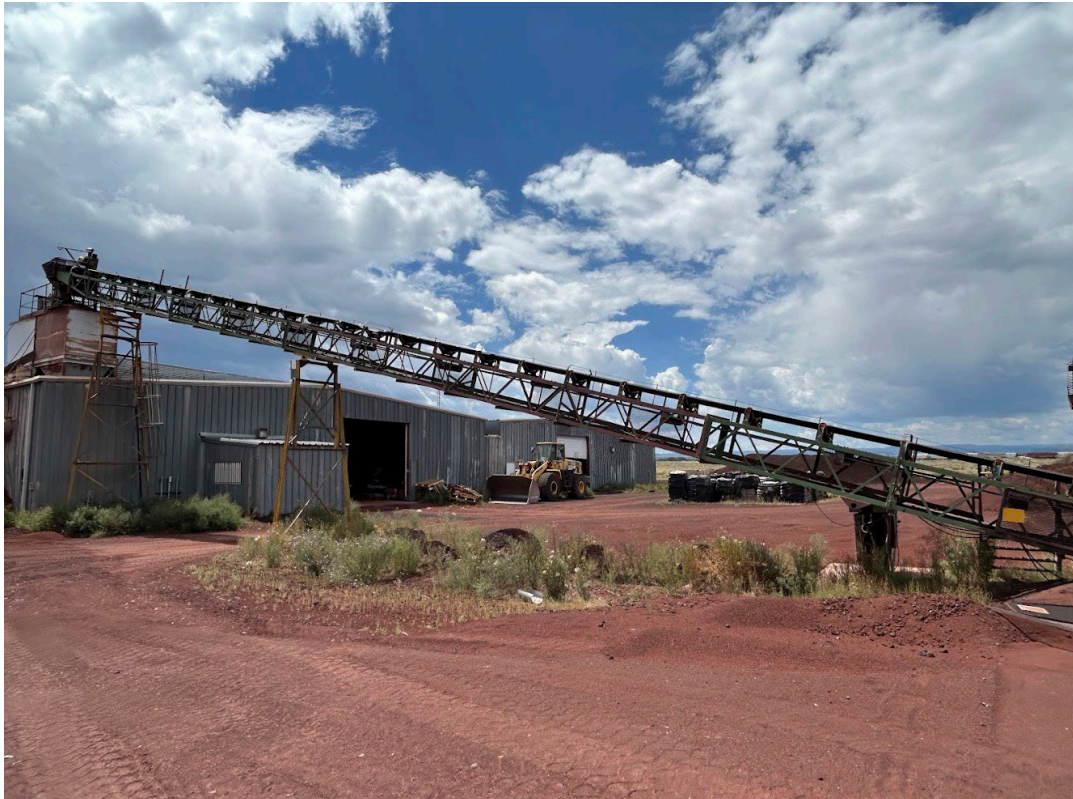
Photo 5: View of the loading garage, wheel loader, and a conveyer.
