MEMORANDUM

Date: September 9, 2025
To: Peter Hays
From: Christopher Prosper
Project: SWTP 2025
Subject: Change Order #2 Summary Completion Memorandum
Doc. No.: 25US0221_1110 - 0

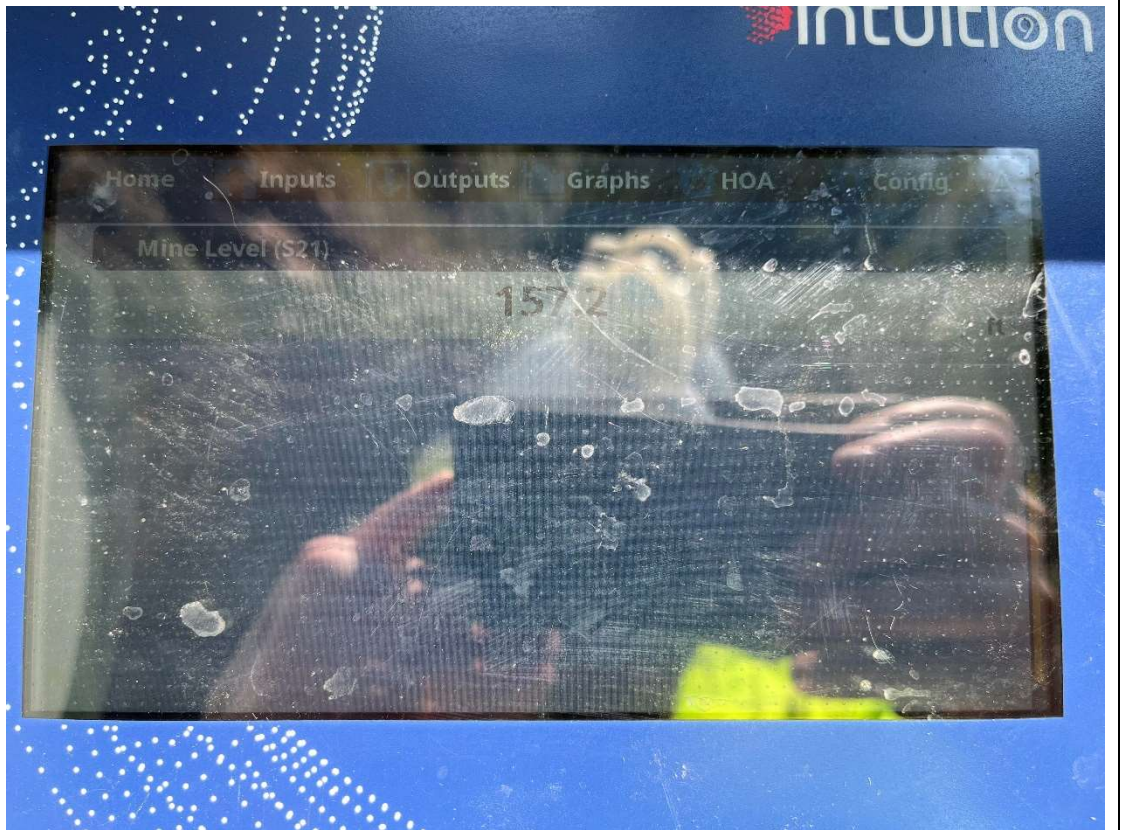
Photo 3.

Transducer PLC reading (157.2 ft) prior to the removal of the transducer from the casing

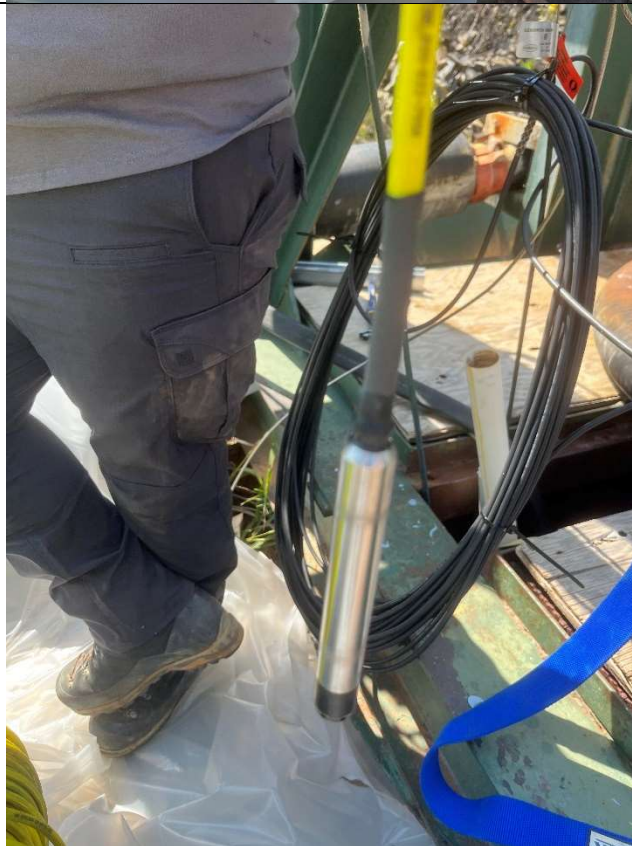
Photo 8.

11:15 AM – 11:30 AM	Removal of transducer	The transducer was slowly re-wound around the original spool during the removal process. As the transducer was being removed, the radiation levels were observed with the Ludlum 2360 meter. No damage was observed on the transducer upon removal.

Transducer removed from the casing. No visible damage was observed.

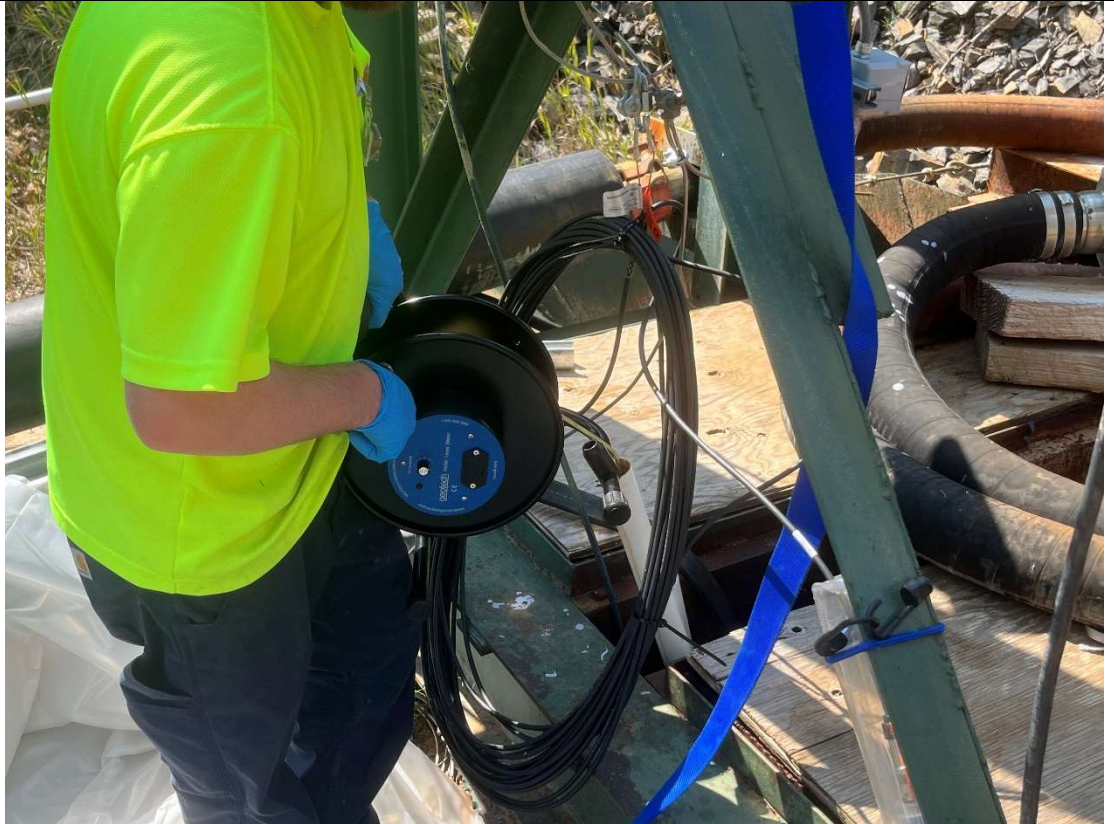
Photo 9.

11:30 AM – 11:35 AM	Lowered down depth-to-water meter	The depth-to-water meter gave a value of 470.4 ft (31.1 ft longer than expected based on the initial reading).

Lowering of the depth-to-water meter in the PVC casing

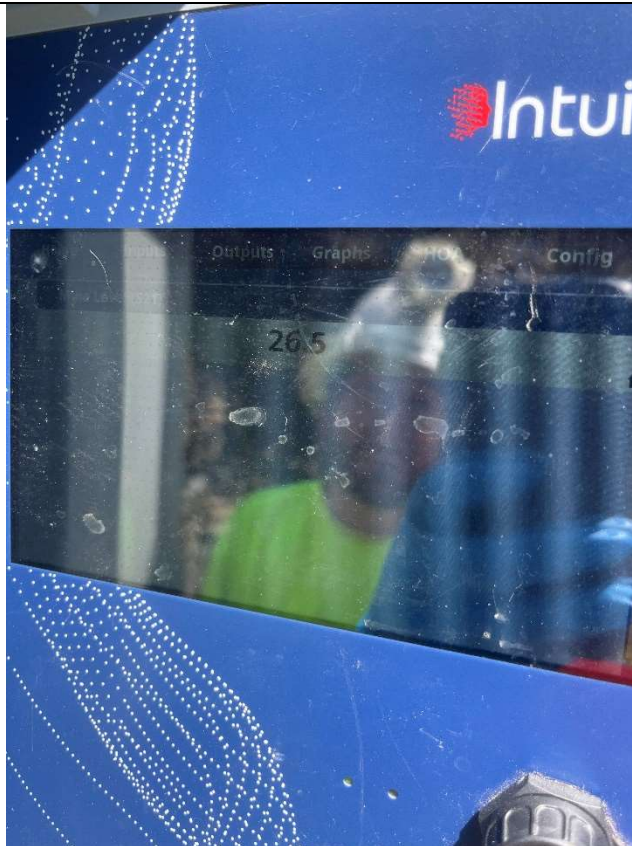
Photo 10.

11:35 AM – 11:45 AM	Troubleshooting	Since the measured value was different than expected, the transducer was connected back to the PLC to observe what reading it was recording while not at pressure. After connecting the transducer back to the PLC, the transducer was recording a value of 26.5 ft when it should have been reading 0 ft. After discussing, it was agreed among all individuals present to perform a 2-point calibration with the 0 point being at the surface and the second process calibration being when the transducer was reinstalled in the minepool.

Transducer reading (26.5 ft) on the mineframe PLC when the transducer was at the surface. The reading should have read 0 ft.

11:45 AM – 12:30 PM	Depth-to-water meter removal, transducer 0-point calibration and preparation for transducer reinstallation	The depth-to-water meter was decontaminated per SOP-3 of the RPP and kept in a bag onsite for future use.

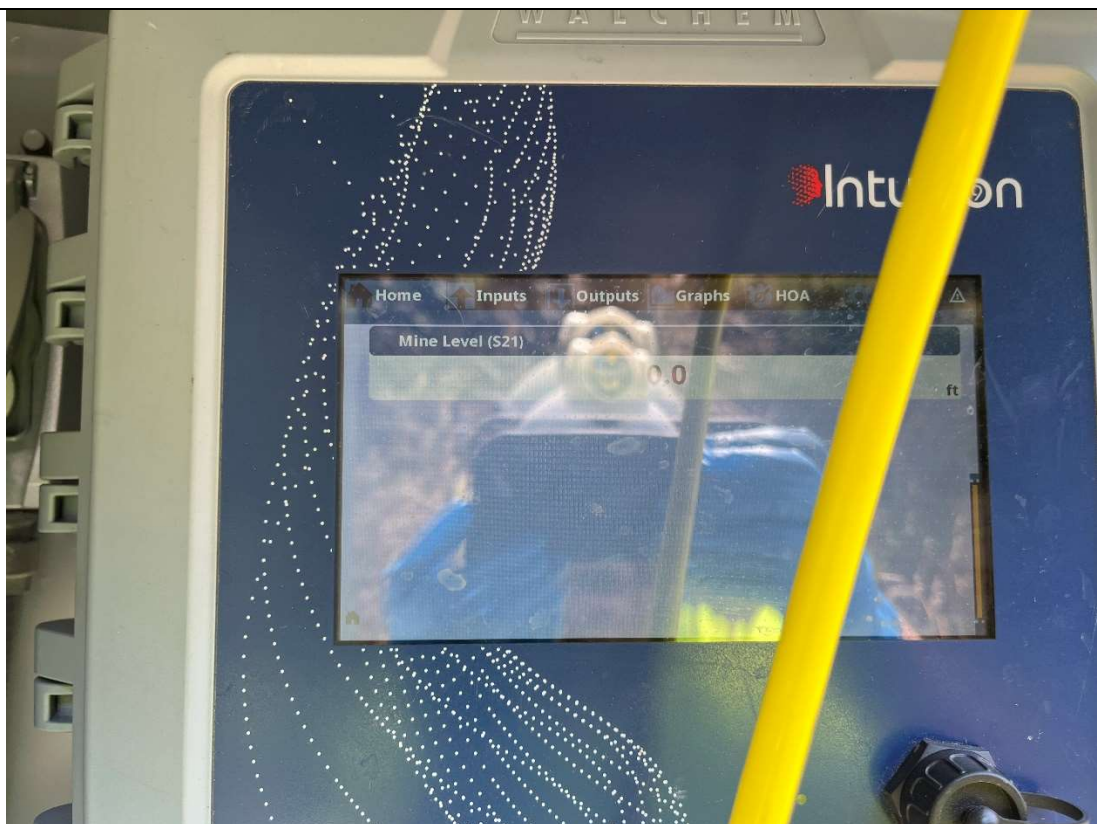
Photo 11.

Transducer reading (0.0 ft) on the mineframe PLC after performing the zero-calibration

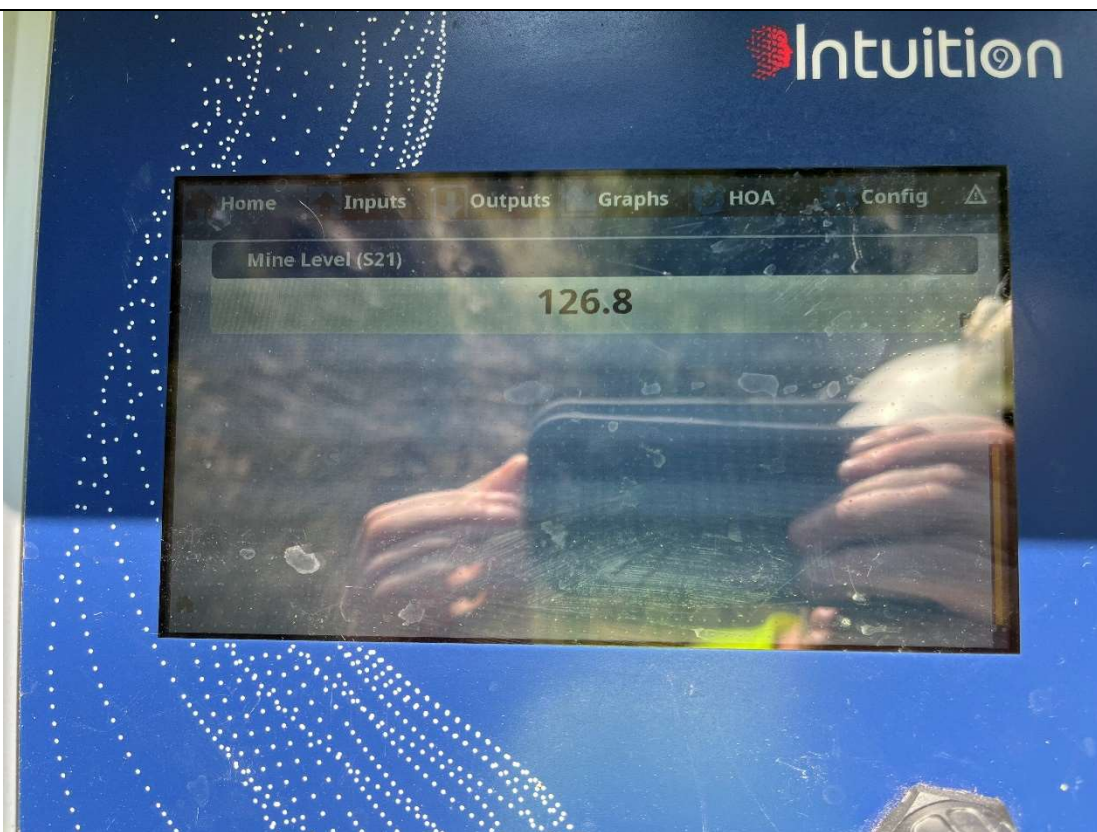
Photo 12.

12:30 PM – 01:00 PM	Reinstallation of transducer	Once reinstalled, a process calibration was performed on the transducer. The final reading of the transducer was calibrated to read 126.8 ft (169.2 ft below compliance level) . The transducer was reinstalled the same way as it was at the beginning of the work.

Transducer reading (126.8 ft) on the mineframe PLC after lowering the transducer back into the casing and performing a process calibration
