MINERALS PROGRAM INSPECTION REPORT PHONE: (303) 866-3567

MINE NAME:		MINE/PROSPECTING ID#:	MINERAL:	COUNTY:
Riley Gravel Pit		M-1978-266	Sand and gravel	Jackson
INSPECTION TYPE:		WEATHER: Clear	INSP. DATE:	INSP. TIME:
Surety-Related Inspection			September 3, 2025	11:00
OPERATOR:		OPERATOR REPRESENTATIVE:	TYPE OF OPERATION:	
Jackson County		Tom Jones	112c - Construction Regular Operation	
REASON FOR INSPECTION:		BOND CALCULATION TYPE:	BOND AMOUNT:	
Normal I&E Program		None	\$0.00	
DATE OF COMPLAINT:		POST INSP. CONTACTS:	JOINT INSP. AGENCY:	
NA		None	None	
INSPECTOR(S):	INSPE	CTOR'S SIGNATURE:	SIGNATURE DAT	`E:
Brock Bowles	Brak Sauls		September 9, 2025	
	/	ı

OBSERVATIONS

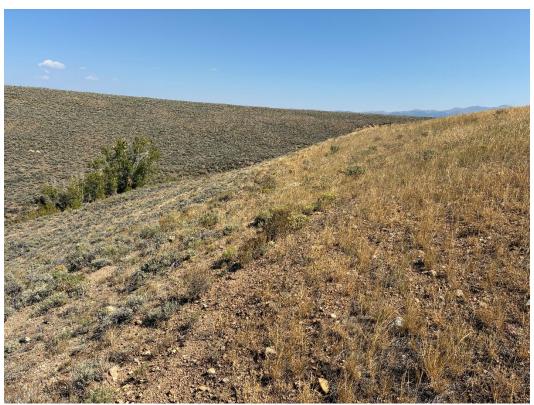
The site has been regraded and backfilled, blending seamlessly with the surrounding landscape (photo 1). The hillside appears stable, with no observed erosion. Reclamation grasses are growing in rows along the hill contour, indicating the seeding technique followed best management practices for erosion prevention (photo 2). All the product stockpiles have been removed, overburden piles have been backfilled and top has been redistributed.

Photo 1- The blending of the pit in with the surrounding landscape looks good.

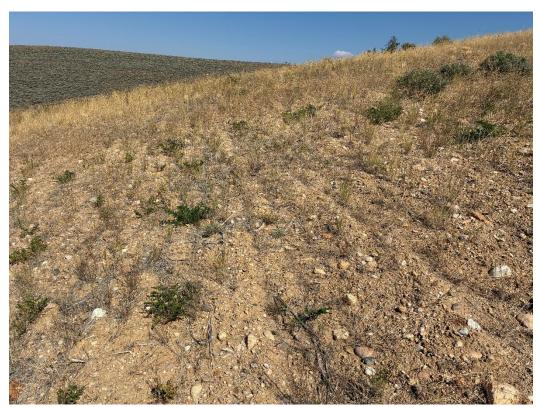
Photo 2- The seeding rows are contoured into the hillside which is best for erosion control.

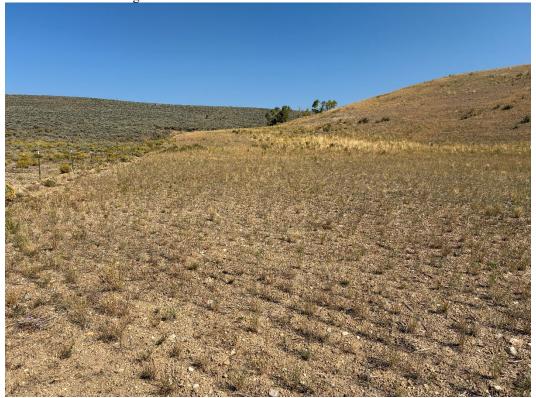
Reclamation on the west side of the permit area appeared to be doing well (photo 3). Observations included several grass species from the seed mix, such as crested wheatgrass, western wheatgrass, and bluebunch wheatgrass. Numerous rubber rabbitbrush shrubs were present in various locations. Wildflowers observed on the site included hoary tansyaster, cicer milkvetch, and what appeared to be silvery lupine. While cheatgrass and Canada thistle, both noxious weeds, were present, they did not dominate the plant community on the west side.

Photo 3- The west side of the pit area looks very good with very few noxious weeds.

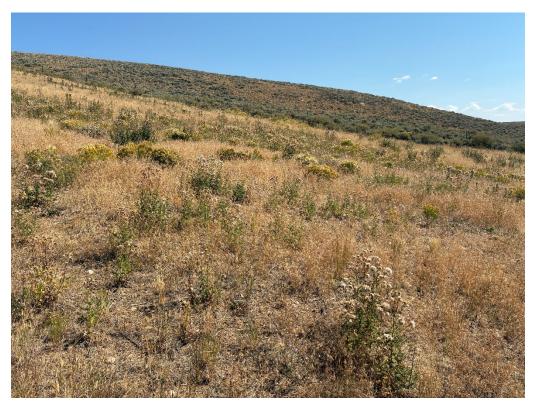
Reclamation efforts on the eastern side of the permit area resulted in a plant community heavily dominated by the noxious weeds cheatgrass and Canada thistle (photo 4), with only a few desirable species such as rubber rabbitbrush and western wheatgrass observed. Although not considered desirable, crested wheatgrass was also present as it was approved in the original 1978 permit.

Photo 4- The east side just above the cabins, the vegetation is dominated by Canada thistle and cheatgrass.

Therefore, the bond release request is denied. The site's dominance by cheatgrass and Canada thistle necessitates treatment in accordance with Rule 3.1.10(6) and the Colorado Noxious Weed Act. To be eligible for bond release, desirable plant species must predominate, and it must be demonstrated that the noxious

weeds are being effectively treated and controlled to foster a plant community similar to the surrounding natural vegetation.

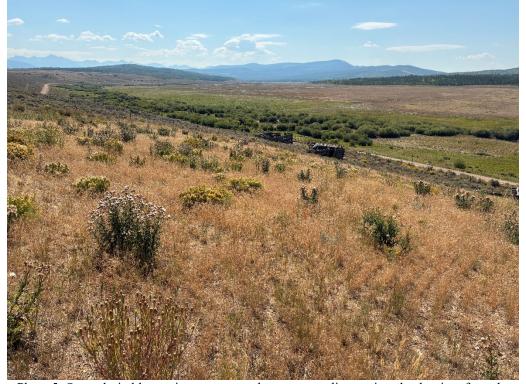
While some noxious weeds are expected during the reclamation process, their significant dominance in this instance makes it unlikely for desirable species to successfully compete and establish the diverse, effective, and long-lasting self-regenerating vegetative cover required by Rule 3.1.10(1) (photo 5).

Photo 5- Some desirable species are present, but are struggling against the density of weeds.
