MINERALS PROGRAM INSPECTION REPORT
PHONE: (303) 866-3567

MINE NAME: WCR 40 Dirt Mine	MINE/PROSPECTING ID#: M-2021-030	MINERAL: Overburden	COUNTY: Weld
INSPECTION TYPE: Monitoring	WEATHER: Clear	INSP. DATE: July 21, 2025	INSP. TIME: 10:00
OPERATOR: Hunt Farms	OPERATOR REPRESENTATIVE: David Hunt and Andy Rodriguez	TYPE OF OPERATION: 112c - Construction Regular Operation	
REASON FOR INSPECTION: Normal I&E Program	BOND CALCULATION TYPE: Complete Bond	BOND AMOUNT: \$325,500.00	
DATE OF COMPLAINT: NA	POST INSP. CONTACTS: None	JOINT INSP. AGENCY: None	
INSPECTOR(S): Nikie Gagnon	INSPECTOR'S SIGNATURE:

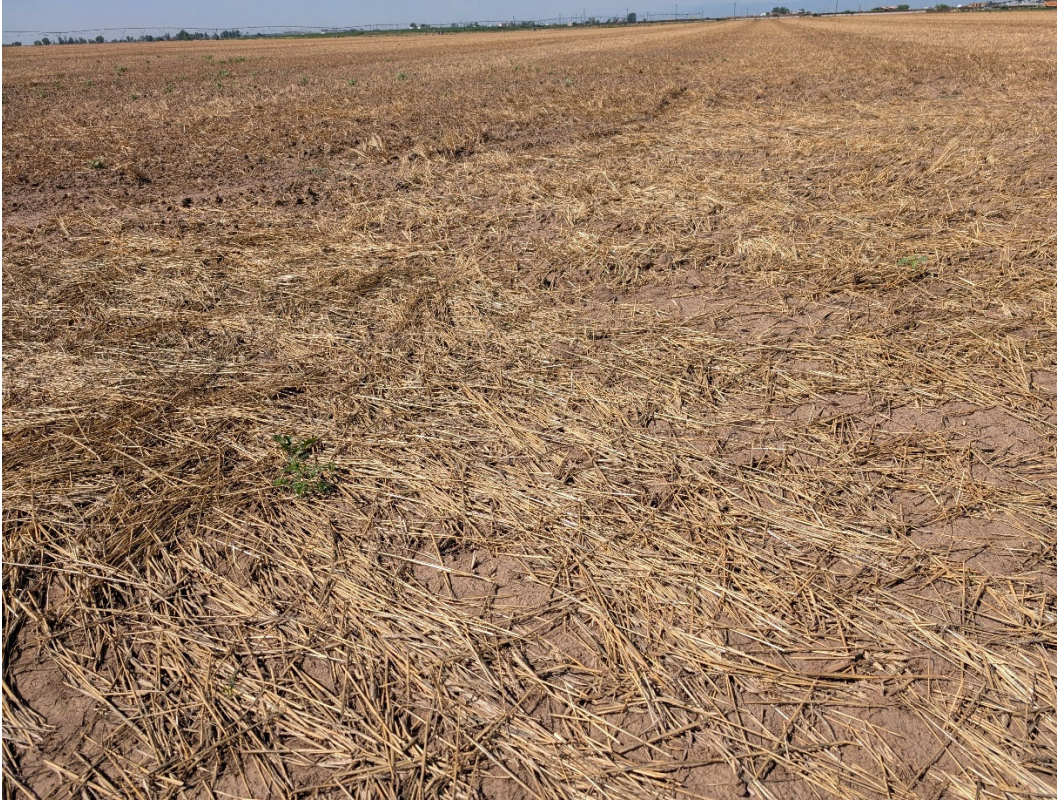
Mining of topsoil and overburden is complete and the site is in reclamation. Approximately 40 acres on the west side have been reclaimed. The west area was planted in triticale, a wheat/rye hybrid, in the fall of 2024. The Division observed the crop has been cut and the operator plans to disc the biomass back into the soil to improve the soil by adding organic matter back in. Approximately 60 acres on the east side of the site was mined in 2024. The east side was recently graded and the northeast portion has been topsoiled. The operator stated he will plant a winter crop across the entire mine site in late August 2025. The operator owns an adjacent stockyard. Stockpiles of manure were observed near the entrance to the site. A portion of the stripped topsoil was salvaged during mining to be used for reclamation. The topsoil is mixed with the manure for an enriched growth medium. The operator is in the process of spreading the mixture across the mined areas on the east side. The Division observed piles of the enriched topsoil in the northeast corner of the permit area.

Photo 1: Looking across the agriculture field on the western side of the permit area. Cut triticale will be disced into the soil.

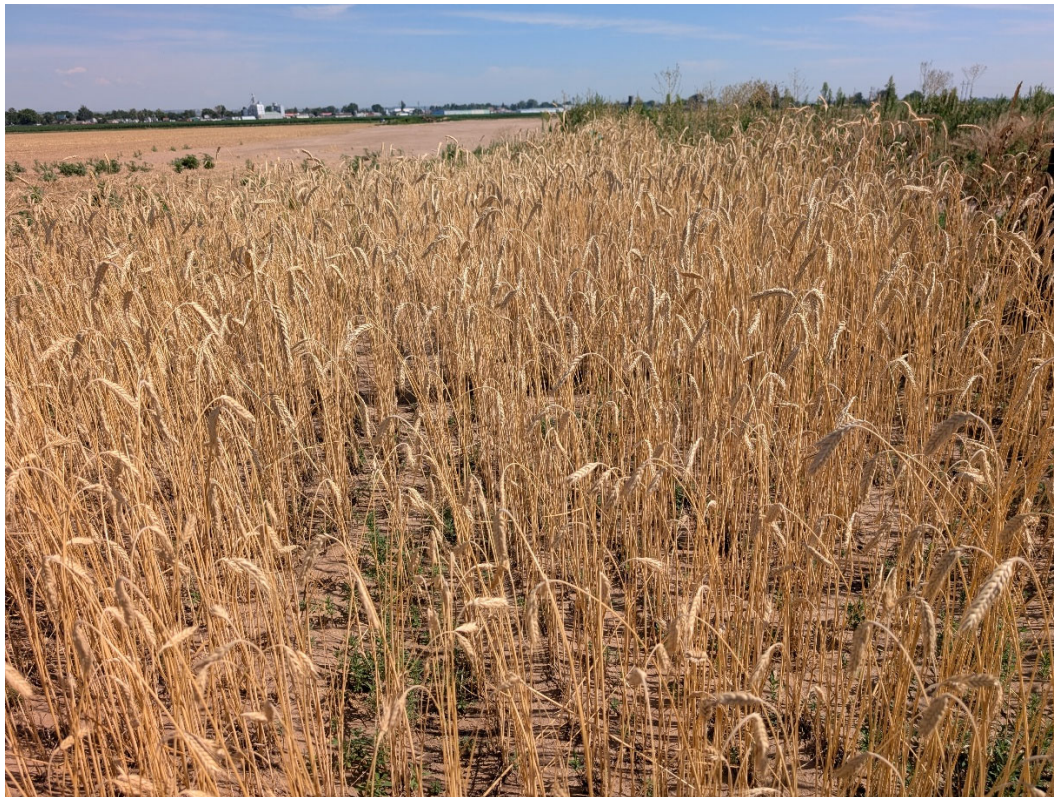
Photo 2: Close up view of the triticale plants in the center of the site.

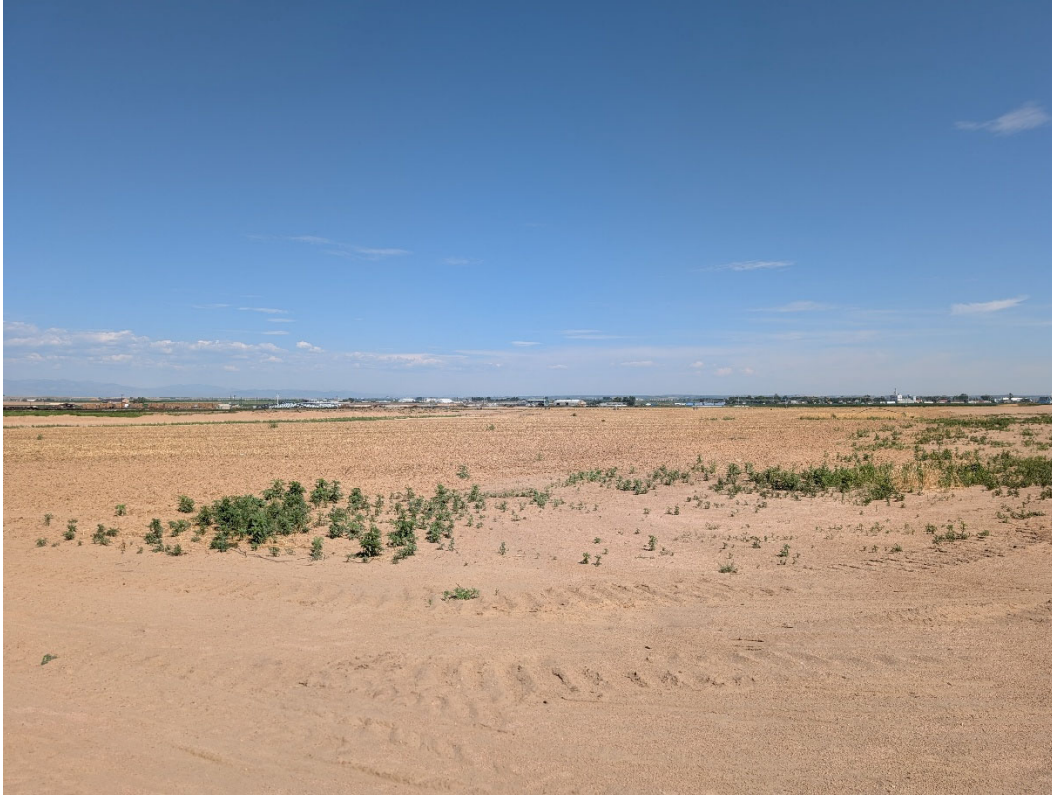
Photo 3: Looking northwest at the regraded and planted field in the southwest portion of the mining area.

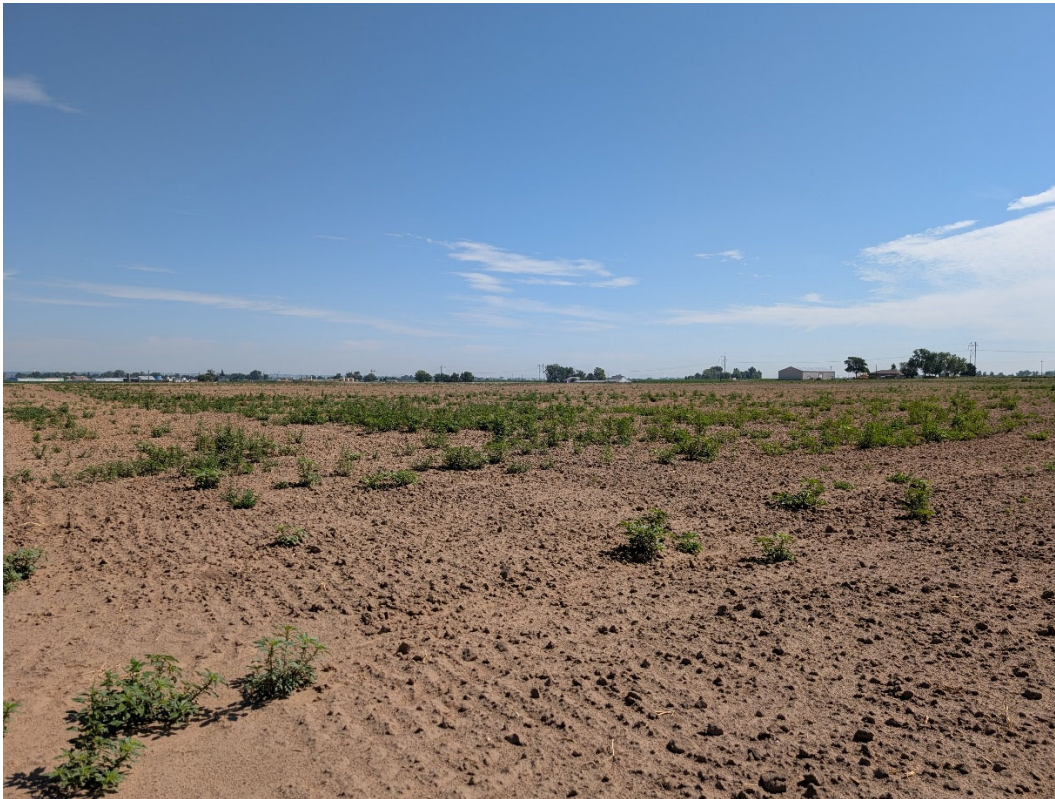
Photo 4: Graded and topsoiled area in the southeast portion of the permit area.

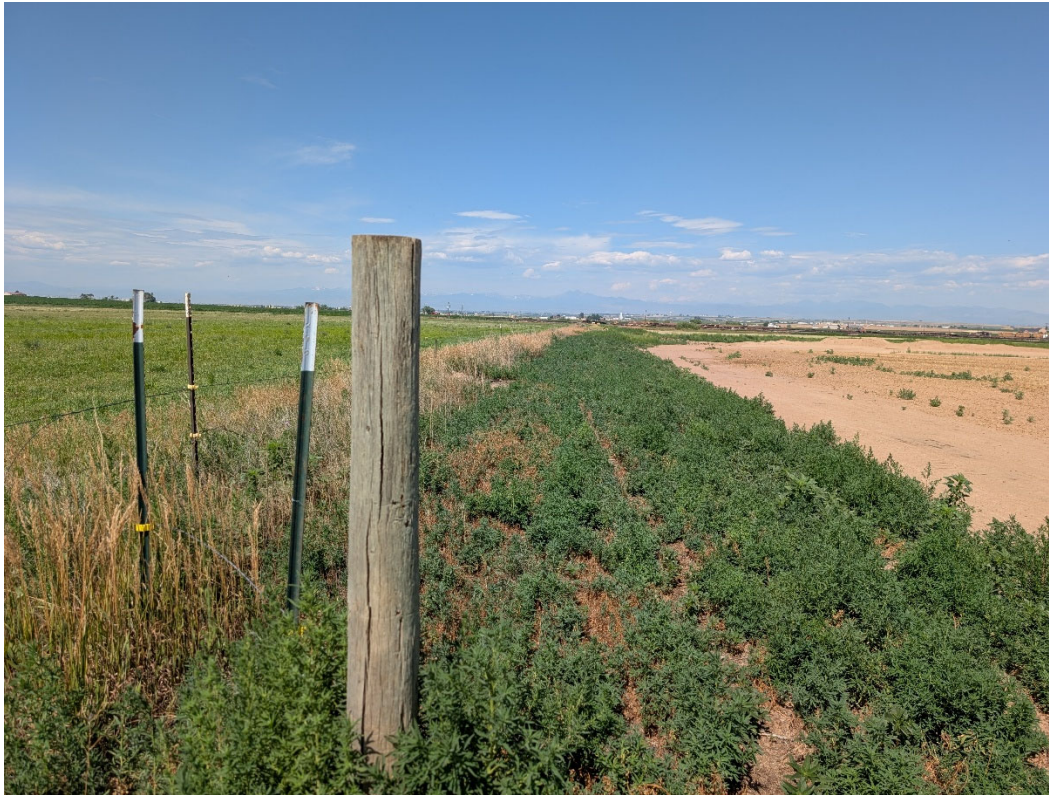
Photo 5: Standing along the southern boundary looking west. The site is graded to tie into the existing contours along the southern boundary.

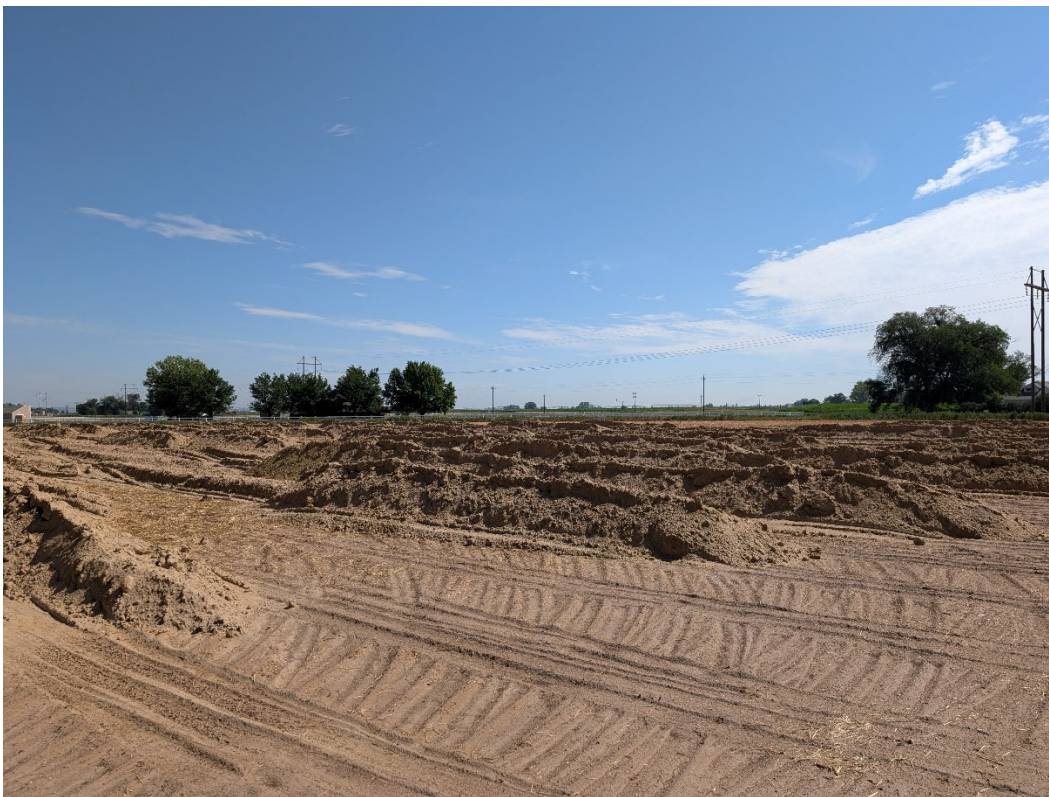
Photo 6: Topsoil and manure mixture used for reclamation observed in the northeast corner of the site.

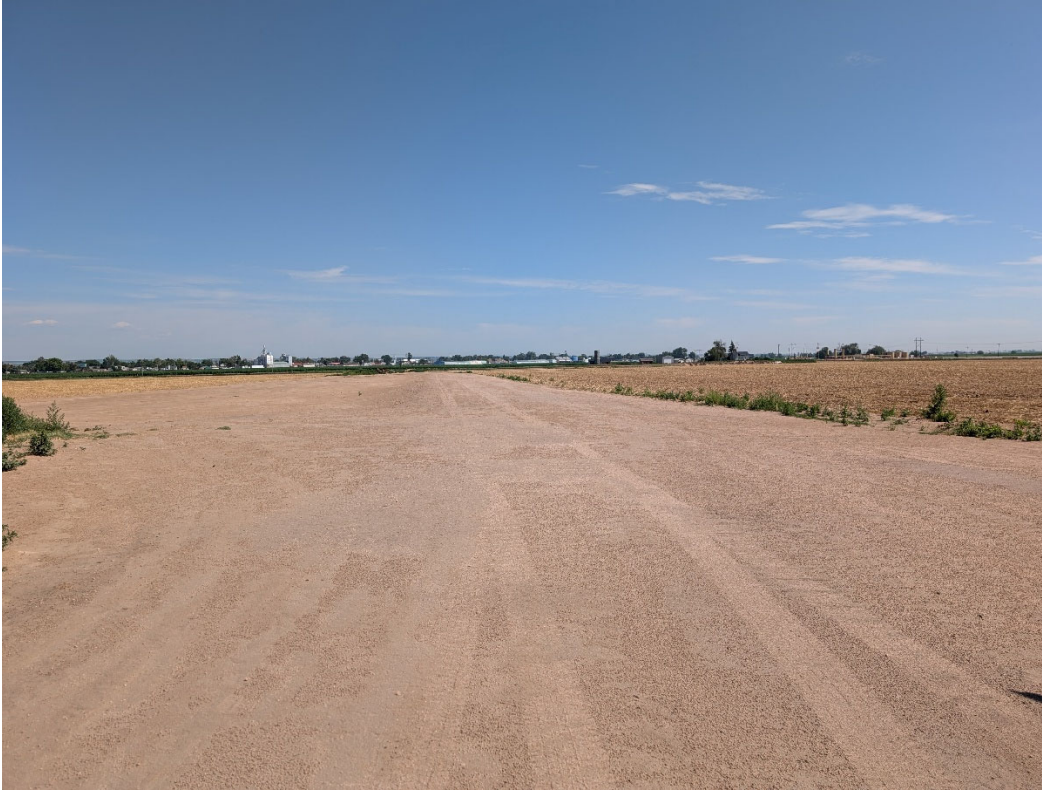
A haul road was observed running north/south between the two pastures. The reclamation plan calls for leaving the road following reclamation. During the inspection, the operator stated that they will reduce the width of the road and grade it for future agricultural use.

Photo 7: Haul road down that runs north south between the two fields.
