**MINERALS PROGRAM INSPECTION REPORT**  
**PHONE: (303) 866-3567**

| <b>MINE NAME:</b><br>Climax Mine | <b>MINE/PROSPECTING ID#:</b><br>M-1977-493 | <b>MINERAL:</b><br>Molybdenum | <b>COUNTY:</b><br>Lake |
| <b>INSPECTION TYPE:</b><br>Monitoring | <b>WEATHER:</b> Clear | <b>INSP. DATE:</b><br>August 20, 2025 | <b>INSP. TIME:</b><br>10:00 |

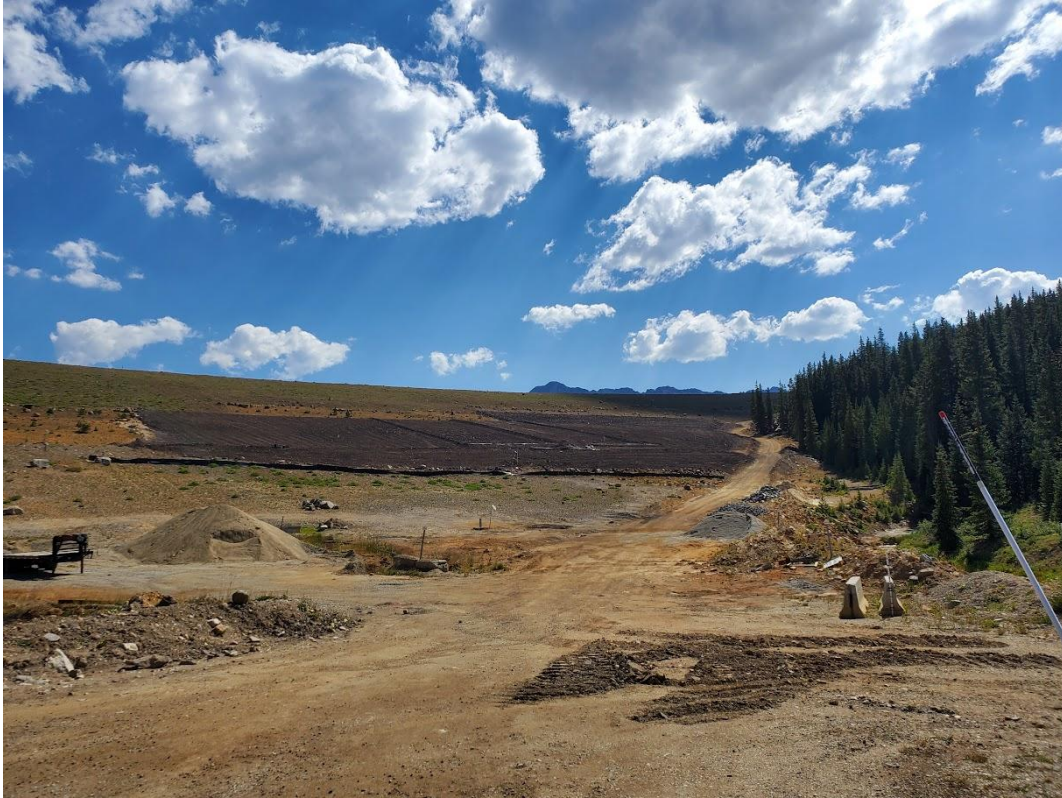
1 Dam forms the eastern embankment of the Robinson TSF. The operator created a reclamation plot on the southern end of the dam (Photo 1). No excessive erosion or displacement was observed on 1 Dam. 2 Dam on the northern end of the Robinson TSF is partially inundated by the upstream portion of the Tenmile TSF in the Tenmile Creek drainage. The dam face was vegetated and stable. No excessive erosion or displacement was observed on the dam face (Photo 2).

Photo 1: View to the east of the reclamation test plot on 1 Dam.

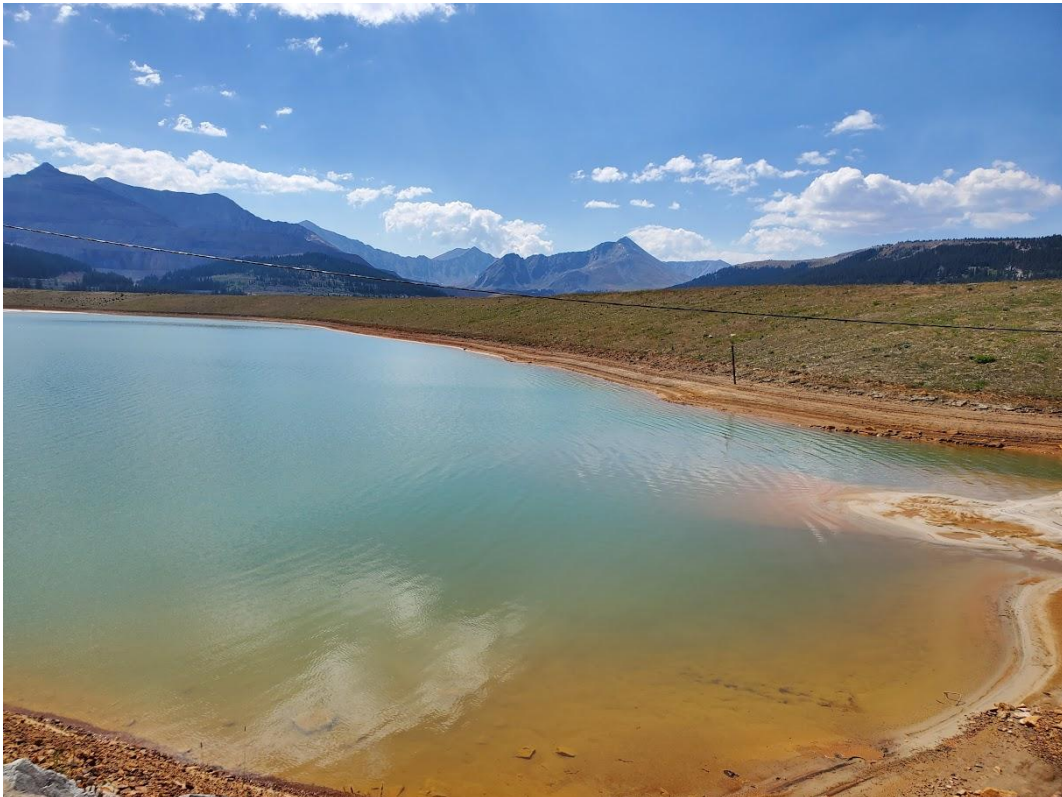
Photo 2: View to the southeast of 2 Dam.

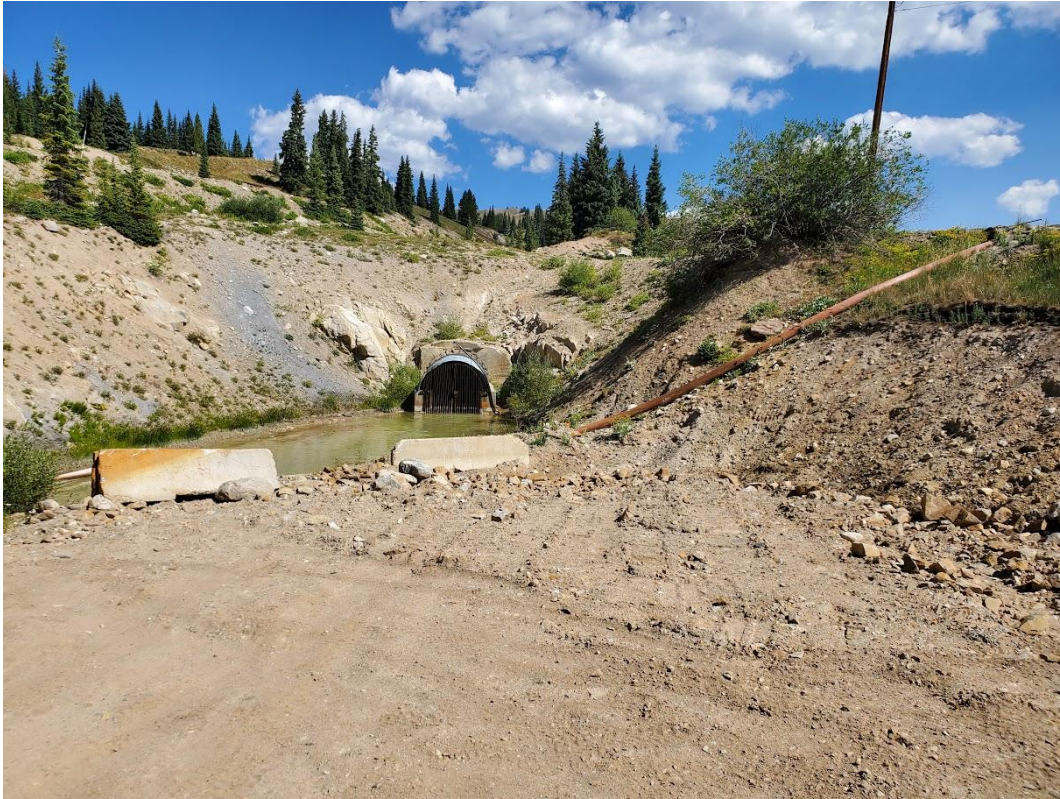
The Tenmile Tunnel delivers process water to the Robinson Pond that is collected in the Tenmile TSF. (Photo 3) The tunnel is walked and inspected annually. Water was flowing through the tunnel at the time of the inspection. The southern portal is in good condition with no signs of significant erosion around the portal. The portal was secured by a gate. There was no signs of slumping or erosion around the portal. The decant intake structure for the tunnel on is located in the southwest corner of the Tenmile TSF. There was a lime delivery occurring at the north portal of the Tenmile Tunnel in the Tenmile TSF. Lime is used to treat water before it is used as process water.

Photo 3: View to the north of the Tenmile Tunnel

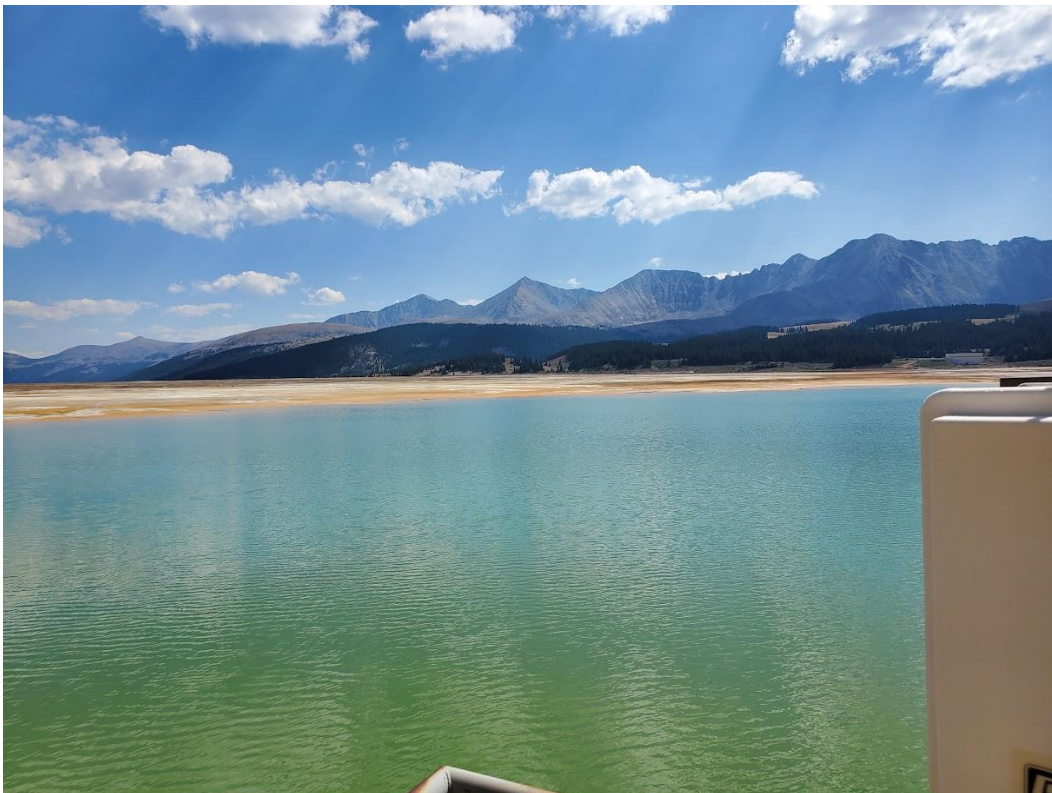
The Tenmile TSF (Photo 4) and 3 Dam (Photo 5) are downstream of the Robinson TSF and 2 Dam in the Tenmile Creek Watershed. The Tenmile TSF contains acid-generating material. Mill tailings are delivered to the TSF through the tailings delivery line. A water pool is maintained at the upstream end of the Tenmile TSF for process water storage, storm water management, and as the first stage in the water treatment system. Lime was currently be delivered. Seepage from 3 Dam is routed to a collection pond and pumped back by vertical turbine pumps to the Sludge Densification Plant or diverted to the water pool on the Mayflower TSF. There was no excessive stormwater erosion noted on the dam face and berms along the benching of the dam appear to be functioning as designed. No slumping or displacement was observed.

Photo 4: View to the northeast across Tenmile TSF.

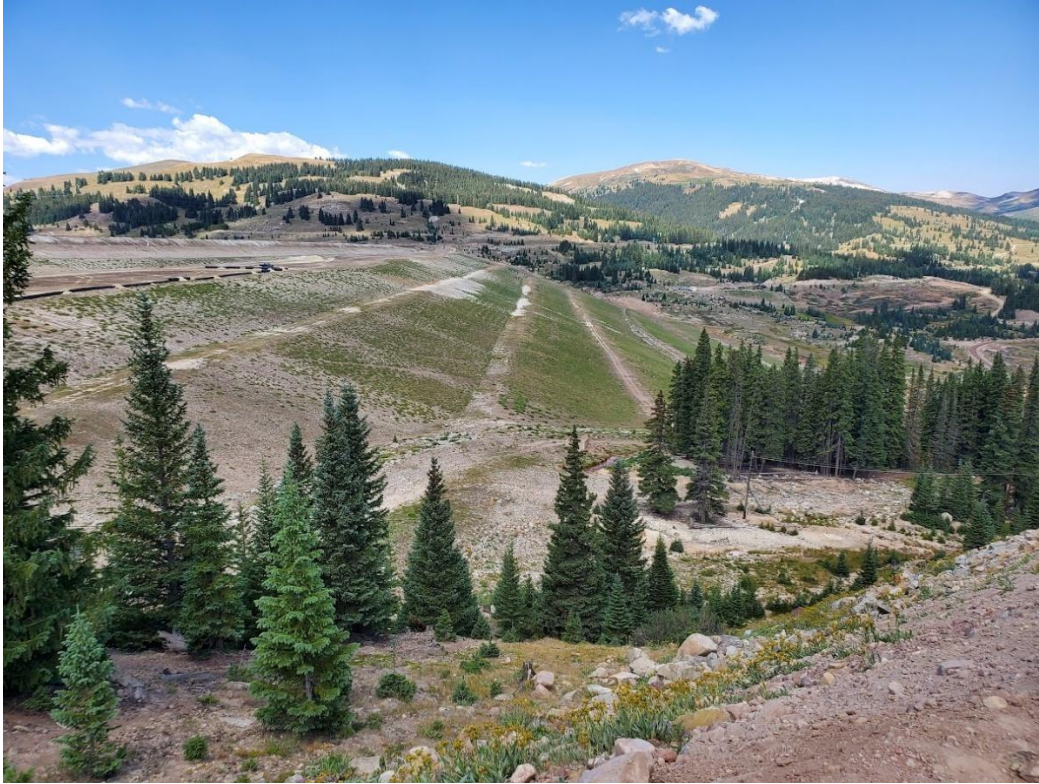
Photo 5: View to the west across 3 Dam

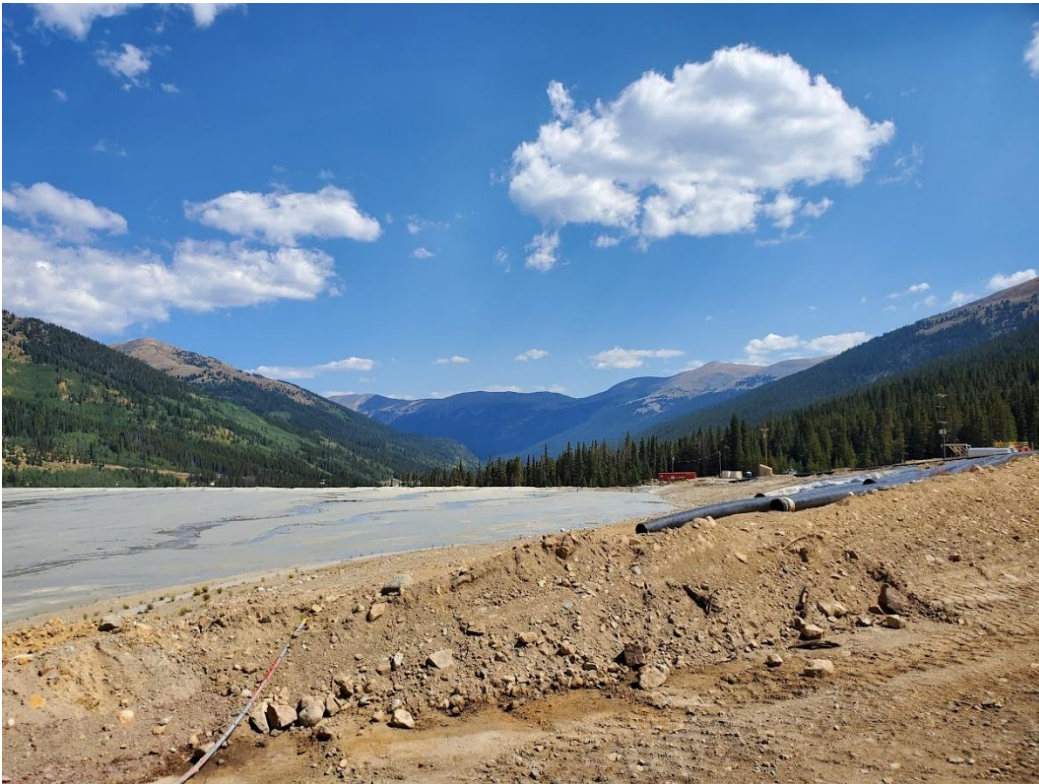
The Mayflower TSF (Photo 6) and 5 Dam are the last downstream TSF in the Tenmile Creek Watershed. The TSF contains acid-generating material. To prevent dam failure, the Mayflower TSF includes an emergency flood bypass tunnel. Along with tailings storage, the Mayflower TSF also provides containment of contaminated materials or designated chemicals that might be accidentally released up-gradient of the TSF. There was no excessive stormwater erosion noted on the dam face and berms along the benching of the dam appear to be functioning as designed. No slumping or displacement was observed.

Photo 6: View to the north of tailings deposition of Mayflower TSF

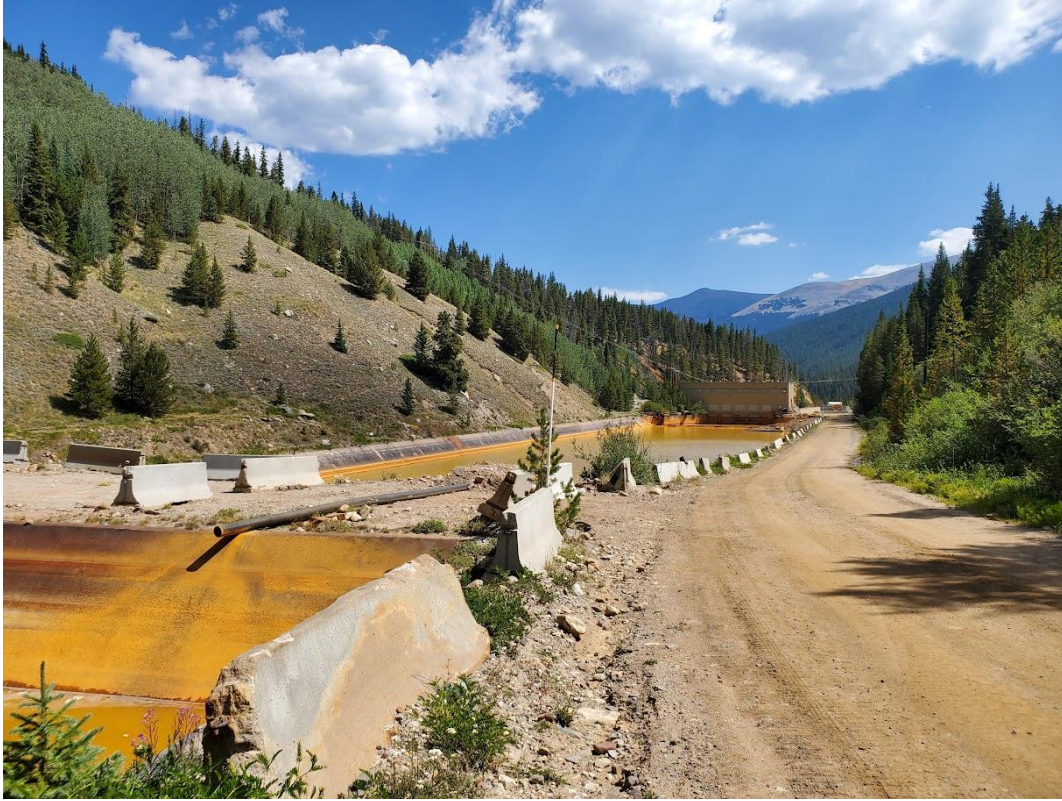
The 5 Dam Seepwater Pump System is design to contain seepage from the toe of 5 Dam. The system consists of 3 cells, all of which were holding water at the time of the inspection. The cells can be cleaned when needed. The cells were below discharge level. No erosion concerns were identified. (Photo 7) A secondary collection system is just downgradient from the main Seepwater Pump System and it is utilized in the event that seep water bypasses the primary collection system.

Photo 7: View to the north of 5 Dam Seepwater Collection System

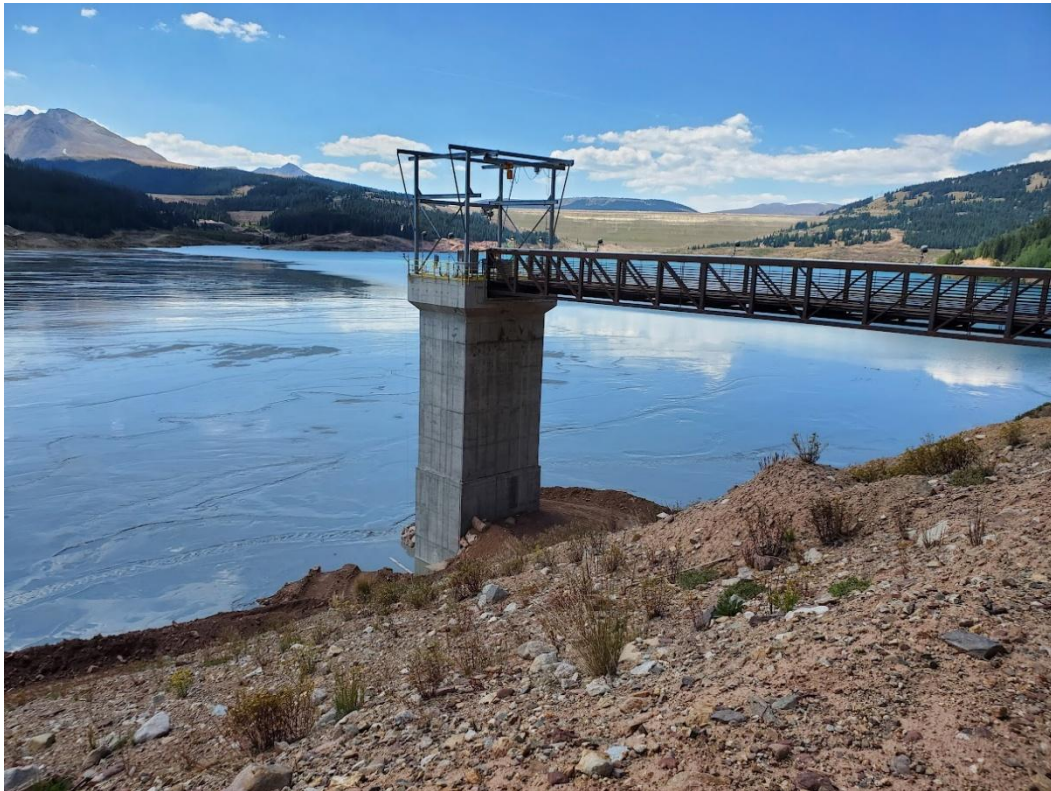
The Mayflower Tunnel acts as an overflow for the Mayflower TSF. The intake for the tunnel on the Mayflower TSF was well maintained with no erosional features noted (Photo 8). The lower portal was sealed at the time of the inspection. The area around the portal is protected by rock bolts and shotcrete. No erosion or displacement was noted around either portal.

Photo 8: View to the southeast of Mayflower Tunnel
