**MINERALS PROGRAM INSPECTION REPORT**  
**PHONE: (303) 866-3567**

| <b>MINE NAME:</b><br>Phil Sheridan Lode | <b>MINE/PROSPECTING ID#:</b><br>M-1988-081 | <b>MINERAL:</b><br>Gold and silver | <b>COUNTY:</b><br>Boulder |
| <b>INSPECTION TYPE:</b><br>Surety Release Inspection | <b>WEATHER:</b> Cloudy | <b>INSP. DATE:</b><br>August 27, 2025 | <b>INSP. TIME:</b><br>12:15 |

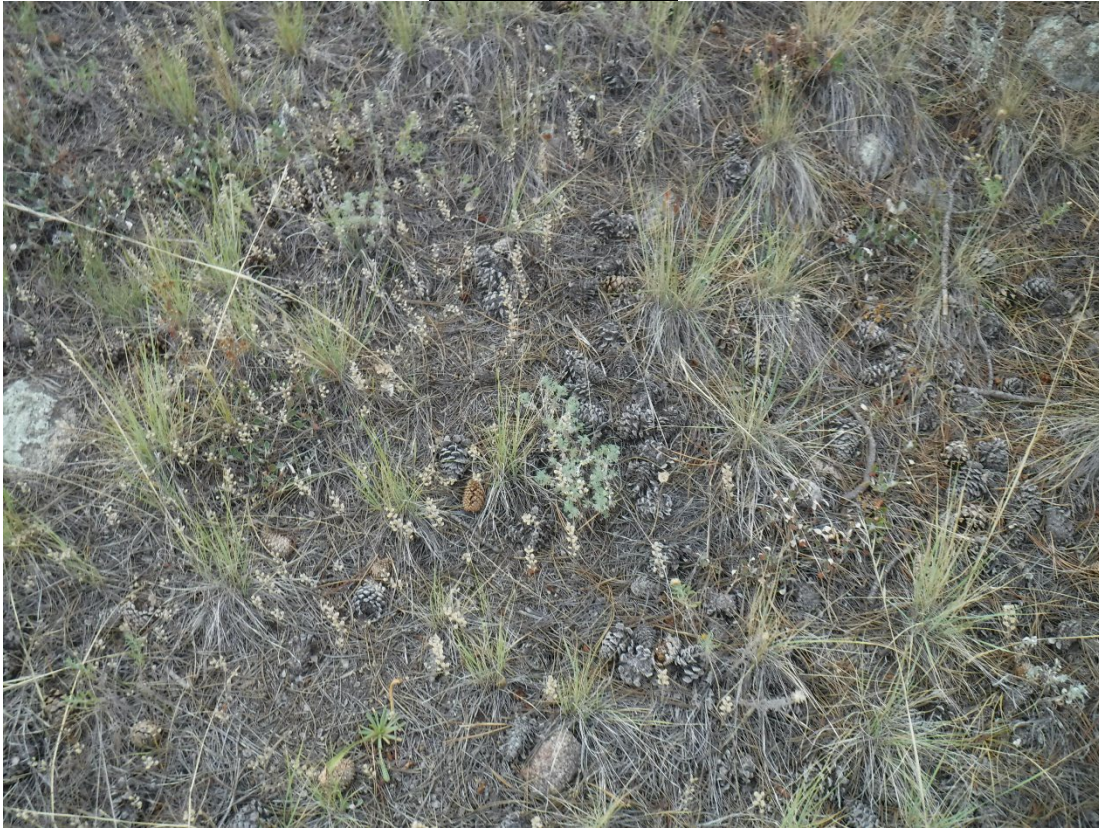
**Photo 1:** Typical vegetation establishment of most of the permitted area

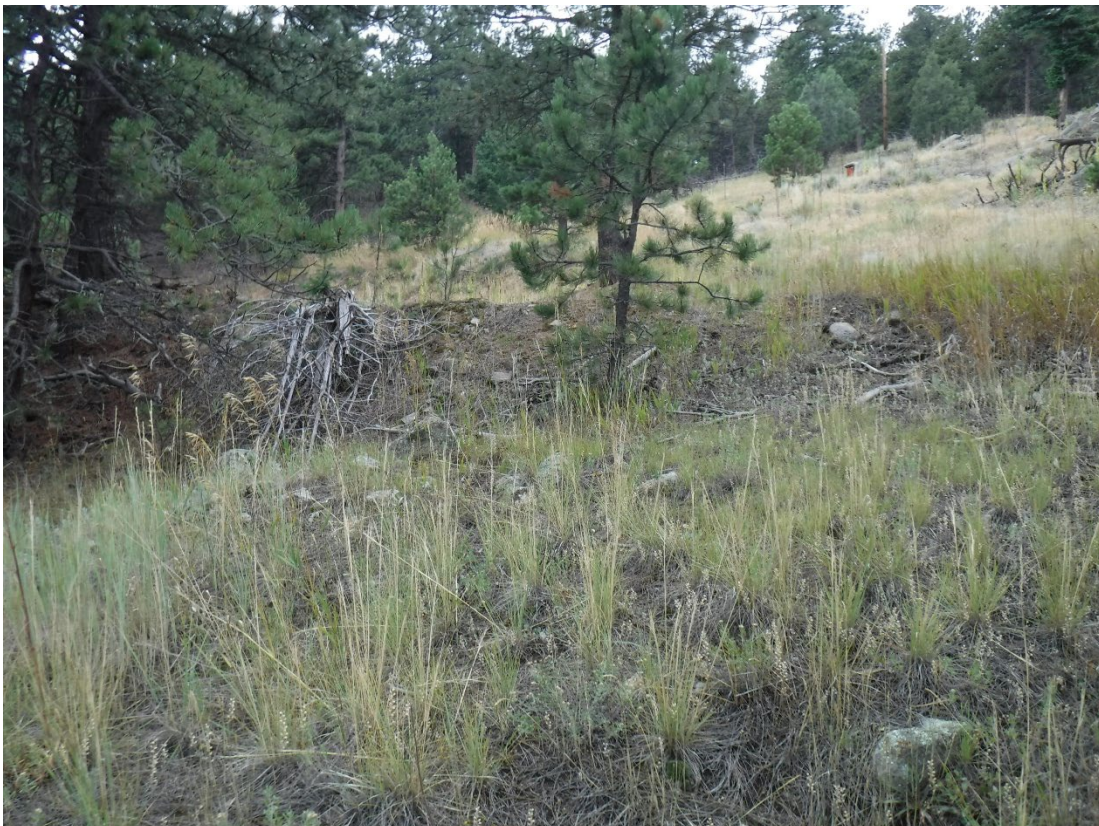
**Photo 2:** Looking SW across the permit area towards the detonator shed (upper right corner of picture)

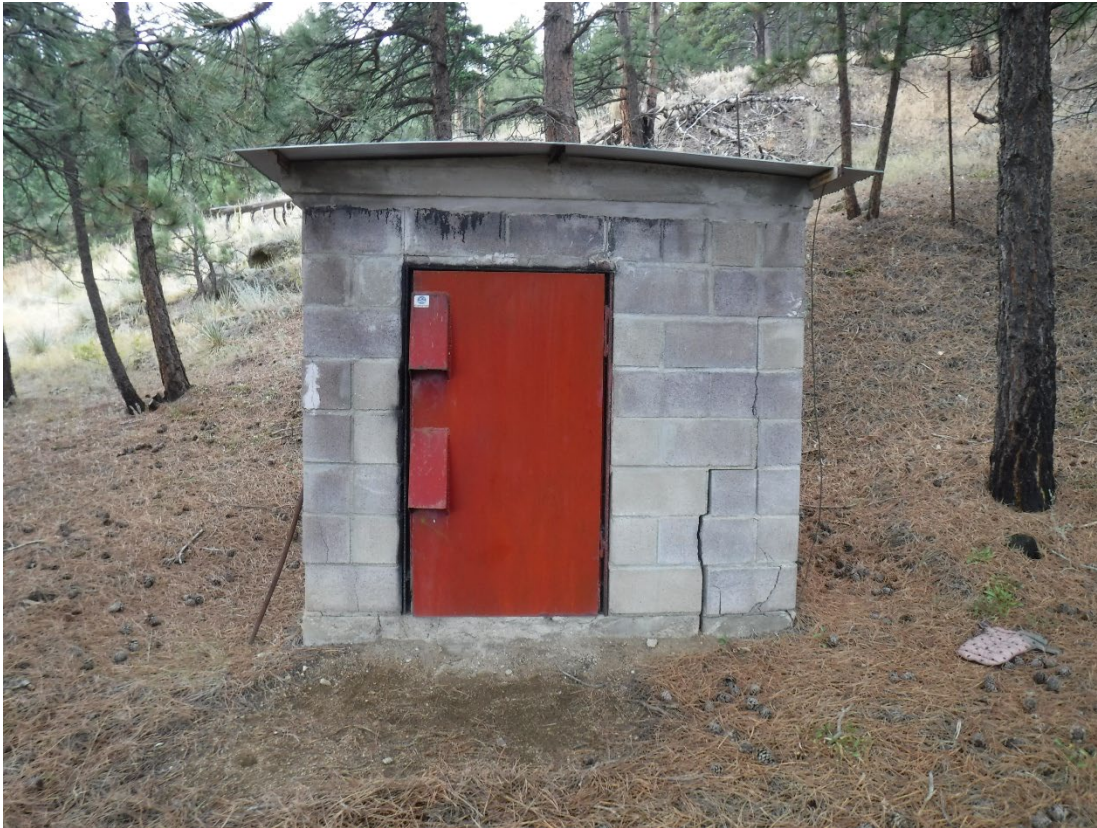
After the inspection and at the request of the landowner from comments received during the public comment period, the Operator returned to the site to determine what, if anything, remained in the detonator and powder storage sheds. The sheds were verified to be empty. The sheds are to remain after reclamation at the site has been completed.

**Photo 3:** Powder storage shed verified as being empty

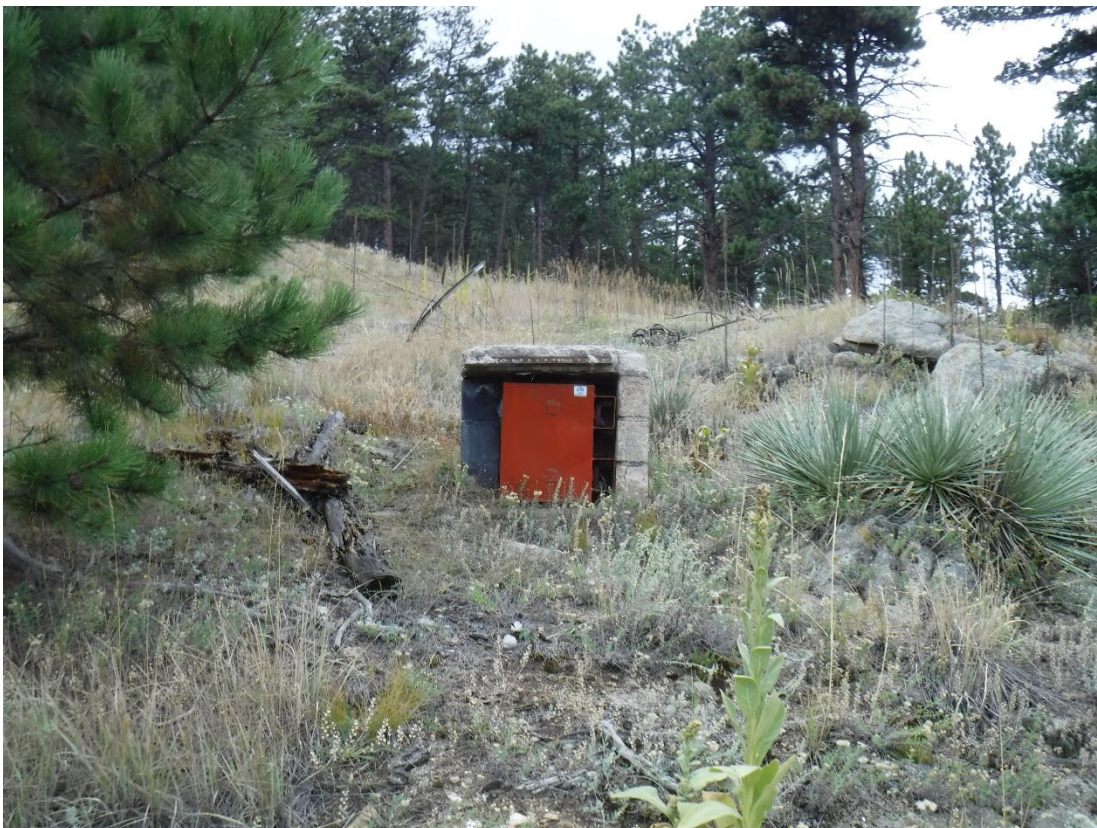
**Photo 4:** Detonator storage shed verified as being empty, note vegetation cover

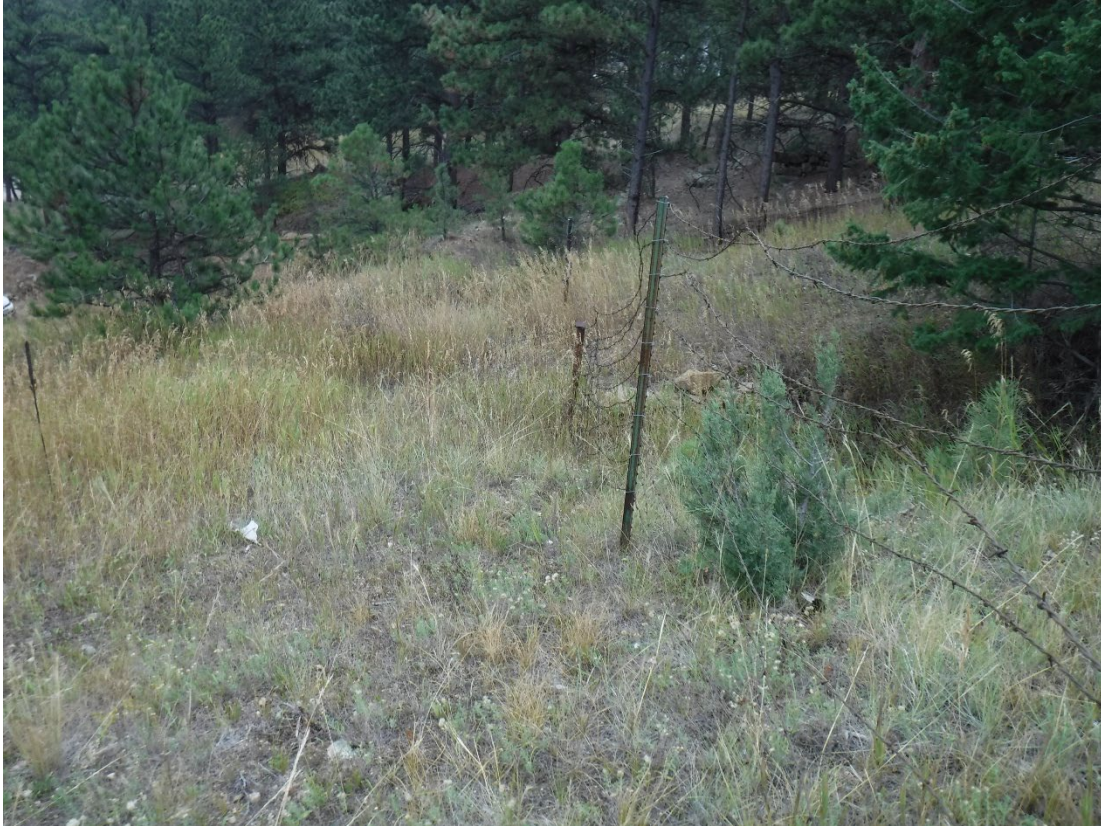
**Photo 5:** Looking SE across the permit area from near the detonator shed

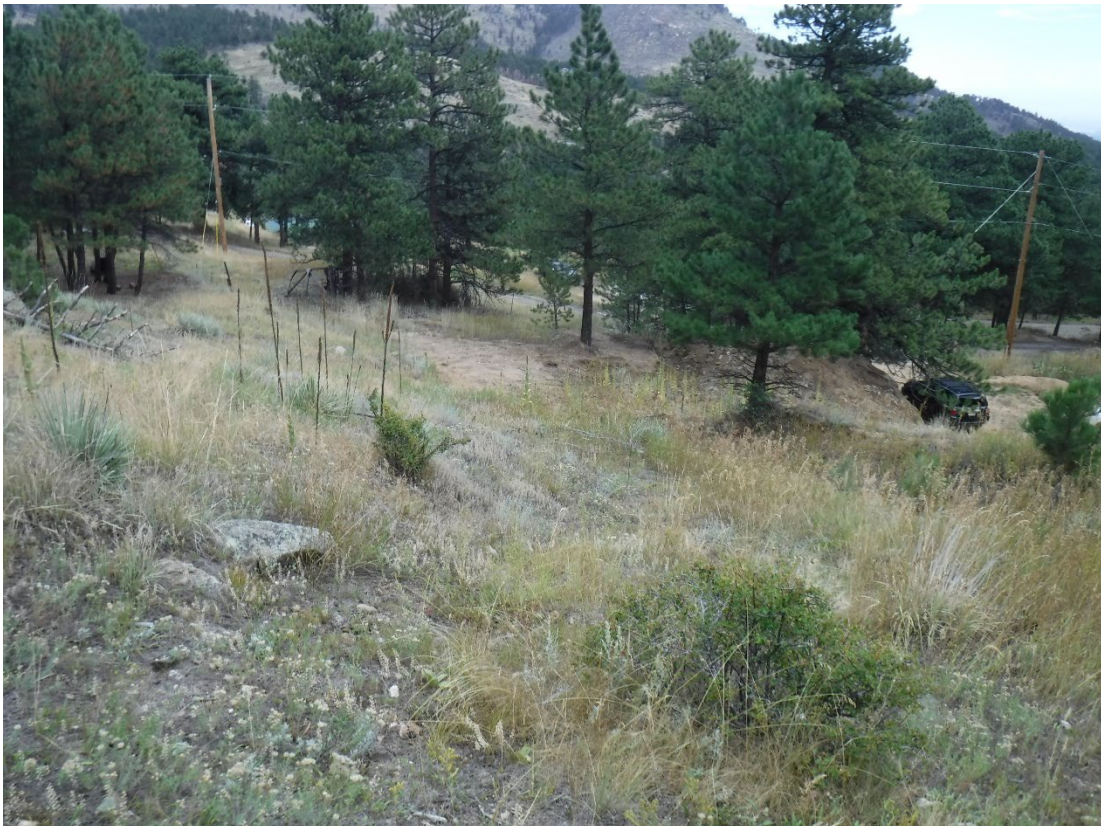
**Photo 6:** Looking NE across the permit area from near the detonator shed

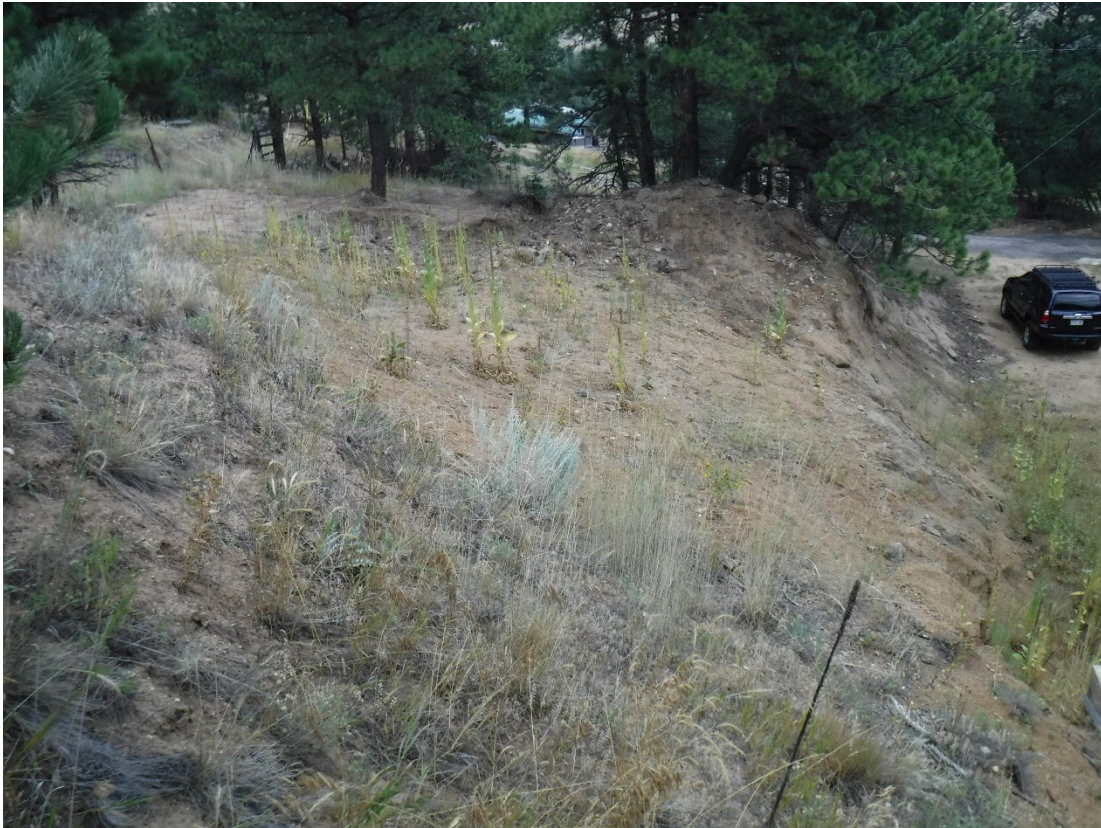
During the inspection in 2023 the Division discussed what was needed to move the permit towards release. At that time, it was agreed that the highwall along the northern border of where the headframe and the winch house was located needed to have erosion control measures installed to mitigate rilling and erosion of the highwall and additional seeding of the area adjacent to the highwall. Since that time the Operator has installed a drainage swale to direct surface runoff away from the highwall and revegetated the area. The vegetation is becoming established and is a mixture of Mullein and native vegetation. The swale appears to be functioning as intended and erosion has significantly decreased. The other areas of the permitted area have a well-established native vegetation cover.

**Photo 7:** Looking NE across the area that was recently revegetated and had a swale installed

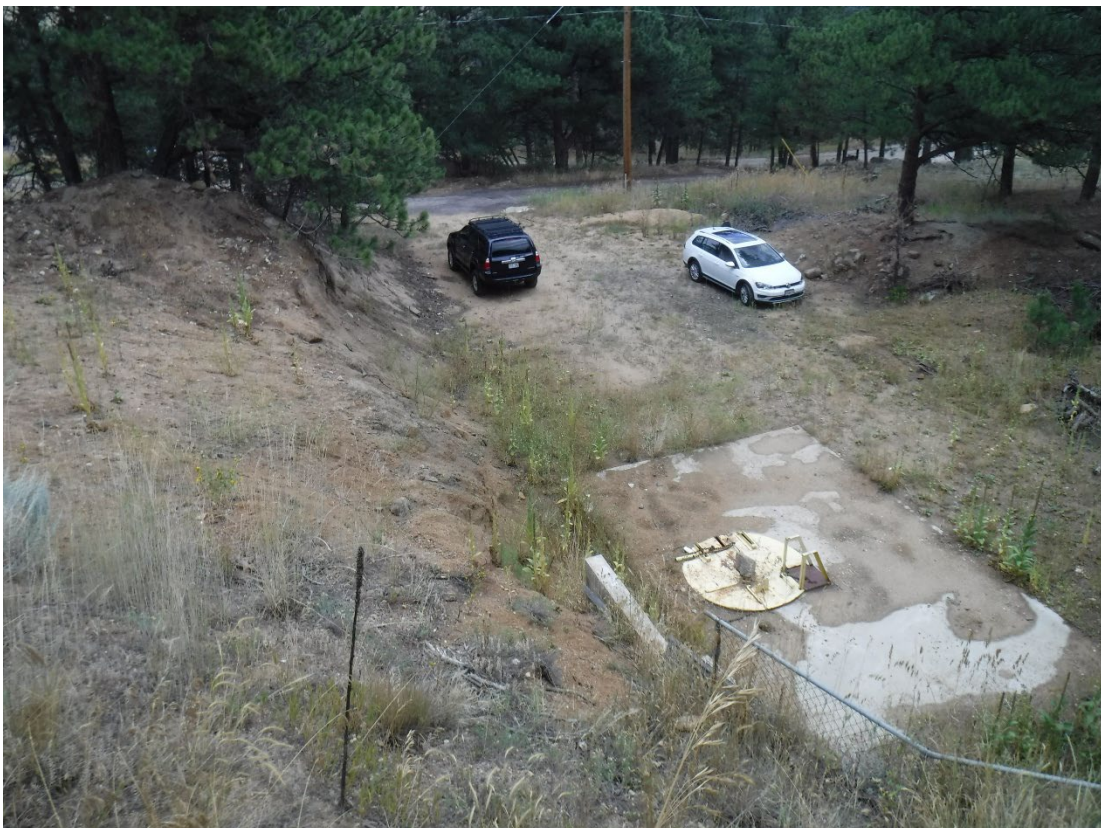
**Photo 8:** Area where the winch house and headframe were located

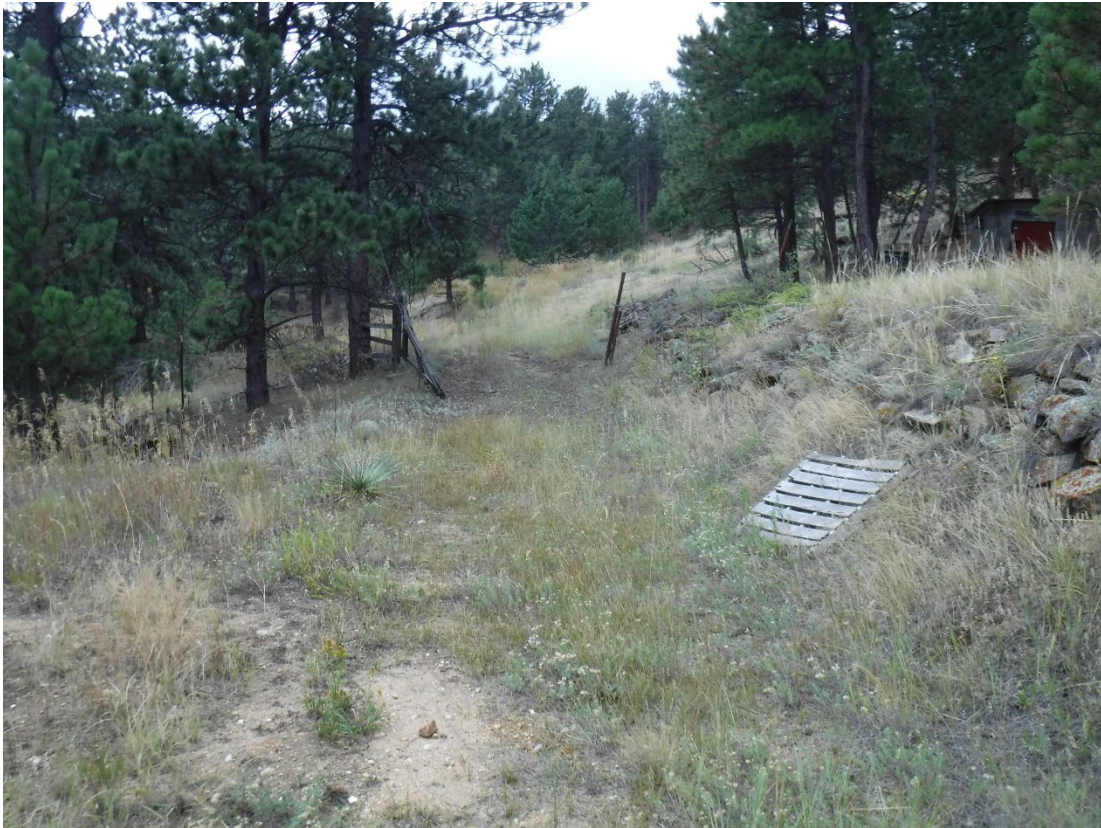
**Photo 9:** Reclaimed access road

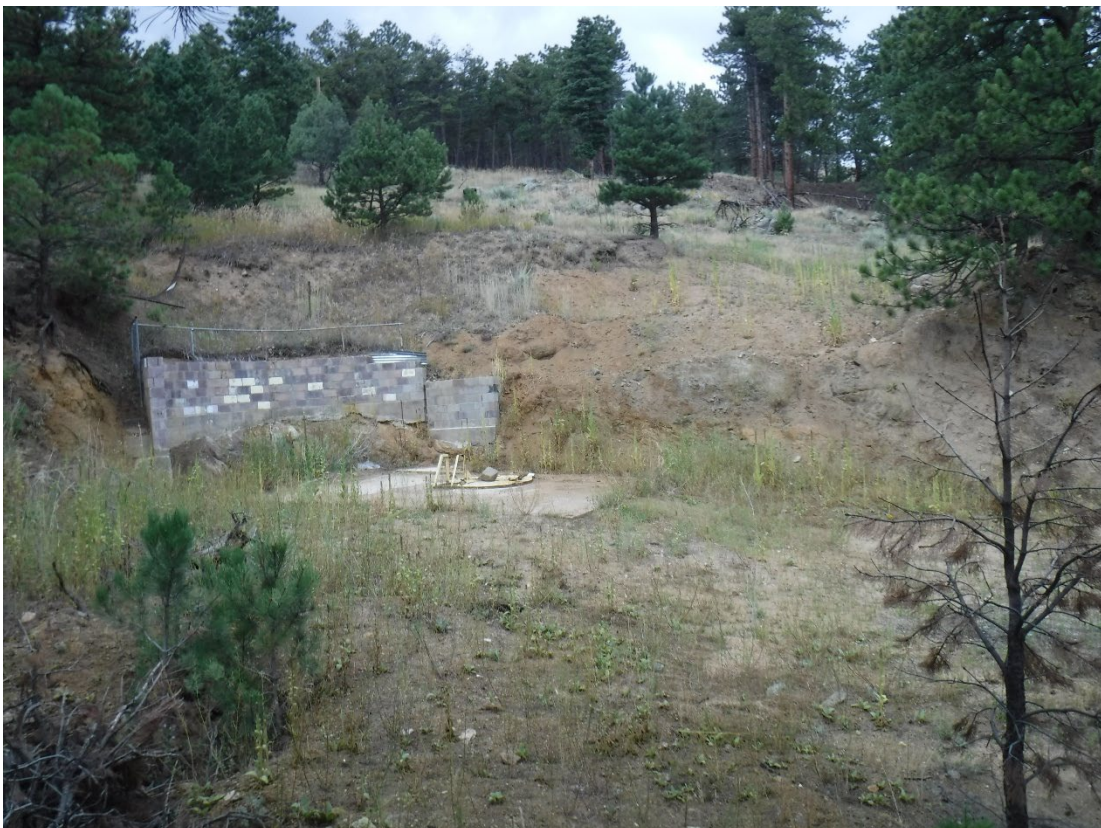
**Photo 10:** Area where the winch house and headframe were located
