RE: Bradbury Pit, Permit No. M-1978-357, Unresolved Problem(s) Noted in a Past Inspection Report

MINERALS PROGRAM INSPECTION REPORT
PHONE: (303) 866-3567

MINE NAME: Bradbury Pit	MINE/PROSPECTING ID#: M-1978-357	MINERAL: Sand and gravel	COUNTY: Mesa
INSPECTION TYPE: Monitoring	WEATHER: Clear	INSP. DATE: July 2, 2025	INSP. TIME: 09:00
OPERATOR: Grand Junction Pipe & Supply Co.	OPERATOR REPRESENTATIVE: Jon Muller	TYPE OF OPERATION: 112c - Construction Regular Operation	
REASON FOR INSPECTION: Normal I&E Program	BOND CALCULATION TYPE: Complete Bond	BOND AMOUNT: \$101,453.12	
DATE OF COMPLAINT: NA	POST INSP. CONTACTS: DRMS	JOINT INSP. AGENCY: None	
INSPECTOR(S): Amy Yeldell	INSPECTOR'S SIGNATURE:

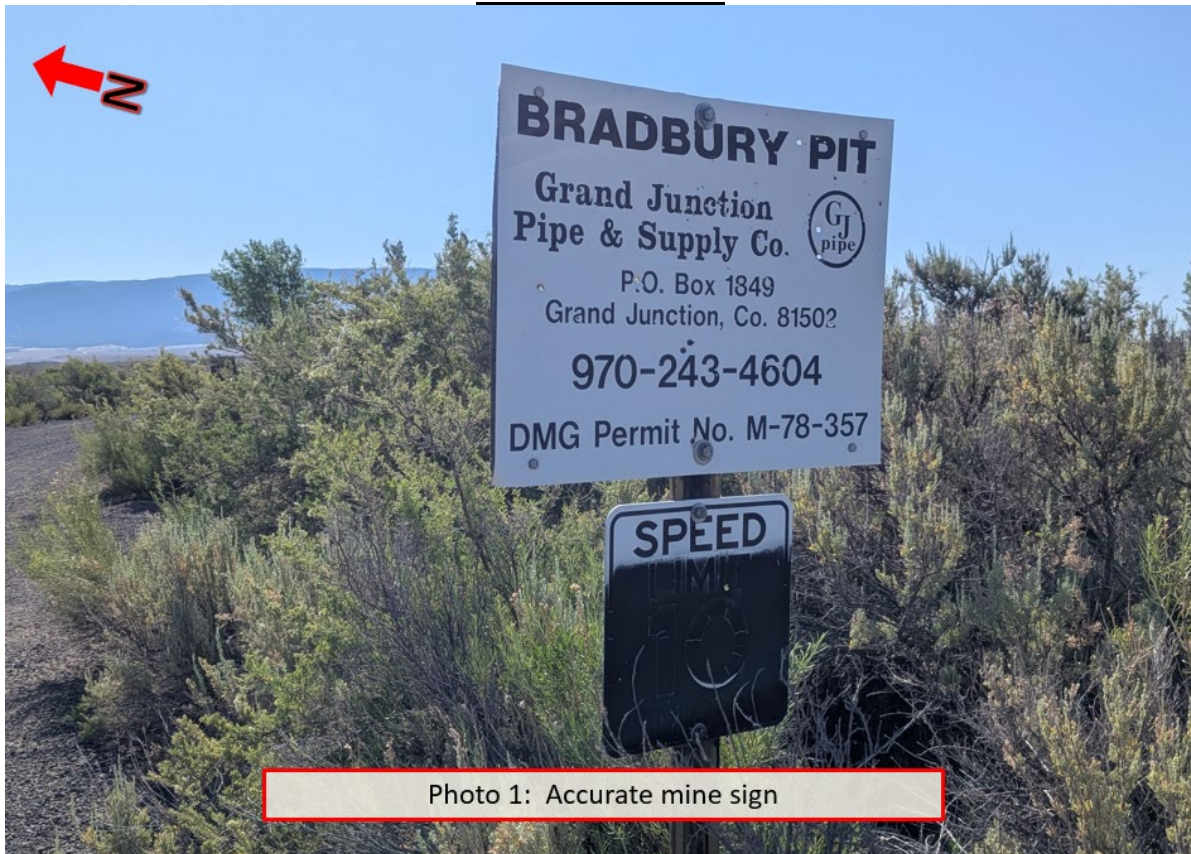
A mine sign was posted at the entrance to the mine site as required by Rule 3.1.12(1). The information depicted was correct/ up to date and the sign was of sufficient size. The permit boundary of the affected land was clearly delineated primarily pursuant to Rule 3.1.12(2). The gate at the mine entrance was locked.

Photo 1: Accurate mine sign

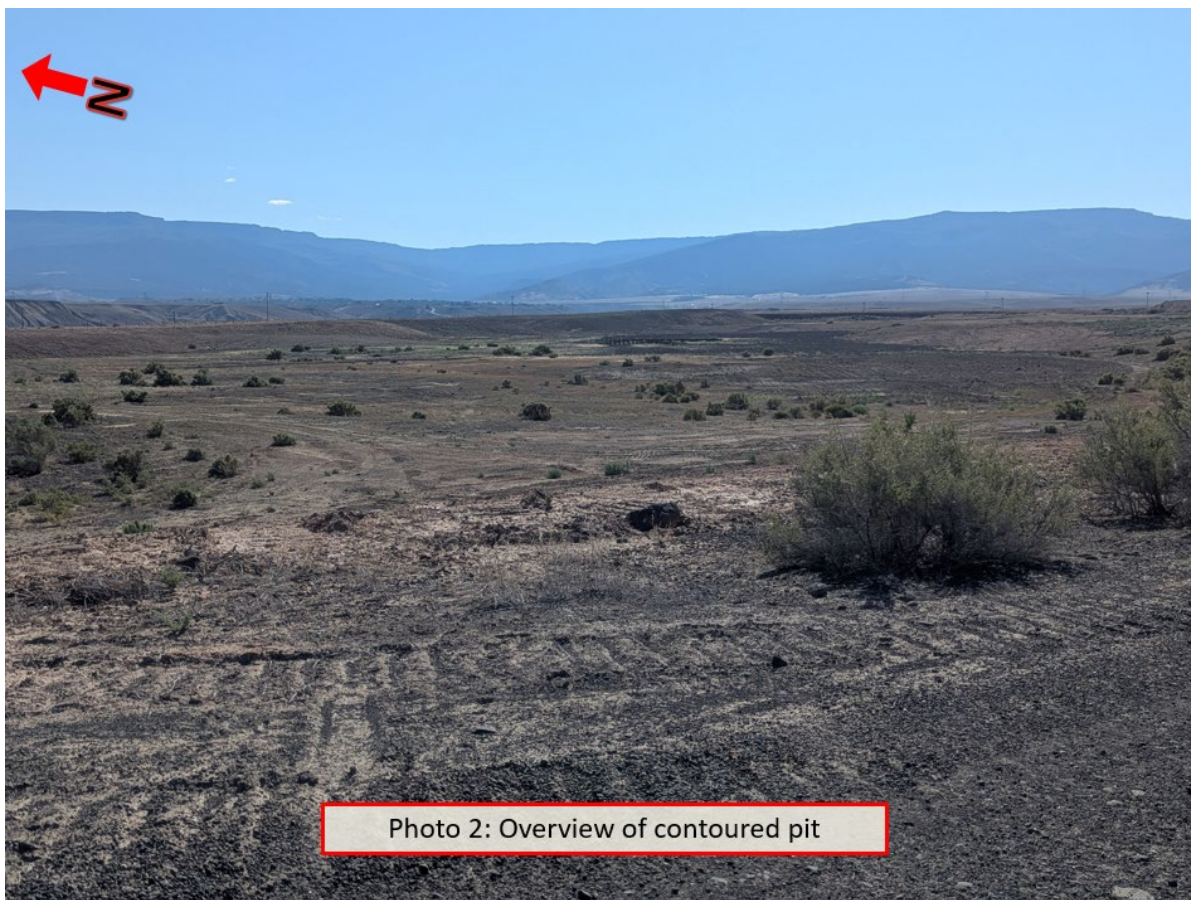
All slopes have been backfilled and/regraded to a 3H: 1V or less.

Mining has concluded at this site and the pit is in Final Reclamation. All equipment has been removed. There are no remaining stockpiles or highwalls.

Photo 2: Overview of contoured pit
