**MINERALS PROGRAM INSPECTION REPORT**  
**PHONE: (303) 866-3567**

| <b>MINE NAME:</b><br>Henderson Mine | <b>MINE/PROSPECTING ID#:</b><br>M-1977-342 | <b>MINERAL:</b><br>Molybdenum | <b>COUNTY:</b><br>Clear Creek |
| <b>INSPECTION TYPE:</b><br>Monitoring | <b>WEATHER:</b><br>Clear | <b>INSP. DATE:</b><br>August 18, 2025 | <b>INSP. TIME:</b><br>09:00 |

This inspection was focused on the Tailings Storage Facility (TSF), including the deposition of tailings, the condition of the 1-Dam and 3-Dam Tailings Impoundments, and the seepwater collection system.

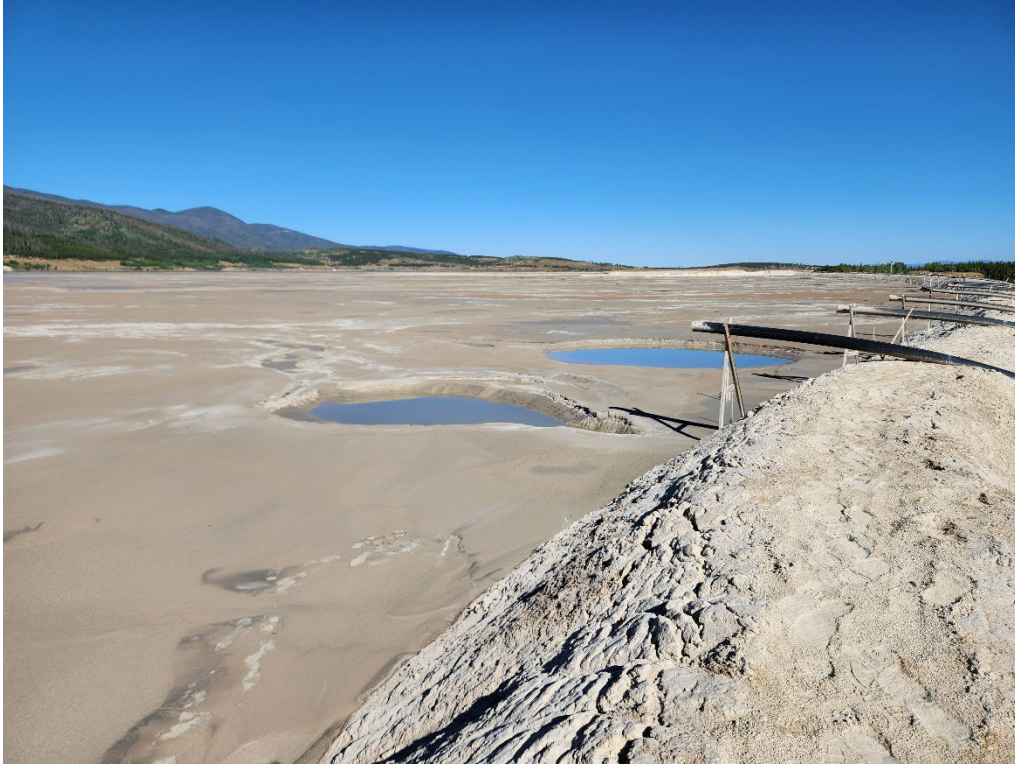
Active tailings deposition was not occurring on 1-Dam or 3-Dam during the inspection. A crew was repairing spigots in the south cell of 3-Dam.

**Photo 1.** Spigots for 3-Dam, looking west.

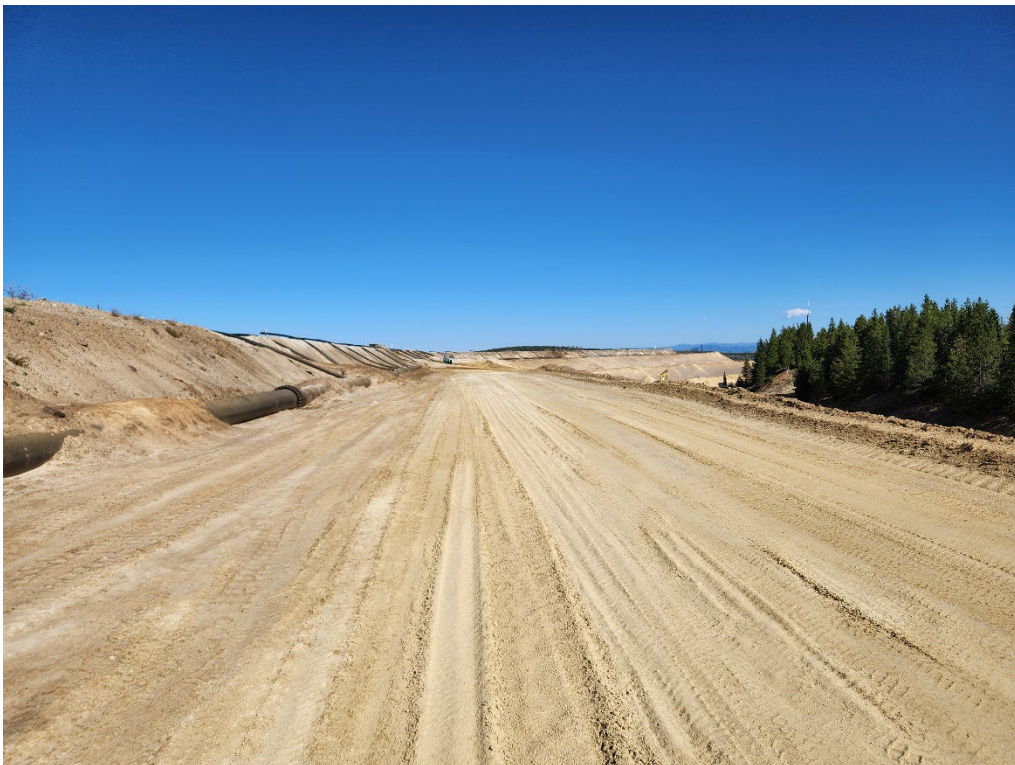
A portion of the Tailings Delivery Line (TDL) was inspected, and no problems were observed. This includes the area where segments of pipe have been replaced or rotated. (Rotation can be used to prolong the life of a pipe segment by putting the worn portion on top.)

**Photo 2.** Access road that follows the tailing delivery line, looking northwest.

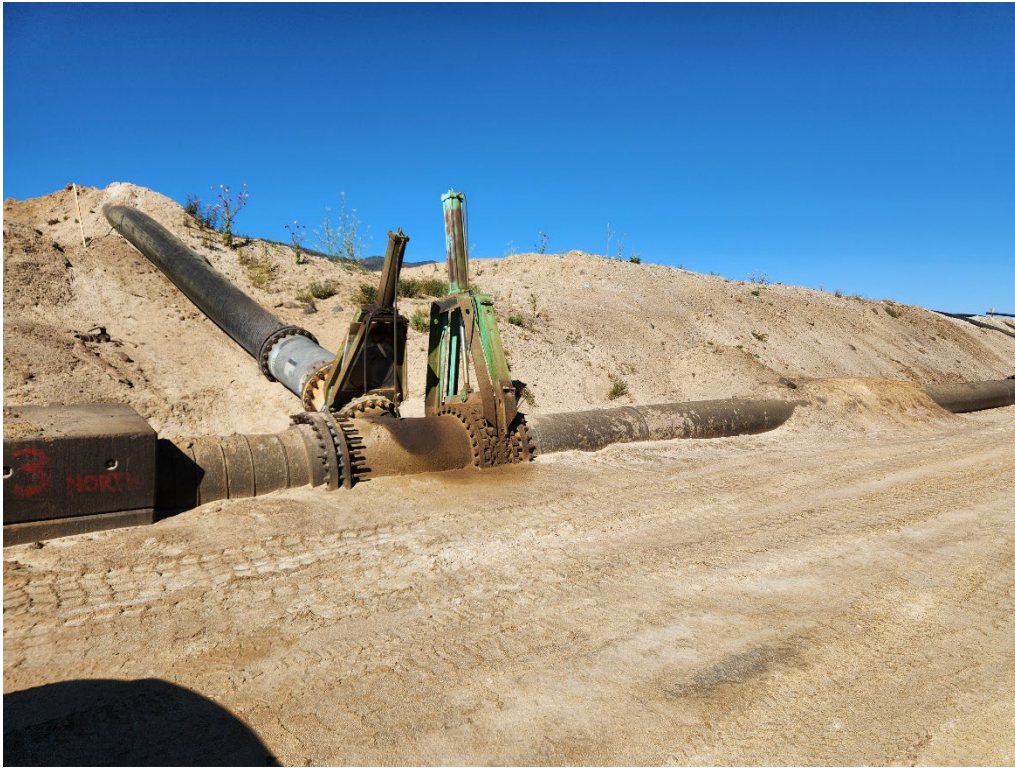
**Photo 3.** A spigot connection to the tailings delivery line.

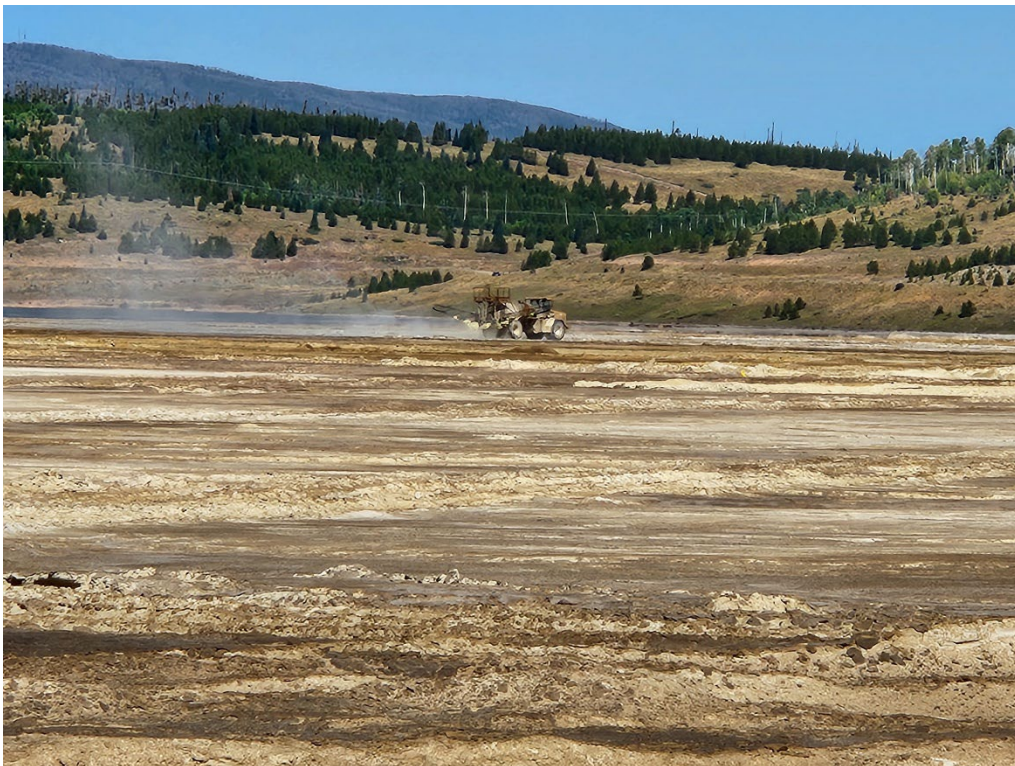
The use of Coherex for dust suppression was apparent in many locations, including the beach, where tire tracks were seen. Evidence of where Coherex was applied can be seen where the deposited tailings have a brown crust-like surface. The use of this material is constant during dry weather conditions per Henderson representatives.

**Photo 4.** Equipment actively applying Coherex dust suppressant to the tailings.

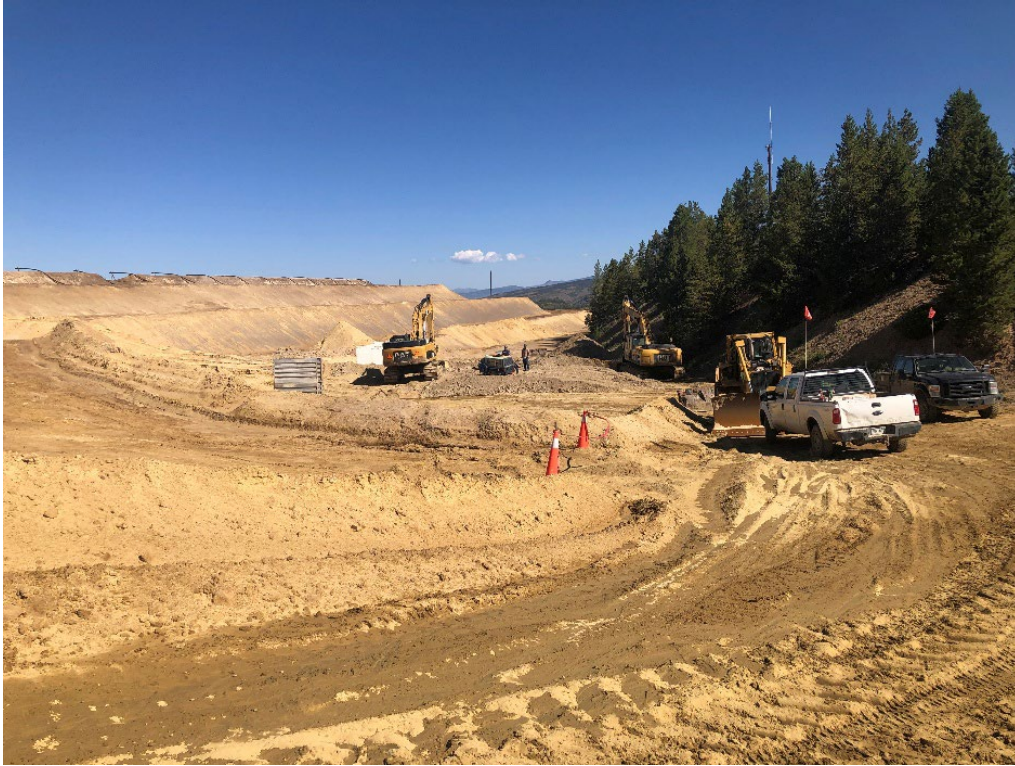
**Photo 5.** Construction area for the future seepage system return pipe.

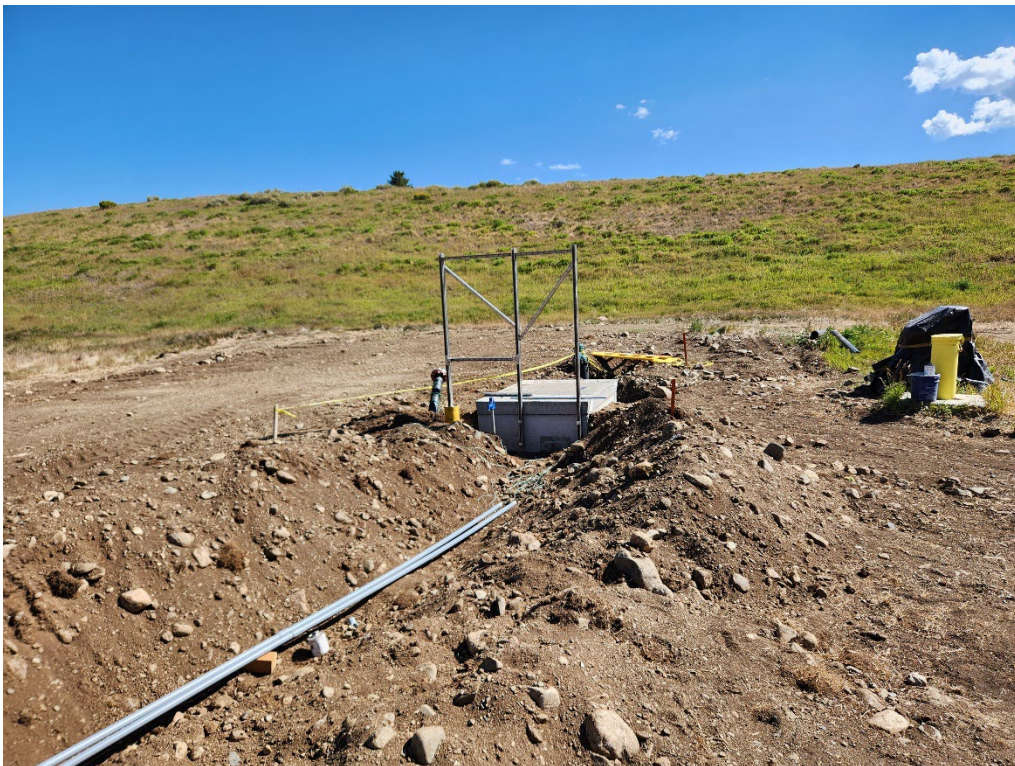
New extraction wells (MLEX-6 and MLEX-7) were observed, and no problems were identified. The wells were completed in 2024, and the rest of this system is still under construction.

**Photo 6.** MLEX-6 Under construction.

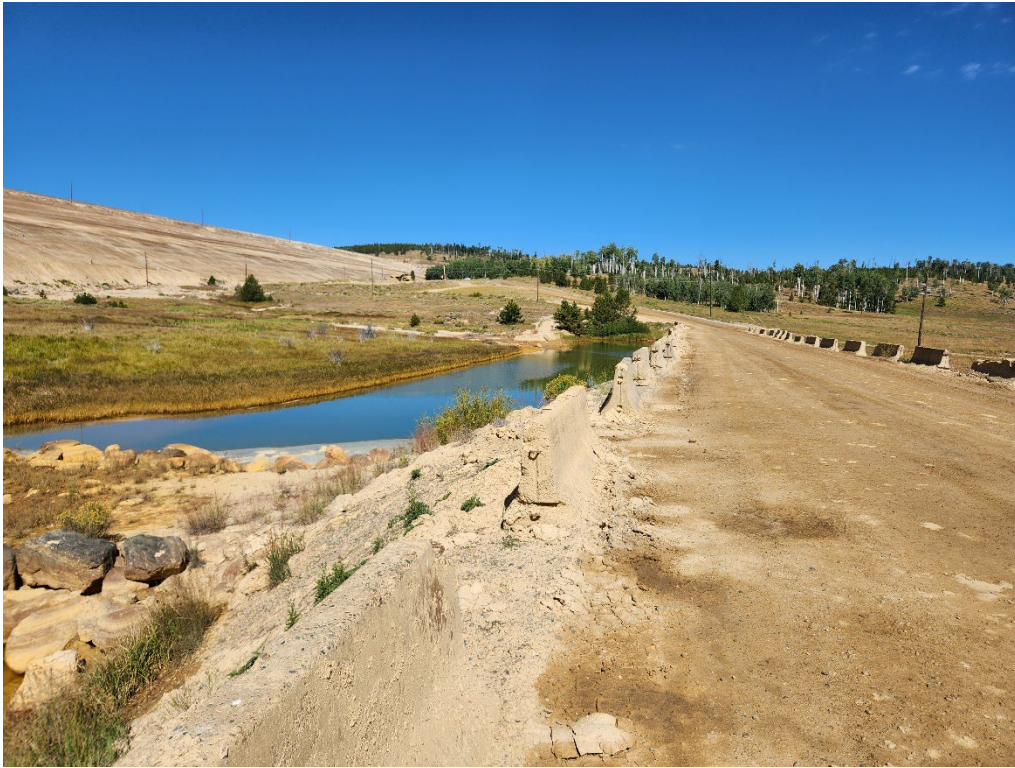
The Seepage Collection Cell was inspected, and no problems were observed.

**Photo 7.** Seepage collection cell, looking northwest.

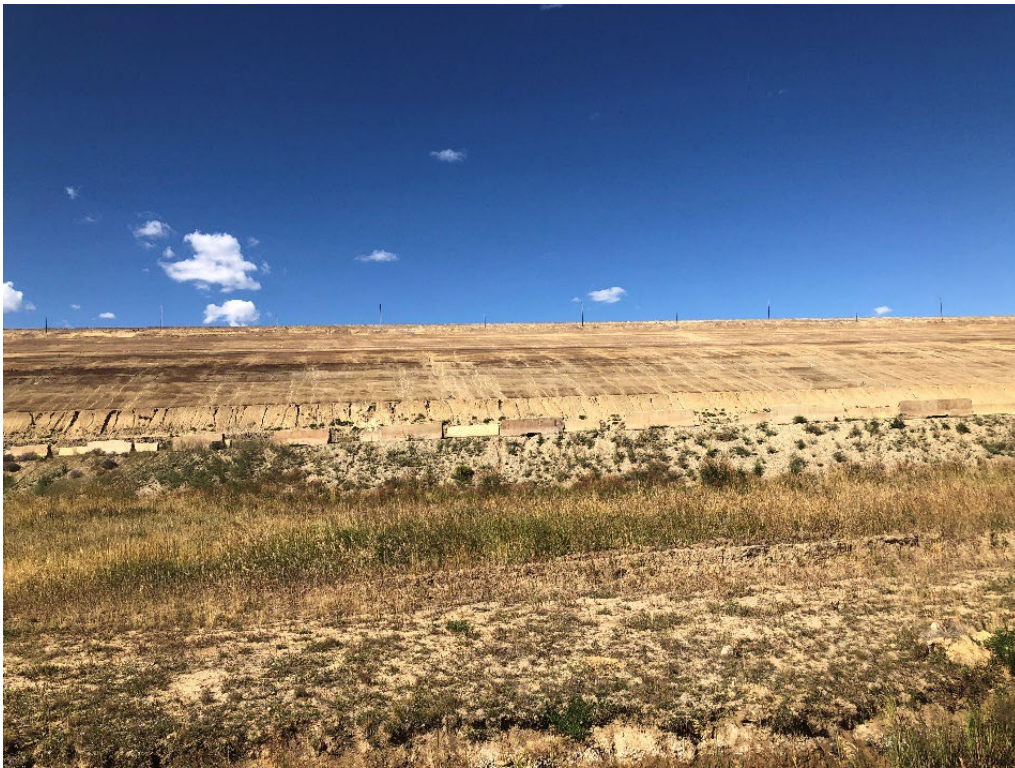
**Photo 8.** Small amount of erosion on face of 1-Dam, at Cell 5 area.

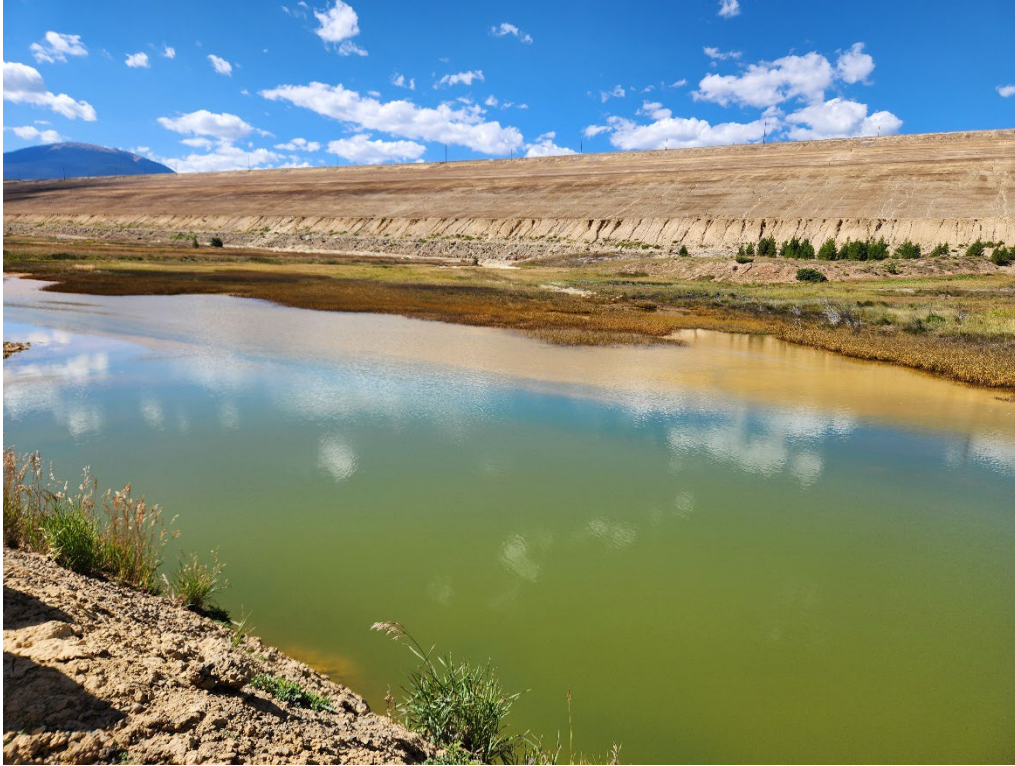
**Photo 9.** Seepage collection cell looking southeast.

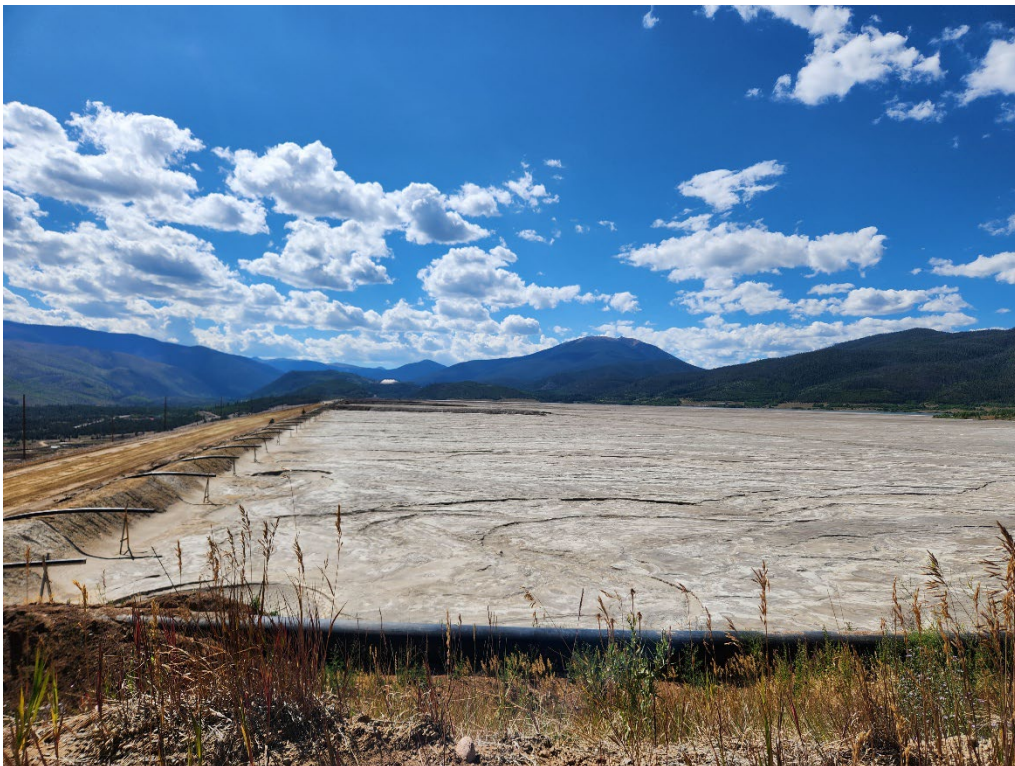
**Photo 10.** View of 1-Dam with Leadoff 9 in the foreground, looking southeast.

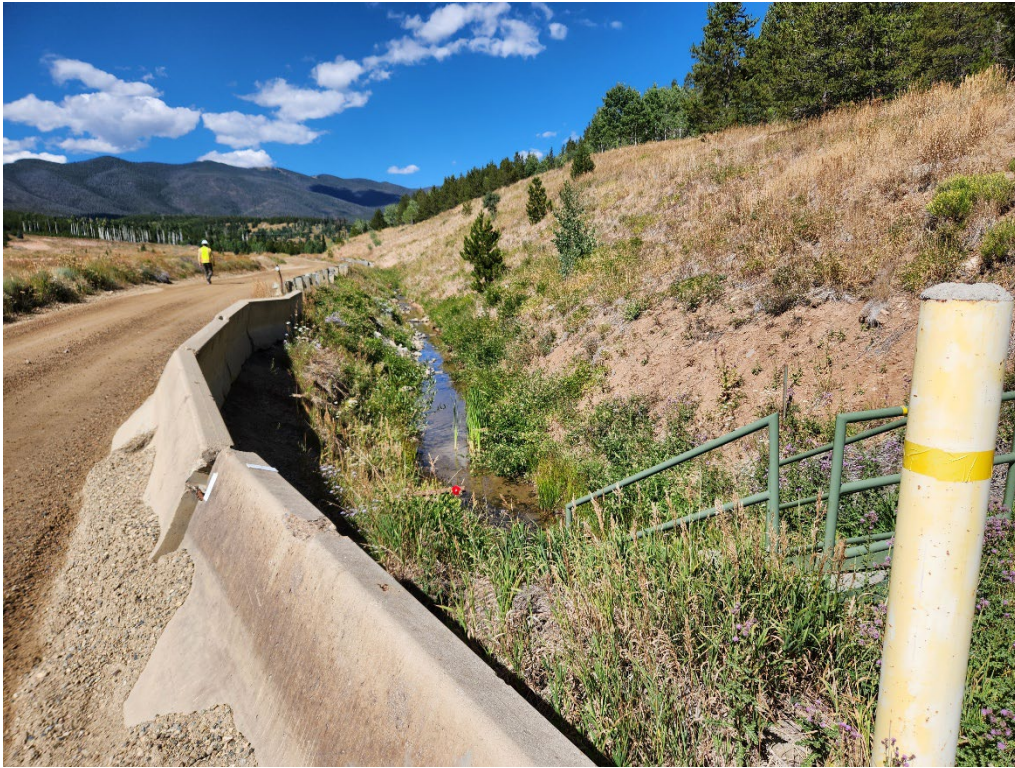
The Ultimate Canal appeared to be operating as designed. The pipe at the lower end of the canal (design from TR-38) has not been constructed yet.

**Photo 11.** Ultimate Canal, looking west.

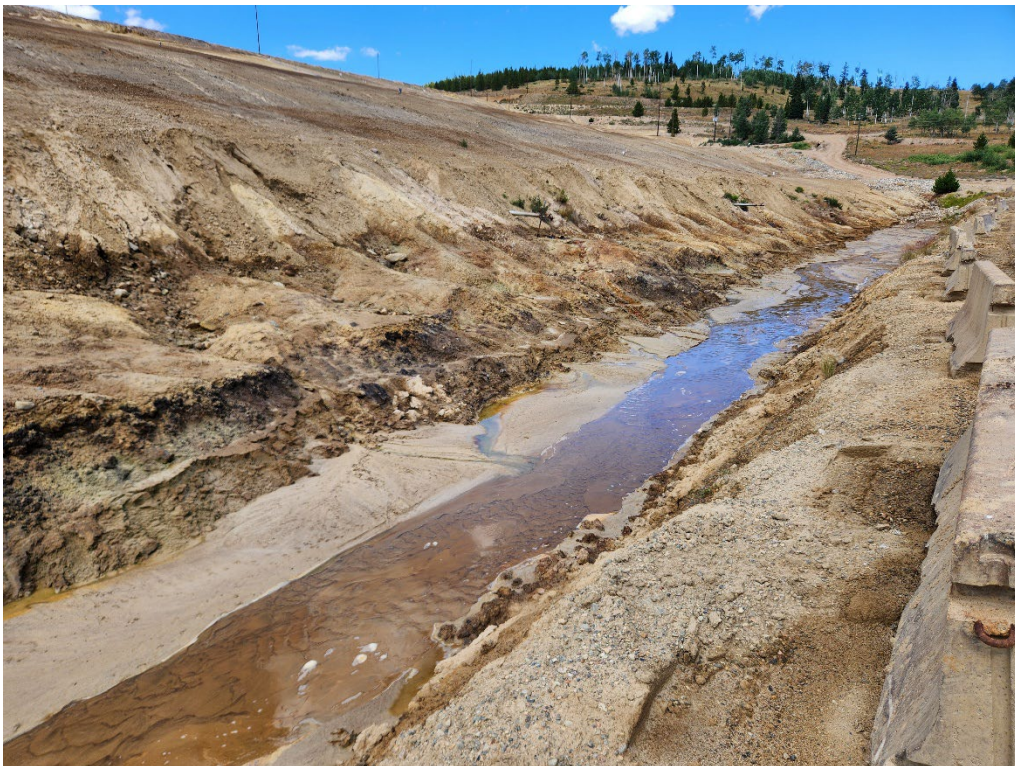
Per Henderson representatives, there are 112 horizontal drains, and almost all (105) are at 1-Dam. They all appear to have P-traps to prevent air from entering the pipes. Many of the horizontal drains were flowing during the inspection; flow rates varied. The water in the discharges appeared to be clear, indicating low amounts of suspended solids. Orange stains were seen below the drains, indicating high values of dissolved iron. AECOM staff were inspecting these drains and looking for signs of any tailings material exiting the horizontal drains.

Some seepage through the TSF was observed near the toe of 1-Dam but did not appear to be problematic as the horizontal drains were operating nearby. The phreatic surface of water in the TSF (darker color of soil) could be observed near these drains.

**Photo 12.** Horizontal drains below 1-Dam, looking north

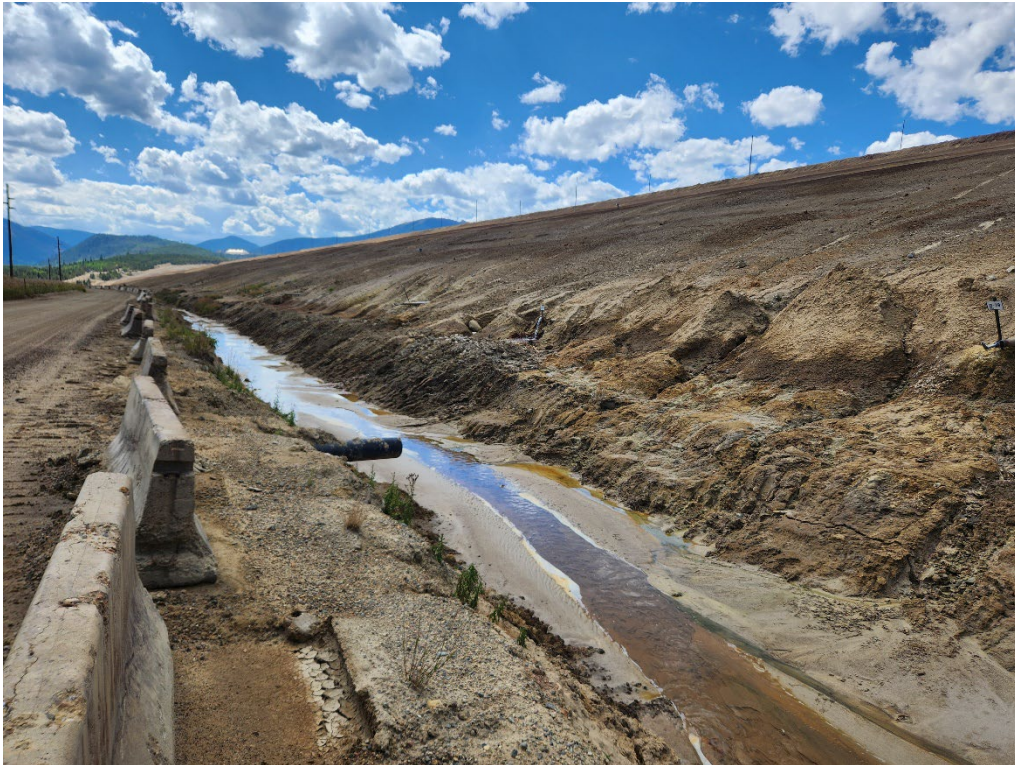
**Photo 13.** Horizontal drains, looking south.

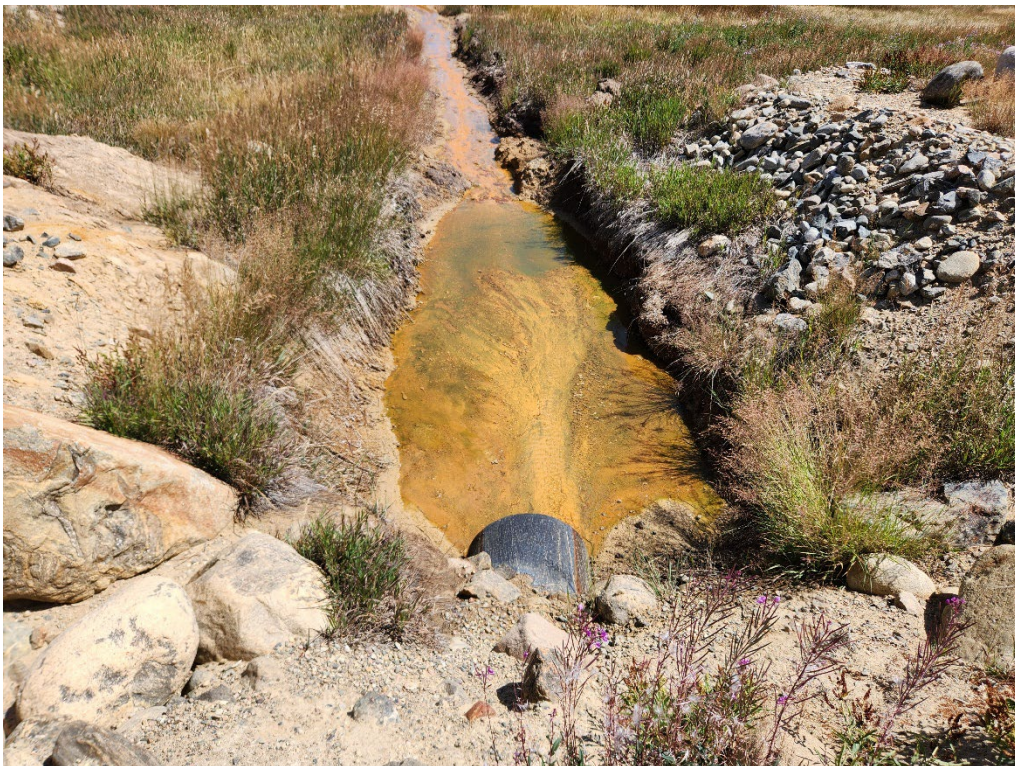
Some of the foundation drains were flowing (e.g., Number 6), and some were not. Per Henderson staff, these drains are not cleaned because they are fragile and nearing the end of their life. Where these drains have failed, Henderson has installed extra horizontal drains.

**Photo 14.** Foundation drain, looking northeast.

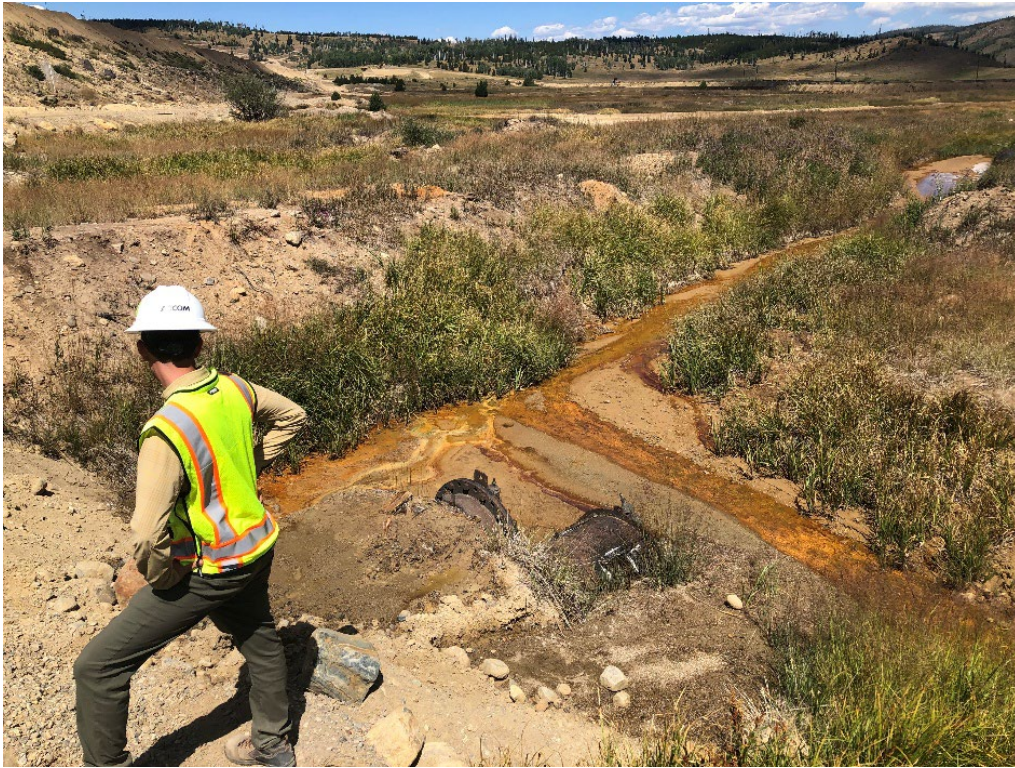
The lower ends of abandoned decant lines were observed, and no problems were observed.

**Photo 15.** Abandoned decant lines below 1-Dam.

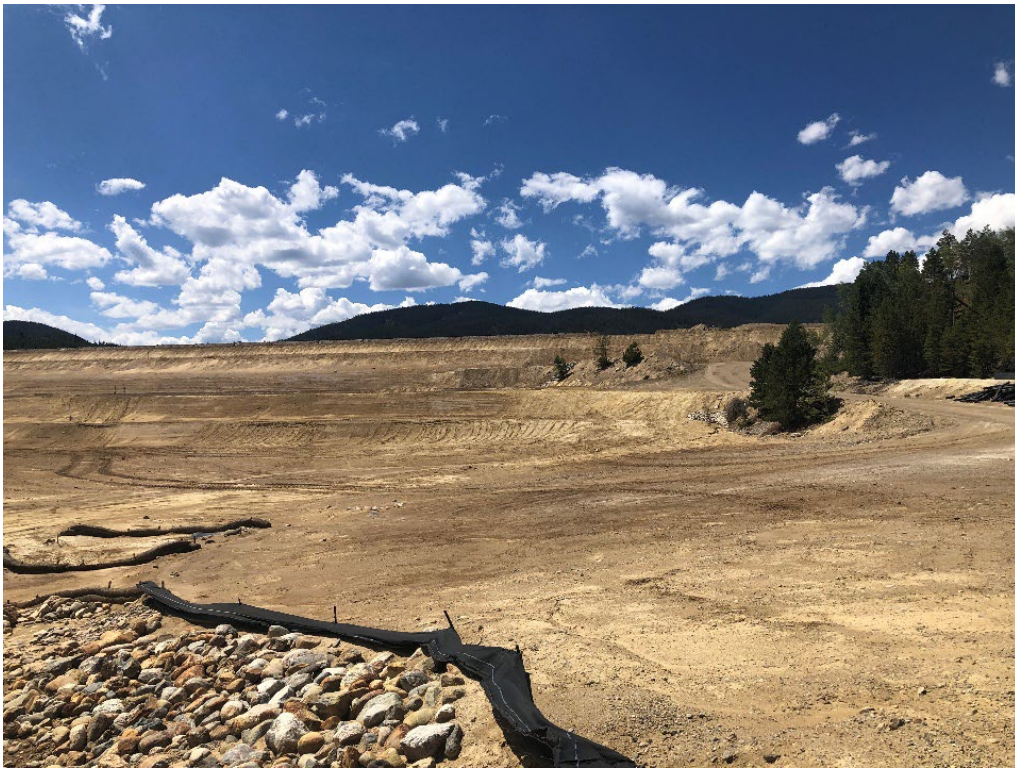
The buttress below the 3-Dam includes a step-back, north toe, and south toe components. These structures were built to provide an extra layer of protection for the TSF. No problems were identified with any elements of the buttress. AECOM and Henderson staff were considering revisions to the seepage collection system above the north toe component, prior to construction of another component of the buttress

**Photo 16.** Buttress Phases 1 and 2 below 1-Dam.

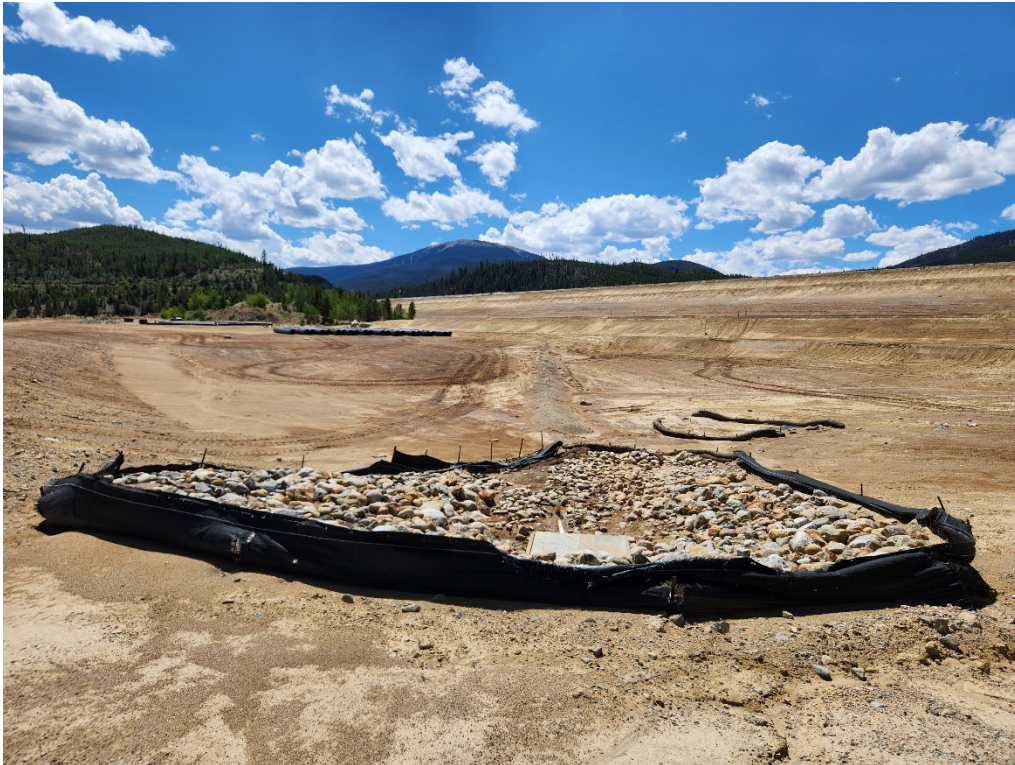
**Photo 17.** Buttress Phases 1 and 2 below 1-Dam, with seepage collection system above the north toe in foreground

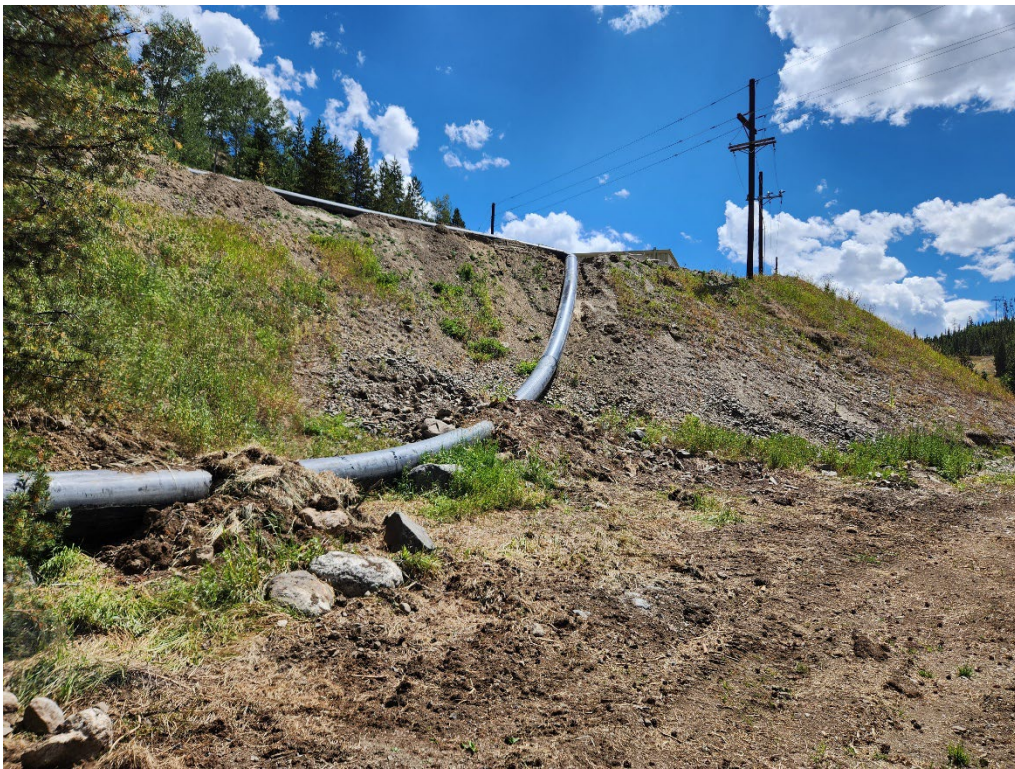
Tailings were being deposited in the East Branch Trunk by a 24-inch pipe. The discharge point is approximately 500 feet below the East Branch Pumphouse. This is in compliance with TR-38 and is discussed in the 2024

The pipeline depositing these tailings is detailed in the Mill EPF 1.3 – Tailings Delivery System. A 24-in lead-off pipe is used to deposit the tailing and this pipeline is intended to be moved as the dam is raised.

**Photo 18.** A 24-in leadoff pipe used to deposit tailings in the East Branch Trunk, looking north.

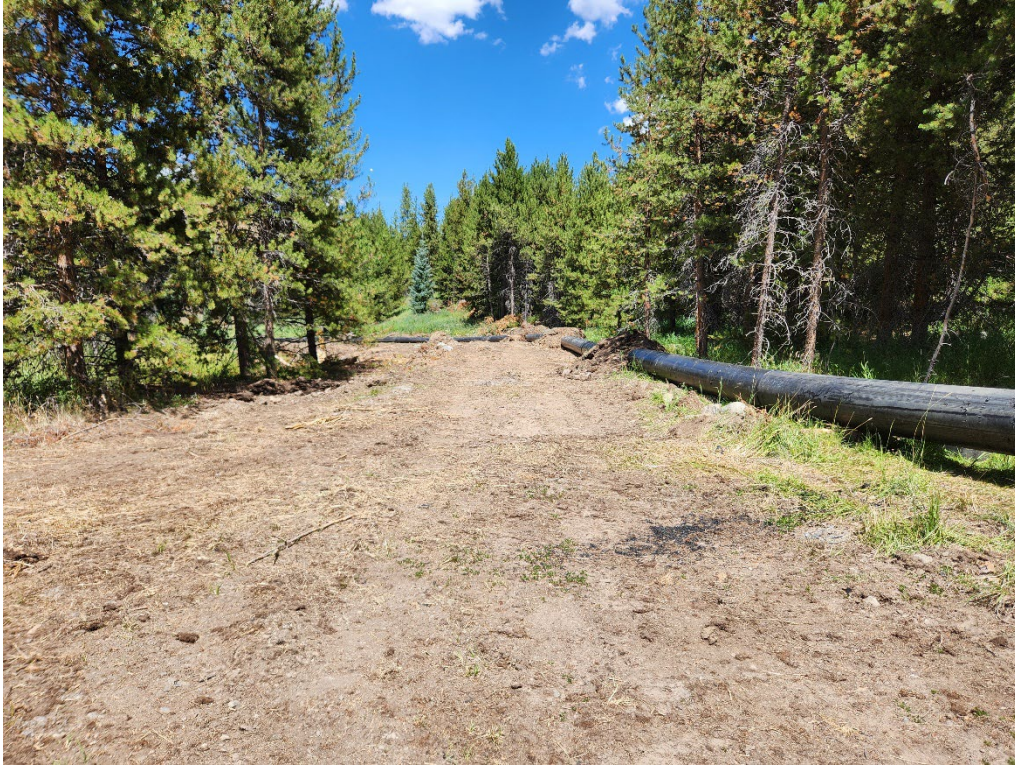
**Photo 19.** Road and pipeline leading down to the East Branch Trunk tailings deposit.

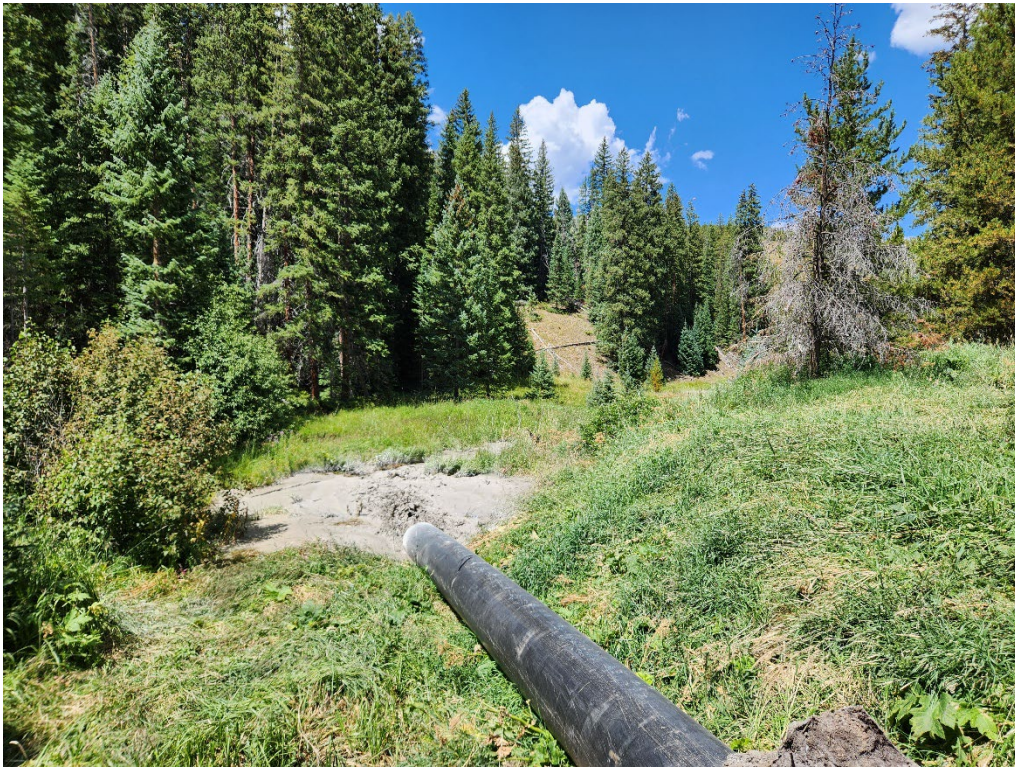
The Division observed tailings actively being deposited the East Branch Trunk in an attempt to create positive drainage into the TSF. At ultimate height, tailings will be near the toe of the reservoir in order to keep positive drainage on the TSF.

**Photo 20.** Tailings slurry flowing into the East Branch Trunk.
