Inspection Report, Coal Complete, September 9-10, 2025, C1981019

Permit Number: C-1981-019 Mine Name: Colowyo Coal Mine Operator: Colowyo Coal Company L.P. Operator Address: Mr Tony Tennyson 5731 State Highway 13 Meeker, CO 81641	County: Moffat, Rio Blanco Operation Type: Surface Permit Status: Active Ownership: Private
	Operator Representative Present: Tony Tennyson
Operator Representative Signature: (Field Issuance Only)

Inspection Start Date: September 9, 2025 Inspection Start Time: 11:30 Inspection End Date: September 10, 2025 Inspection End Time: 13:30	Inspection Type: Coal Complete Inspection Inspection Reason: Normal I&E Program Weather: Clear
Joint Inspection Agency: None	Joint Inspection Contacts:
Post Inspection Agency: None	Post Inspection Contacts:
Inspector(s): Hunter Ridley	Inspector's Signature: <i>Hunter Ridley</i> Signature Date: September 17, 2025

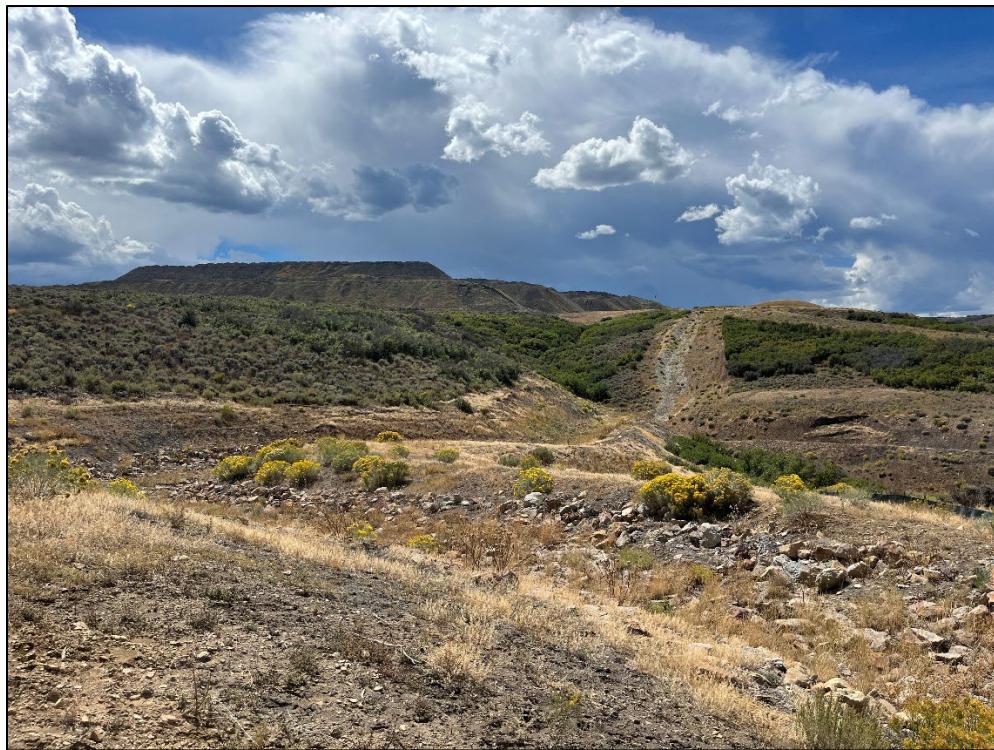
The following ditches in Collom Pit were inspected this month: Ditches D-1, D-2, D-3, and D-4 (Photos 1-4). Ditches were walked where accessible and checked for erosional issues and stability, for which no issues were observed. All ditches appeared to be functioning as designed. Small vegetation is present in un-riprapped lengths of the ditches.

Photo 1: View south of ditches D2 and D1.

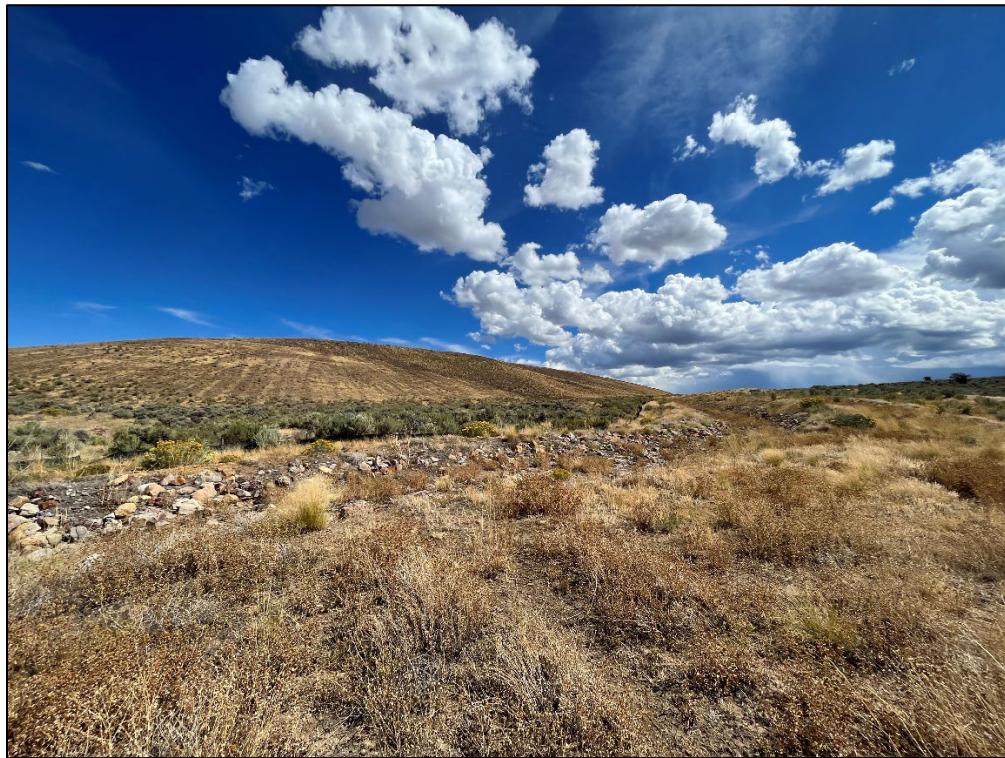
Topsoil piles across the site contained appropriate markers and were well vegetated (e.g. Photo 2).

Photo 2: View north of ditch D2 and topsoil pile 26A.

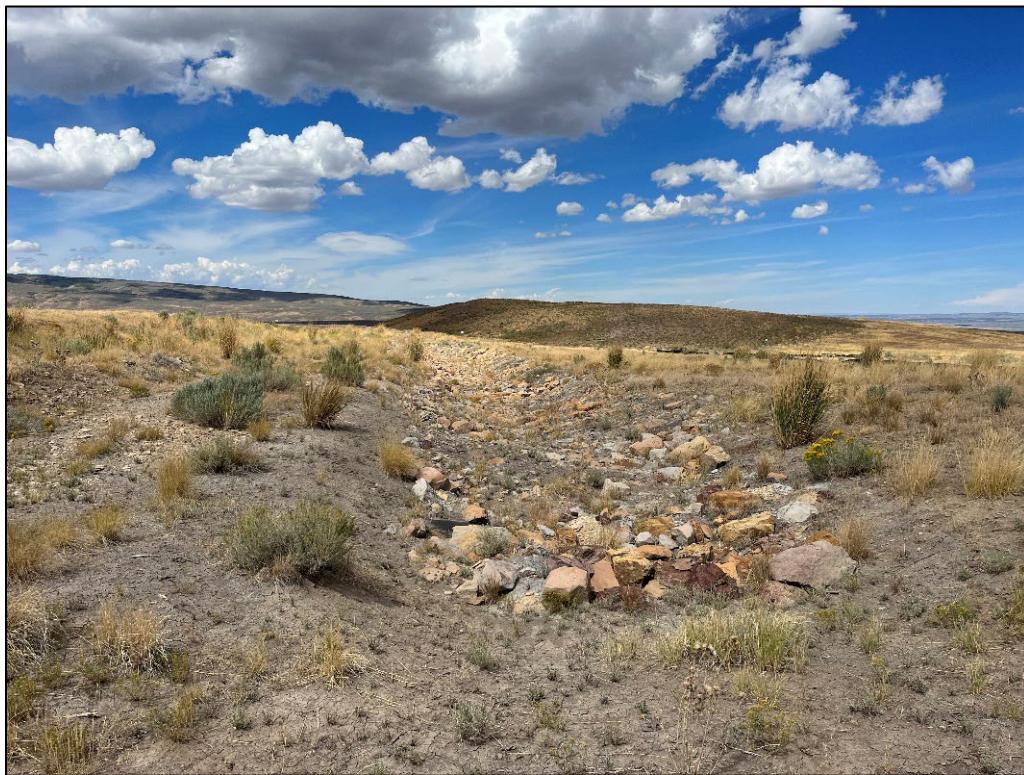
Photo 3: View northwest of the eastern end of ditch D2.

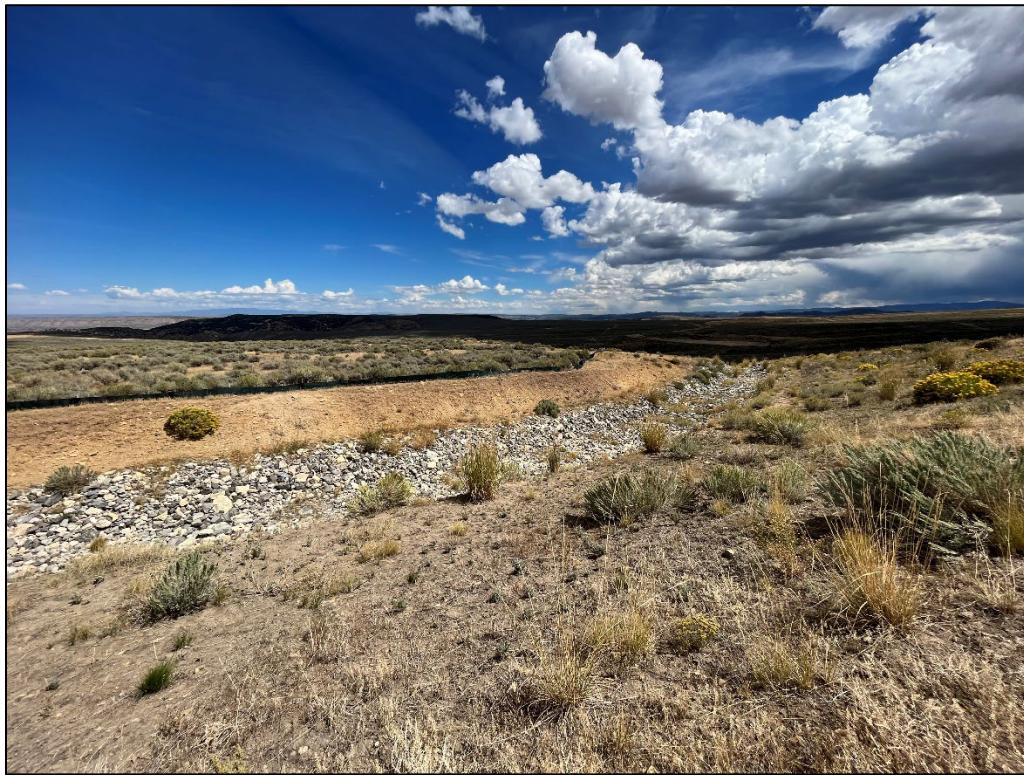
Photo 4: Ditch D3.

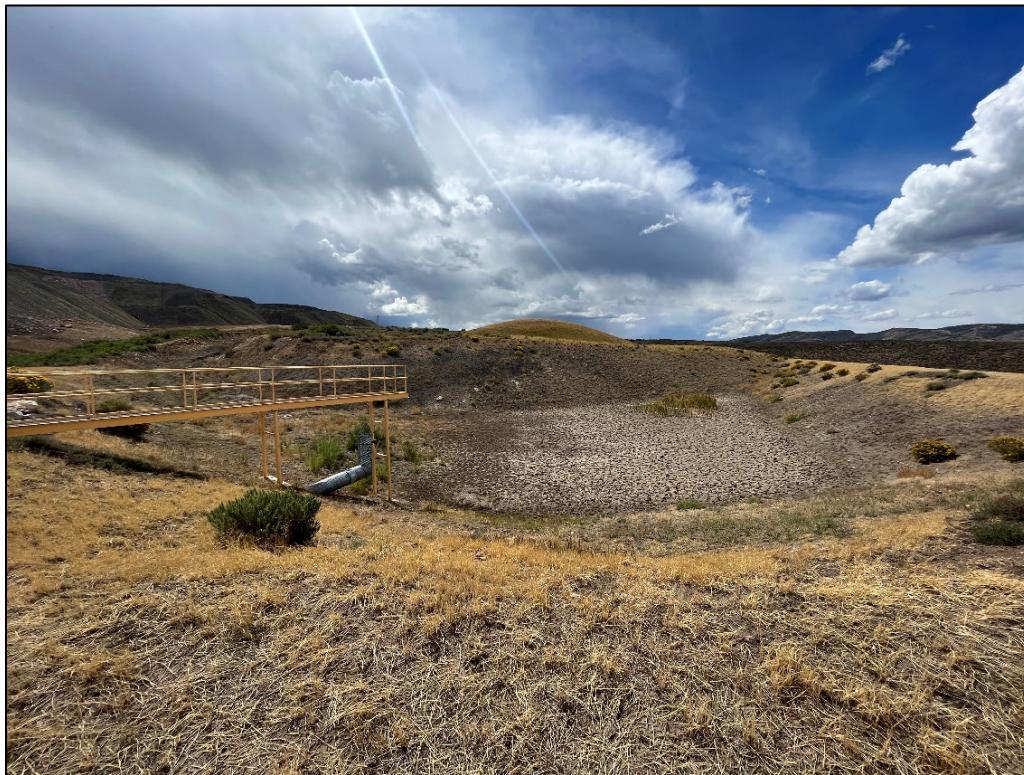
The following ponds in Collom Pit were inspected this month: Section 26, Sidehill, Section 36, Middle, and Section 25. All ponds, except Sidehill and Section 25 Pond, were seen to be holding water, although

water was very low in all ponds that did hold water. All inlet / outlet areas were free of obstructions and no issues with erosion were noted (Photos 5 and 6 & 9-11).

Photo 5: Sidehill Pond.

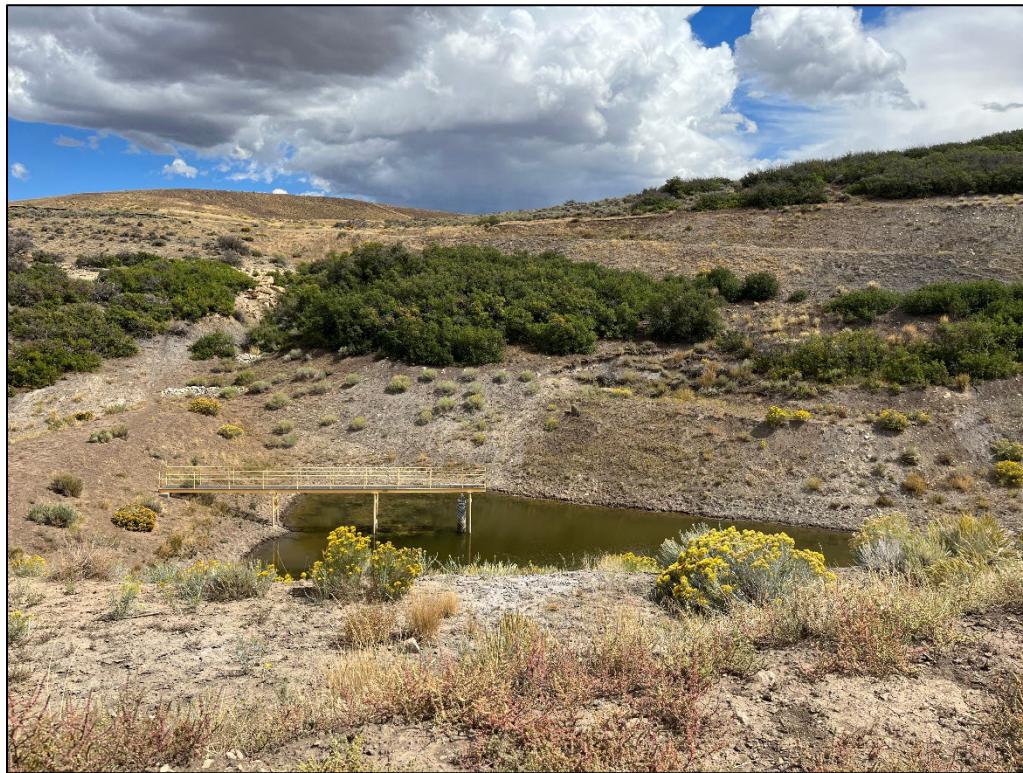
Photo 6: Section 26 Pond.

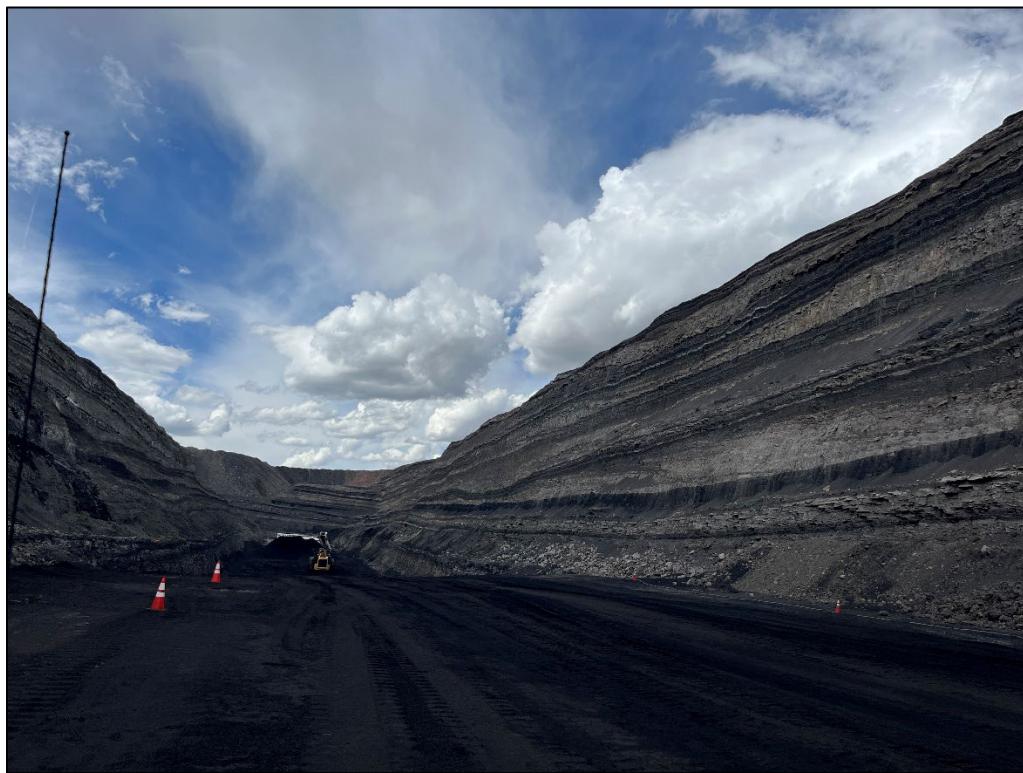
Active backfill operations were noted in the large, western Collom Pit (Photo 7). Backfill in the eastern box cut area did not appear to have progressed much since the Division's last inspection.

No active highwall mining operations in Collom Pit were observed during this month’s inspection. Haul truck teams were noted in the area to be working on backfilling of previously mined highwall areas (Photo 7). A train was noted at the loadout during the first day of inspection.

Photo 7: View into the Collom Pit, backfilling operations in progress.

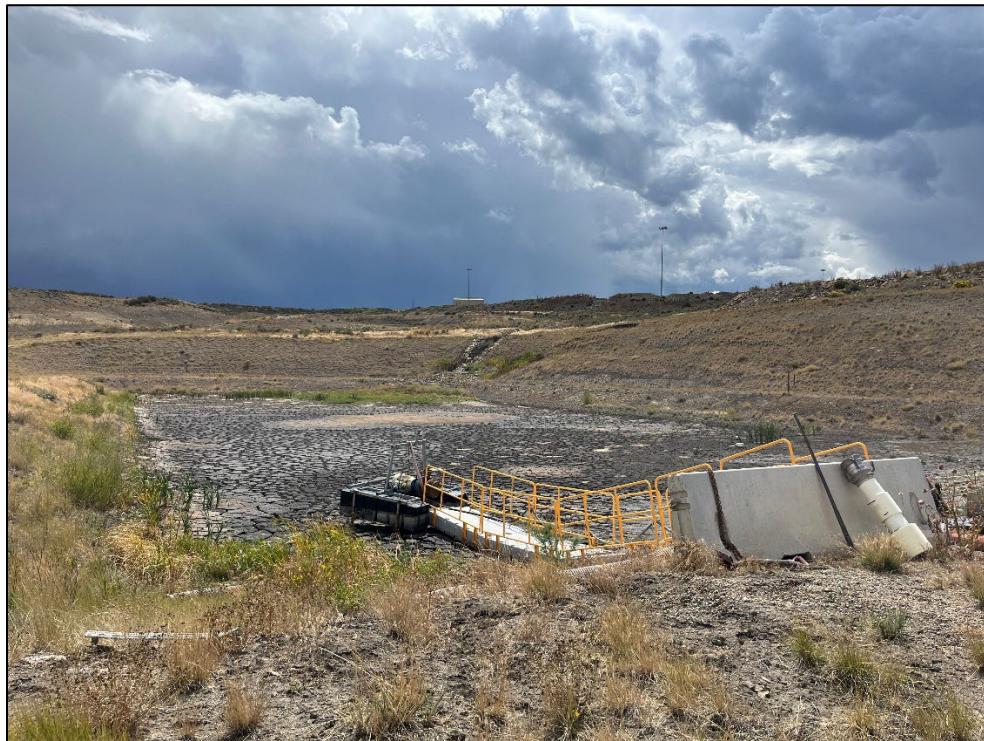
The Wilson Storage Pond and Temporary Facilities Ponds were inspected and both found to be dry and heavily vegetated (Photos 12 and 13). The Coal Stockpile Pond in Collom Pit was inspected and mostly dry with stable slopes (Photo 8).

Photo 8: Coal Stockpile Pond in Collom Pit.

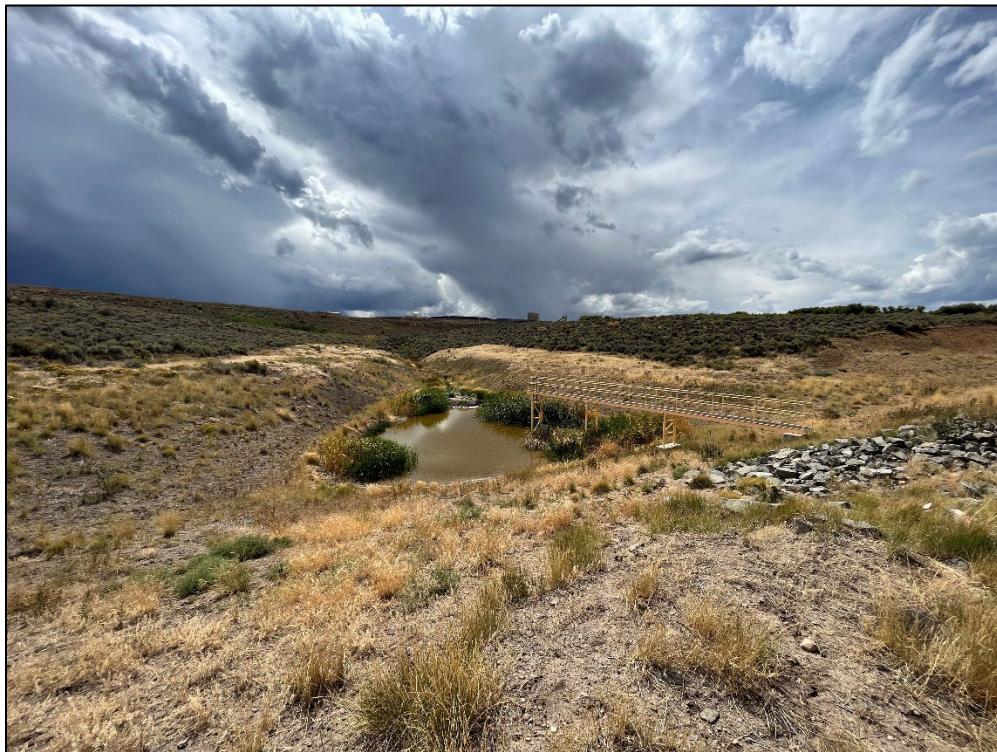
Photo 9: Section 36 Pond.

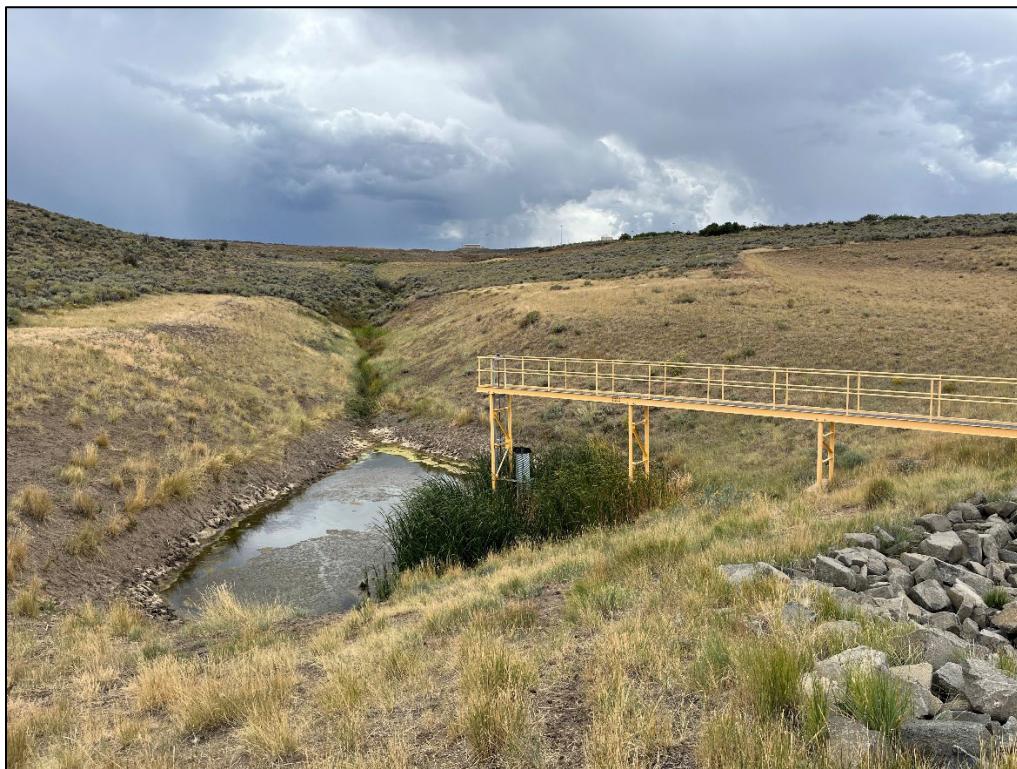
Photo 10: Middle Pond.

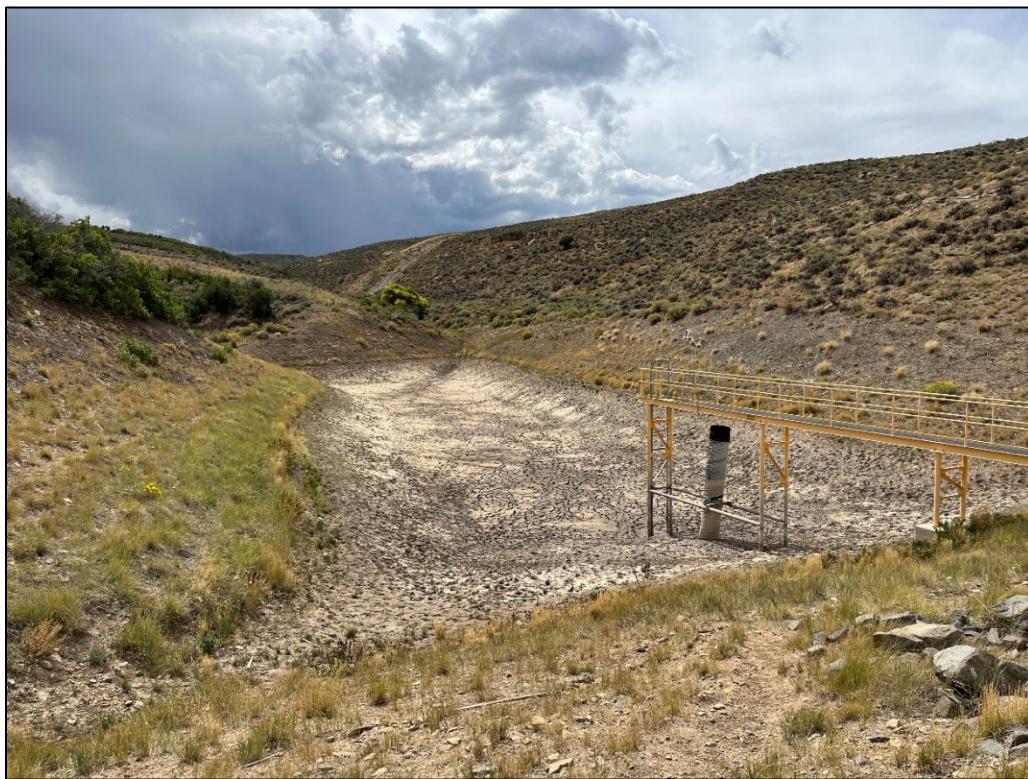
Photo 11: Section 25 Pond.

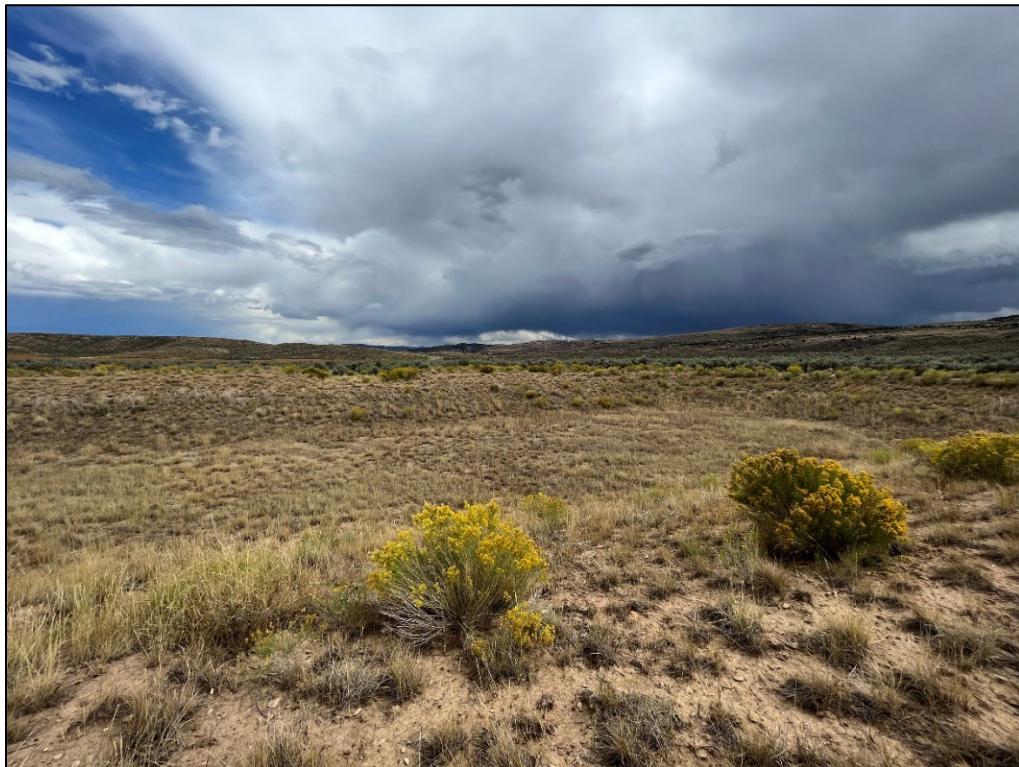
Photo 12: Temporary Facilities Pond, west of Gossard Loadout.

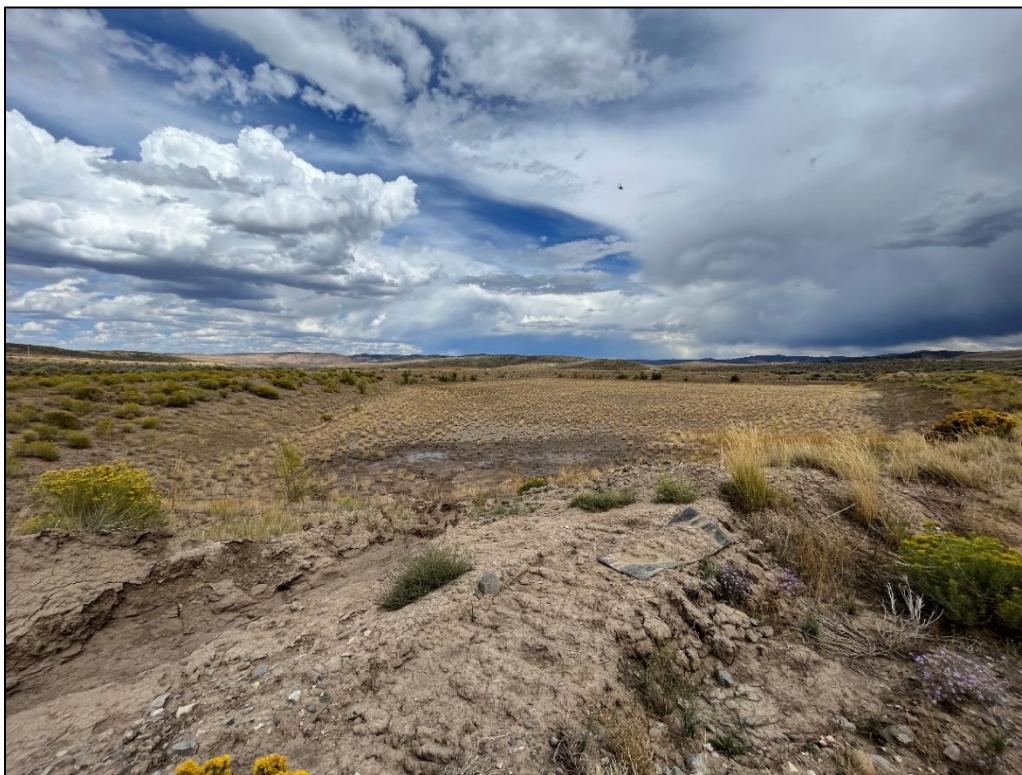
Photo 13: Wilson Storage Pond, west of Gossard Loadout.

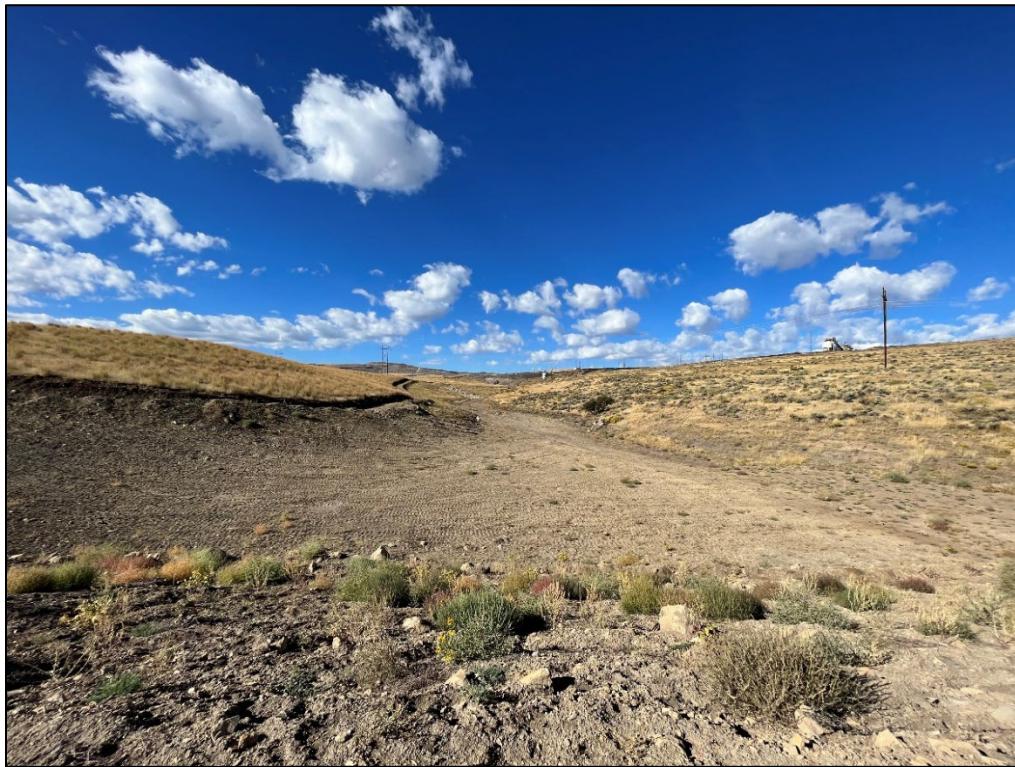
Upper and Lower Section 3 Ponds were inspected and were both dry. No erosional or stability issues were noted at the berm between the two ponds or on the outslope of the Lower Section 3 Pond (Photo 14).

Photo 14: View west of Lower Section 3 Pond.

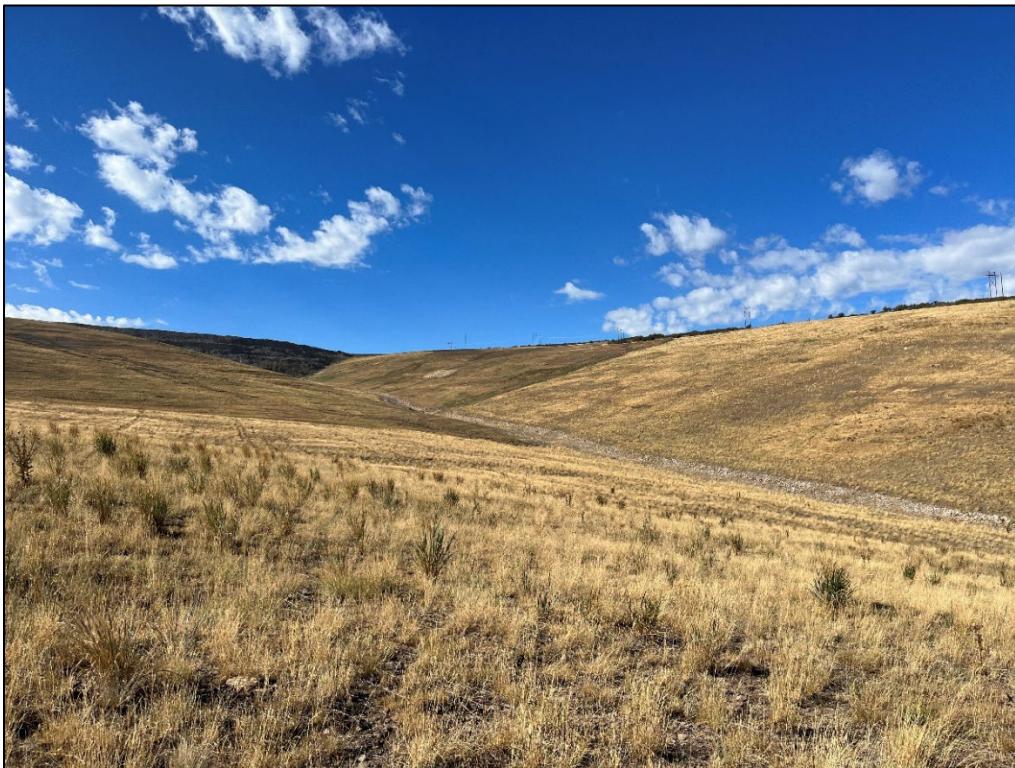
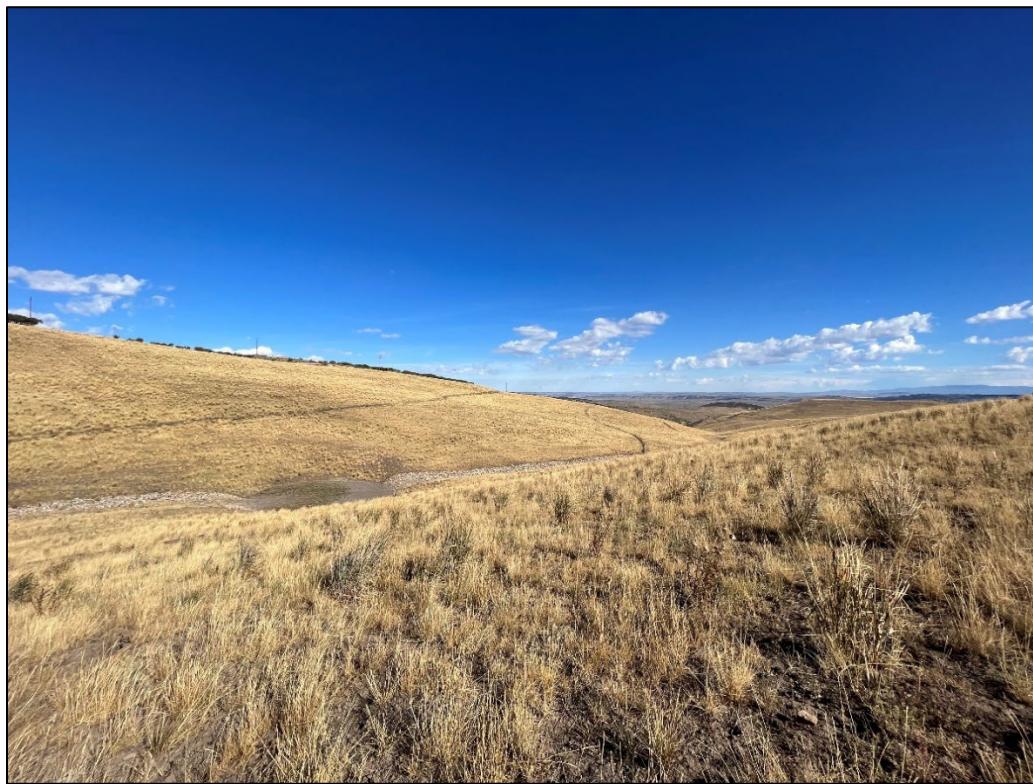
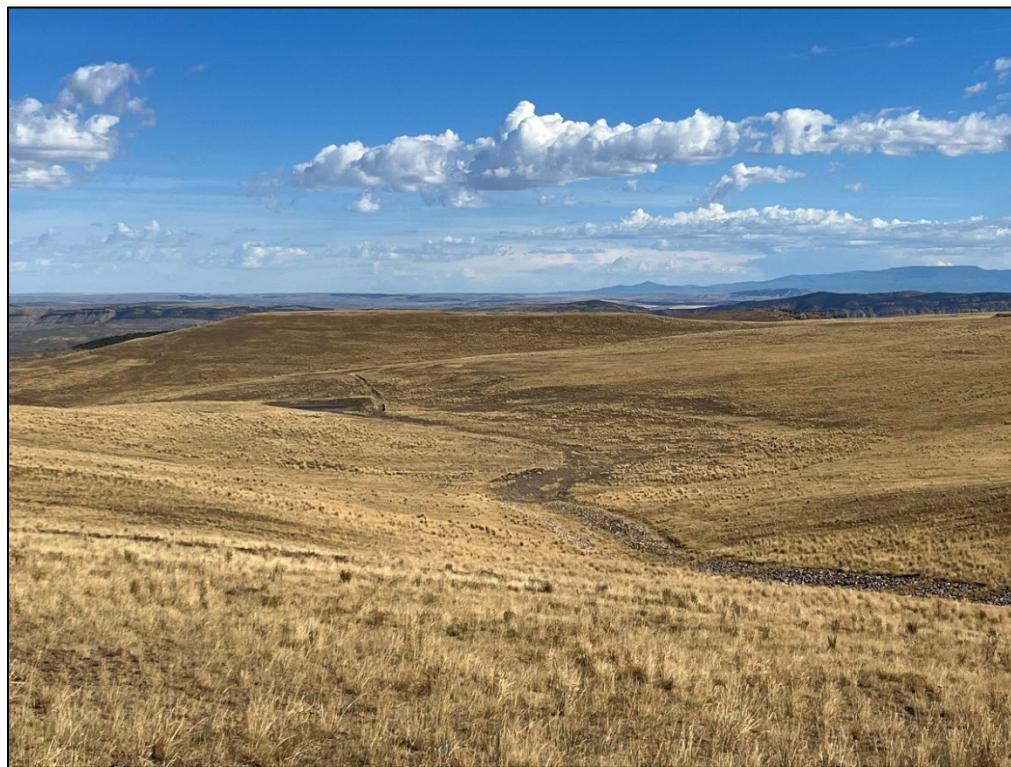
West Pit has been almost entirely backfilled and is mostly in its revegetation phase. West Pit was inspected from within its reclamation areas (Photos 15-17). A large southern portion of the West Pit area was recently approved for a Phase I Bond Release under SL-24. Mature bunch grasses and various wildlife were observed in the active revegetation areas and no major erosion rills or gullies were noted.

The following stock ponds in the West Pit area were inspected this month: TD1, TD2 and ETD1 (Photos 15-17). All stock ponds appeared to be dry, with no erosional issues or concerns noted.

The following ditches in the West Pit area were inspected this month: East Taylor Ditch and Taylor Ditch (Photos 15-17). Both ditches were inspected from within the West Pit reclaimed area. No signs of erosion or cutting were visible along any of the observed West Pit ditches and inlet / outlet design for stock ponds appeared to be functioning properly.

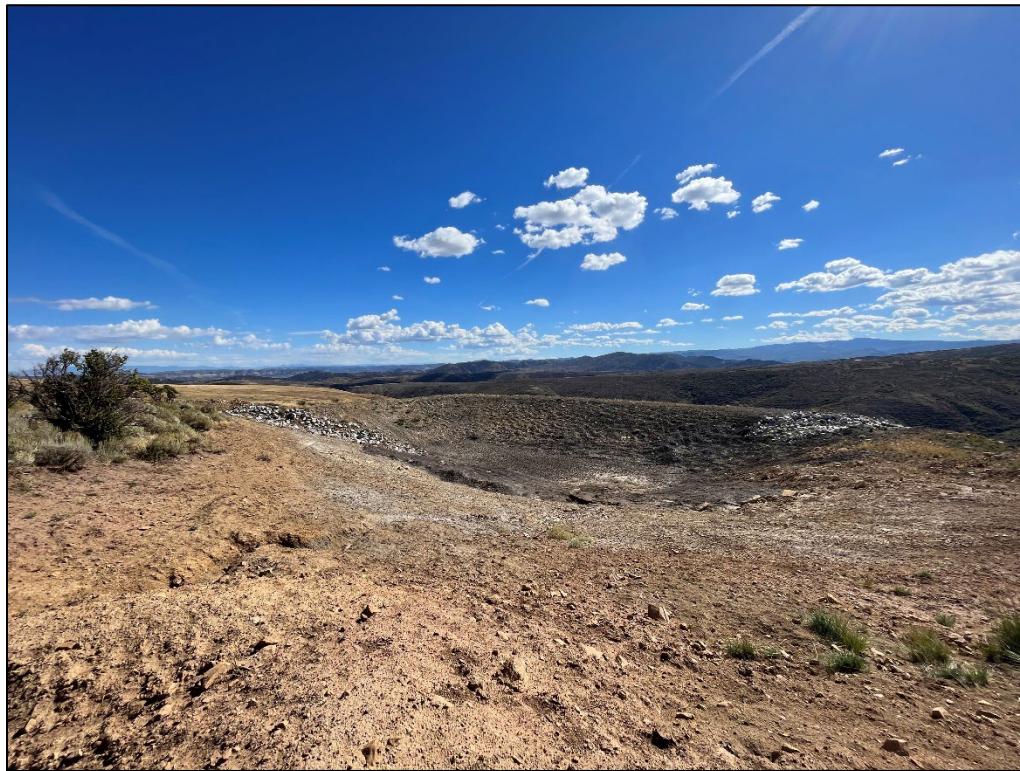
Section 15 Pond and Ditch (Photo 18) were observed in East Pit. Section 15 Pond was completely dry and was free of any stability or erosional issues. Section 16 Pond was inaccessible due to ongoing grading and excavation activity in the South Taylor temporary spoil pile areas.

Photo 18: Section 15 Pond.

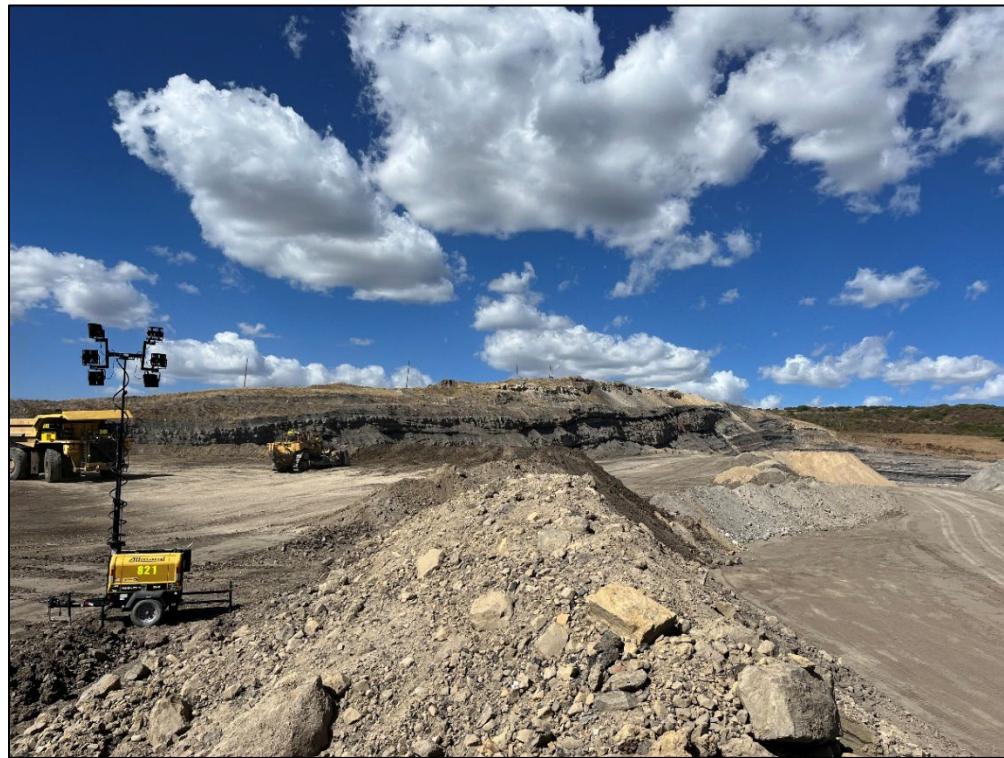
Active backfill operations were observed during this inspection of the South Taylor Pit. Haul trucks were noted to be distributing spoil material into the southwestern corner of the pit (Photo 19.). At the time of inspection, material was being excavated from the northeastern edge of the South Taylor Pit temporary spoil pile.

Photo 19: Active backfill area in South Taylor Pit.

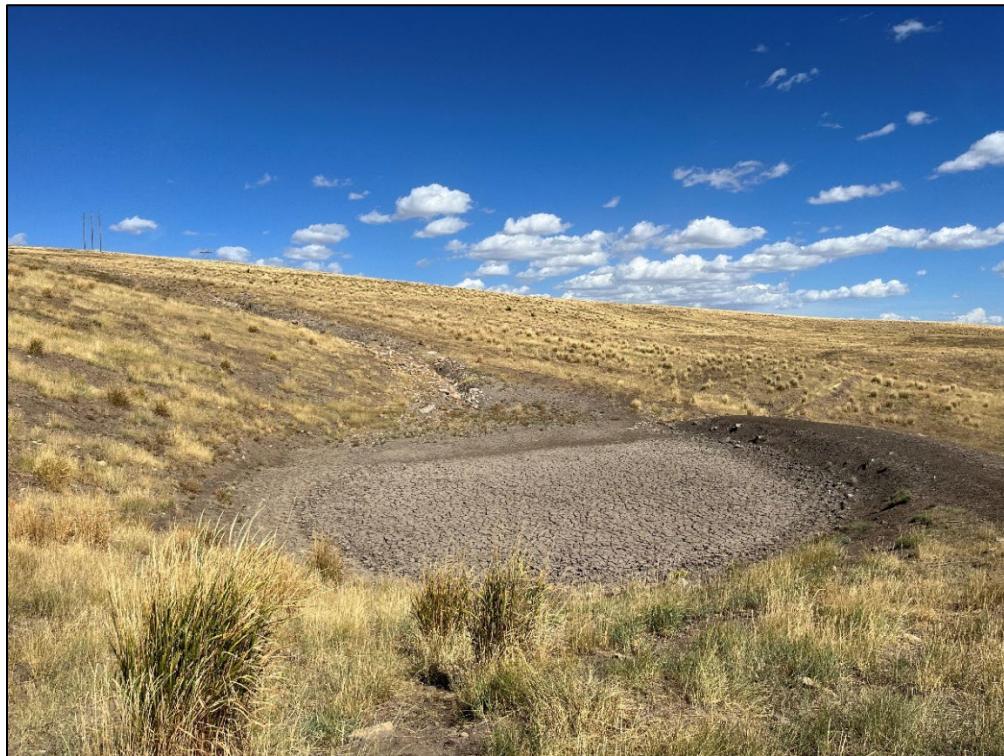
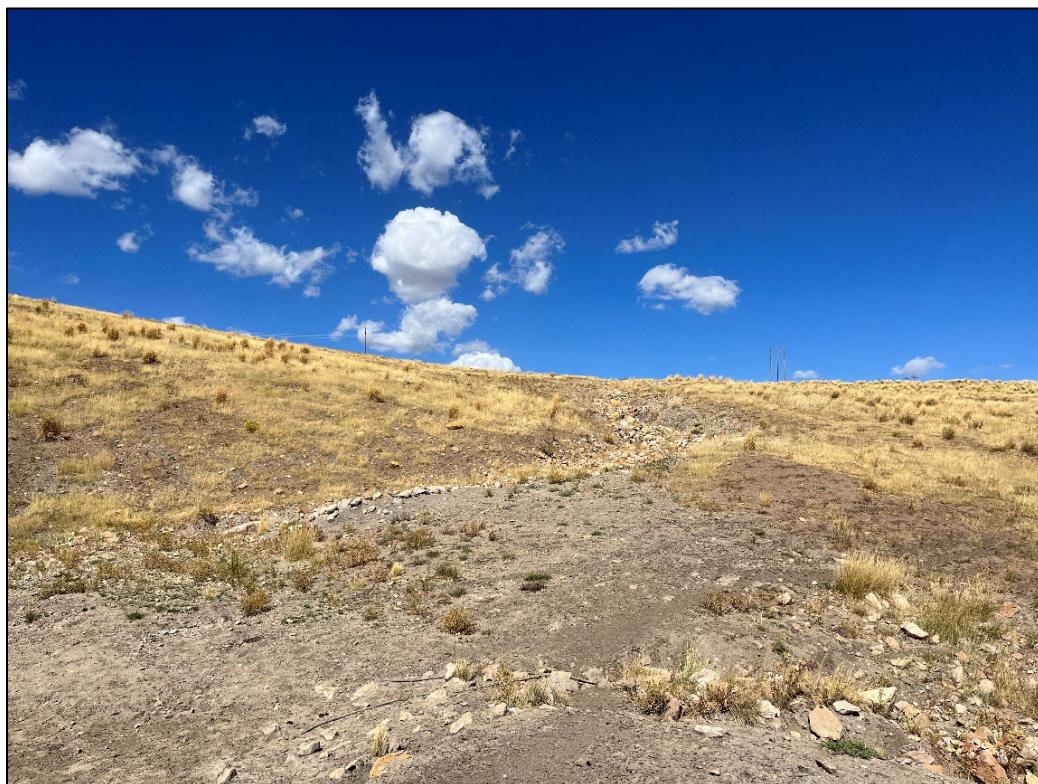
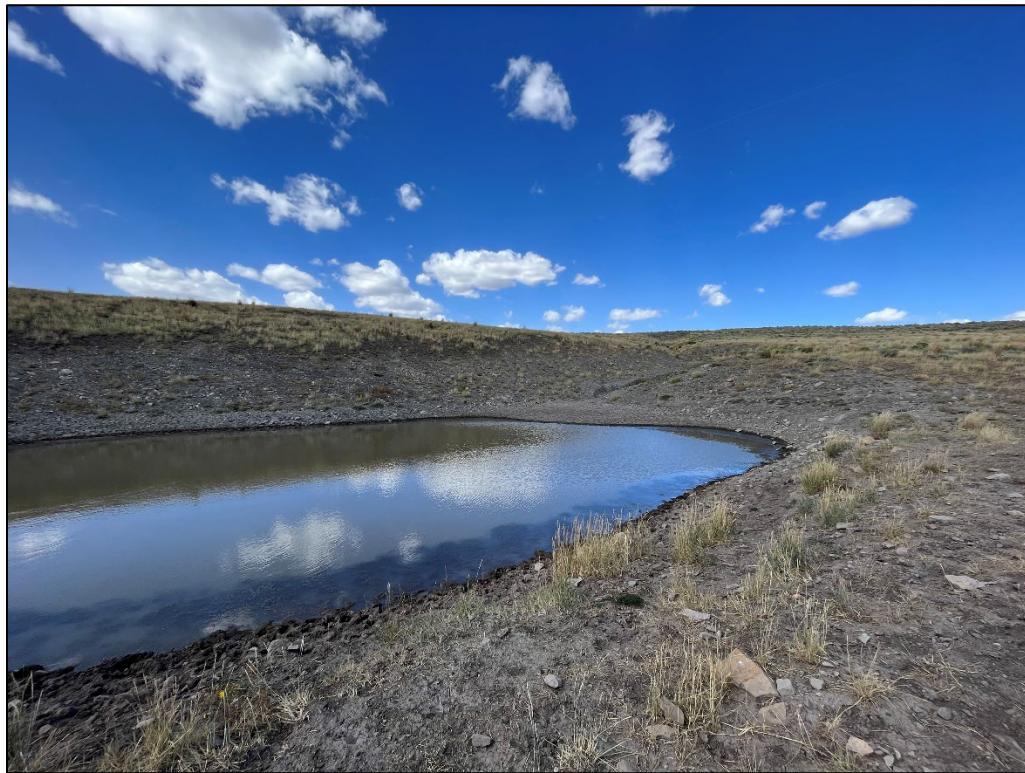
The following stock ponds in the East pit were observed during this inspection: PD1, PD2 and NTEP1 (Photos 20 -22), NTEP1 was the only stock pond holding water. EP1, EP2 and EP3 and were observed from above at the Section 15 Ditch. Only EP2 appeared to be holding any water and was flowing into Reach 2 of the Final East Pit Ditch as designed.

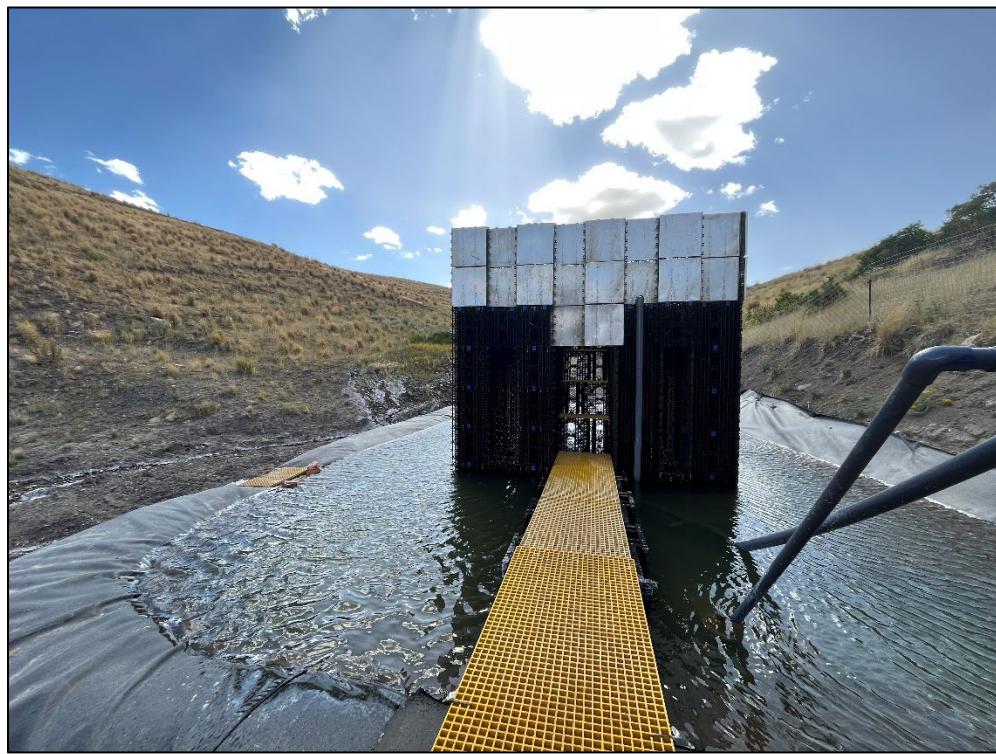
The test pilot water treatment plant at East Taylor Pond, approved under MR-263, is fully constructed and operating (Photo 23). The system was observed to be pumping water from the spoil spring outfall at the pond into the test evaporation system. At the top of every hour, water is misted across the black evaporation system. Colowyo will be assessing the success of this system in preparation for the future necessity of perpetual water treatment for East Taylor Pond water.

Photo 23: Pilot test plant at East Taylor Pond for water treatment.

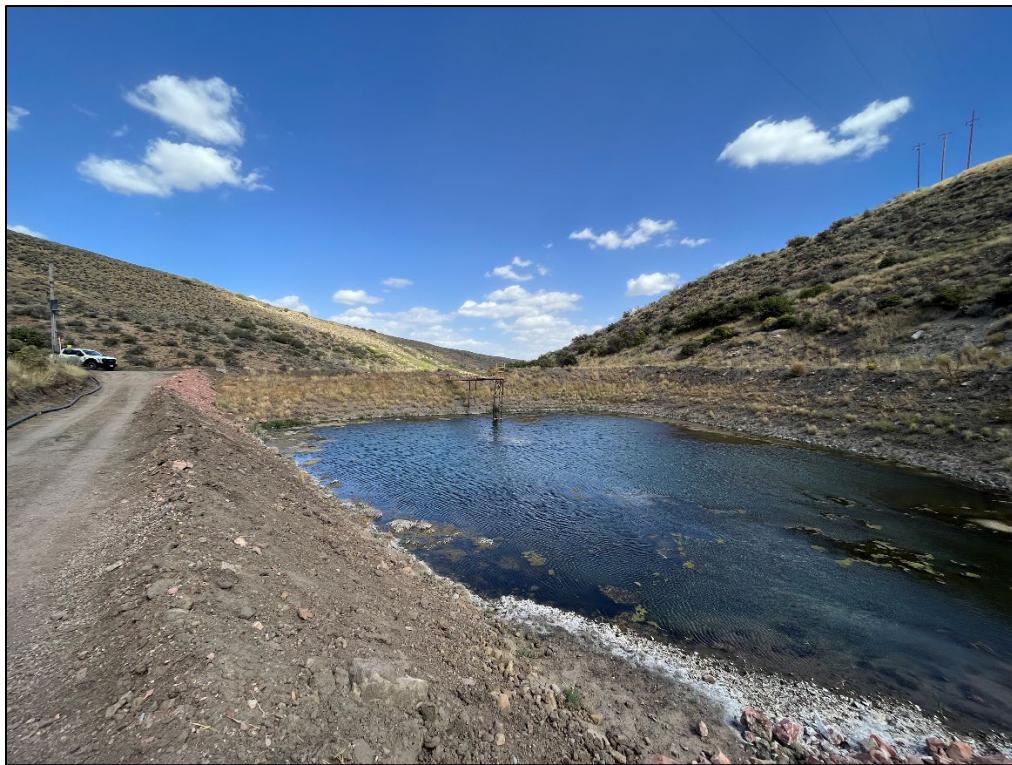
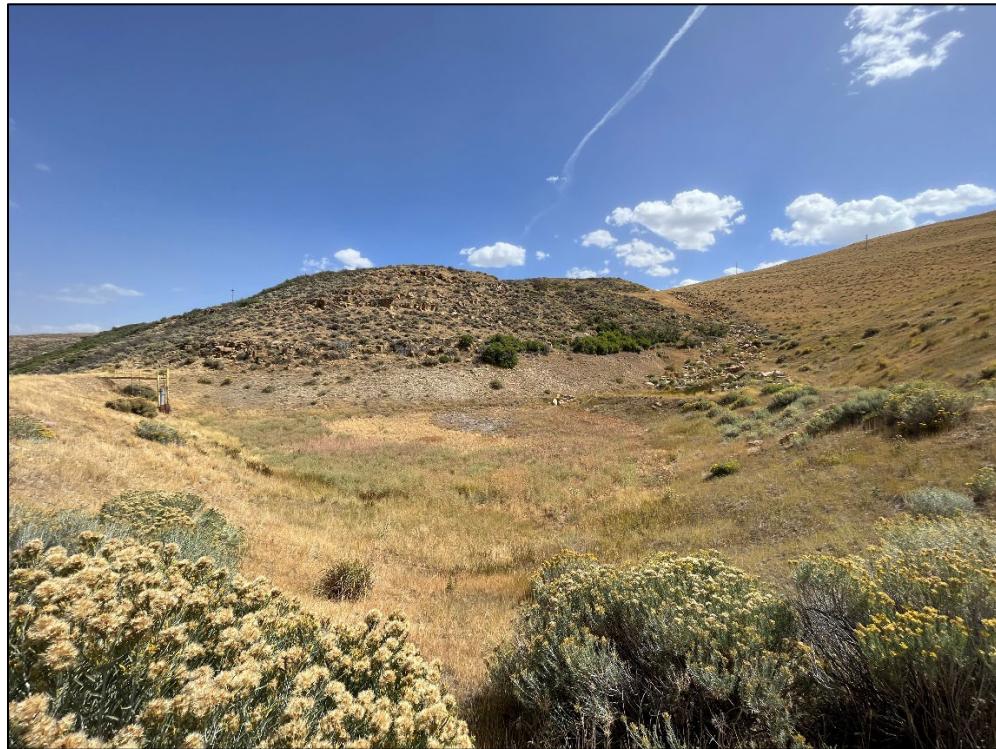
West Pit Pond, East Taylor and West Taylor Pond were inspected this month along Taylor Creek (Photos 23-25, and 29). East Taylor and West Taylor ponds were holding water and had stable embankments. Inlet and outlet structures were free of obstructions. West Pit Pond was dry and vegetated. No issues were noted.
