Inspection Report, Coal Complete, September 9-10, 2025, C1981019

Permit Number: C-1981-019 Mine Name: Colowyo Coal Mine Operator: Colowyo Coal Company L.P. Operator Address: Mr Tony Tennyson 5731 State Highway 13 Meeker, CO 81641	County: Moffat, Rio Blanco Operation Type: Surface Permit Status: Active Ownership: Private
	Operator Representative Present: Tony Tennyson
Operator Representative Signature: (Field Issuance Only)

Inspection Start Date: September 9, 2025 Inspection Start Time: 11:30 Inspection End Date: September 10, 2025 Inspection End Time: 13:30	Inspection Type: Coal Complete Inspection Inspection Reason: Normal I&E Program Weather: Clear
Joint Inspection Agency: None	Joint Inspection Contacts:
Post Inspection Agency: None	Post Inspection Contacts:
Inspector(s): Hunter Ridley	Inspector's Signature: <i>Hunter Ridley</i> Signature Date: September 17, 2025

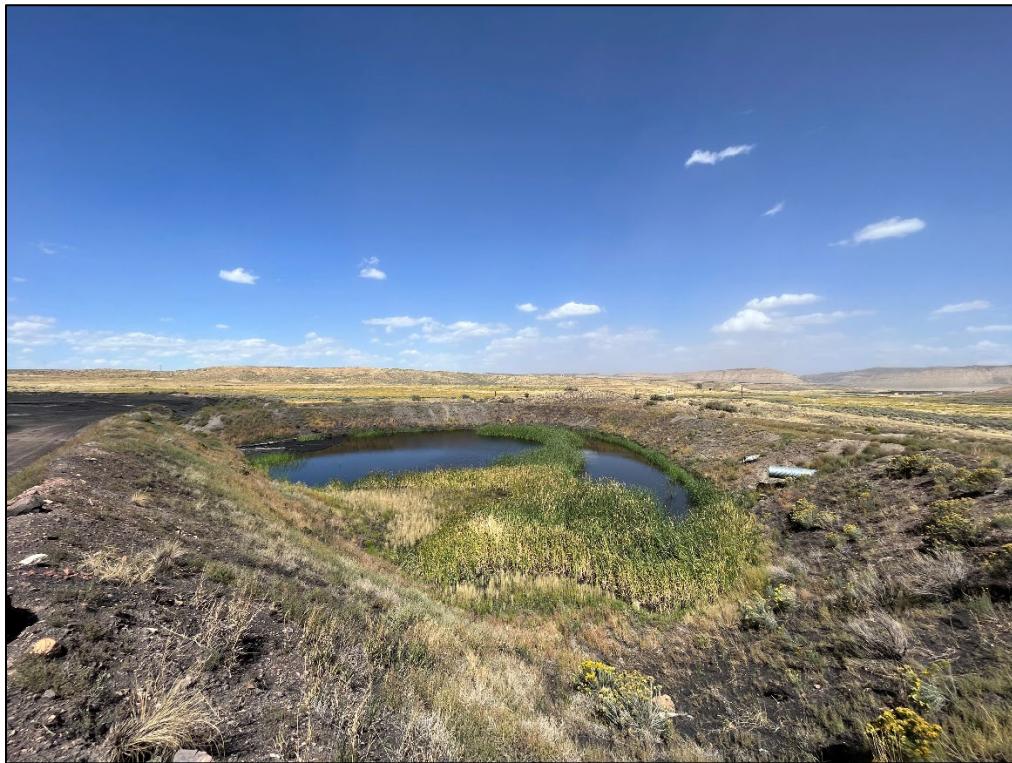
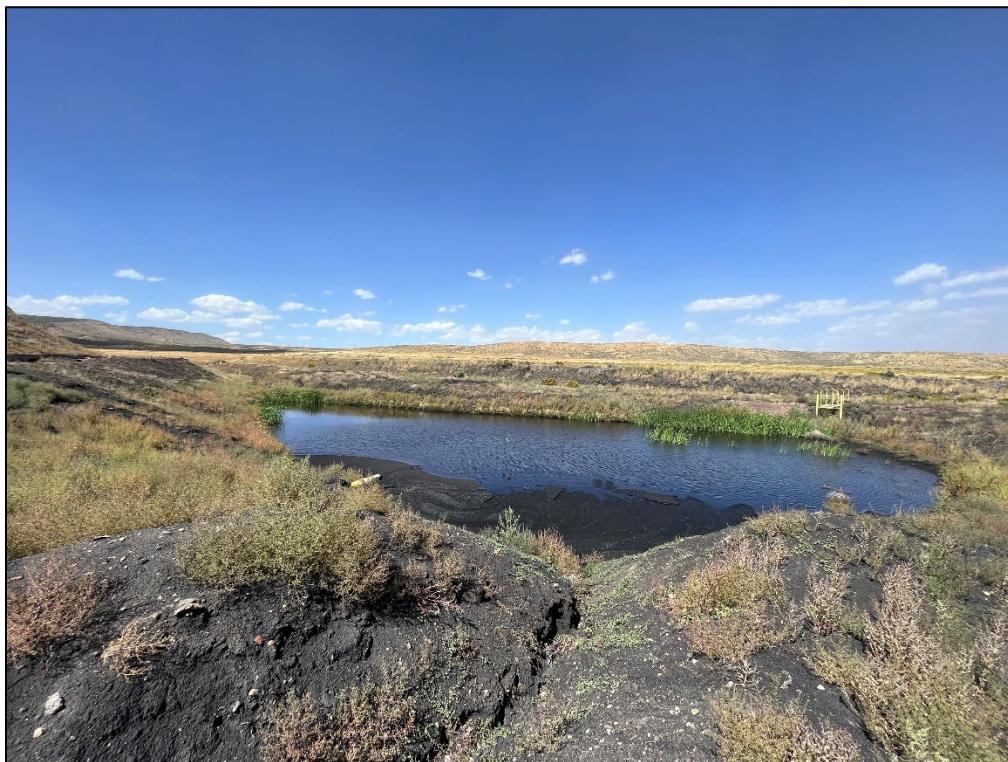
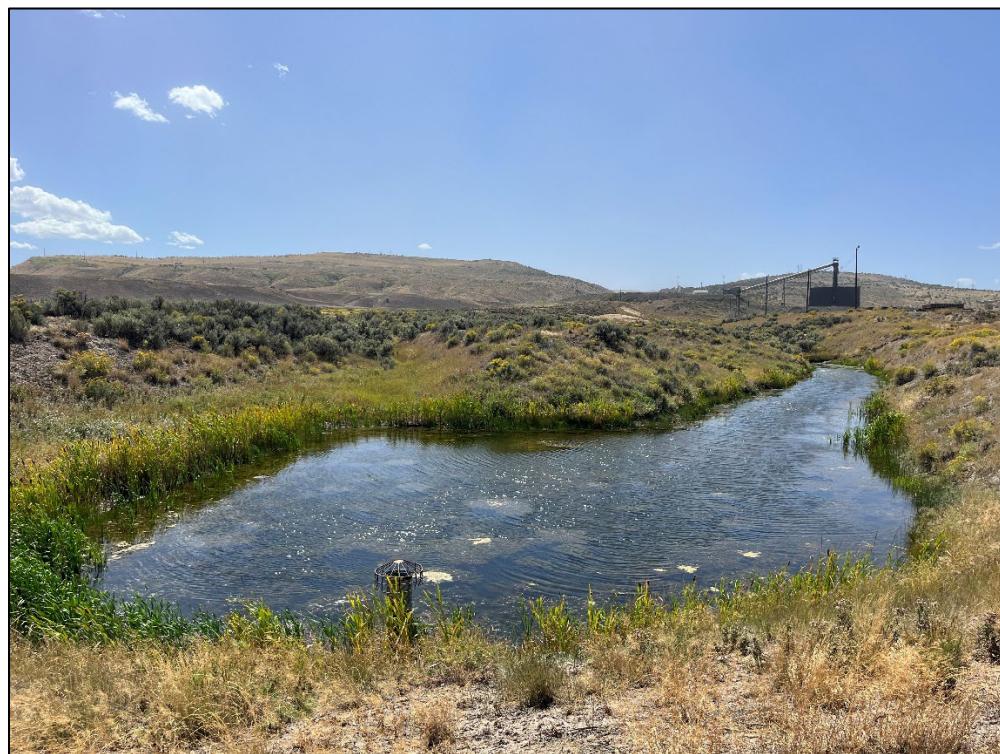
The Stoker Siding, Rail Loop, and Gossard Ponds were observed in the loadout area. A train was being loaded with coal on the first day of inspection. All ponds were holding water and were free of any issues

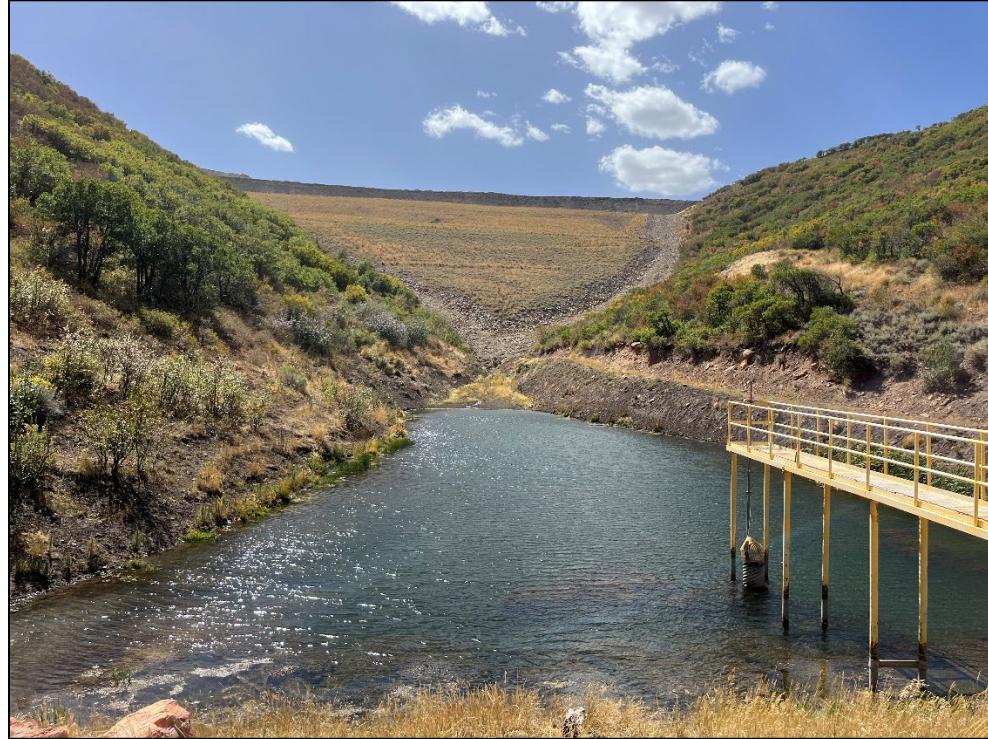
The West Taylor Valley Fill area was inspected from below at the West Taylor Pond (Photo 29). The face of the valley fill is well covered with vegetation, made up of sagebrush and native grasses and no erosional issues were visible. Side ditches, which divert water from the face of the fill, were observed to be stable.

Photo 29: West Taylor Valley Fill and West Taylor Pond.
