MINERALS PROGRAM INSPECTION REPORT
PHONE: (303) 866-3567

MINE NAME: May Day Mine	MINE/PROSPECTING ID#: M-1981-185	MINERAL: Gold and silver	COUNTY: La Plata
INSPECTION TYPE: Monitoring	WEATHER: Cloudy	INSP. DATE: September 3, 2025	INSP. TIME: 12:40
OPERATOR: Sunrise Mining LLC	OPERATOR REPRESENTATIVE: Jack Nielsen	TYPE OF OPERATION: 112d-2 - Designated Mining Operation	
REASON FOR INSPECTION: Normal I&E Program	BOND CALCULATION TYPE: None	BOND AMOUNT: \$137,448.00	
DATE OF COMPLAINT: NA	POST INSP. CONTACTS: None	JOINT INSP. AGENCY: None	
INSPECTOR(S): Dustin Czapla	INSPECTOR'S SIGNATURE:

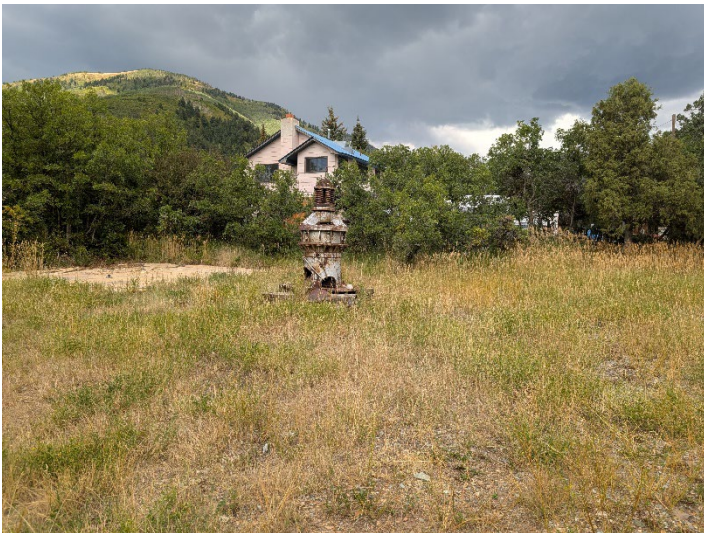
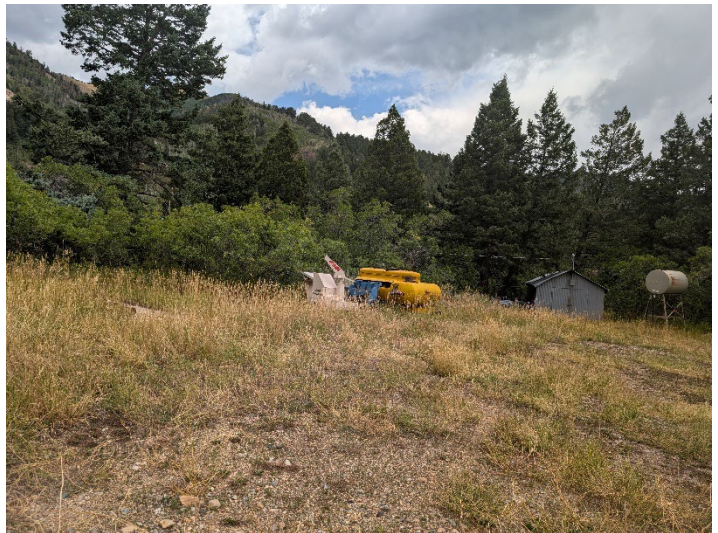
The base of operations area is well maintained and orderly. Noxious weeds were not observed. No fuels or toxic materials are stored here.

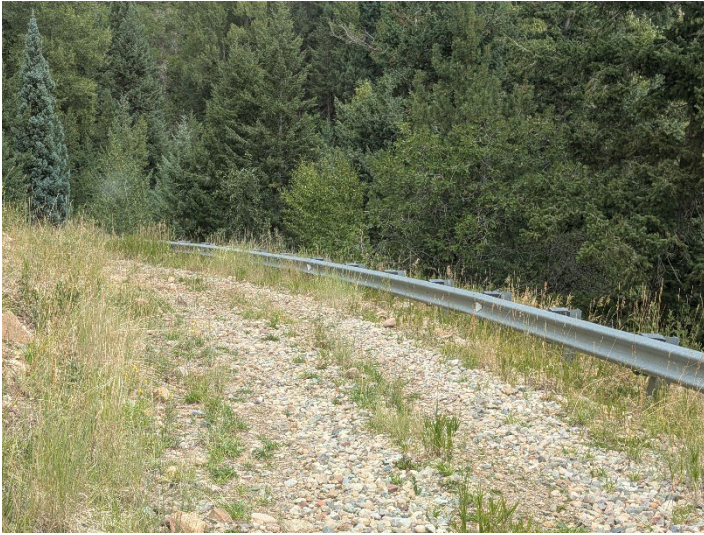
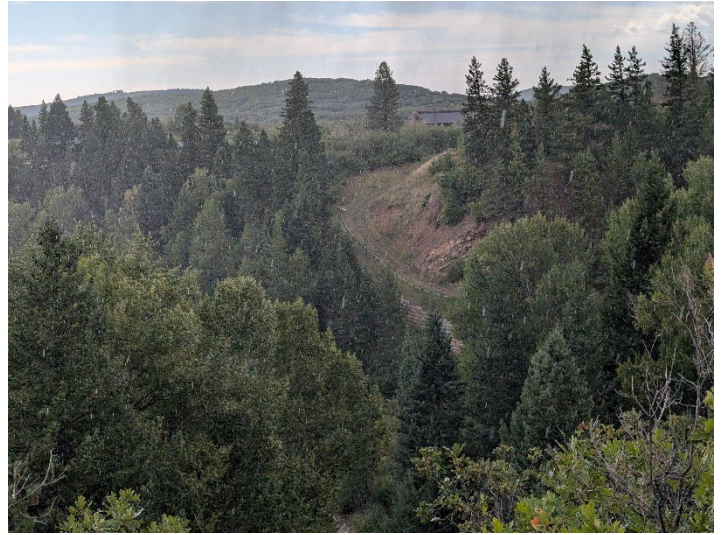
The access roads were in good condition. No erosion or stability concerns were noted.

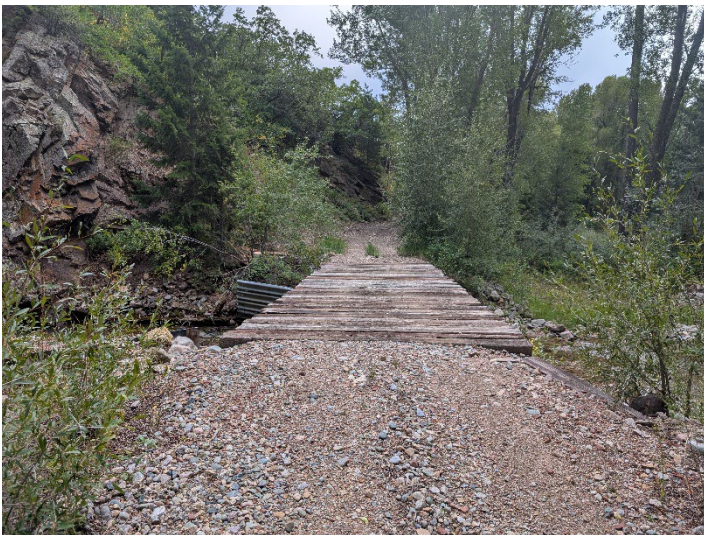
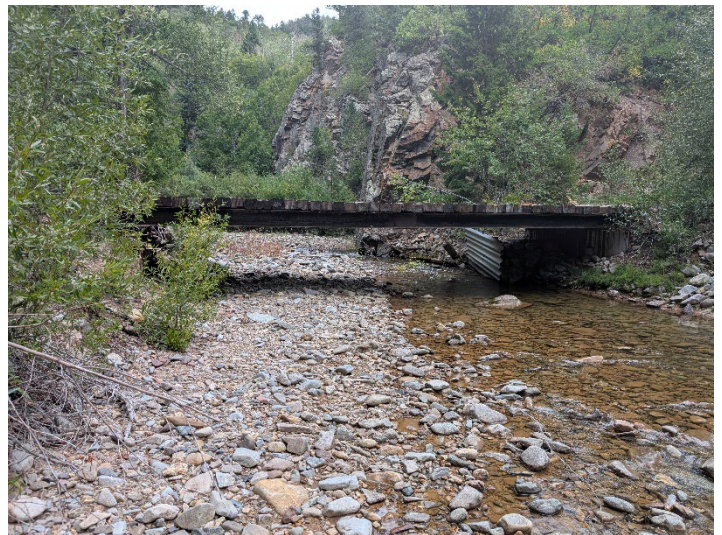
On June 13, 2012, the operator submitted Technical Revision 3 (TR-03) which proposed a plan for renovation of the bridge crossing the La Plata River. TR-03 proposed bolstering the existing steel abutments and girders, replacing the wood decking with steel decking, and adding guard rails. TR-03 was approved by the Division on June 26, 2012. The wood decking on the bridge has been replaced with new wood decking. However, to date, the bridge renovations approved through TR-03 have not been commenced or completed by the operator. The renovations must be completed before any hauling of ore from the site can occur.

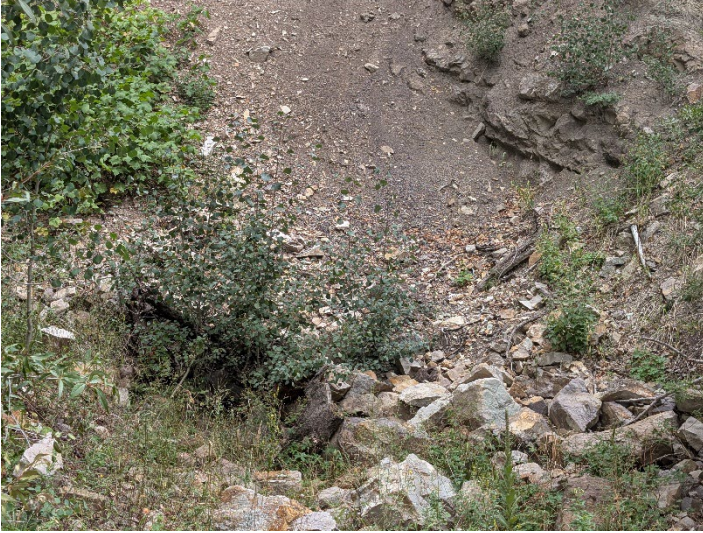
Conditions at the May Day 2 area are unchanged from previous inspections. The culvert system located in Little Deadwood Gulch appears to be functioning as designed. The portal remains collapsed. No erosion or stability concerns were noted. Noxious weed infestations were not observed. No problems or violations were noted in this area.

May Day 2 collapsed portal

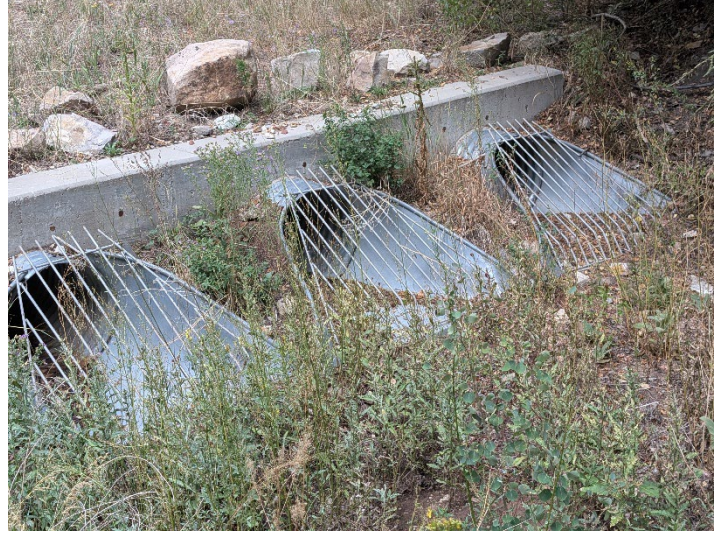
Little Deadwood Gulch culvert system

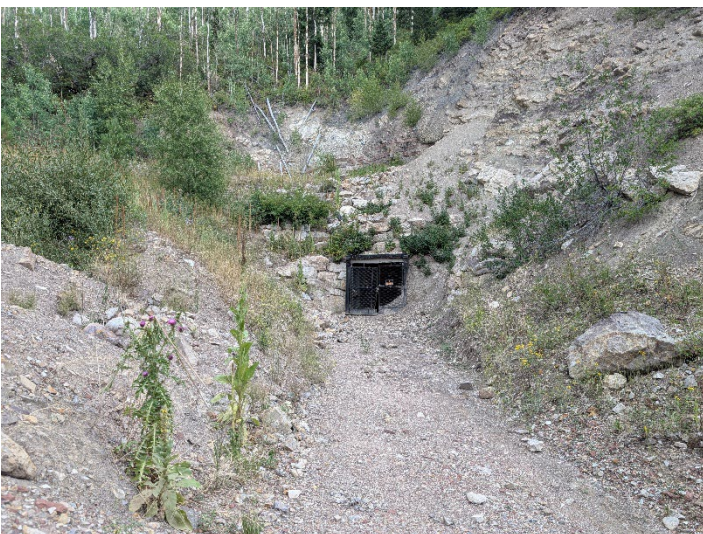
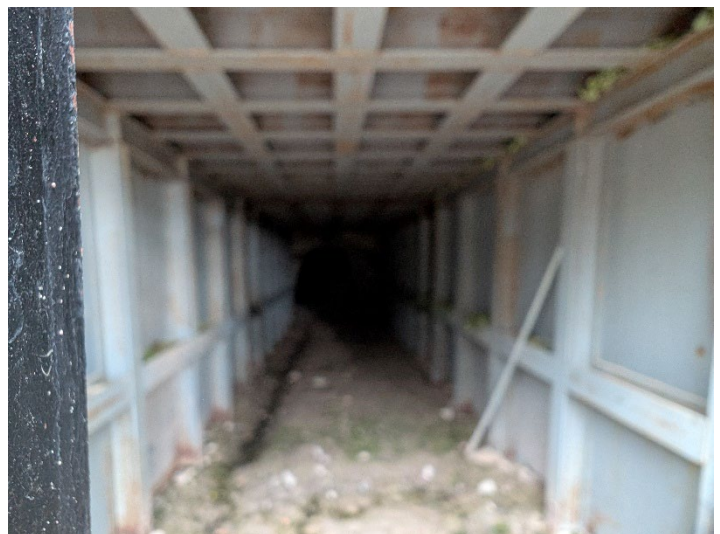
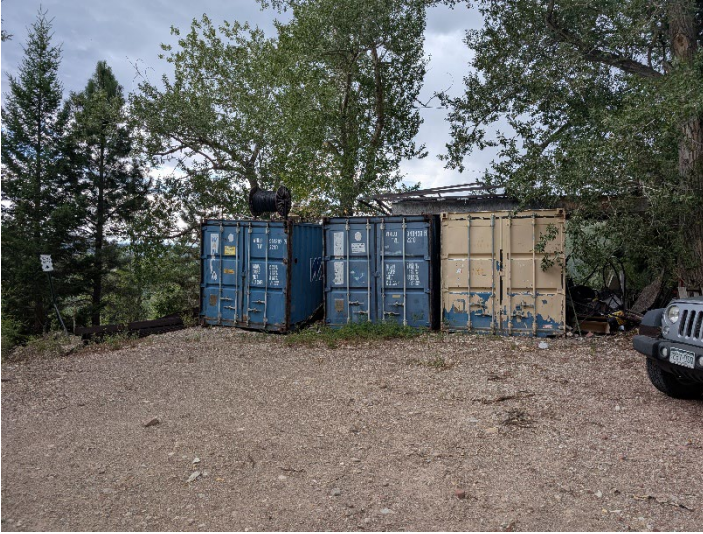
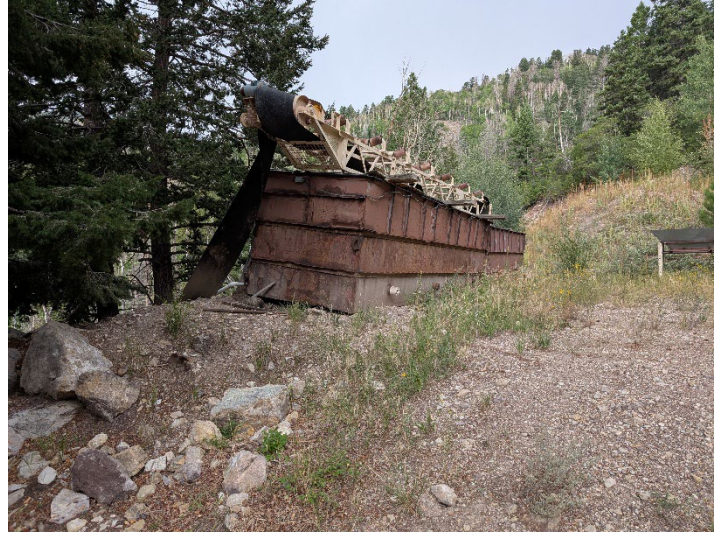
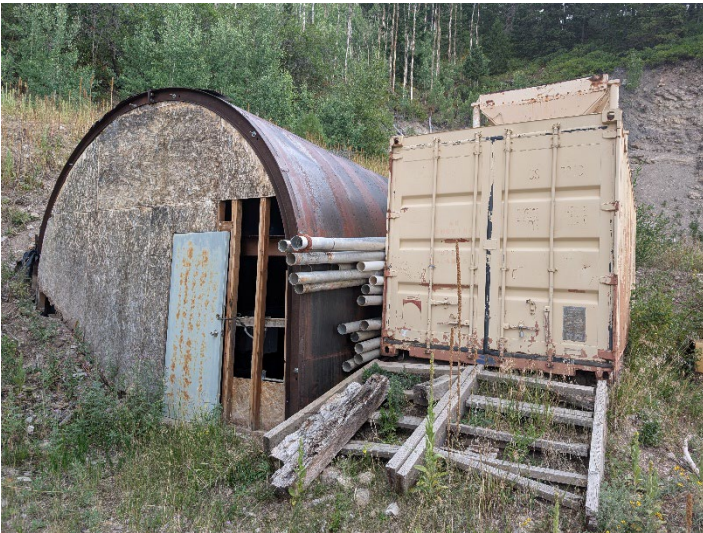
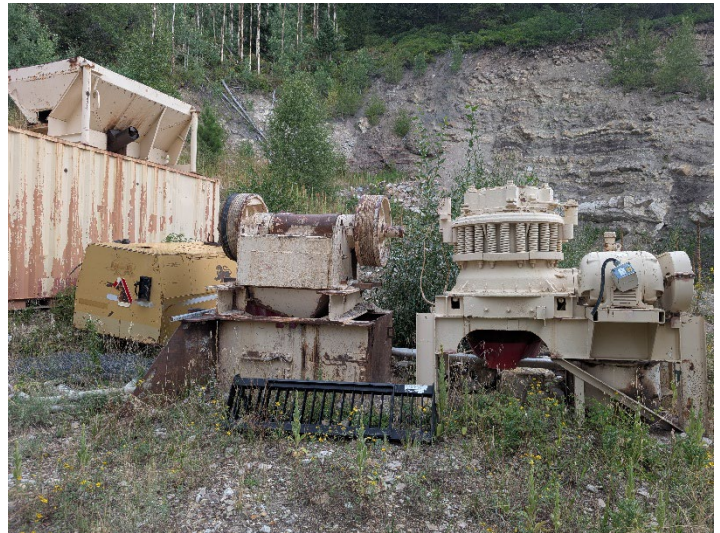
Conditions at the May Day 1 Area are mostly unchanged from previous inspections. Evidence of any recent mining activity was not observed in this area. The portal is secured with a locked gate. Wire mesh and rock bolts used to stabilize the highwall above the portal appear to be functioning effectively. The milling equipment that was removed from the collapsed mill portal is still located on the May Day 1 pad, along with several shipping containers. No stability or erosion concerns were noted here. Noxious weed infestations were not observed in this area. No problems or violations were noted in this area.
