**MINERALS PROGRAM INSPECTION REPORT**  
**PHONE: (303) 866-3567**

| <b>MINE NAME:</b><br>Greer Pit | <b>MINE/PROSPECTING ID#:</b><br>M-1985-115 | <b>MINERAL:</b><br>Sand and gravel | <b>COUNTY:</b><br>La Plata |
| <b>INSPECTION TYPE:</b><br>Monitoring | <b>WEATHER:</b><br>Clear | <b>INSP. DATE:</b><br>September 3, 2025 | <b>INSP. TIME:</b><br>11:00 |

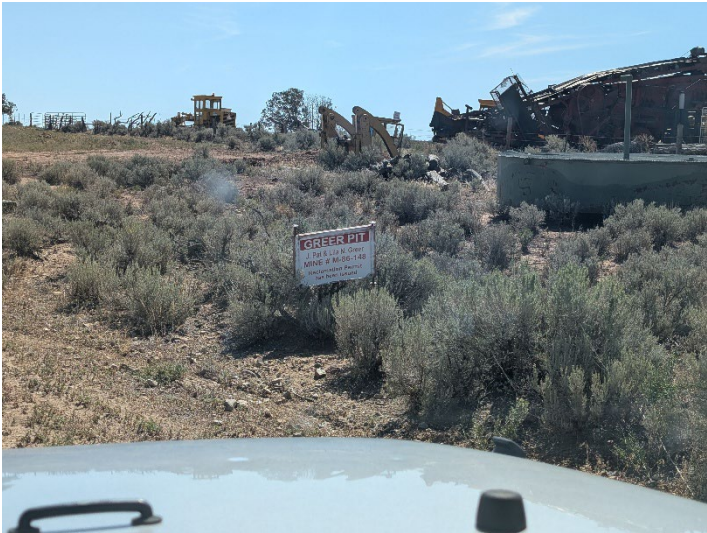
Adequate mine identification signage was noted at the entrance to the site.

Sign at entrance

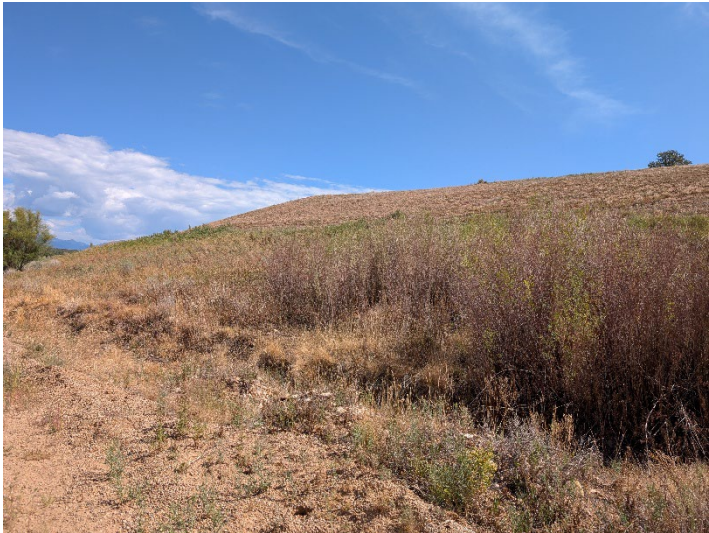
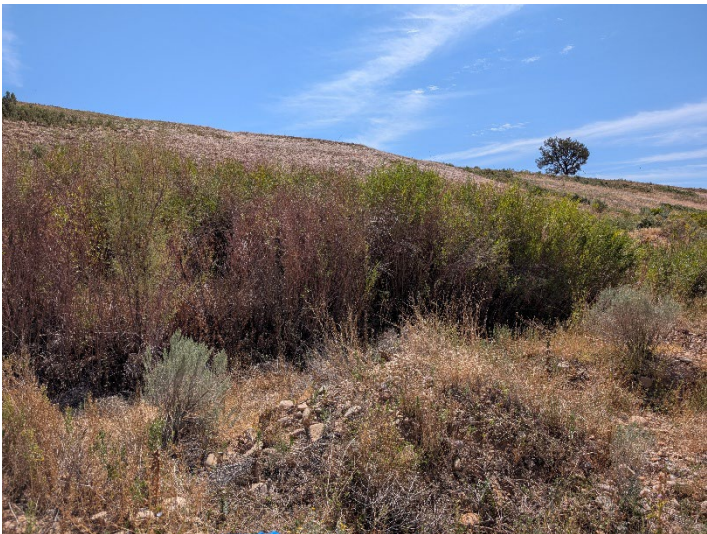
Nearly the entire permit area has been disturbed by the mining operation. Mining will now continue downward to extract the remaining gravel. The highwall on the east side has been backfilled and graded to 3H:1V. Vegetation is well established on this slope. Backfilling of the south highwall is underway. The slope was at an approximate 1H:1V grade at the time of this inspection. The highwall on the west end of the pit has been reduced to 3H:1V. The west end of the pit will eventually daylight to the west. There is no highwall on the north side of the pit. Overburden and topsoil are stockpiled in berms above the highwalls. Crushed gravel stockpiles are located on the pit floor.

East highwall

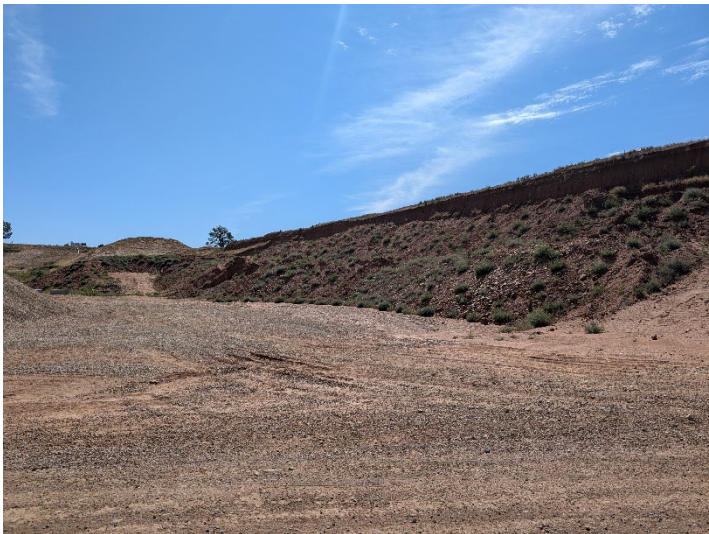
South highwall

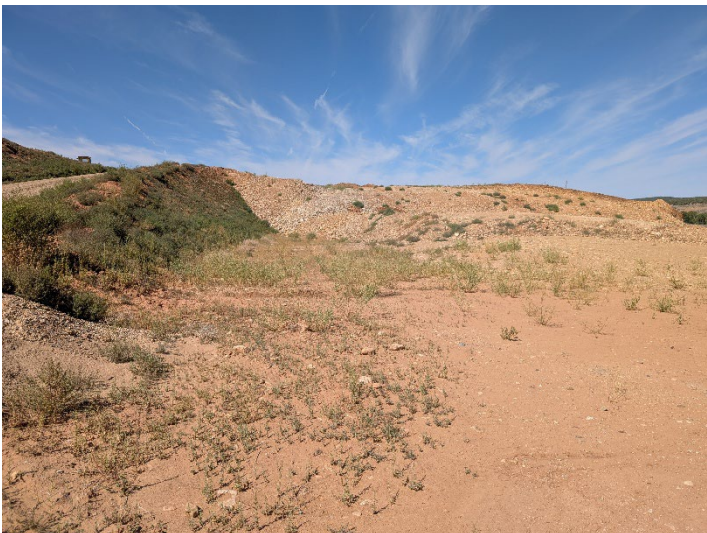
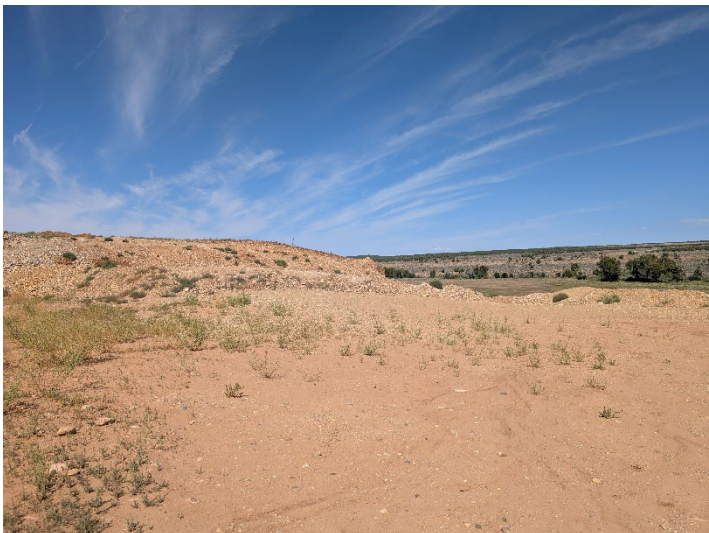
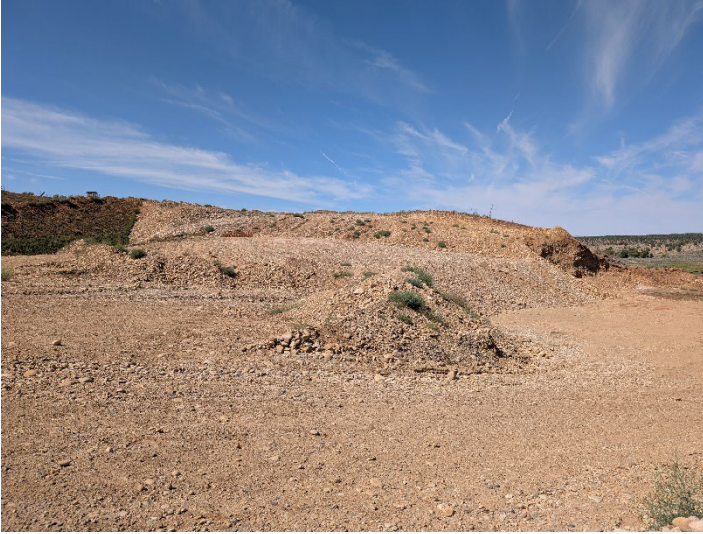
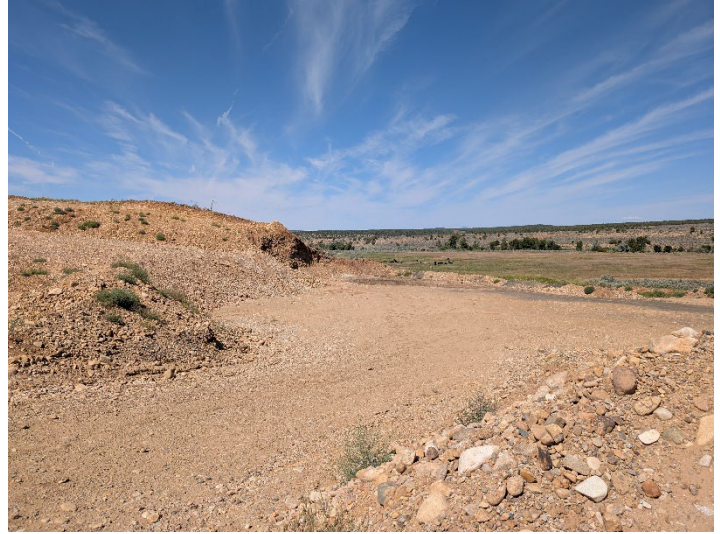
West highwall
