**MINERALS PROGRAM INSPECTION REPORT**  
**PHONE: (303) 866-3567**

| <b>MINE NAME:</b><br>Henderson Mine | <b>MINE/PROSPECTING ID#:</b><br>M-1977-342 | <b>MINERAL:</b><br>Molybdenum | <b>COUNTY:</b><br>Clear Creek |
| <b>INSPECTION TYPE:</b><br>Monitoring | <b>WEATHER:</b><br>Clear | <b>INSP. DATE:</b><br>August 18, 2025 | <b>INSP. TIME:</b><br>09:00 |

This inspection was focused on the Tailings Storage Facility (TSF), including the deposition of tailings, the condition of the 1-Dam and 3-Dam Tailings Impoundments, and the seepwater collection system.

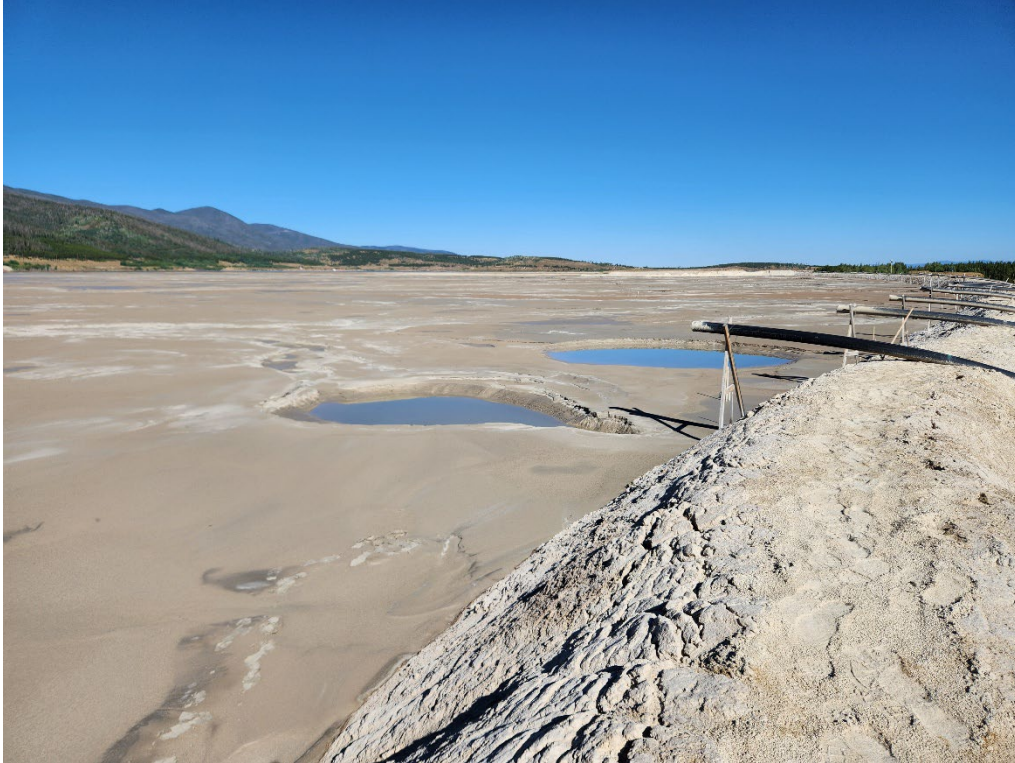
Active tailings deposition was not occurring on 1-Dam or 3-Dam during the inspection. A crew was repairing spigots in the south cell of 3-Dam.

**Photo 1.** Spigots for 3-Dam, looking west.

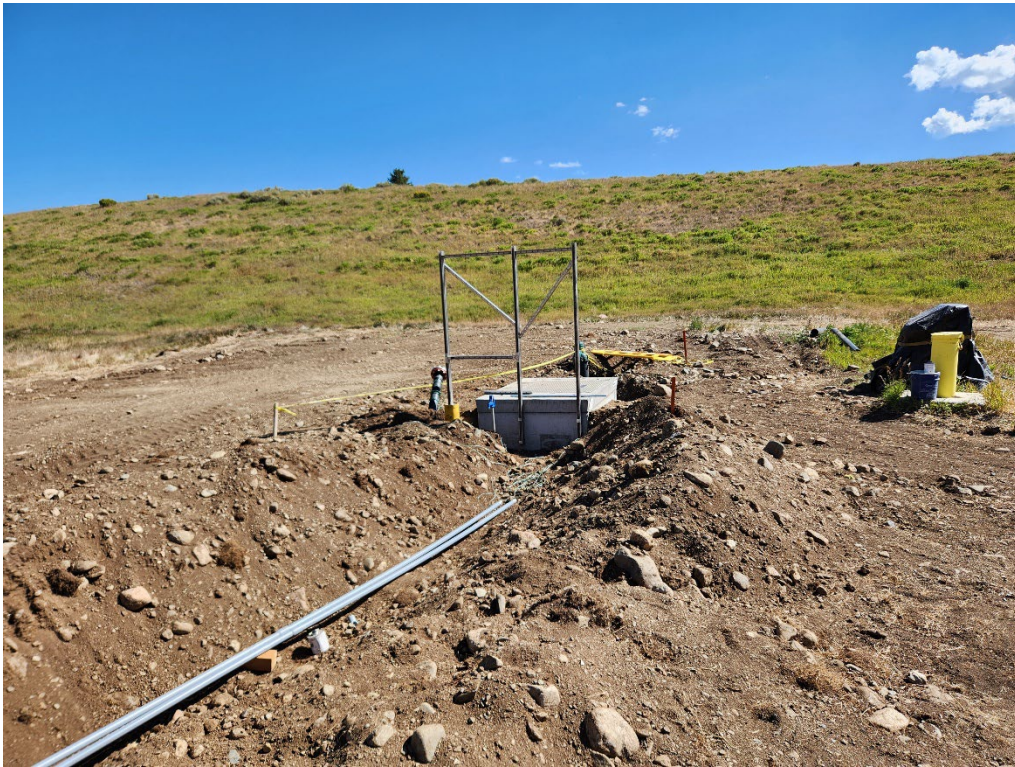
New extraction wells (MLEX-6 and MLEX-7) were observed, and no problems were identified. The wells were drilled in 2024, and the rest of this system is still under construction.

**Photo 6.** MLEX-6 Under construction.

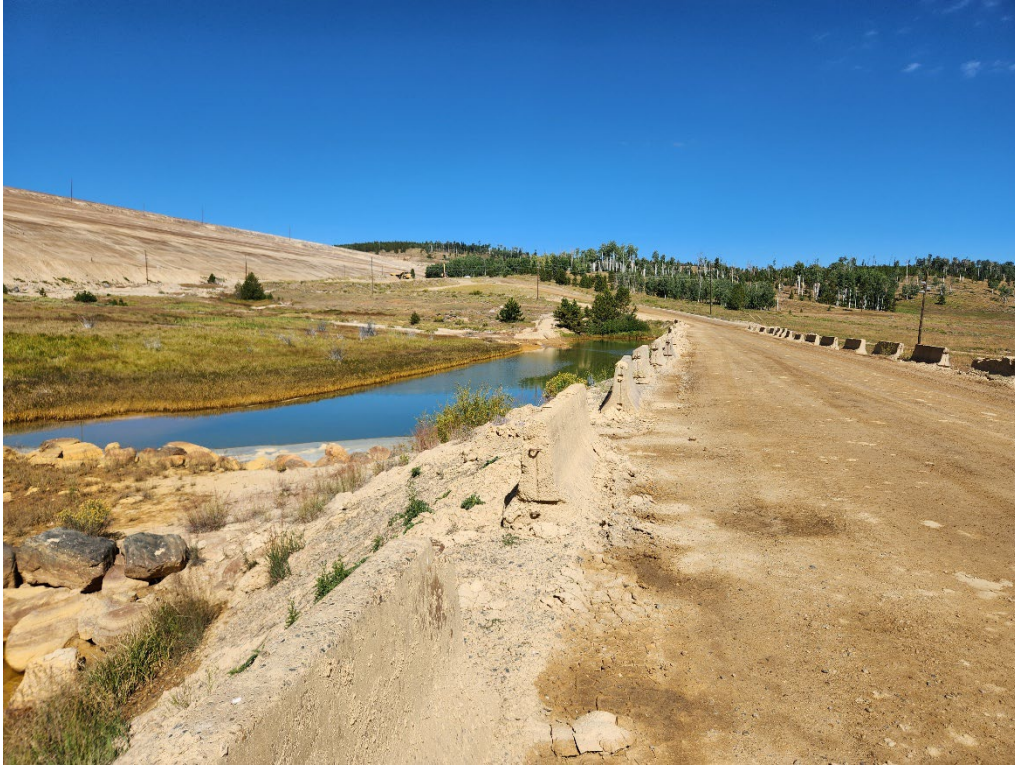
The Seepage Collection pond was inspected, and no problems were observed.

**Photo 7.** Seepage collection pond, looking northwest.

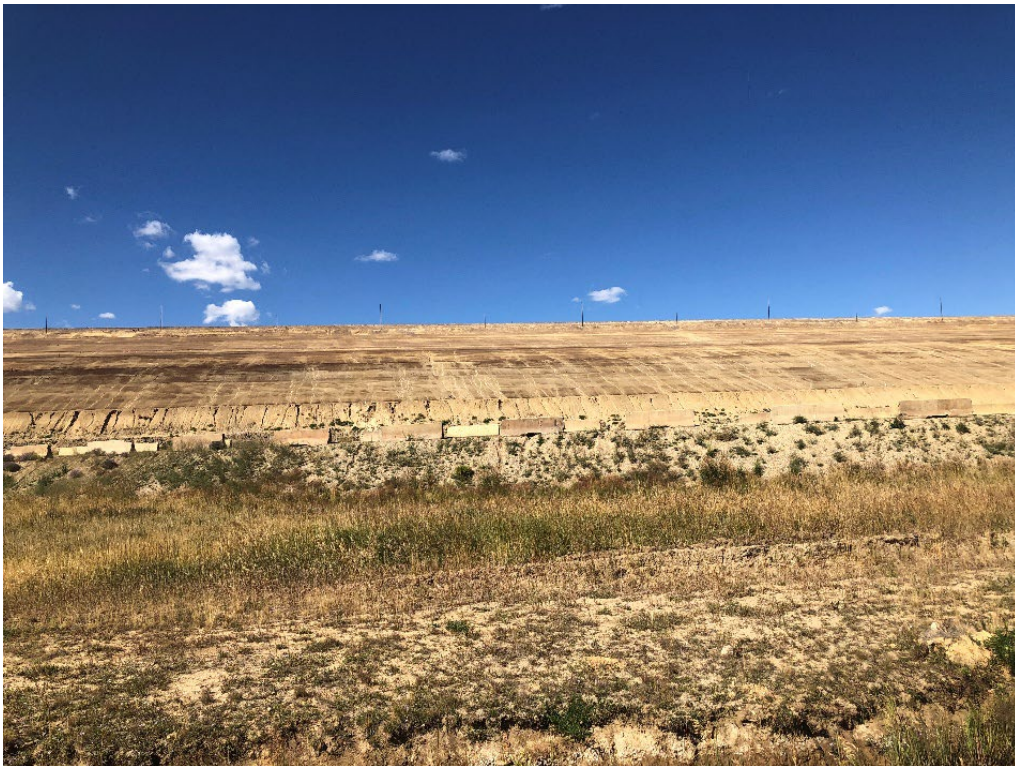
**Photo 8.** Small amount of erosion on face of 1-Dam, at Cell 5 area.

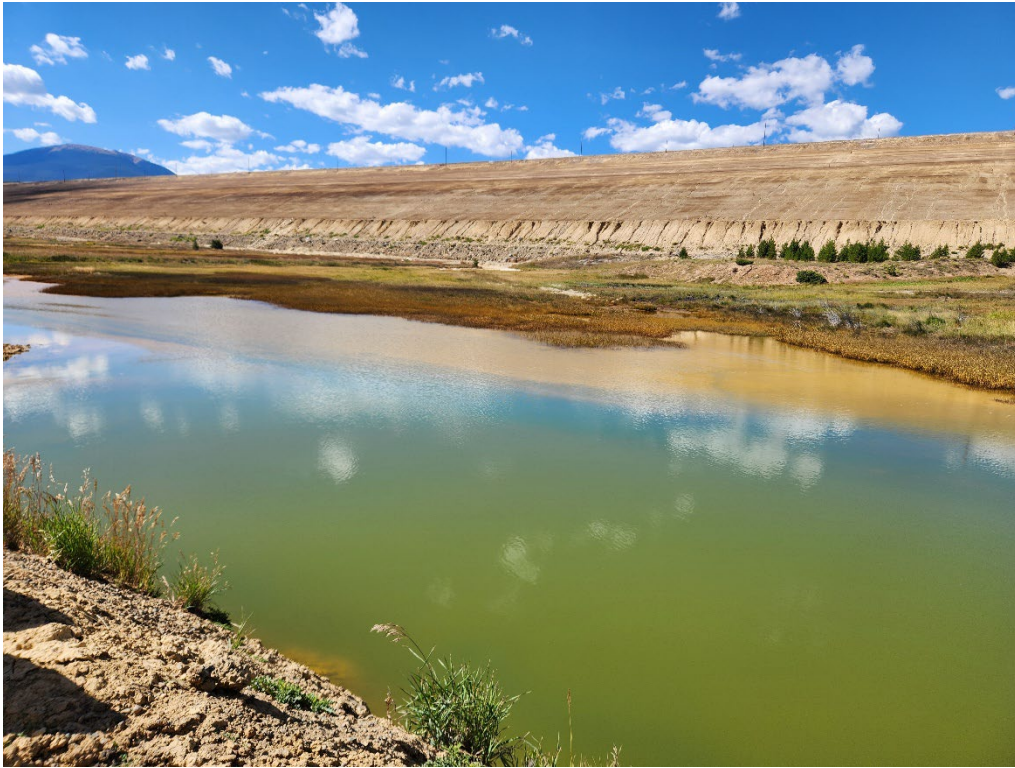
**Photo 9.** Seepage collection pond looking southeast.

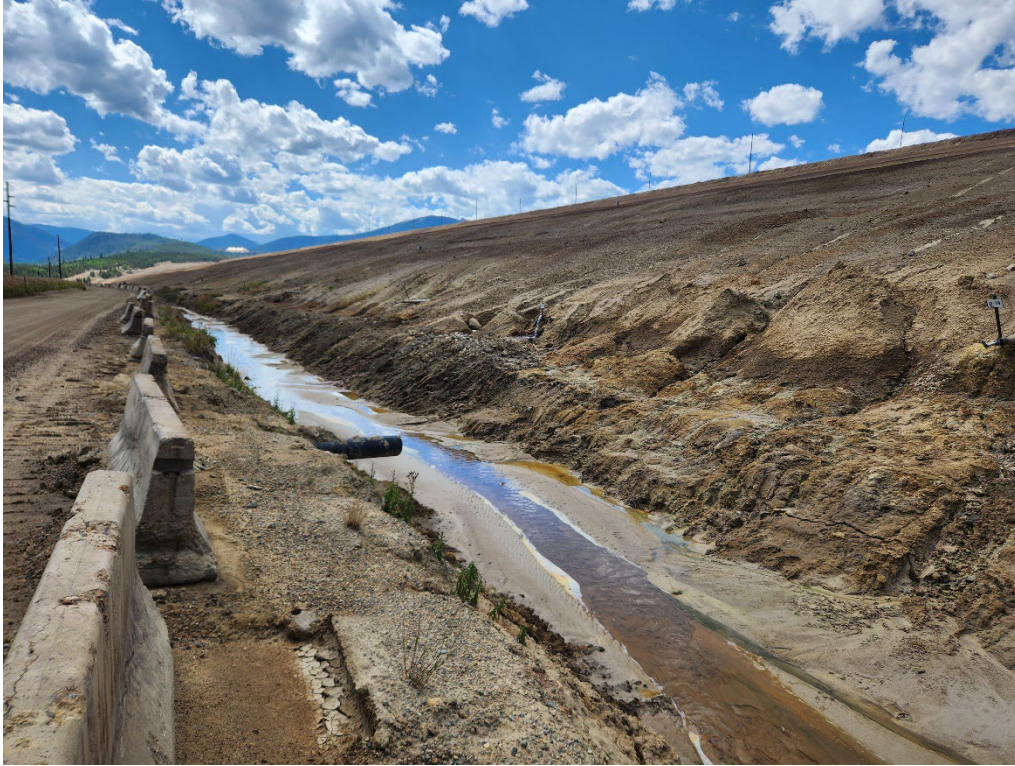
Per Henderson representatives, there are 112 horizontal drains, and almost all (105) are at 1-Dam. They all appear to have P-traps to prevent air from entering the pipes. Many of the horizontal drains were flowing during the inspection; flow rates varied. The water in the discharges appeared to be clear, indicating low amounts of suspended solids. Orange stains were seen below the drains, indicating high values of dissolved iron. AECOM staff were inspecting these drains and looking for signs of any tailings material exiting the horizontal drains.

**Photo 13.** Horizontal drains, looking south.

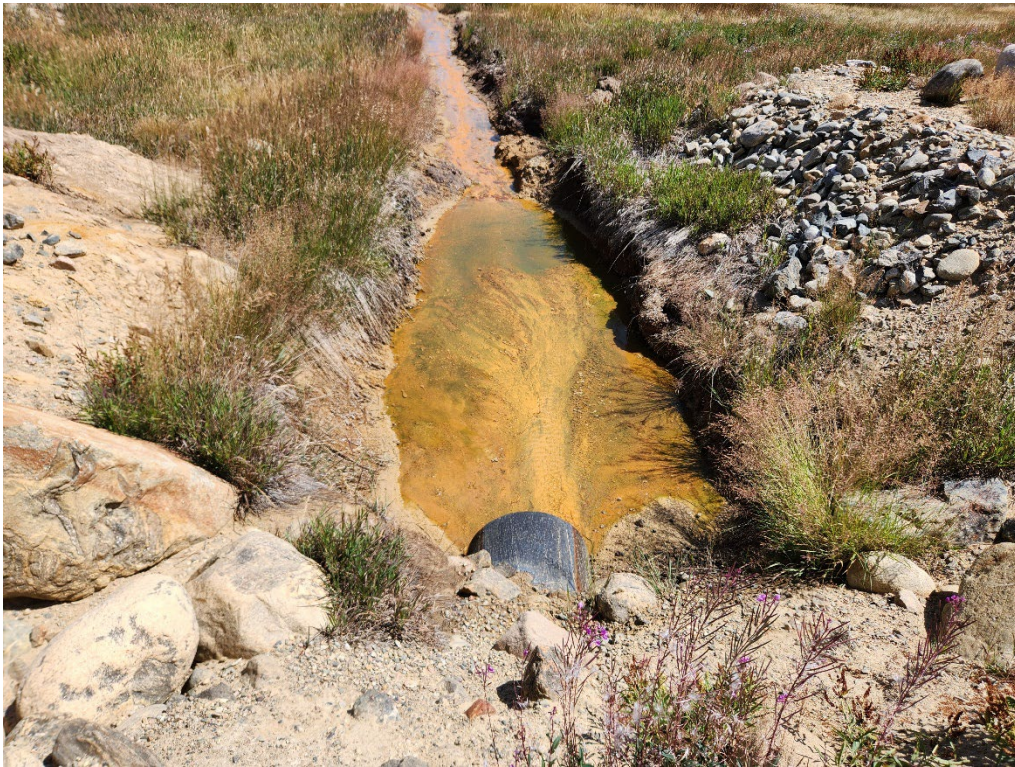
**Photo 14.** Culvert in the collection channel.

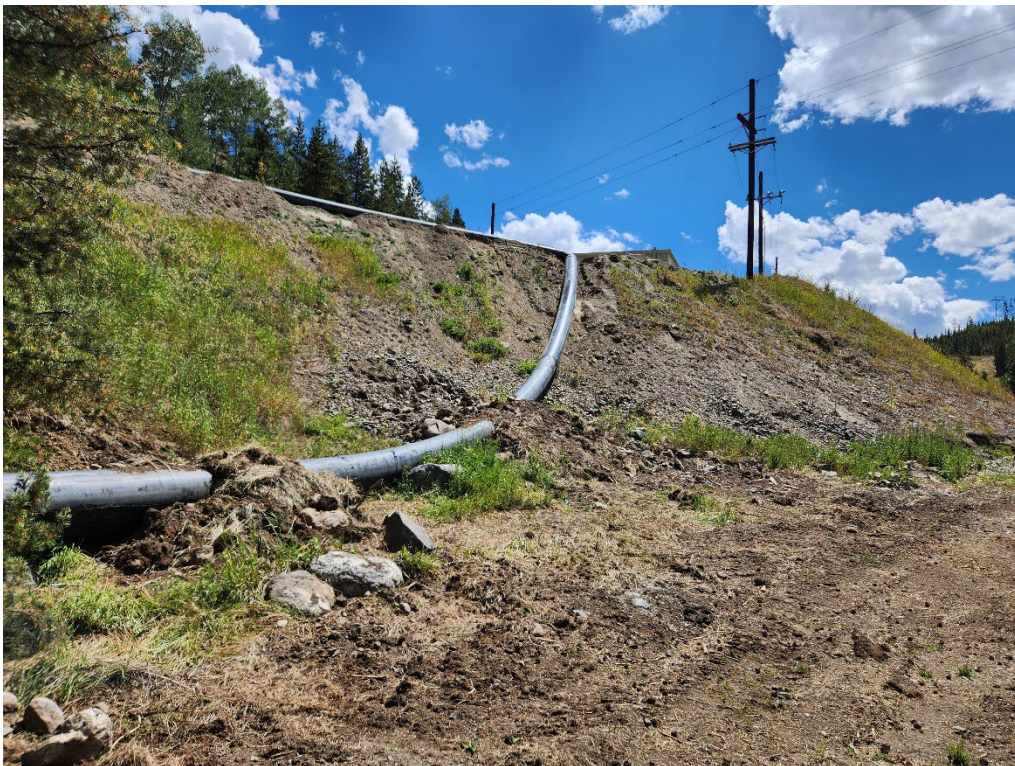
The pipeline depositing these tailings is detailed in the Mill EPF 1.3 – Tailings Delivery System. A 24-in lead-off pipe is used to deposit the tailing and this pipeline is intended to be moved as the dam is raised.

**Photo 18.** A 24-in leadoff pipe used to deposit tailings in the East Branch Trunk, looking south.
