Division of Reclamation,  
Mining and Safety

### PERMIT INFORMATION

| <b>Permit Number:</b> C-1981-012<br><b>Mine Name:</b> New Elk Mine<br><b>Operator:</b> New Elk Coal Company, LLC<br><b>Operator Address:</b><br>12250 Highway 12<br>Weston, CO 81091 | <b>County:</b> Las Animas<br><b>Operation Type:</b> Underground<br><b>Permit Status:</b> Suspended<br><b>Ownership:</b> Private |

### INSPECTION INFORMATION

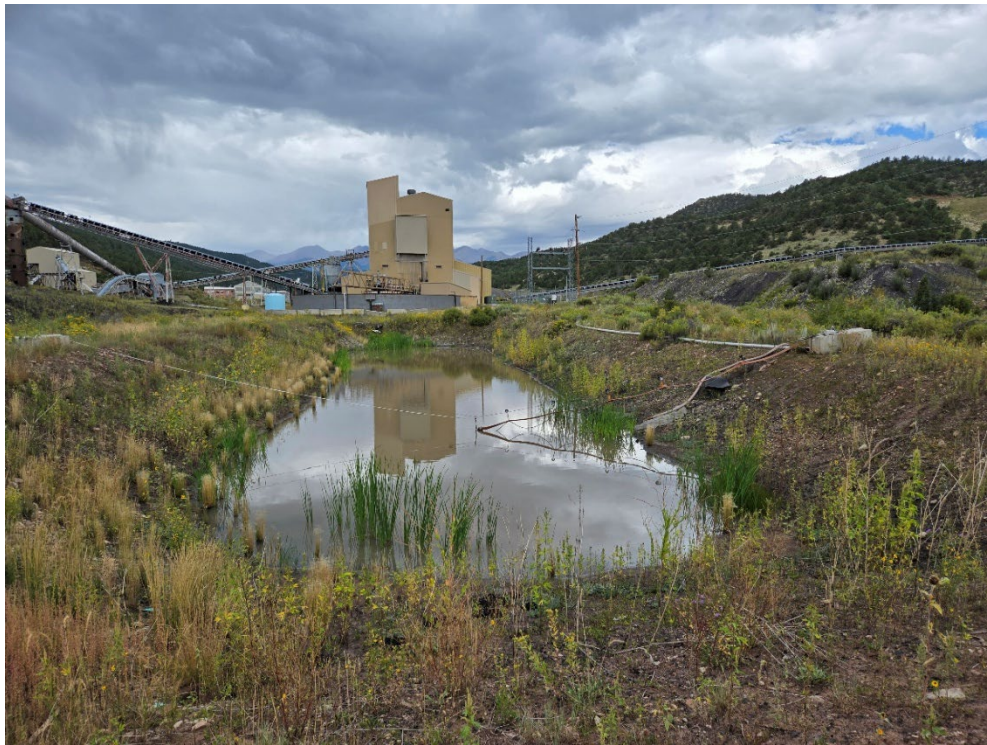
- Pond 006A - contained some water at the time of the inspection. The banks of the pond appeared to be stable.
- Pond 007A - the water was high at the time of the inspection but had plenty of capacity before reaching the blue marker on the white PVC pipe. The water level is below the top few holes of the principal spillway. The pond was not discharging. The banks appeared stable and the emergency spillway was clear.
- Pond 08 - contained some water at the time of the inspection and was below its capacity. The spillways appeared clear, and the banks were stable. Pond 08 was not discharging.

*Photo 1: Looking west at Pond 006a.*

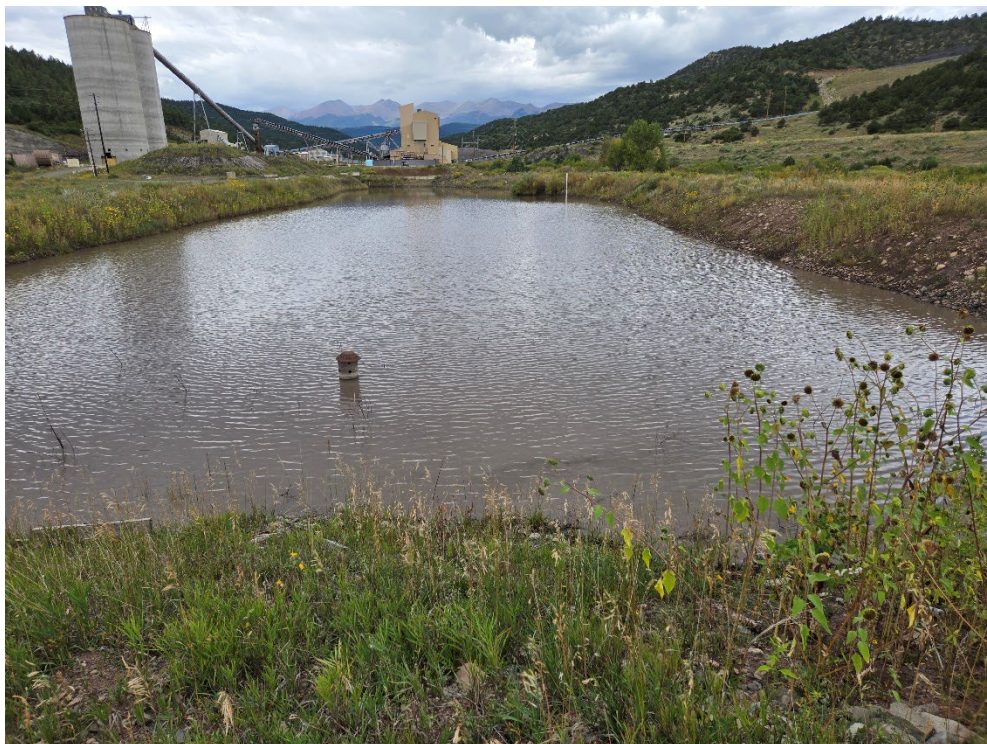
*Photo 2: Looking west at Pond 007a.*

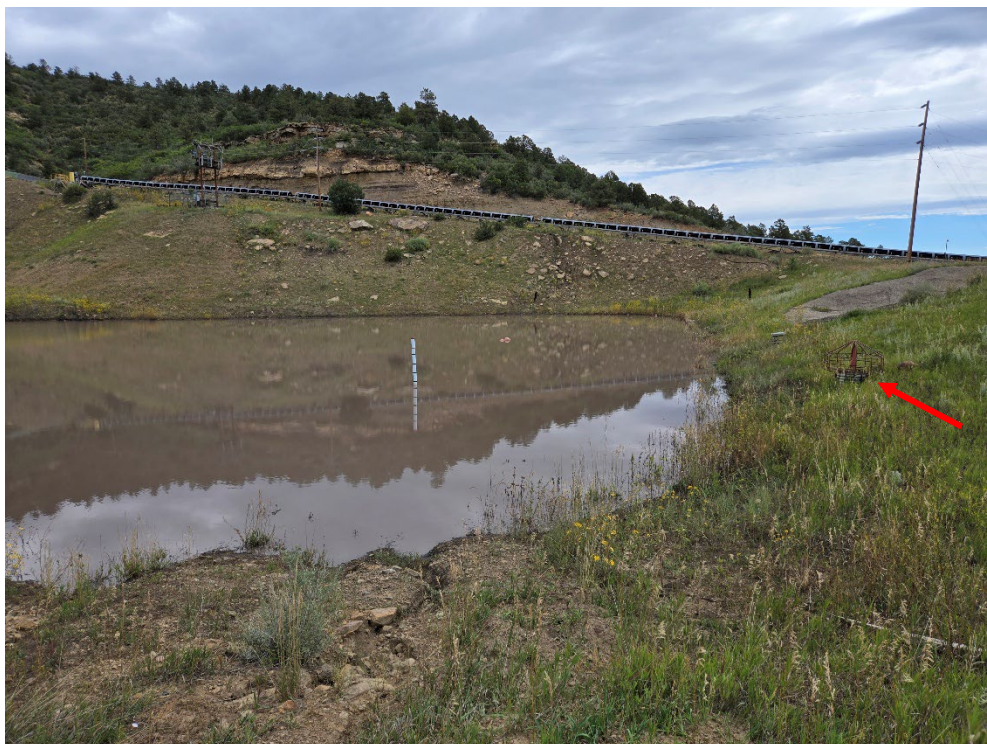
*Photo 3: Looking east at the south bank of Pond 08. The arrow points to the principal spillway.*

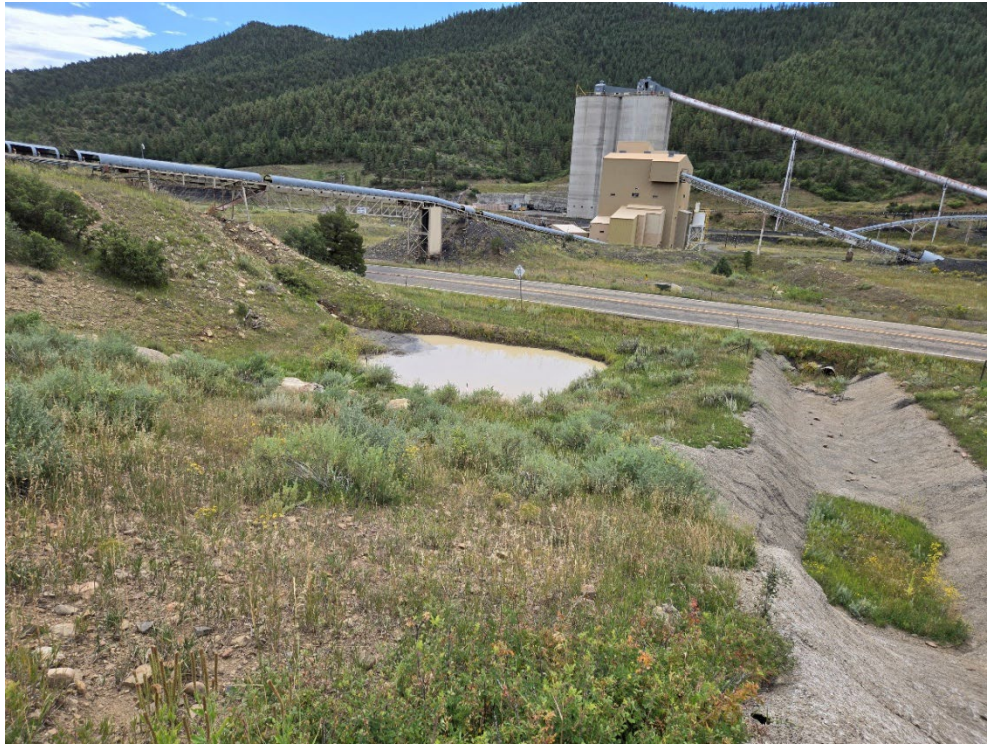
- Containment Area #5 contained water at the time of the inspection. Once maintenance can resume onsite, the sediment accumulated in this containment area should be removed to help increase capacity.

*Photo 4: Looking south at Containment Area #5.*

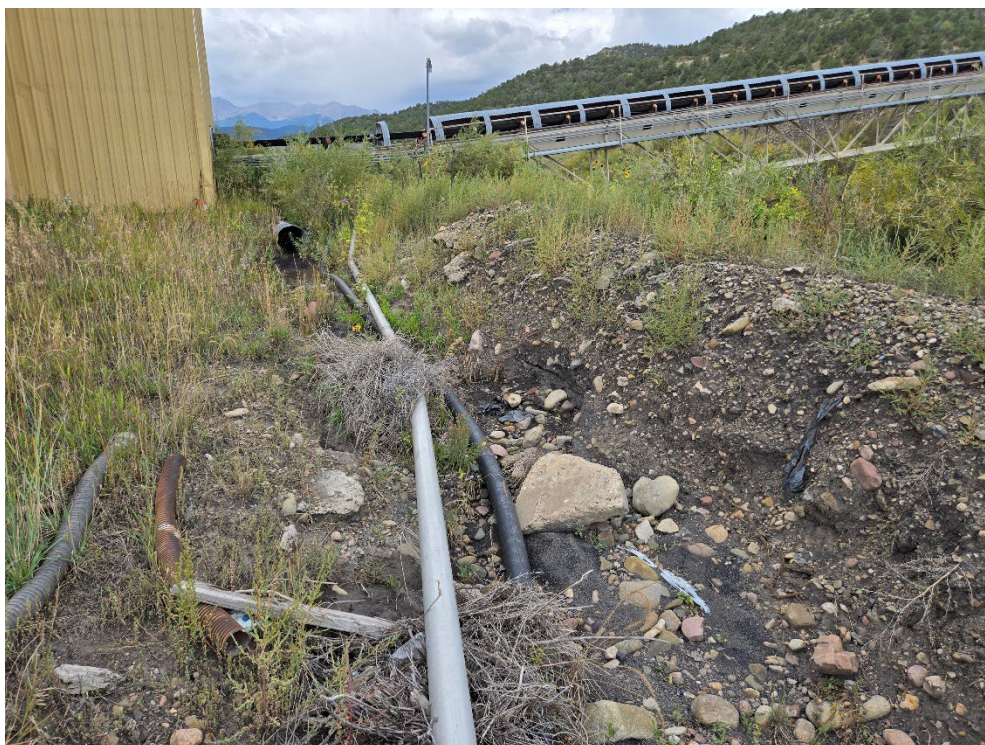
*Photo 9: C64 outlet. South side of ditch D32A alongside showed minor signs of cutting, but the ditch appeared to be stable and no signs of erosion on the river side were observed.*

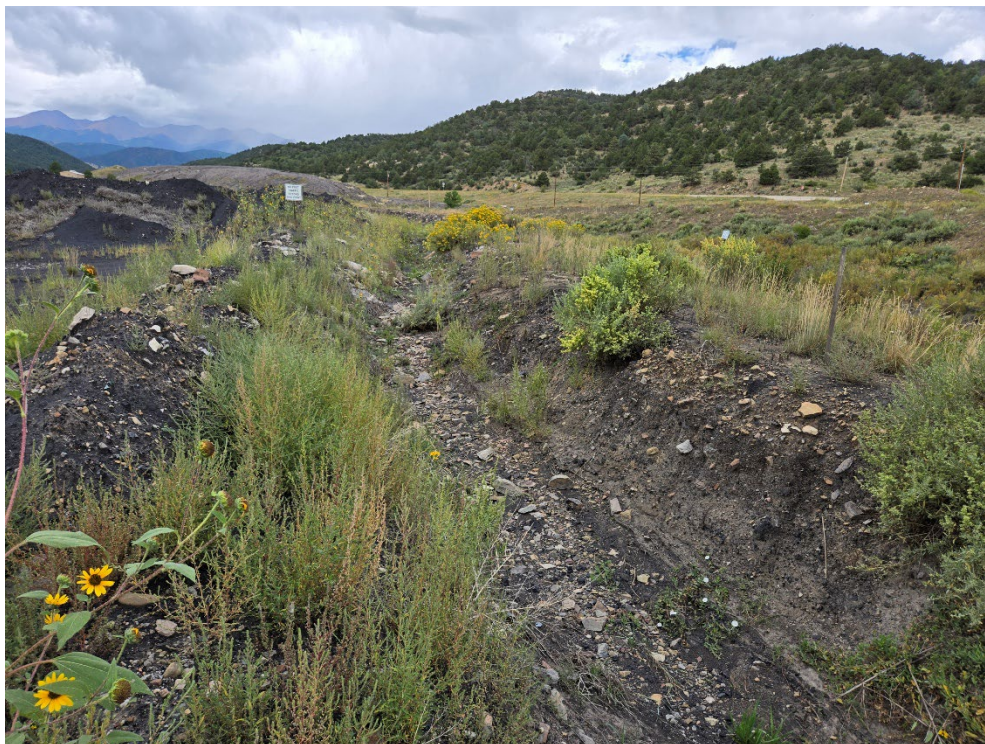
*Photo 12: Ditch D32, looking west*

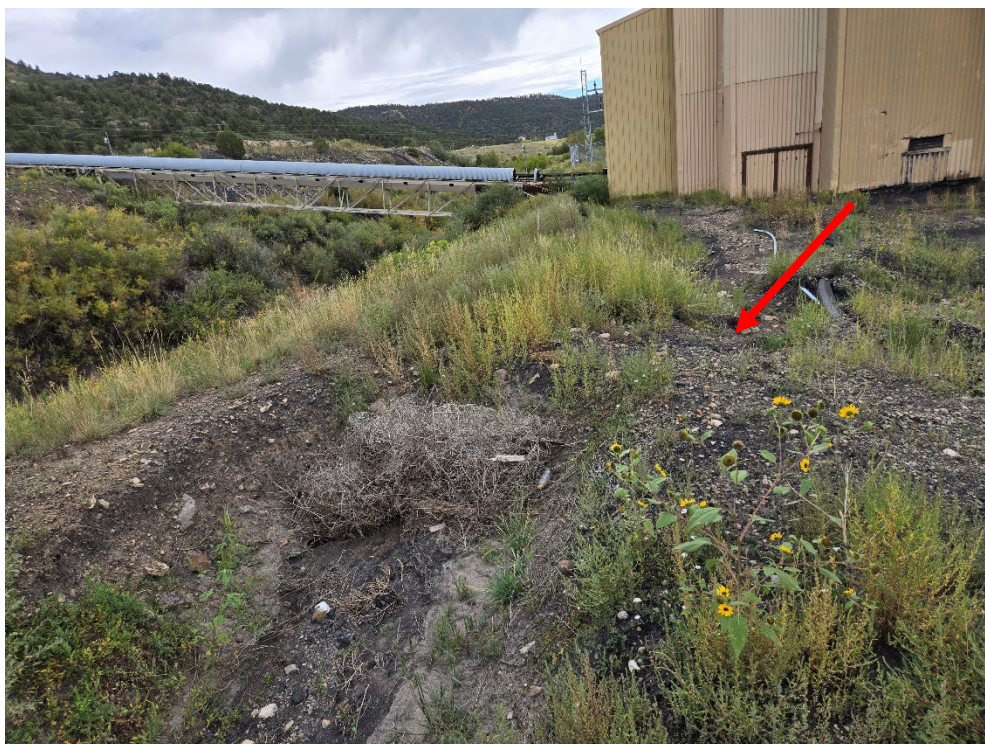
- **OMI:** (August 2025 report) Culvert C64, within Ditch D32, is blocked by vegetative debris. As a result, water has cut around the ditch and has deposited sediment within the raw coal storage area. No water appears to have overflowed on the north side, which leads to the river. **The Operator shall clear the debris from C64 and repair D32 to ensure that water from this ditch flows directly to Pond 007a as designed.**
- Culverts C65, C64 (outlet), C19, C12A, C13 (outlet), C74 (outlet), C17B (outlet), and C17A were clear of debris and sediment.
- Culvert C22 was mostly clear but had some sediment accumulation at the outlet.
- **Culverts C17B (inlet) and C17 (inlet), in addition to the inlet for C64, need to be cleaned of sediment and debris accumulation.**

*Photo 13: Looking east in D32 at the inlet for C64. The arrow points to where water had overtopped.*

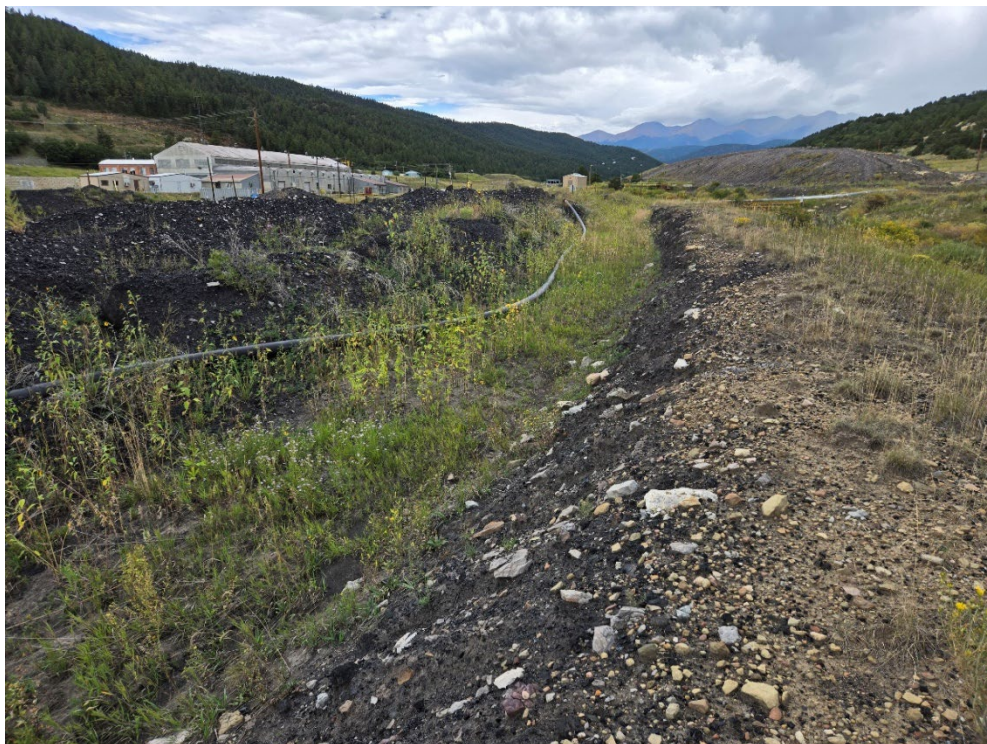
*Photo 14: Looking west within D32 where D32 turns into D15.*

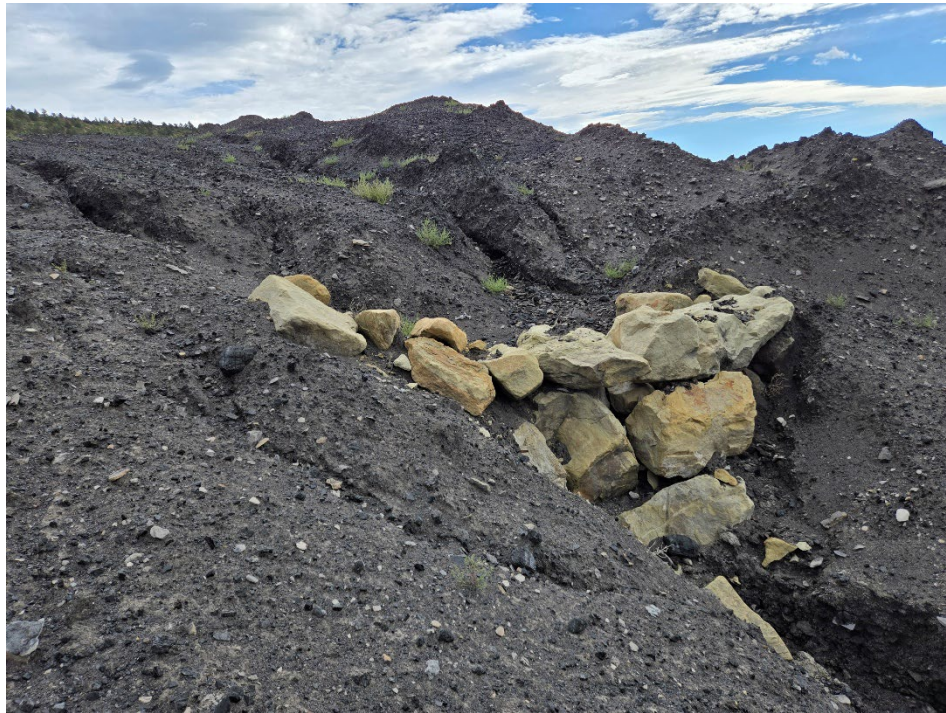
Photo 23: Looking at a check dam along the backside of the unreclaimed bench face, leading to the sediment basin.

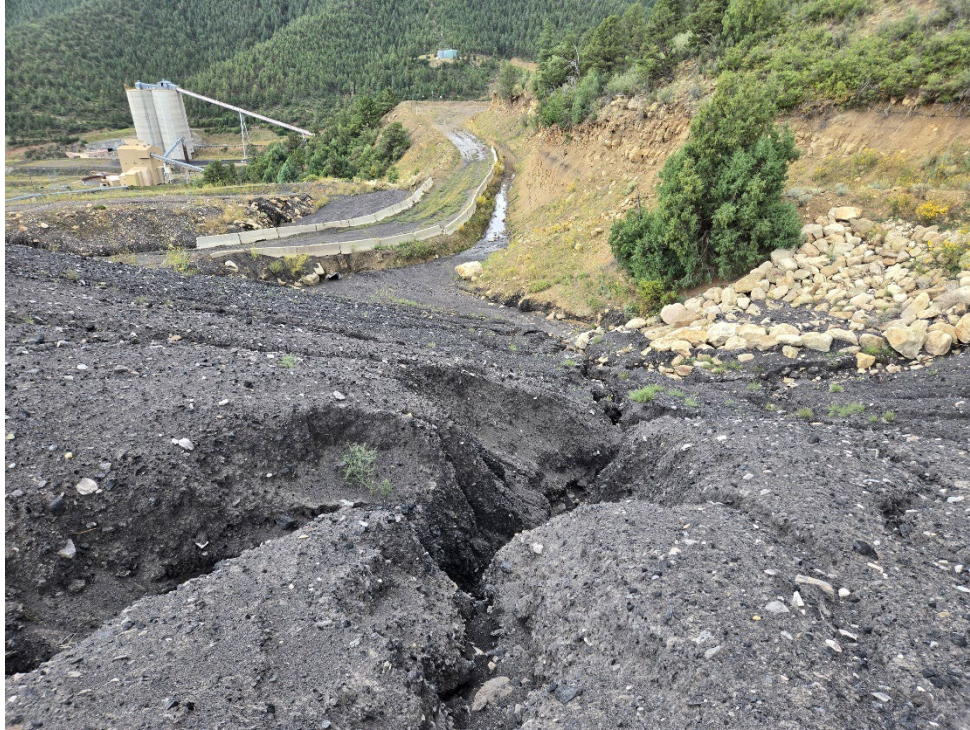
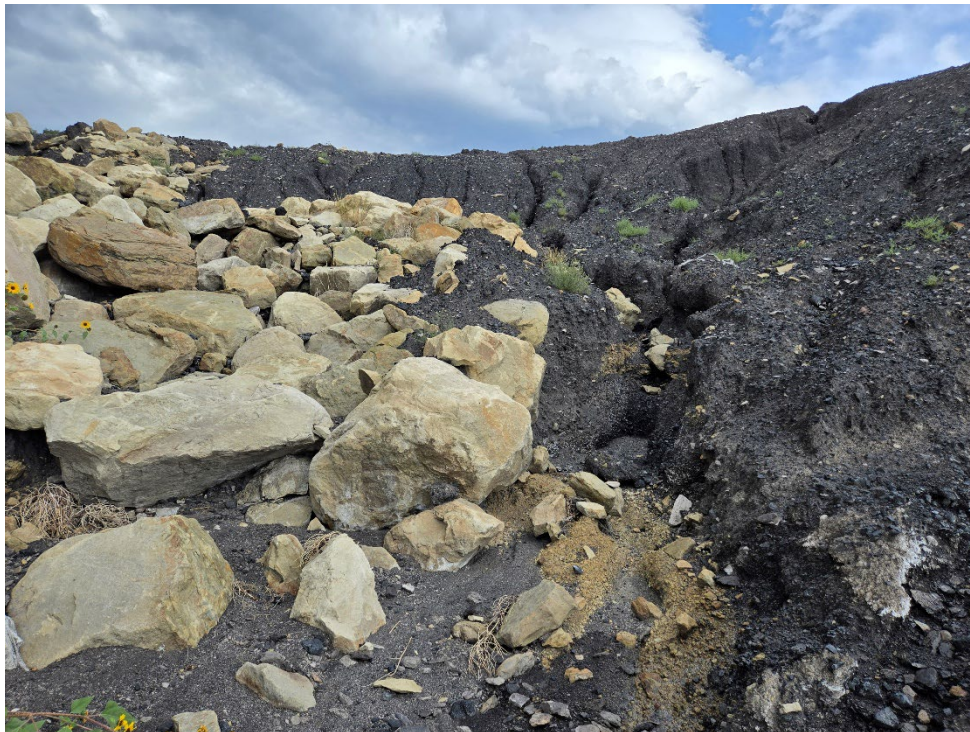
- The top of the RDA is still exhibiting positive drainage to the back and side ditches.
- **OMI:** (December 2024 report) RDA:
  - a. The northernmost bench, before the leveled area at the top of the RDA, has a small ditch that runs east-west toward the drainages on either side of the RDA. The west side of the bench has a check dam to help slow runoff into the area that leads to culvert C81. The check dam appears functional at the end of the ditch, but erosion has cut around on the slope next to the check dam in some areas, leading to increased sedimentation in the basin leading to C81. **The Operator shall implement additional erosion control structures along the west slope of the RDA to help reduce erosion on the slope, and stabilize the eroded slopes.**

*Photo 24: Looking down from the top of the RDA at the erosion gullies leading to the sediment basin by the road.*

*Photo 25: Looking up at the erosion gullies seen in Photo 24.*

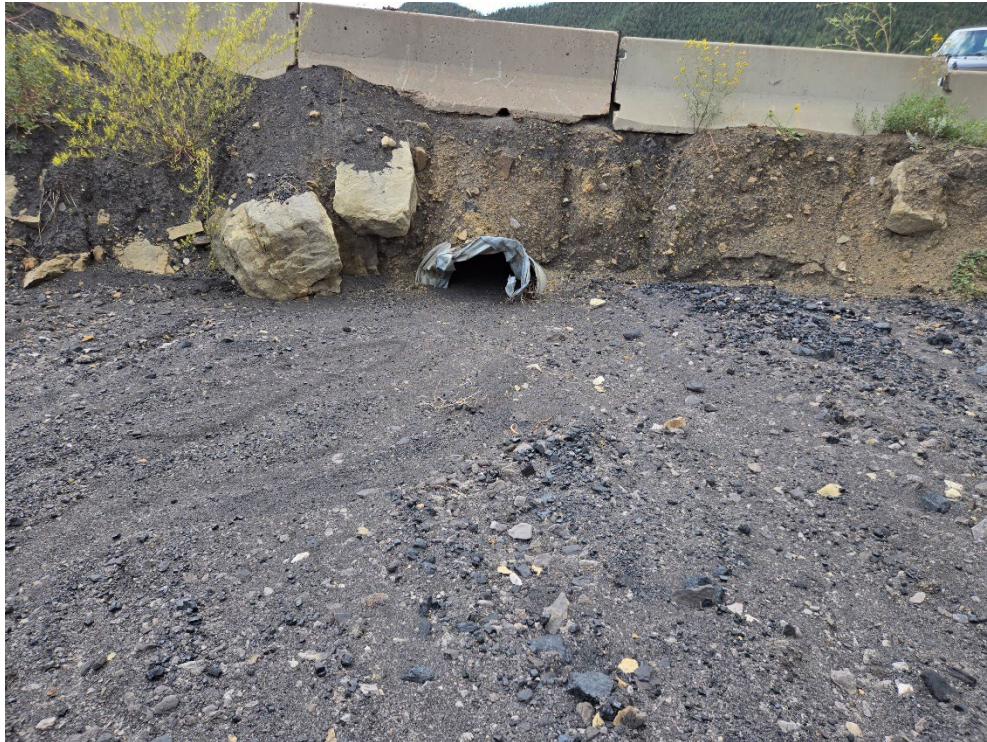
- c. There is a culvert (C81) at the end of ditch D55 and the unnamed ditch that allows runoff to flow under the road and out to the ditch leading to Pond 08. ~~The inlet side of C81 (located on the north side) appears to be clear of obstructions at this time.~~ **However, the Operator shall remove some of the sediment that has accumulated in the basin to the north of C81 to help minimize the sediment load deposited into Pond 08. \*\*As of the August 2025 inspection, the inlet side of C81 has begun to fill with sediment.**

*Photo 26: Looking south at the inlet side of C81.*

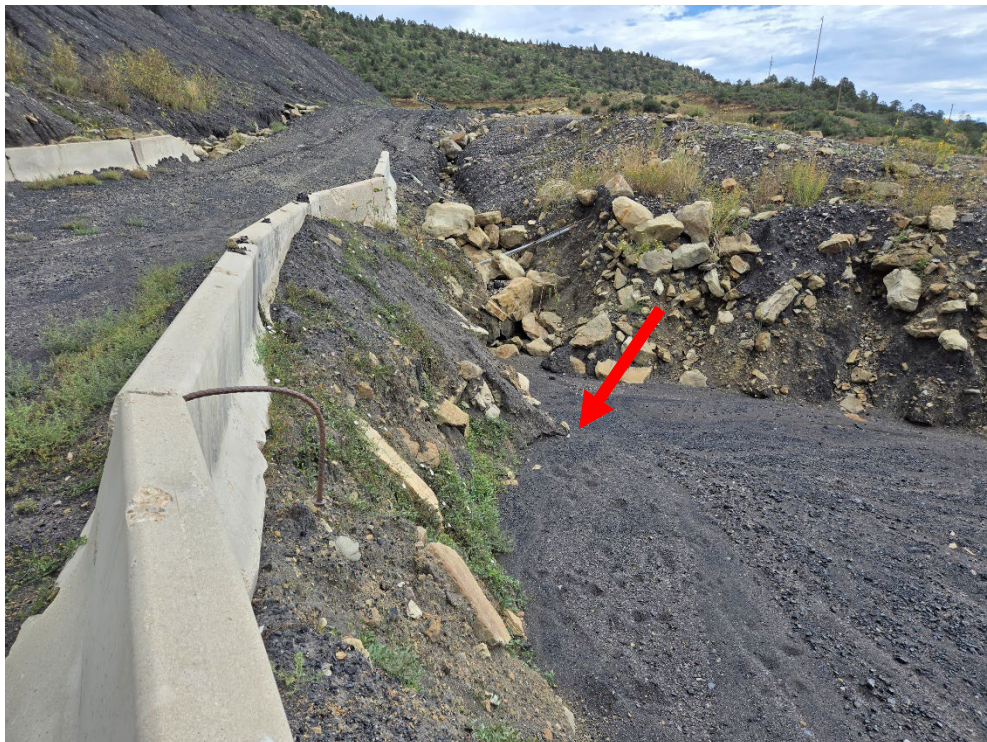
- d. The outlet side of C81 (located on the south side) ~~has been partially filled with sediment.~~ **The Operator shall clean sediment out of C81 and from the area around the culvert. \*\*As of the August 2025 inspection, the outlet side of C81 has been completely covered by sediment.**

*Photo 27: Looking east at the outlet side of C81 (buried).*

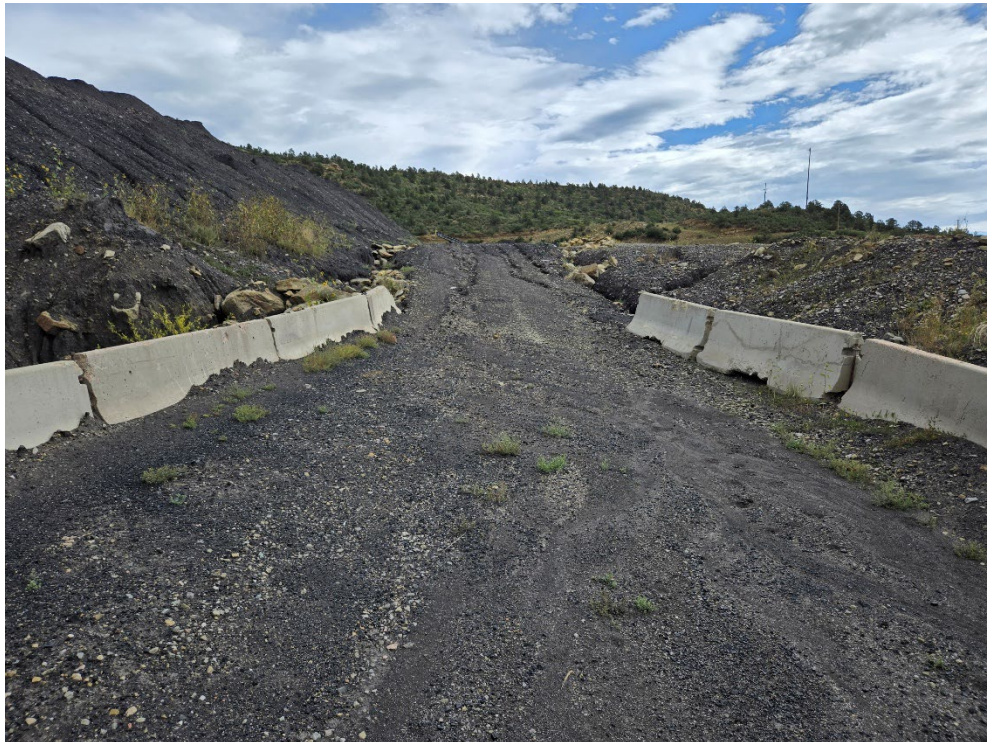
- **OMI:** (March 2025 report)
  - a. Check dams line the north and south side of the road leading to the top of the RDA. These ditches along the road have filled with sediment, and many of the check dams in the ditch need to be repaired. **The Operator will need to clean the sediment from these ditches and repair the check dams.**

*Photo 28: Looking east at the damaged check dams contributing to the sediment accumulation on both sides of the road near C81.*

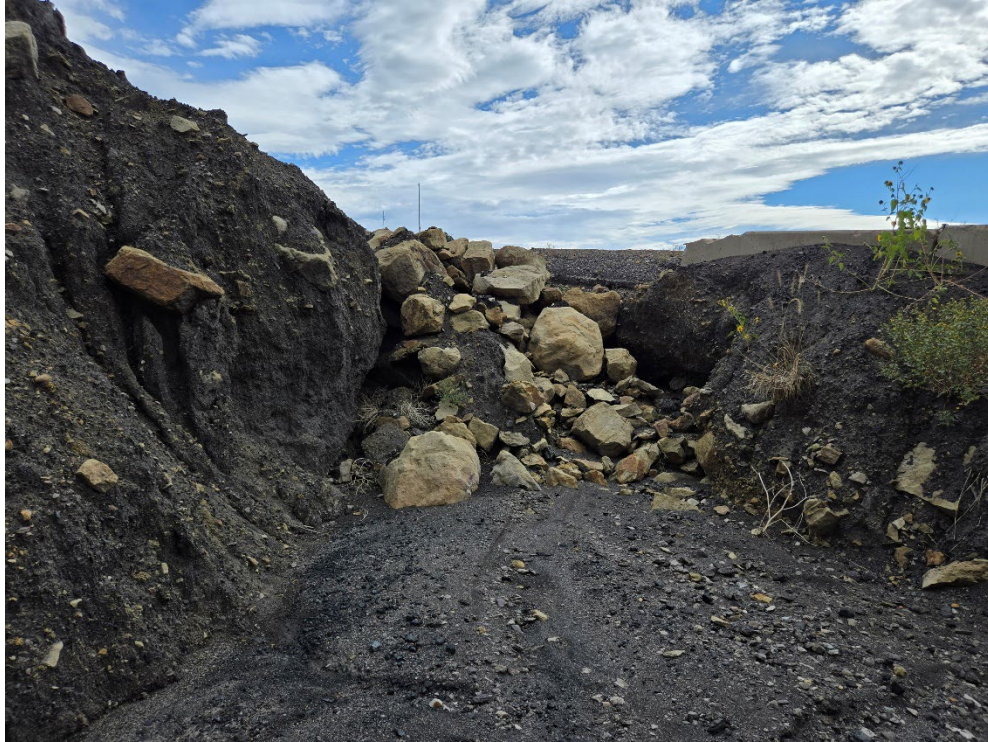
*Photo 29: Looking east at the sediment deposited into the sediment basin on the north side of the road, by the ditches running along the north side of the road.*

- Because the sediment basin leading to C81 has filled with an increased amount of sediment, the ditch on the west side of the haul road has begun to fill with sediment and water. During this inspection, recently deposited fine-grained-grey sediment was observed on the haul road. It appears to have overtopped the ditch where the road bends, and has spread towards the armored channel that leads to Pond 08. **The Operator shall remove excess sediment from this ditch to ensure areas offsite do not become impacted by sediment generated from stormwater or snowmelt run-off.**

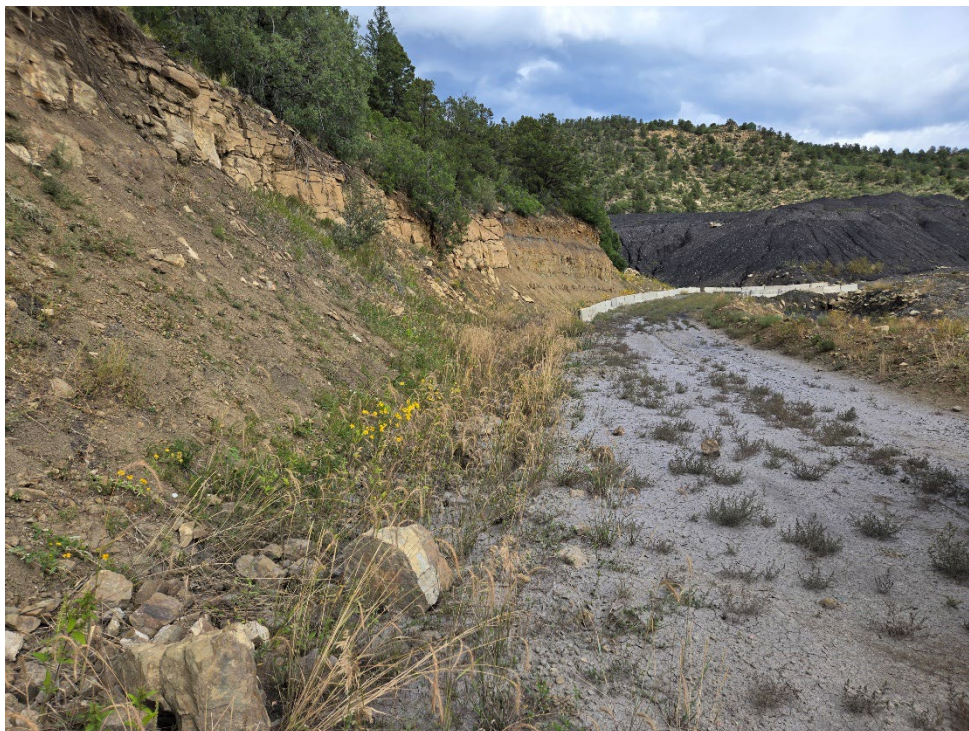
*Photo 30: Looking north at the fine-grained grey material deposited on the road from ditch D56.*

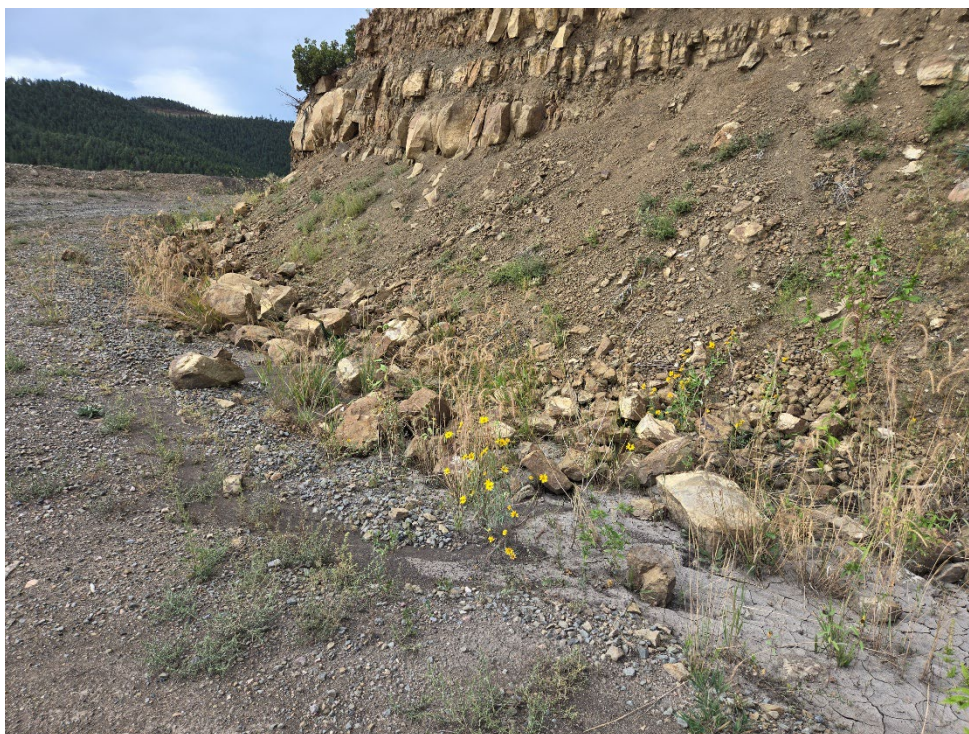
*Photo 31: Looking southwest at the end of where sediment has accumulated within D56, near the bend in the haul road.*

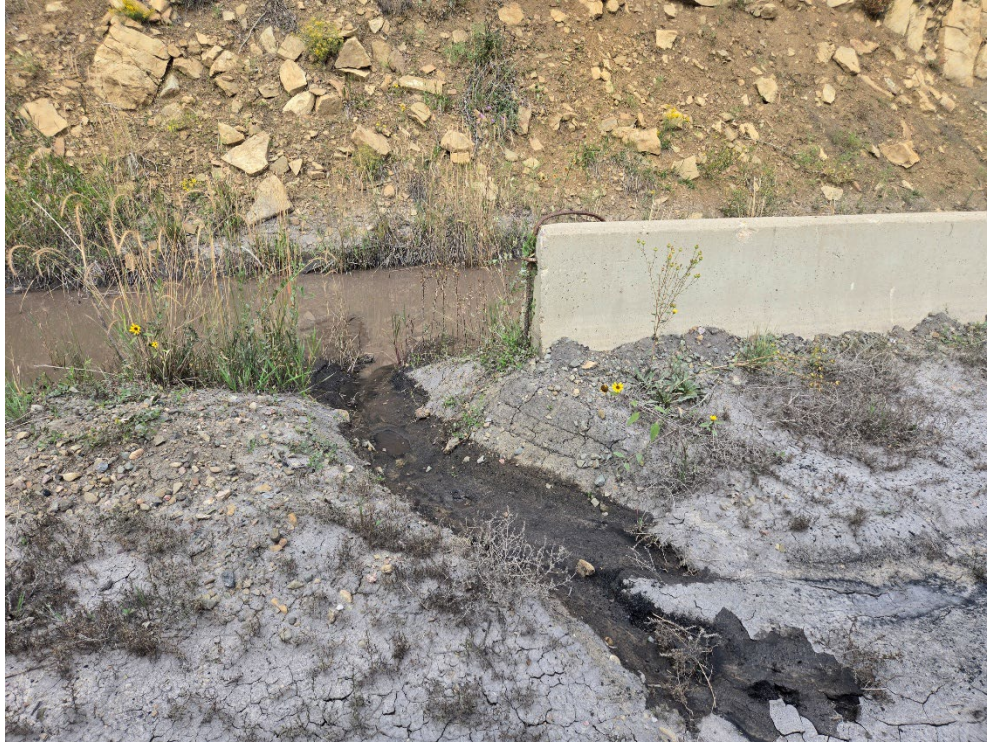
Photo 32: Looking at where water carrying the grey sediment had recently flown onto the haul road, depositing the grey material.

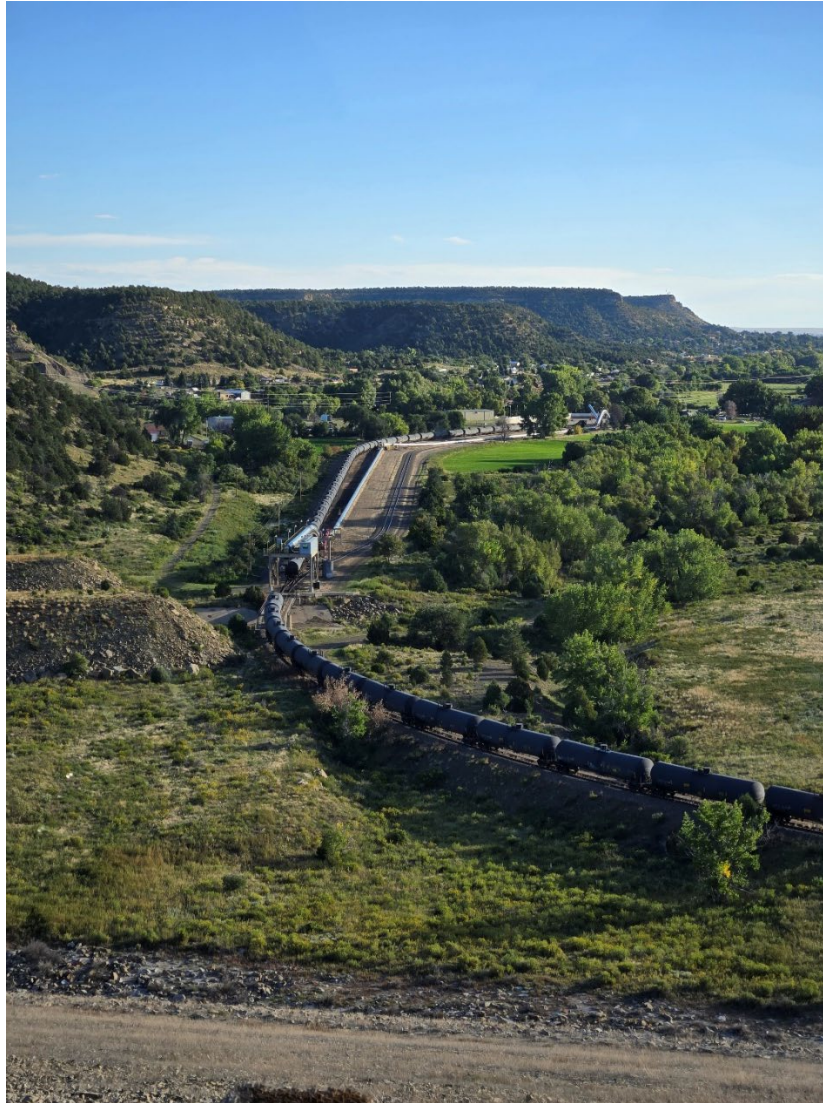
- The facilities at the Jansen Loadout were observed from the Trinidad Lake dam, on the way to the New Elk Mine site. The loadout appeared to be in use by a separate entity. The right of entry issues at this loadout will be addressed when there is a new Permittee in place.

*Photo 33: Jansen Loadout being utilized by a separate entity on the day of the inspection.*
