**MINERALS PROGRAM INSPECTION REPORT**  
**PHONE: (303) 866-3567**

| <b>MINE NAME:</b><br>Daniels Sand Pit 2 | <b>MINE/PROSPECTING ID#:</b><br>M-1973-007-SG | <b>MINERAL:</b><br>Sand and gravel | <b>COUNTY:</b><br>El Paso |
| <b>INSPECTION TYPE:</b><br>Monitoring | <b>WEATHER:</b> Clear | <b>INSP. DATE:</b><br>September 3, 2025 | <b>INSP. TIME:</b><br>10:00 |

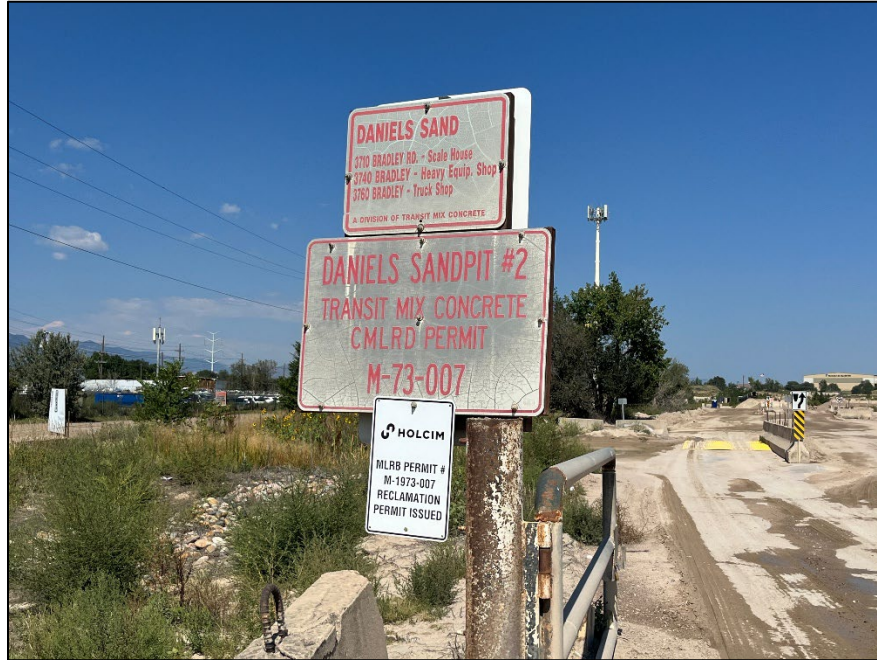
Signs and Markers: The permit sign was properly posted (Photo 1), and boundary markers were observed to be consistent with previous inspections. The permit sign will need to be updated with the Amrize West Central Inc. name with the approval of SO-4.

**Photo 1: Mine identification sign posted at the site office access road off of Bradley Rd.**

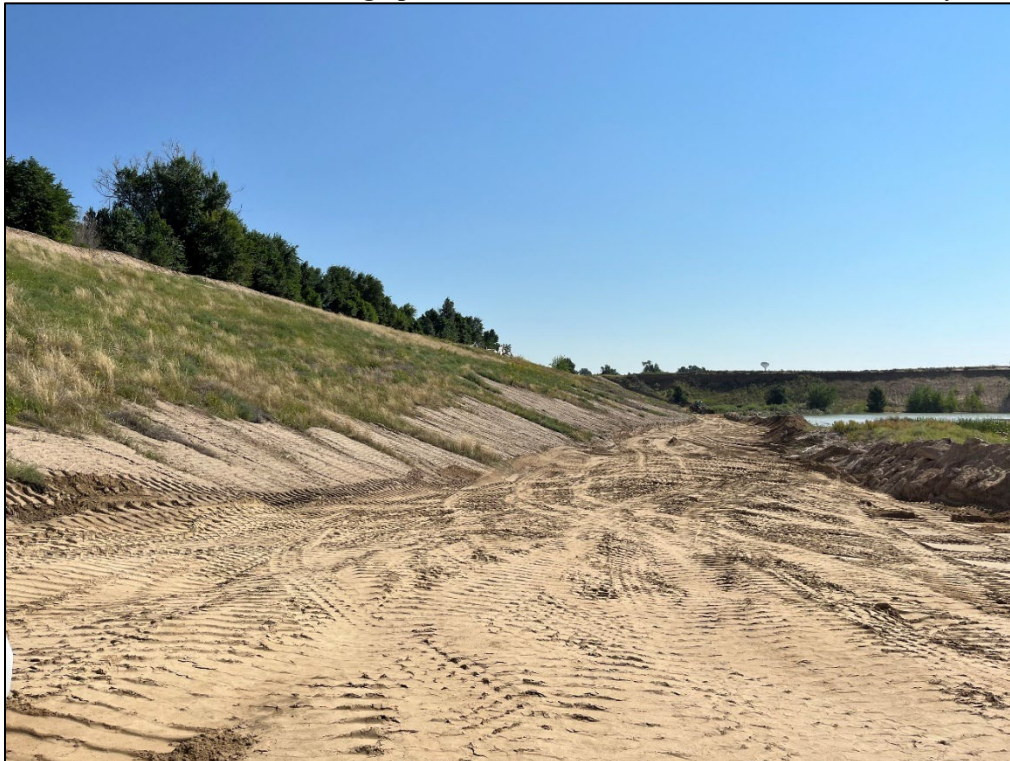
Revegetation: Site representatives indicated they had not seeded any areas at the time of the inspection, although it was mentioned that the berm south of the Fountain Mutual Ditch, which has struggled with erosional issues for many years, may be hydro mulched in the near future to reduce erosion (Photo 2). Volunteer vegetation appeared well established on the surface of the old wash pond (Photos 8 and 9),

Sediment Control: No erosion problems that might result in offsite impact were observed and no BMPs were needed at the time of the inspection. The aforementioned slope between the large wash pond and the Fountain Mutual Ditch has been previously monitored by a professional engineer for any erosion or instability that may impact the ditch. This monitoring began in January 2021 and continued until June 2025, as required by the Division. Geotechnical reports were submitted on a combination of monthly, quarterly and bi-annual scheduling and helped to identify erosion areas in need of repair and monitor for slope stability. These reports have consistently shown that while the berm struggles with erosional issues, slope stability has not been compromised. Therefore, the Division is not requiring additional geotechnical inspection of the Fountain Mutual Ditch slope at this time.

**Photo 2: View east of the slope between Fountain Mutual Ditch and the easternmost large wash pond, recent repair of erosion is visible.**

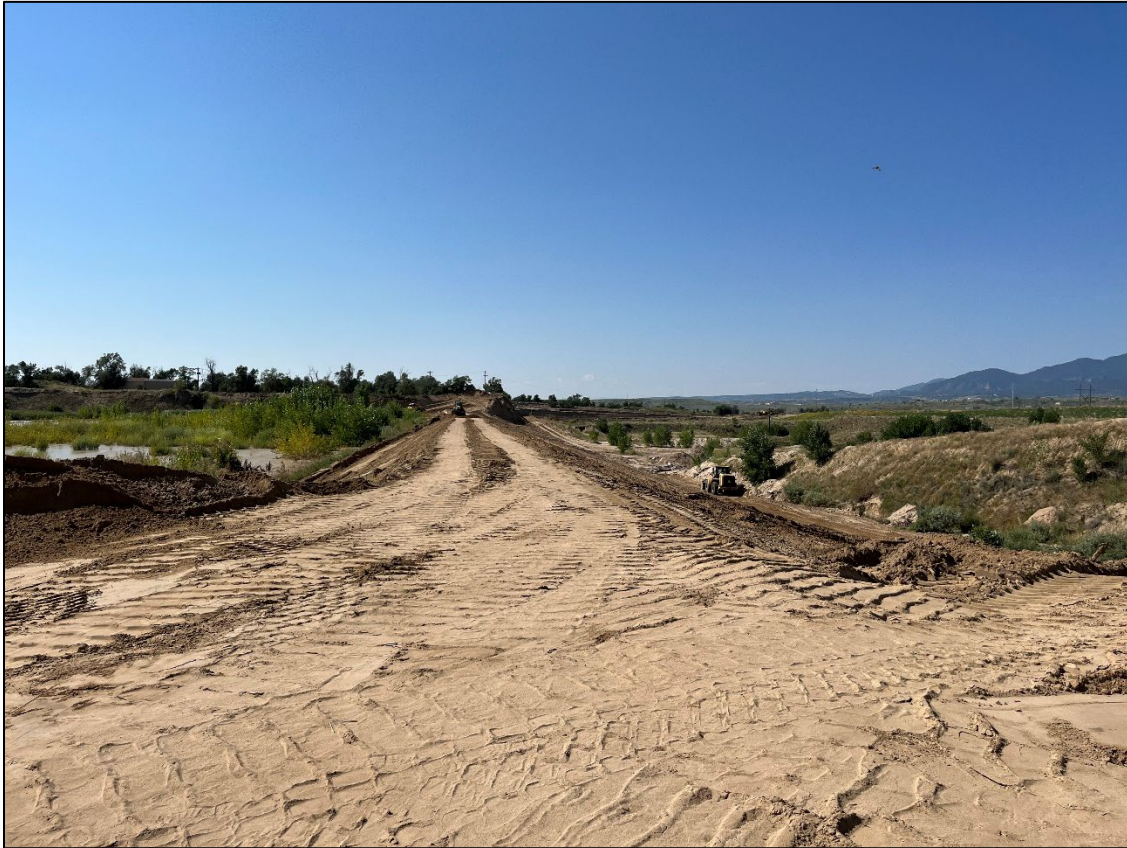
around unused slopes in the active pit area (Photo 7), and around the edges of the large wash pond (Photos 3 and 4). No noxious weeds were observed.

**Photo 3: View south of the newly expanded berm on the west side of the wash pond.**

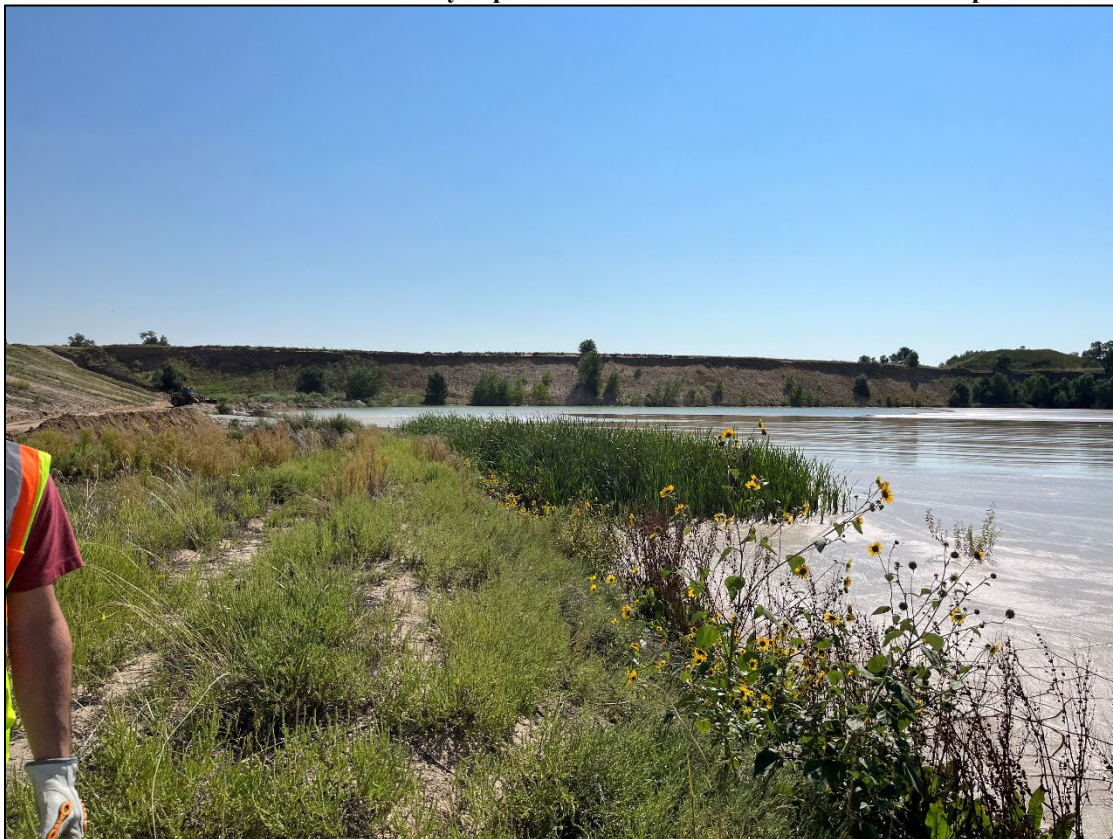
Gen. Compliance with Mine Plan: The operation appeared to be in compliance with the approved mine plan. The maximum allowed disturbed area is 286.12 acres (based on the approval of AR-2 in 2018). Google Earth was used to measure the disturbed area, which was approximately 255 acres, based on 2025 imagery. The main active pit area (Photo 7) has both coarse and fine material, which is transported to the nearby processing plant via conveyor system. Slurry from material processing is currently pumped into a wash pond on the eastern side of the permit boundary (Photos 4 and 5).

**Photo 4: View east of the wash pond.**

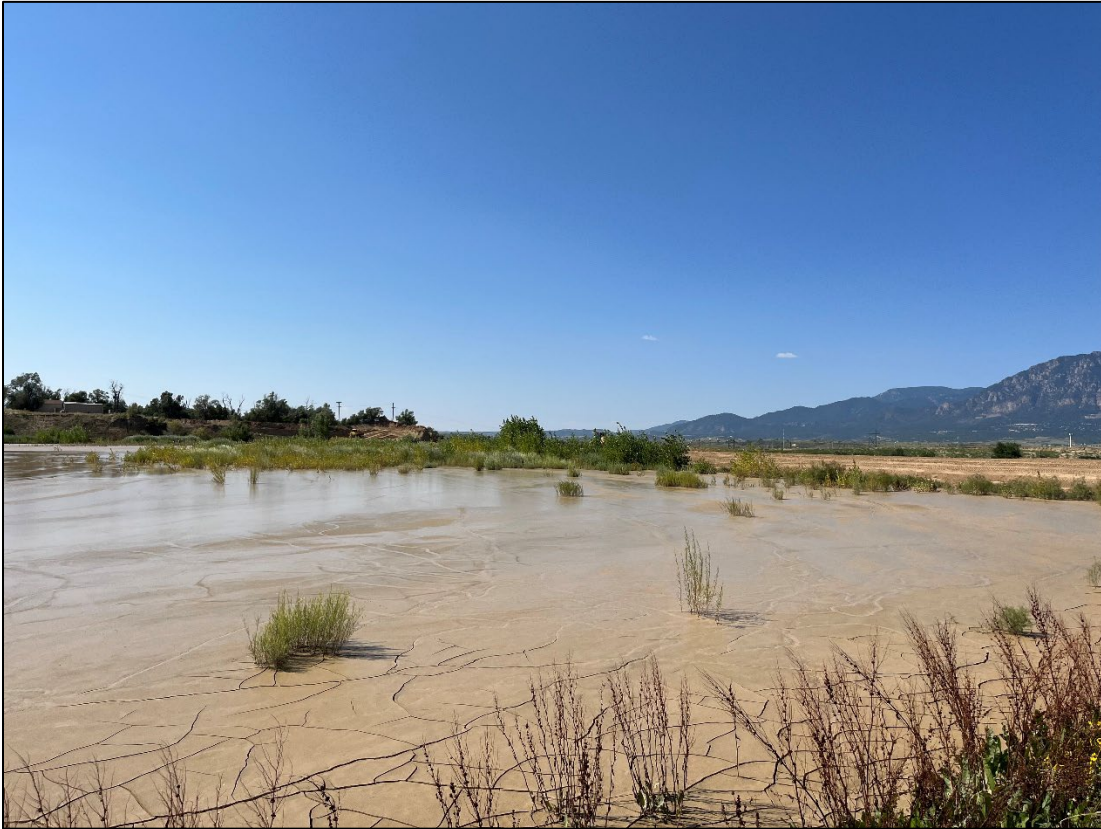
**Photo 5: View southwest of the inlet area of the wash pond.**

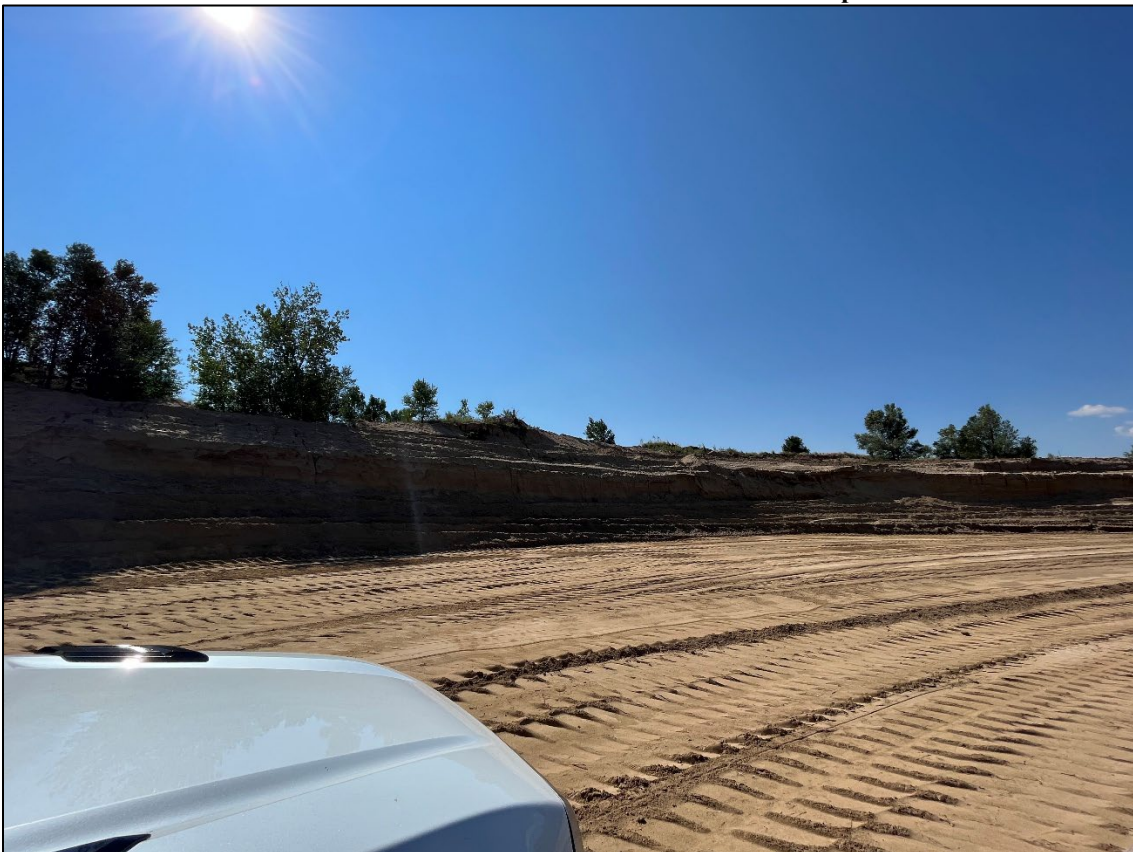
Backfilling and Grading: Sufficient backfill material appeared to be available in and around the active pit area for use in final reclamation. Under TR-11, the Division approved expansion of the easternmost, large wash pond to allow for increased volume storage of slurry and fines. At the time of inspection, work was active in this area, as the expanded berm on the western side of the pond was being constructed (Photo 3). Overburden and excess material from the northwestern corner of the site, which was approved to be mined under TR-12, is being used to construct this expanded wash pond berm. The site plans to use fines, which have been previously deposited in this same TR-12 NW corner area to regrade and slope highwalls (Photo 6) once mining is complete in this area.

**Photo 6: Current highwall in the southwest corner of the site which will be mined as approved under TR12.**

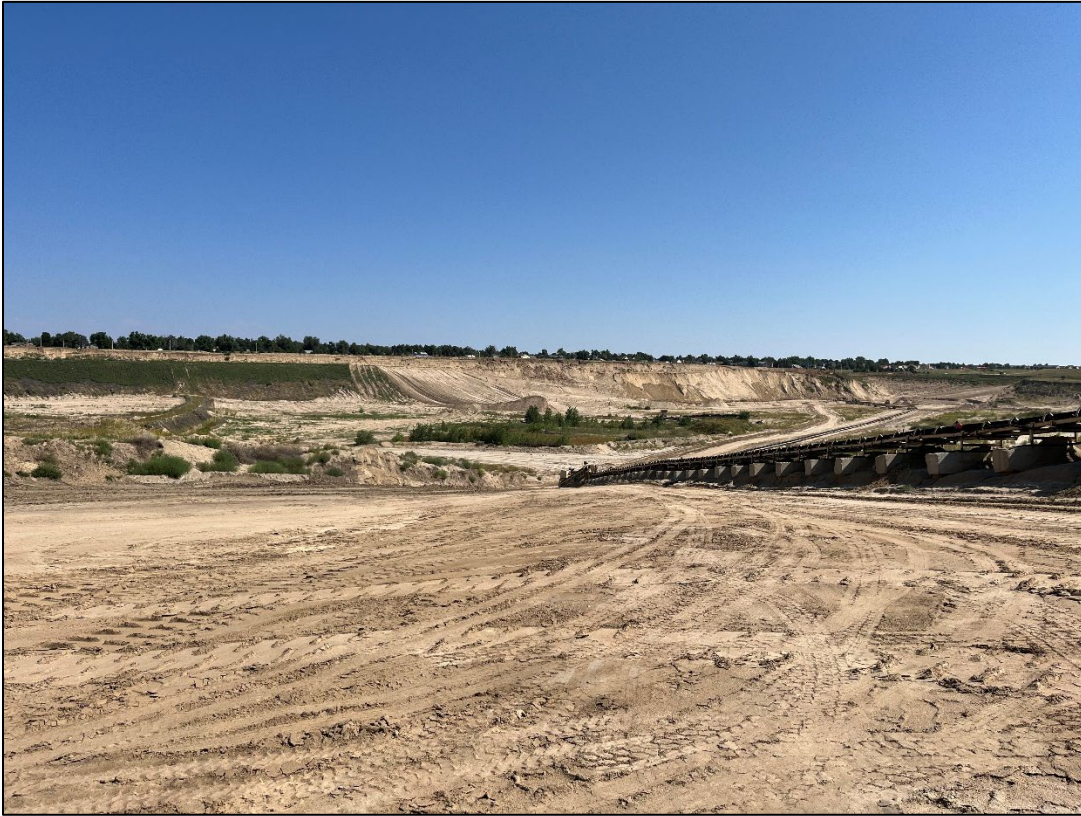
Hydrologic Balance: A small amount of standing water was observed in the active pit (Photo 7). This is expected due to the sandy nature of the native material, when the adjacent Fountain Mutual Ditch is flowing, as it was at the time of the inspection. The ponded water is not considered groundwater. If necessary, excess ponded stormwater is pumped around the pit to smaller sump areas to encourage and disperse ground infiltration.

**Photo 7: View north down into the active mining area. Fountian Mutual Ditch is behind (south) of the vantage point.**

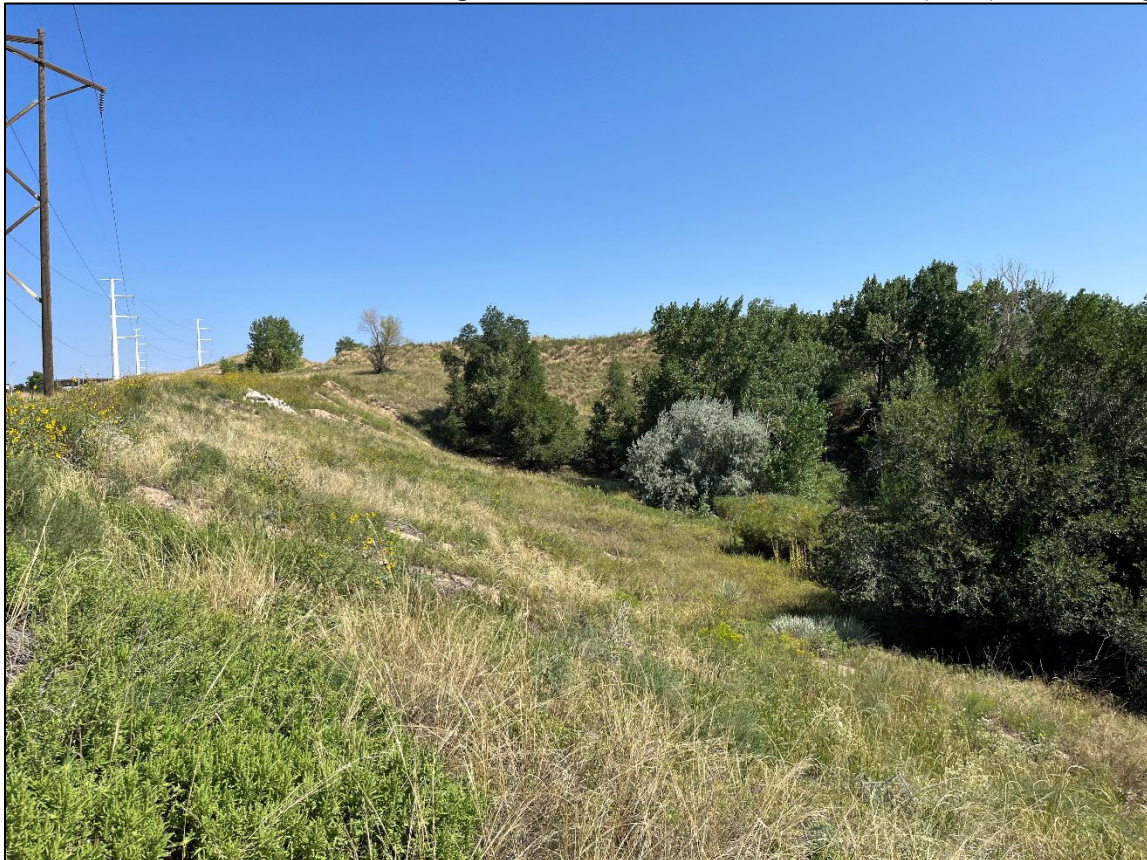
The south facing slope above the augmentation pond (Photo 8) is well vegetated with volunteer vegetation but is too steep for final reclamation and will need to be laid back prior to final release. Site representatives agreed and stated that there was likely enough room to the north to flatten the slope out to an acceptable grade.

**Photo 8: View north of the south and east facing berms at the old wash pond.**

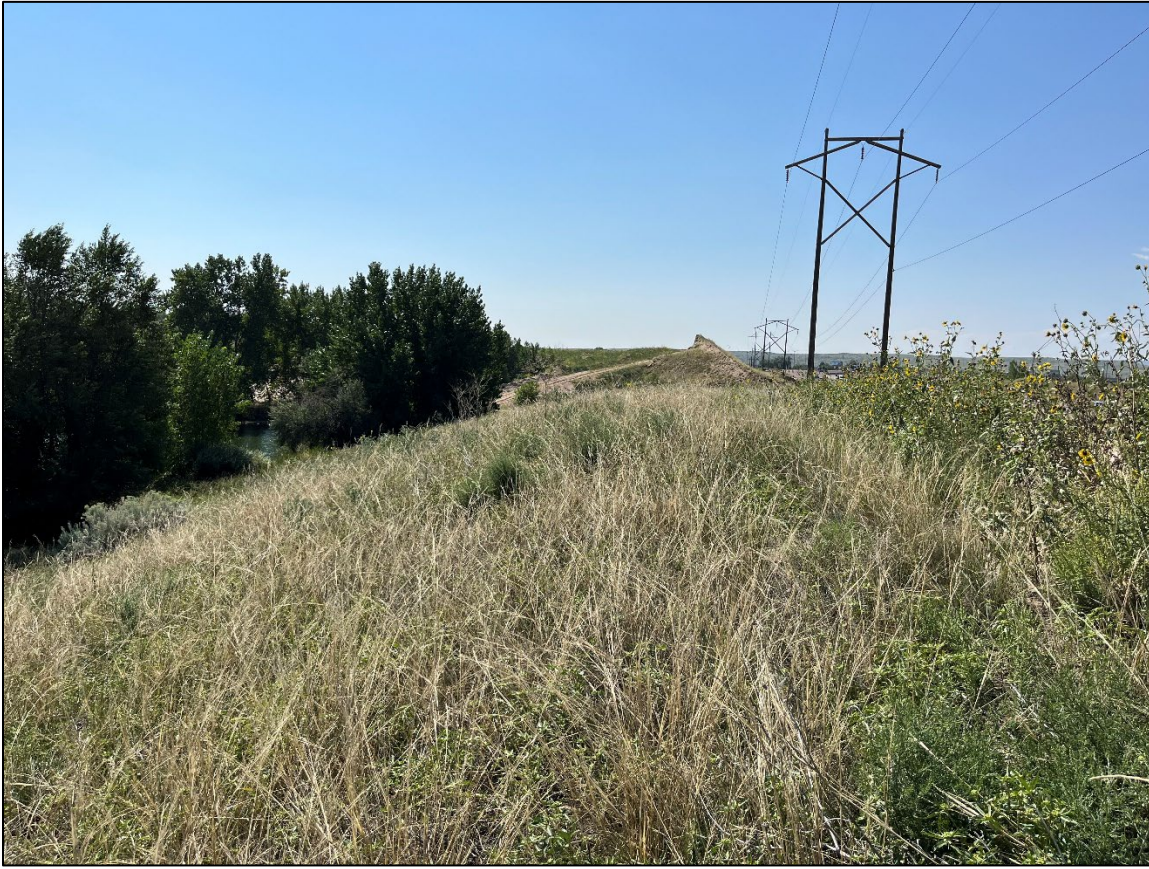
The old wash pond located east of S Academy Blvd., which is now used as an augmentation pond for water rights, has two tall berms. One berm is south facing, and one is east facing. The east facing berm is currently slightly steeper than the approved 3H:1V reclamation slopes. However, this east facing slope is heavily vegetated with native and desirable species and is not experiencing issues with erosion (Photo 9). Therefore, the Division would not recommend re-disturbance or layback of this slope in final reclamation, which is already well vegetated and stable.

**Photo 9: View south of the east facing slope at the old wash pond.**

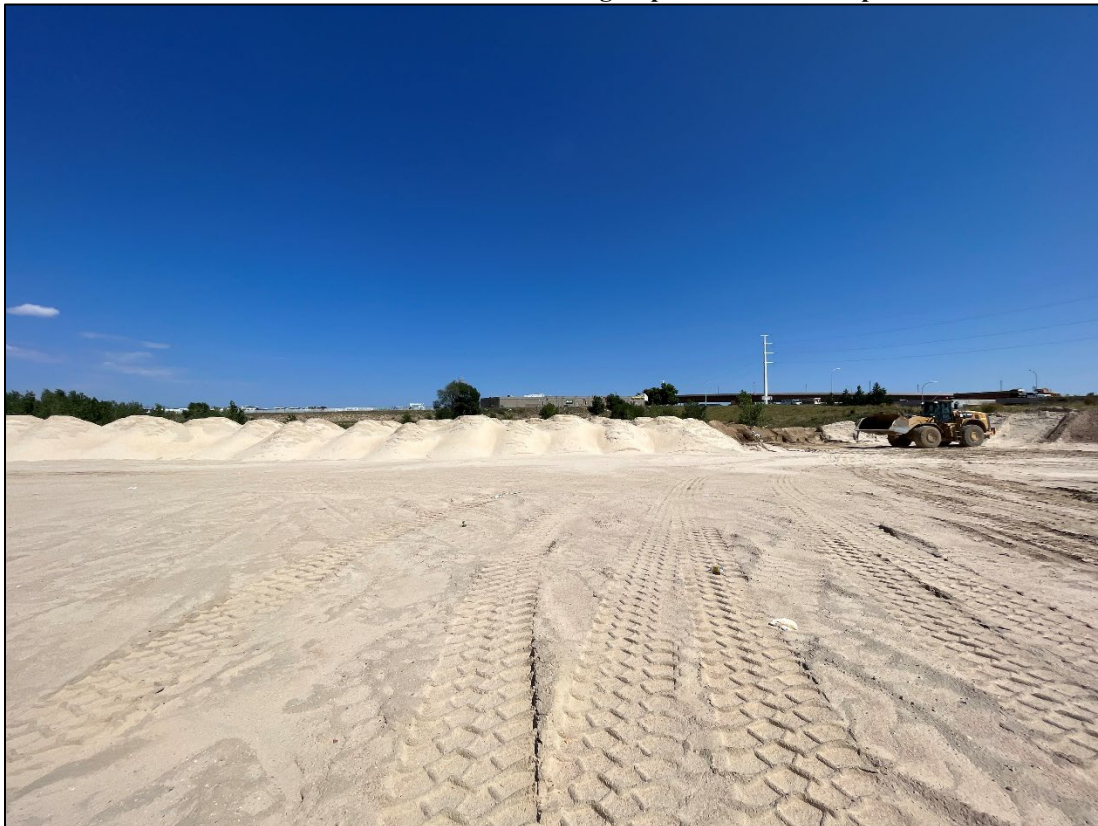
There is a small, noncontiguous permit area to the northwest of the main active pit area (Photo 10) which is used for material storage. This area makes up approximately 35 acres of the full permit acreage.

**Photo 10: View north of the noncontiguous, northwestern portion of the permit boundary.**

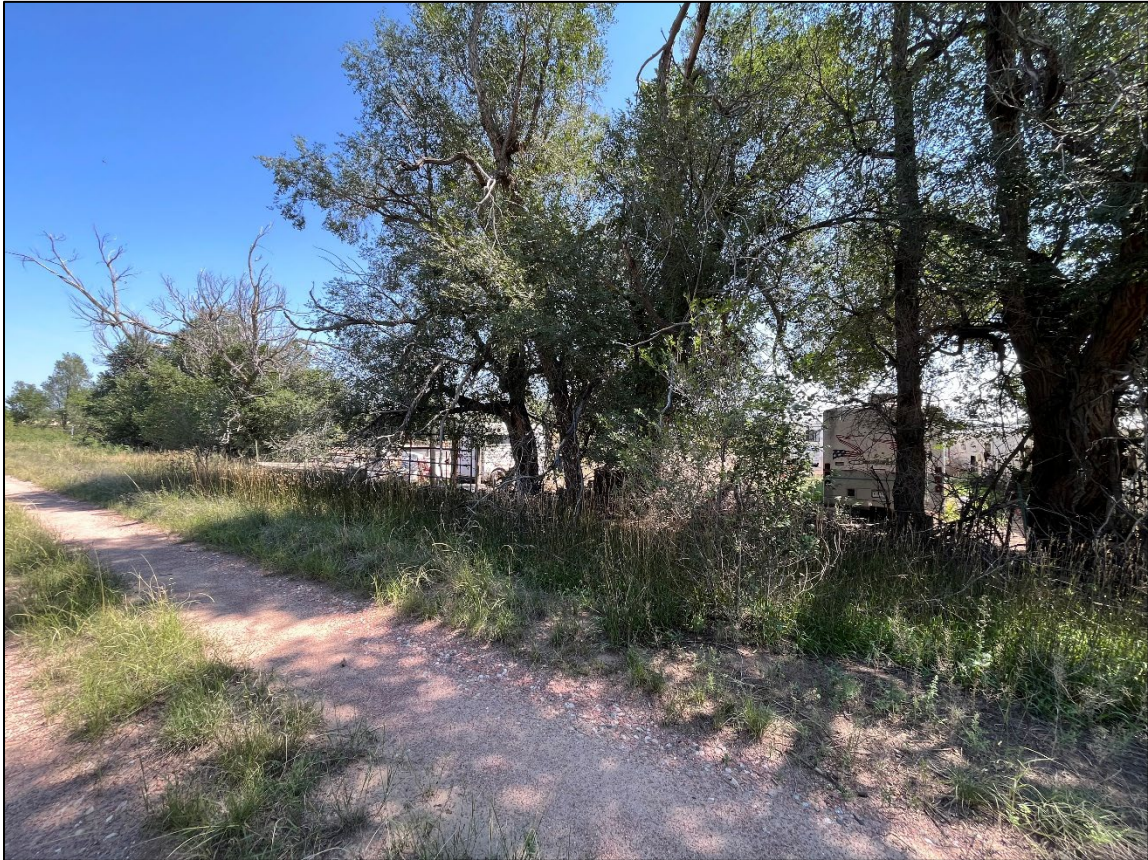
The area known as the ‘Little J Property’ located just south of the wash pond, is currently used for equipment storage (Photo 11).

**Photo 11: View east of the 'Little J' property portion of the permit boundary, located along the southern edge of the permit.**
