**MINERALS PROGRAM INSPECTION REPORT**  
**PHONE: (303) 866-3567**

<b>MINE NAME:</b> Speer Mining Resource	<b>MINE/PROSPECTING ID#:</b> M-1983-176	<b>MINERAL:</b> Gravel	<b>COUNTY:</b> Adams
<b>INSPECTION TYPE:</b> Monitoring	<b>WEATHER:</b> Clear	<b>INSP. DATE:</b> July 10, 2025	<b>INSP. TIME:</b> 11:45
<b>OPERATOR:</b> Asphalt Specialties Co., Inc.	<b>OPERATOR REPRESENTATIVE:</b> Greg Geras	<b>TYPE OF OPERATION:</b> 112c - Construction Regular Operation	
<b>REASON FOR INSPECTION:</b> Normal I&E Program	<b>BOND CALCULATION TYPE:</b> Complete Bond	<b>BOND AMOUNT:</b> \$678,169.00	
<b>DATE OF COMPLAINT:</b> NA	<b>POST INSP. CONTACTS:</b> None	<b>JOINT INSP. AGENCY:</b> None	
<b>INSPECTOR(S):</b> Nikie Gagnon	<b>INSPECTOR'S SIGNATURE:</b>

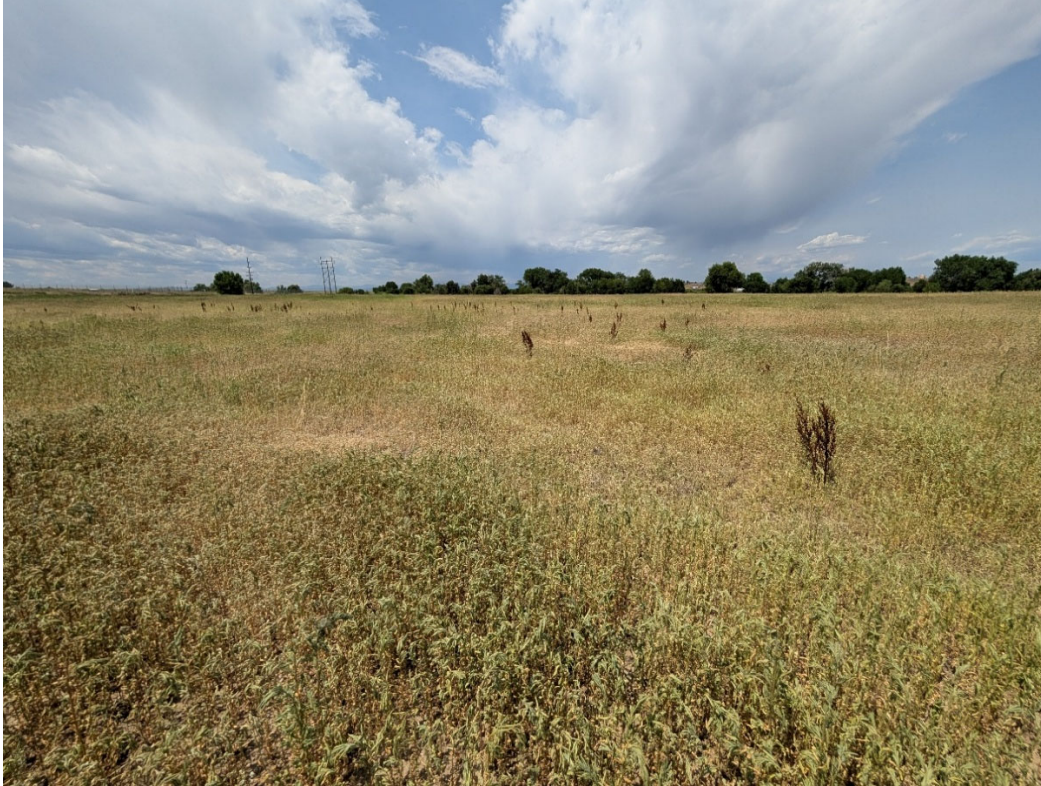
In 2024, 55 acres were graded and reseeded, according to the annual report and operator statements to the Division. While some desired grasses were observed in reclaimed areas (western wheatgrass), most of the site is covered in annual weeds. The operator must closely monitor revegetation and reseed and mulch as needed to ensure successful growth.

Photo 1: Looking southwest across the graded and seeded area on the south end of the permit area. Annual weeds dominate here.

**The Division reminds the operator to follow the approved topsoiling (place 6-12 inches on all disturbed level areas and 3:1 slopes above the expected high waterline on the pond) and the seeding requirements for the site as approved in Amendment in 2003. Additionally, Technical Revision 2, approved in 2014, committed ASCI to monitoring all permit boundary areas for weed infestation and controlling state-listed noxious weeds through mowing, tilling before seed fall, or herbicide treatment for small, intense infestations.**

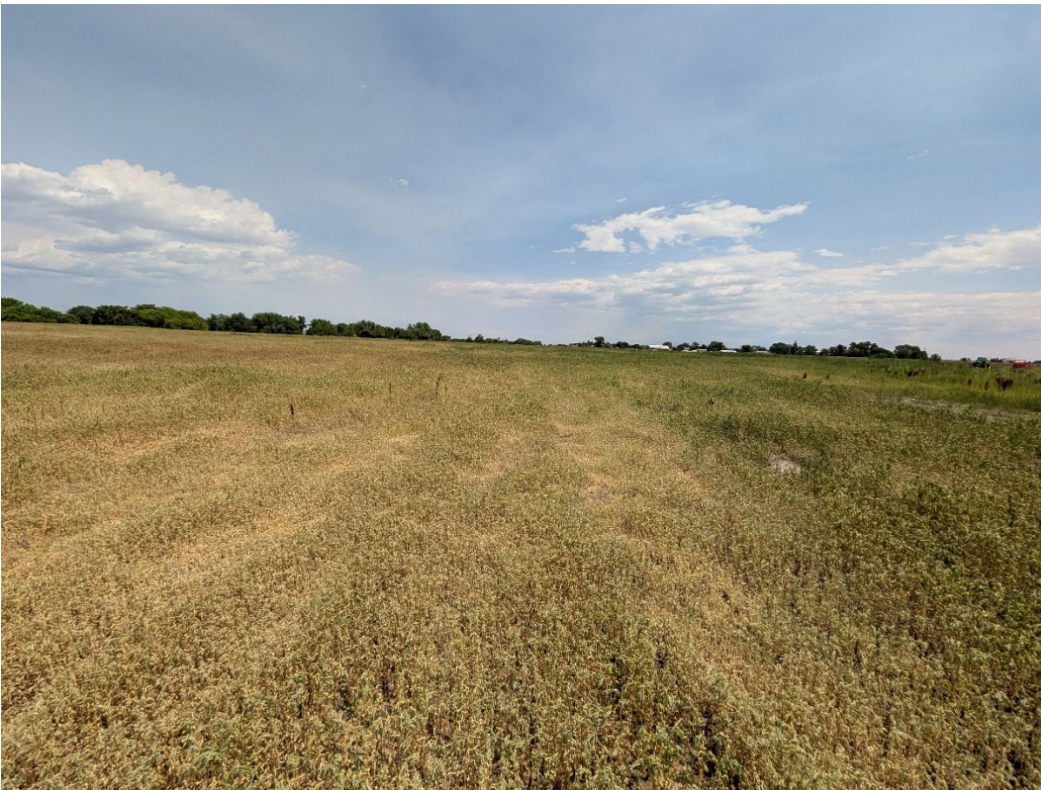
Photo 2: Looking northwest across the graded and seeded area in the middle of the permit area. Annual weeds dominate here.

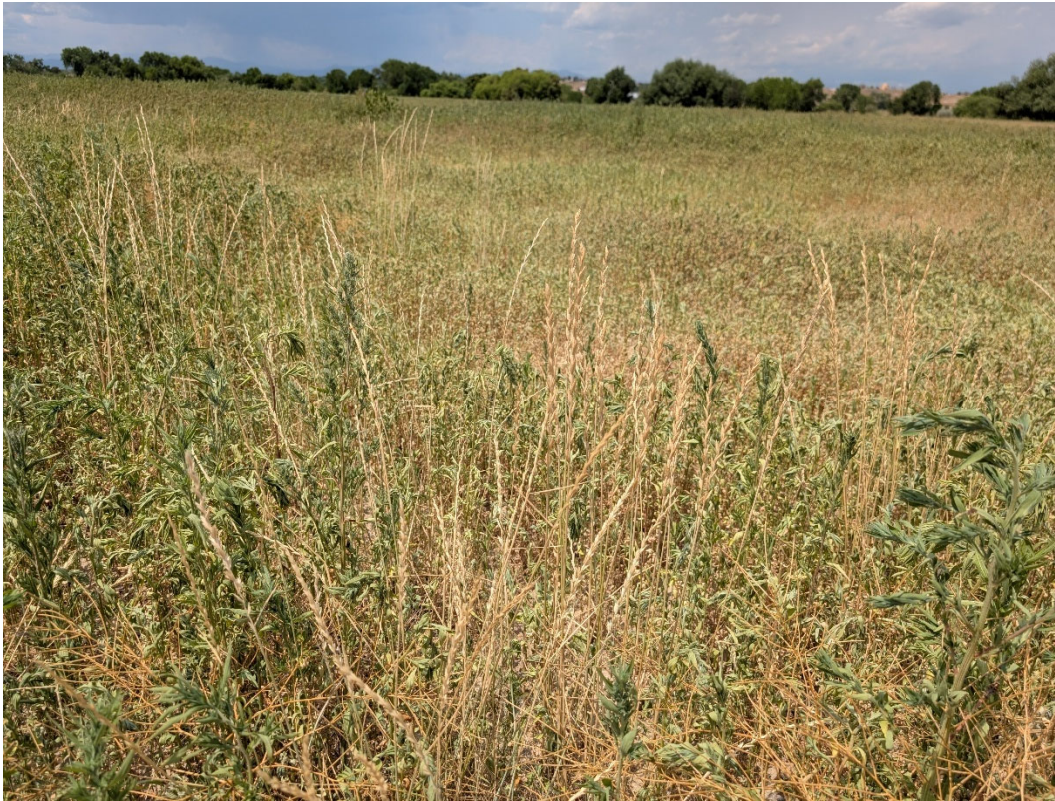
Photo 3: Close-up view of the reestablished vegetation in the center of the reclaimed area. Some wheatgrass plants observed here near the access road.

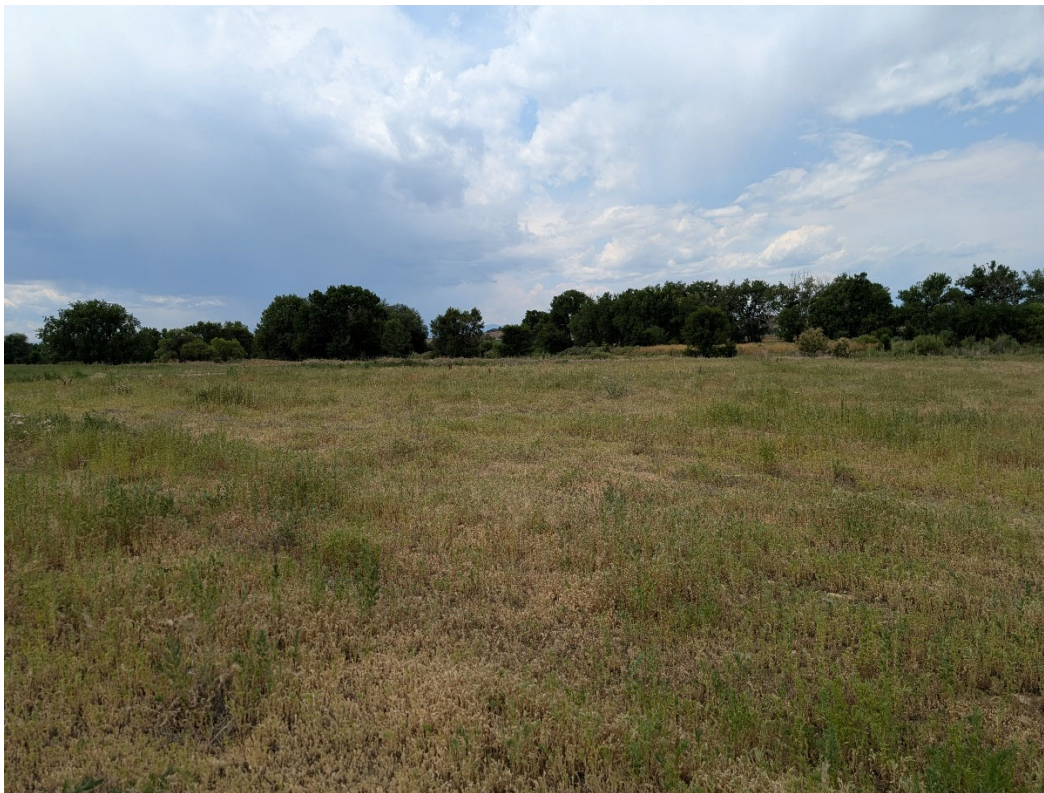
Photo 4: Looking west at the revegetation on the north end along the river side. Mostly annual weeds observed here.

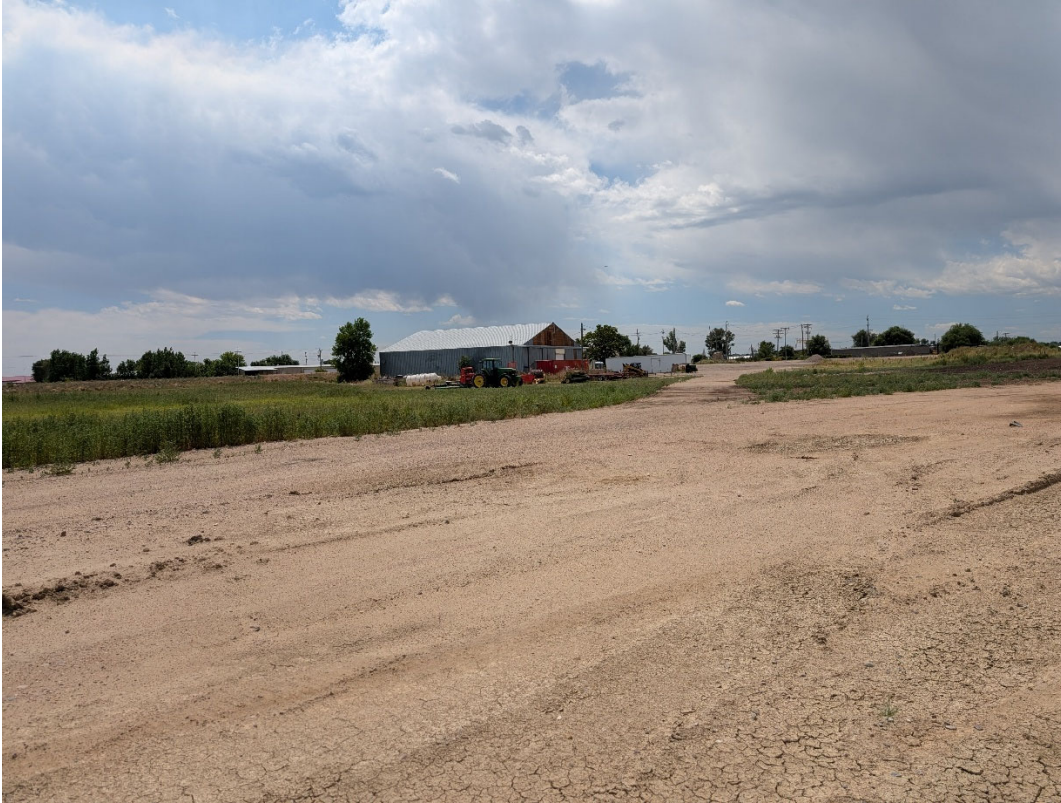
Photo 5: Looking at the existing shop near the entrance on the south end. The shop is approved to remain for future agricultural use.

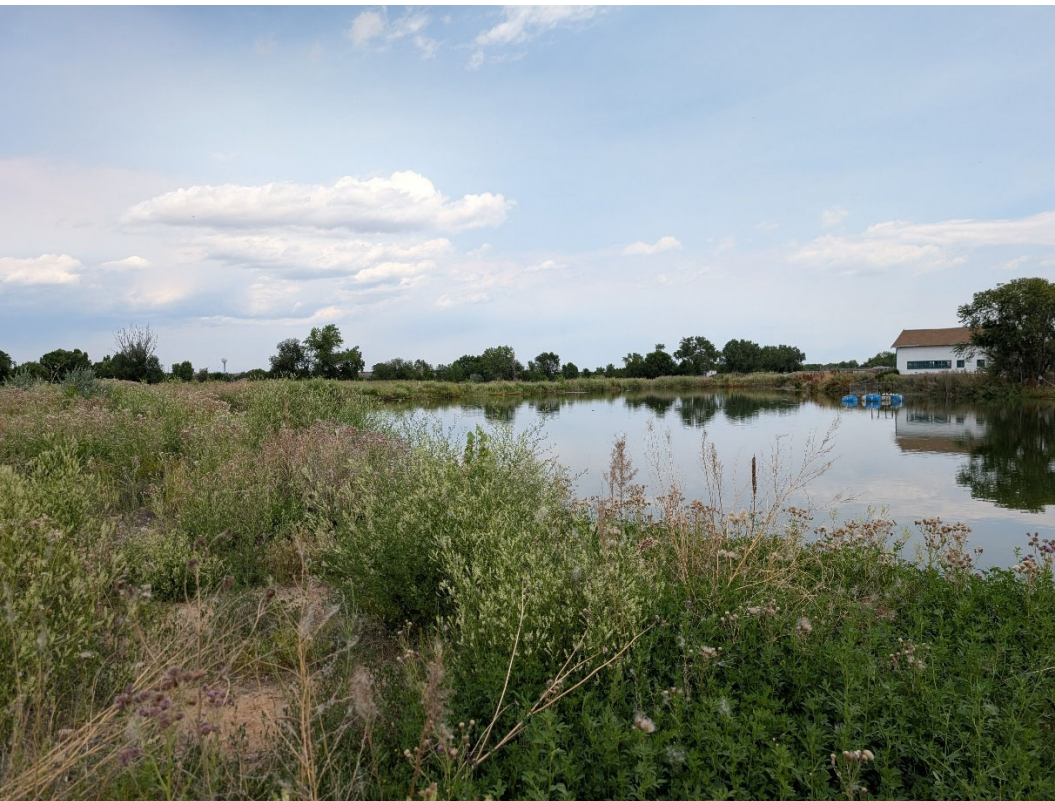
The two-acre open water pond area has not been graded or seeded, with bare ground visible where backfilling occurred in 2022. Dense vegetation, primarily annual weeds, was observed around the pond, with a few patches of Canada thistles along the eastern side. The north end of the permit area has little vegetation growing and does not appear to have been topsoiled or seeded.

Photo 6: Looking at the 2-acre open water pond in the northeast portion of the permit area. Dense vegetation surrounds the pond. Some Canada thistle plants observed in this area.

Following the inspection, the operator confirmed the site is scheduled for mowing in the Fall of 2025.

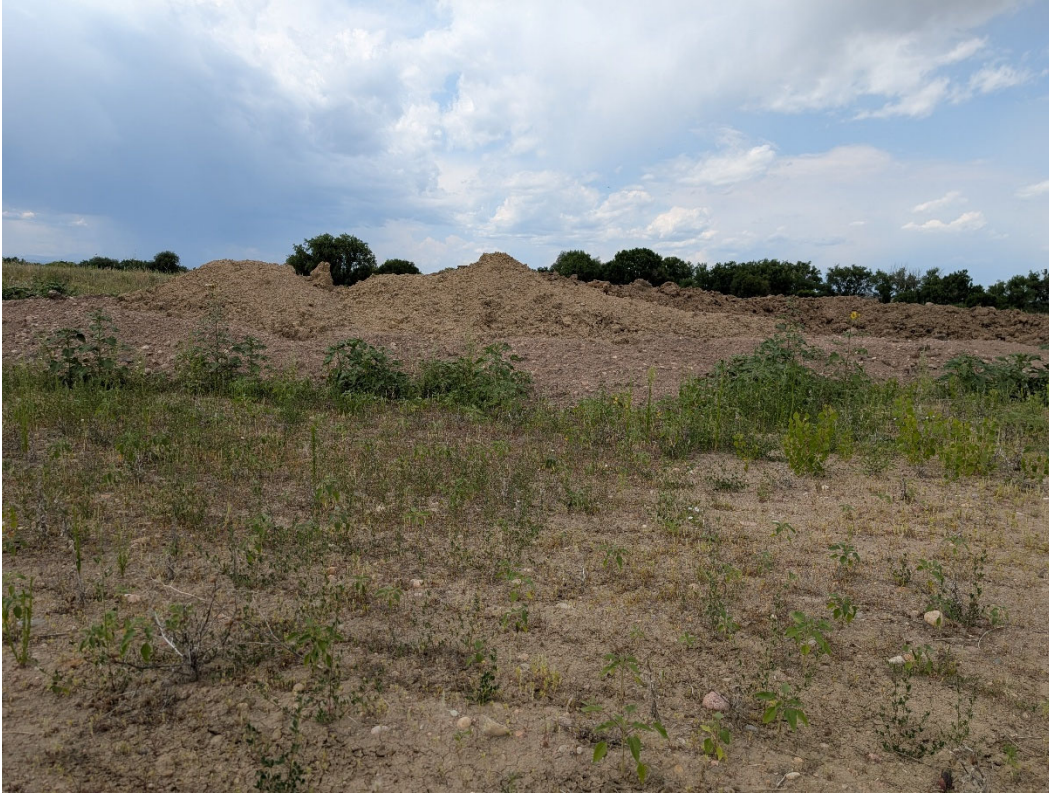
ASCI began backfilling a 10-acre open groundwater pond in the northeast corner in the summer of 2022 to reduce its size to 2-acres, in accordance with the approved reclamation plan in Technical Revision 4 approved in July 2022. The pond is proposed to be clay lined. However, on August 30, 2022, the landowner obtained a cease-and-desist notice citing issues over water rights for the pond. According to Mr. Geras, ongoing litigation regarding the pond must be resolved before ASCI can complete the reclamation plan or ASCI will be required to submit a Technical Revision for any changes to the final reclamation plan.

Photo 7: Looking at the area that was backfilled in 2022 adjacent to the neighbors land. Stockpiles of material to use for backfilling and lining remain in this area.

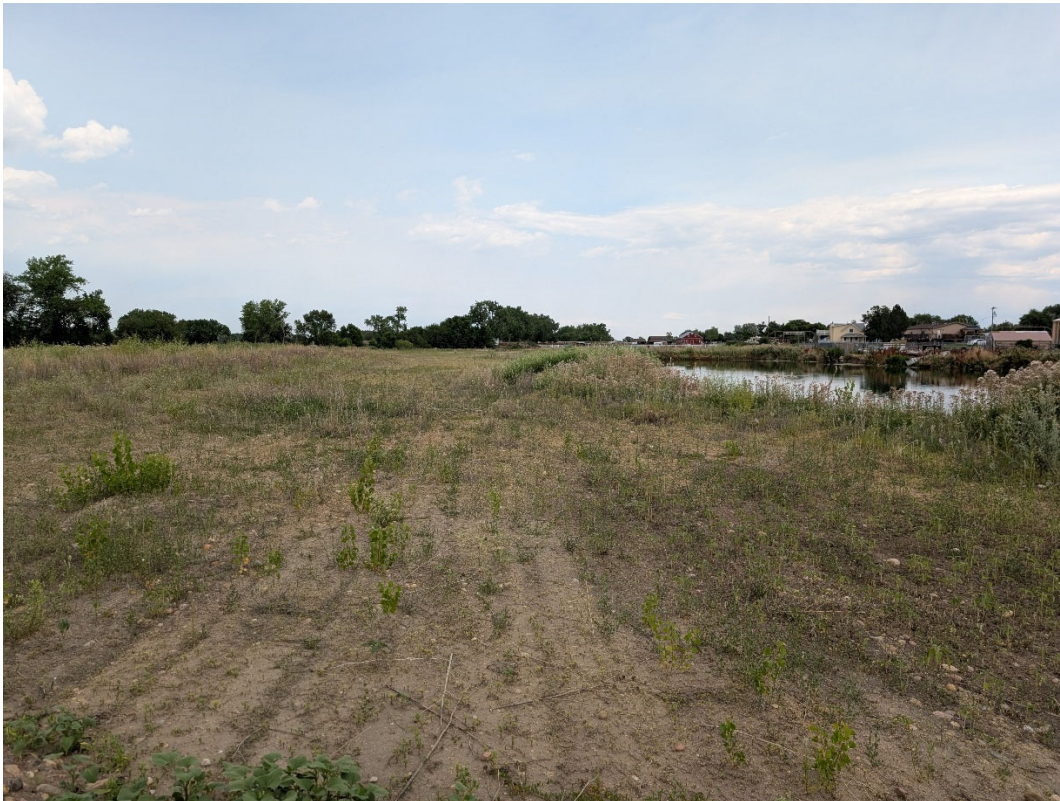
Photo 8: Looking at the area adjacent to the pond on ASCI's property.

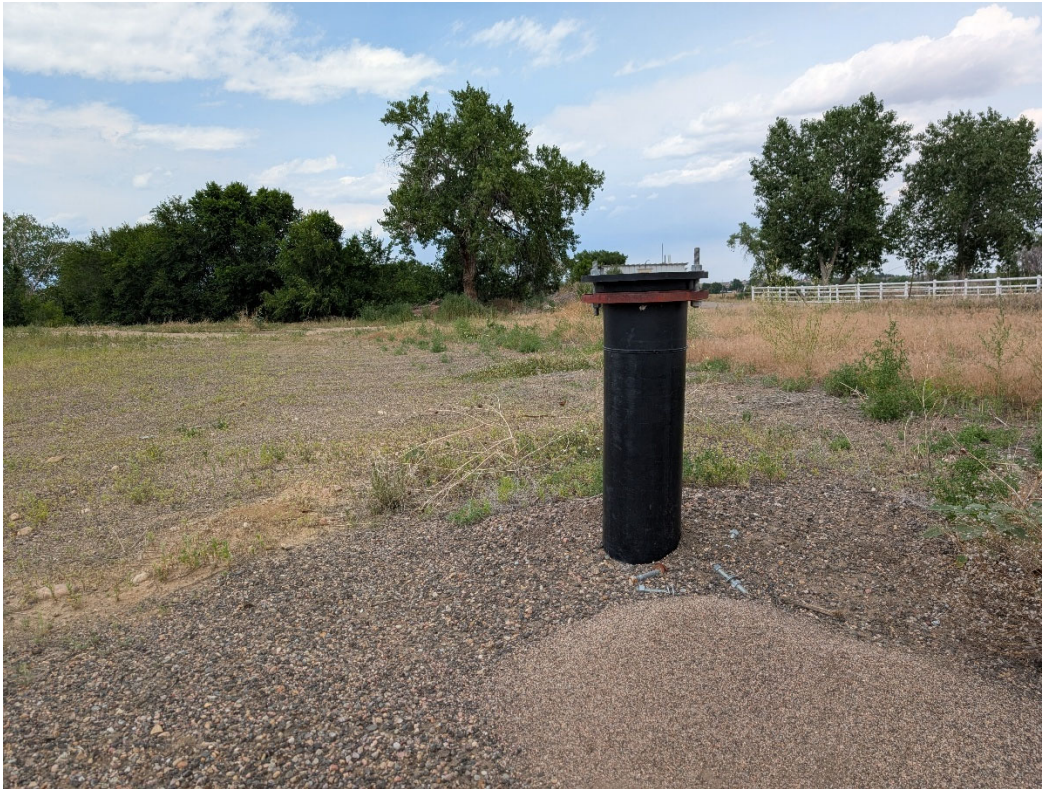
observed the standpipe and outlet discharge point on the north end of the permit area. Water was flowing from the French drain into the South Platte River and a water was observed in the unlined pond. The French drain around the pond is still incomplete, pending resolution of the lawsuit with the landowner. Mr. Geras confirmed the French drain receives regular clean out maintenance.

Photo 9: Looking at the standpipe for the Phase 1 French drain on the north end of the permit area. This end of the permit area has not been topsoiled or seeded.

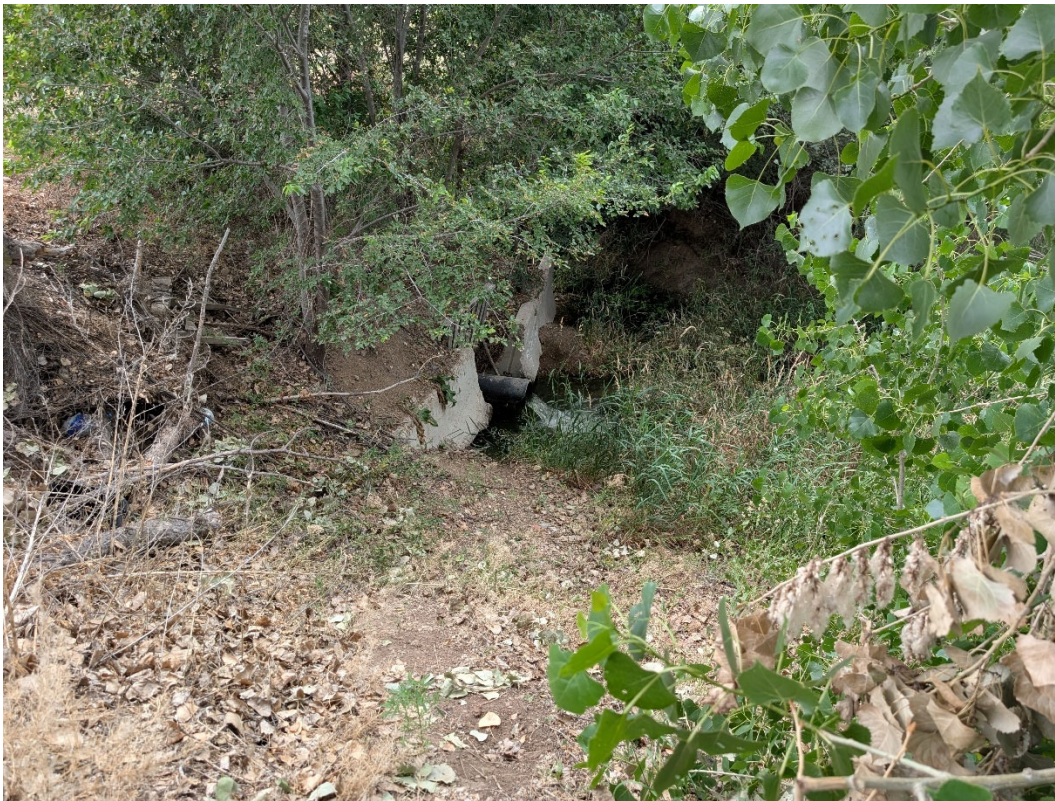
Photo 10: Looking at the outlet for the French drain adjacent to the South Platte River in the northwest corner of the permit area.

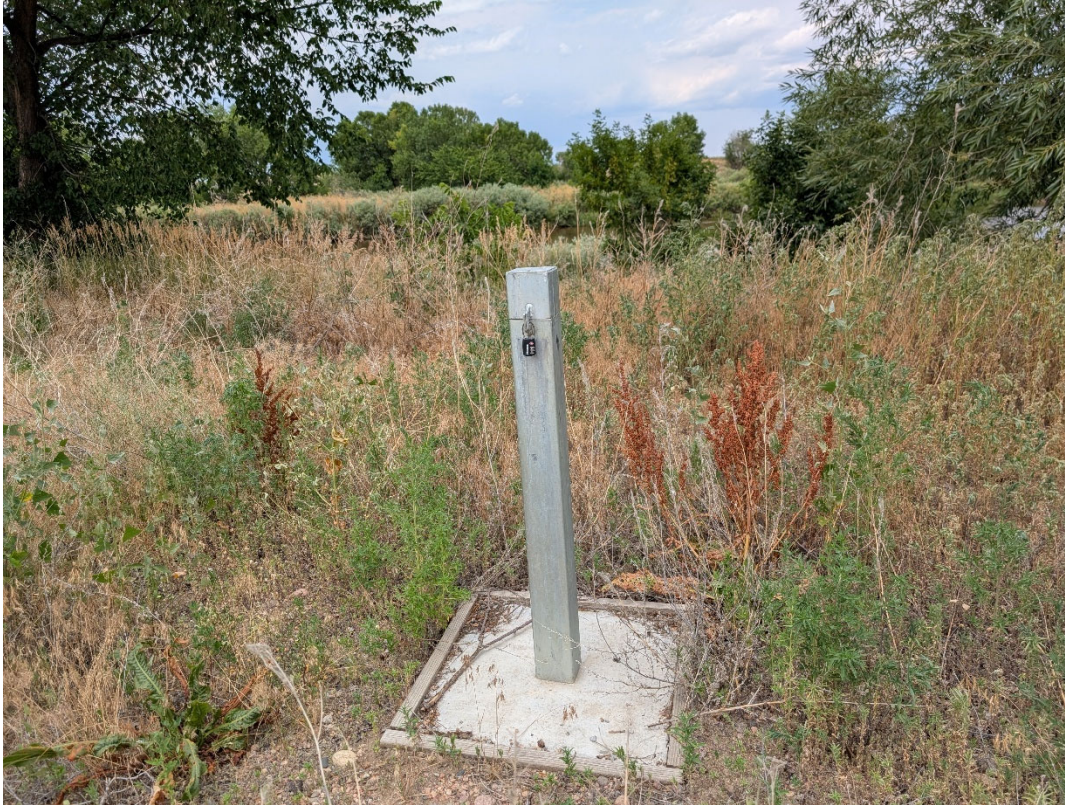
Photo 11: Looking at a monitoring well in the northern end of the permit area, adjacent to the South Platte River.

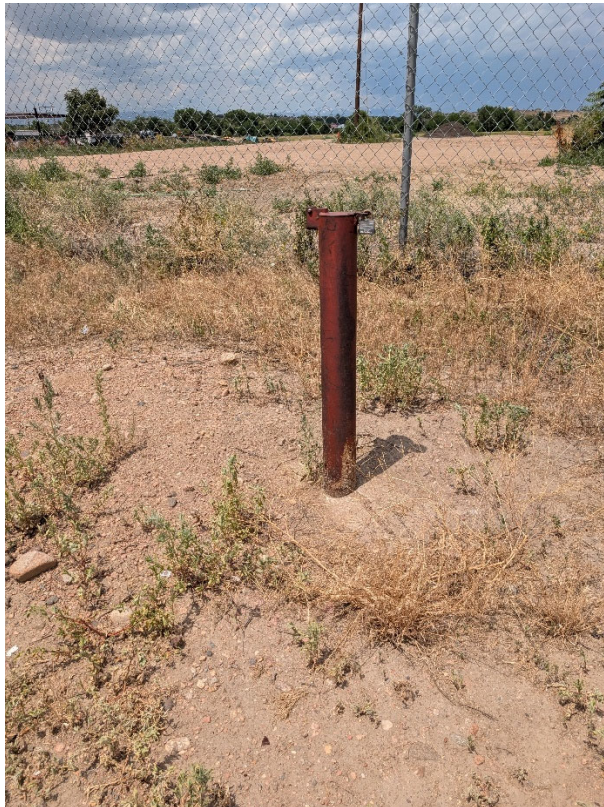
Photo 12: Looking at a monitoring well in the southeast end of the permit area.

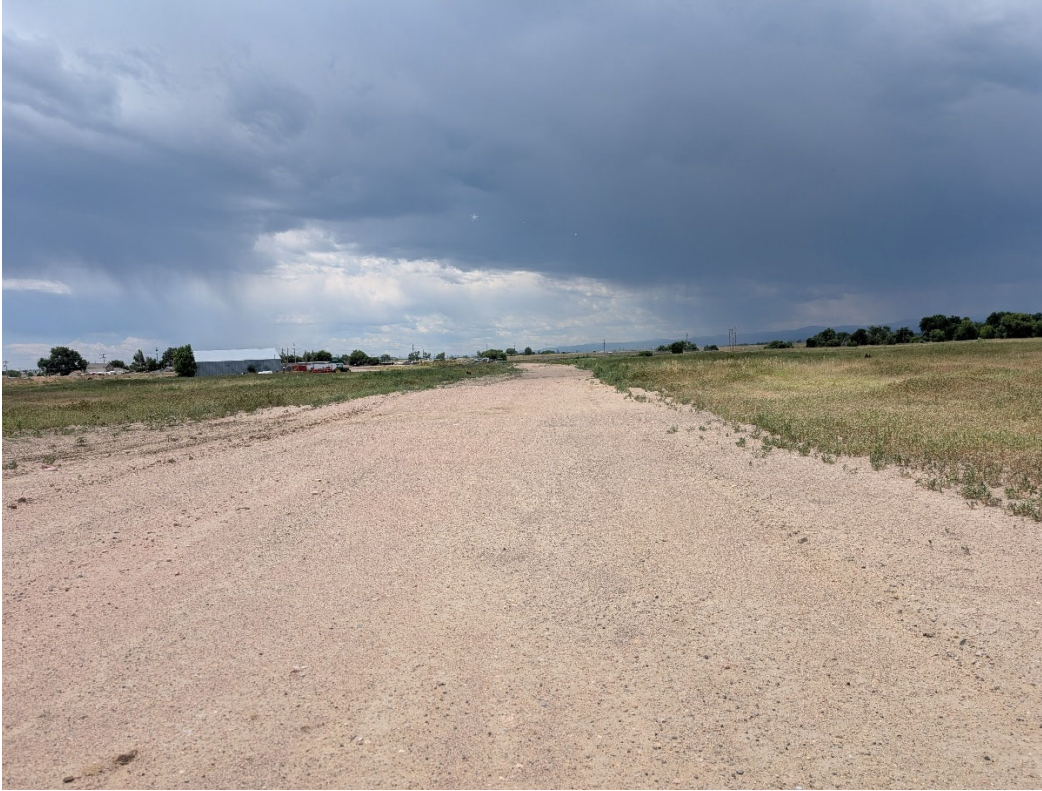
Photo 13: Looking south at the access road that runs through the center of the site.

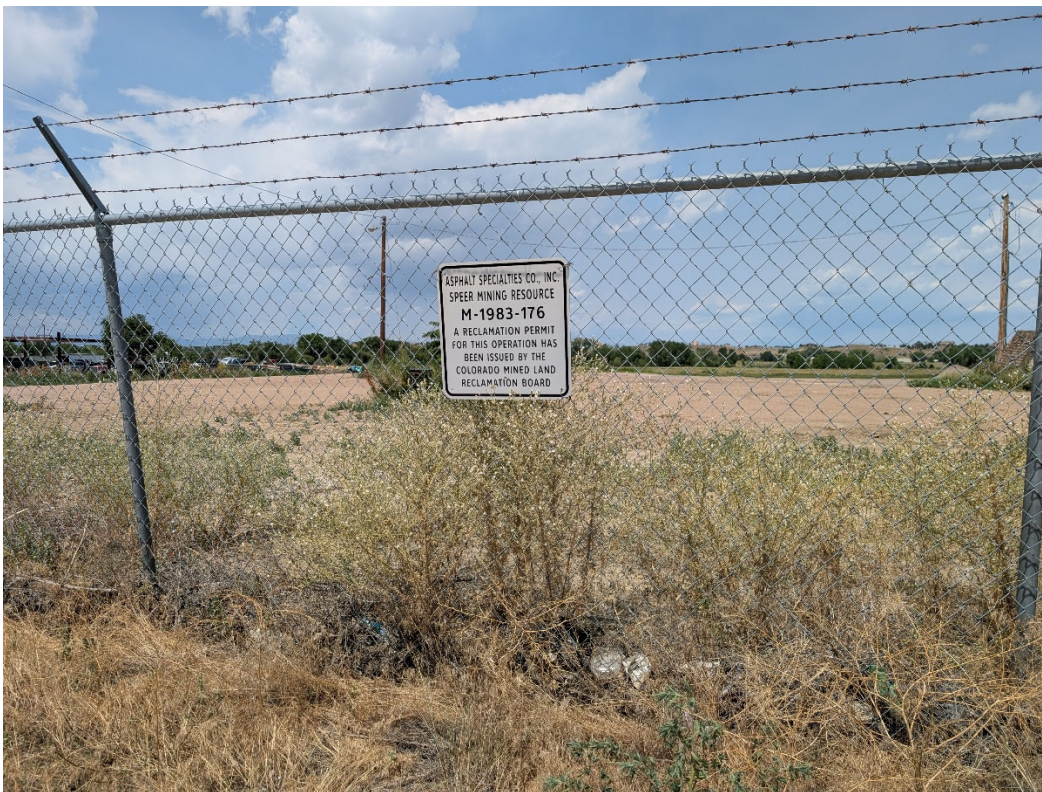
A mine sign was posted at the mine entrance pursuant to Rule 3.1.12. Fencing and t-posts mark the boundaries.

Photo 14: Looking at the mine sign posted at the entrance to the site.
