Division of Reclamation,  
Mining and Safety

### PERMIT INFORMATION

| <b>Permit Number:</b> C-1996-084<br><b>Mine Name:</b> Lorencito Canyon Mine<br><b>Operator:</b> New Elk Coal Company, LLC<br><b>Operator Address:</b><br>12250 Highway 12<br>Weston, CO 81091 | <b>County:</b> Las Animas<br><b>Operation Type:</b> Surface<br><b>Permit Status:</b> Suspended<br><b>Ownership:</b> Private |

### INSPECTION INFORMATION

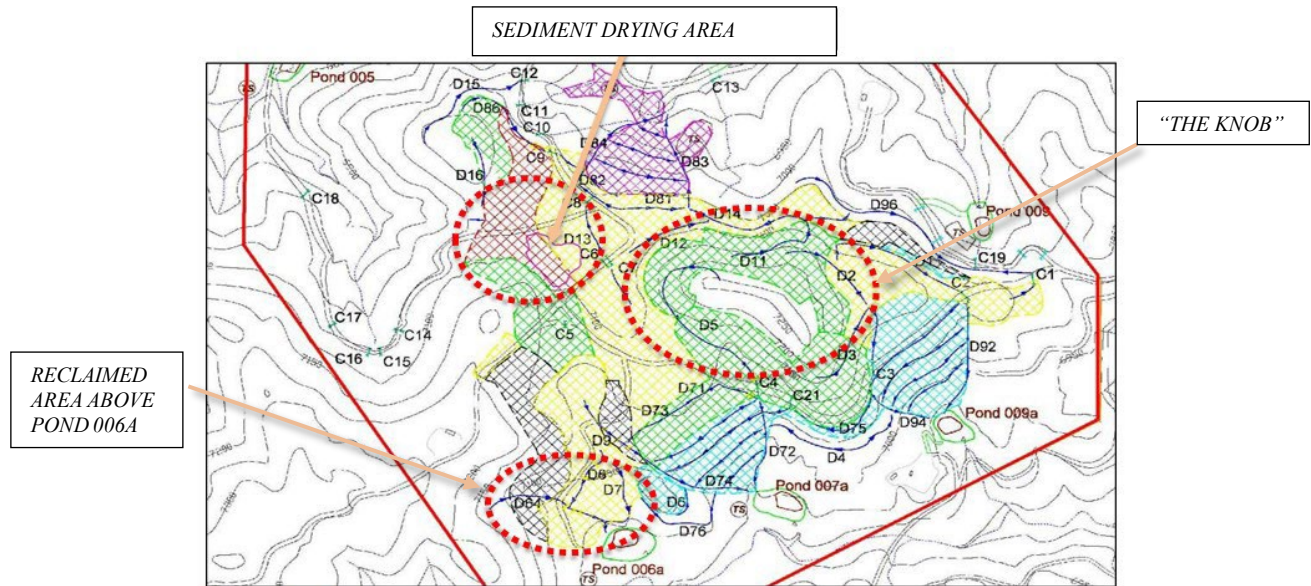
- **OMI:** (January 2024 report) Many erosional rills and gullies have formed in the areas shown in Figure 1, that pursuant to Rule 4.14.6 need to be addressed. A Technical Revision will be required to expand on the current Rill and Gully plan in the PAP. **The Operator shall submit the technical revision, obtain approval, repair the erosion, and stabilize the slopes pursuant to the approved plan.**

FIGURE 1. AREAS WHERE RILLS, GULLIES AND SPARSE VEGETATION HAS BEEN FOUND TO BE A PERSISTENT PROBLEM AT THE SITE ARE WITHIN THE DOTTED CIRCLE AREAS. BACKGROUND IMAGE IS THE 2020 ANNUAL REPORT MAP.

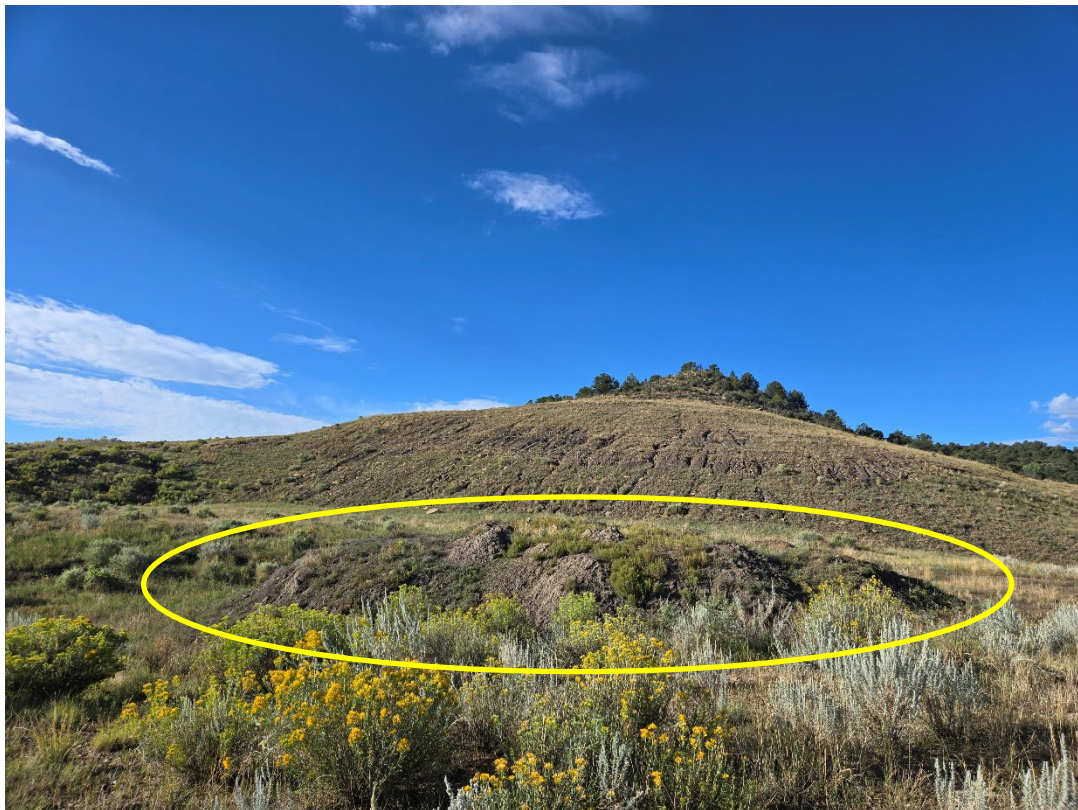
Photo 1: Looking south at the north-facing side of the reclaimed area above the sediment drying pile. The sediment drying area is shown within the circle.

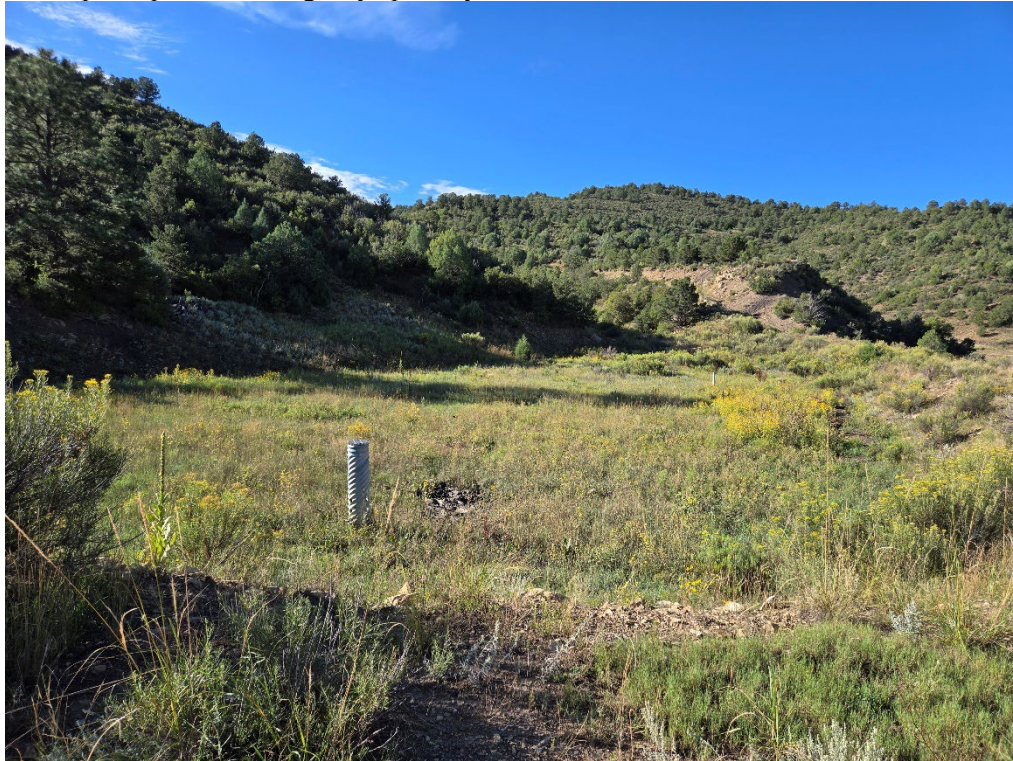
- Pond 005
  - Pond 005 was dry at the time of the inspection.
  - The flume contained water but was not discharging.
  - The pond banks were stable.
  - The principal and emergency spillways were clear.

Photo 2: Pond 005

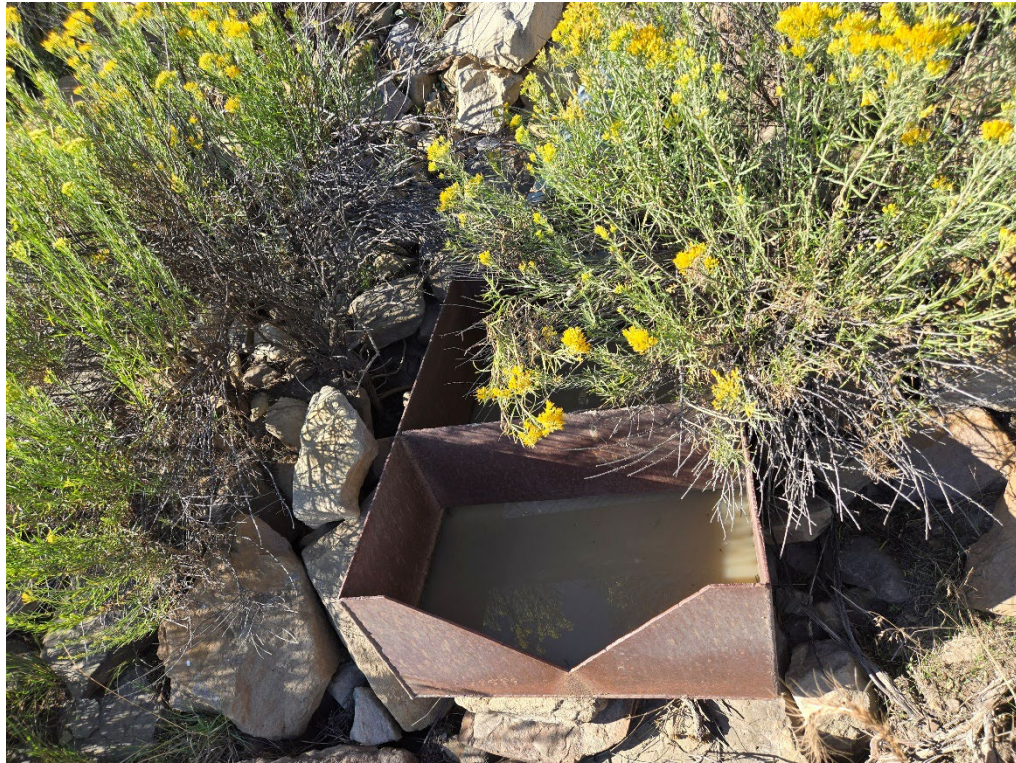
*Photo 3: Flume for Pond 005*

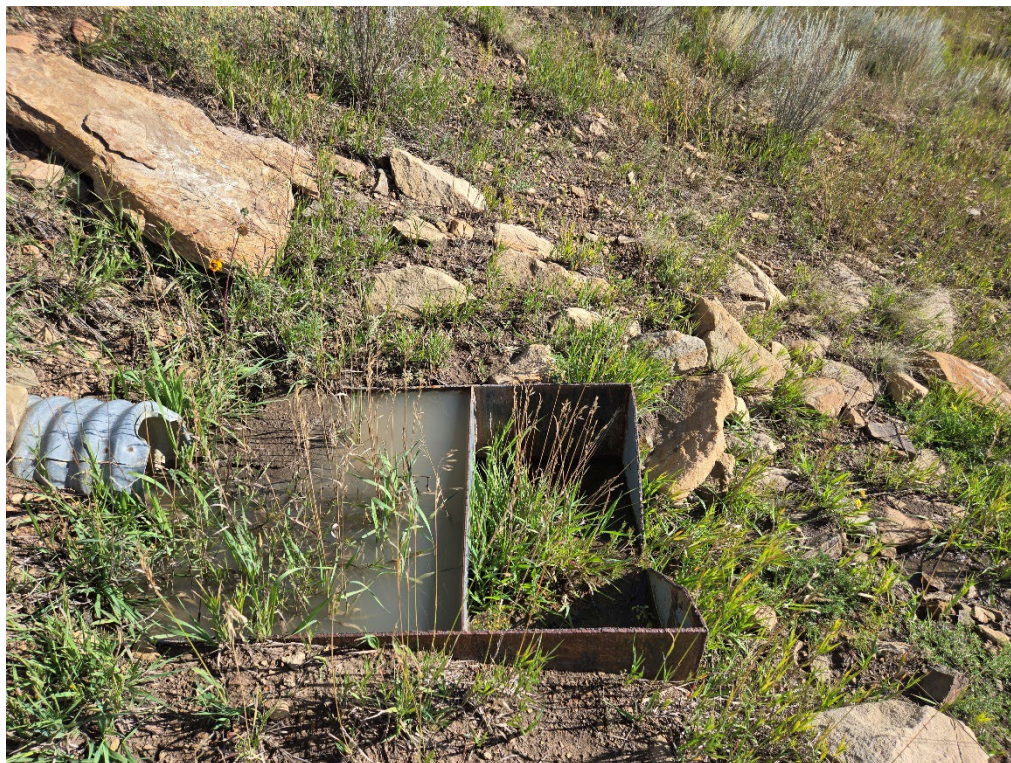
- Pond 006a:
  - Pond 006a contained water at the time of the inspection. The principal and emergency spillways were clear. The flume contained water and was slowly discharging.

- **OMI:** (October 2024 report) Pond 006a - Sediment has built up within the upper portion of the flume. **The Operator shall clean the flume of sediment and vegetation to ensure it functions properly.**

*Photo 4: Flume for Pond 006a*

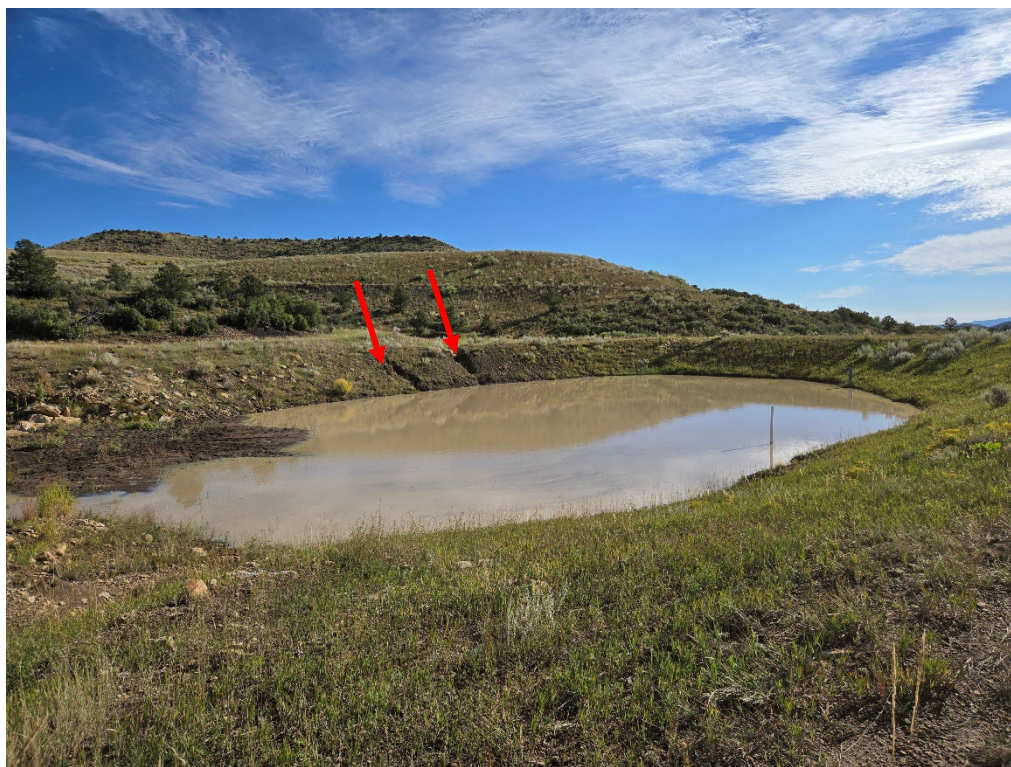
- **OMI:** (January 2024) Erosion rills are forming on the north and west banks of Pond 006a. The erosion on the north bank appears to have been addressed at some point, because rebar is placed above the rills. However, it appears that the prior BMPs are no longer functioning adequately. **Pursuant to Rule 4.05.5(1)(c), the Operator shall address the erosion and repair the north bank.** The erosion on the west bank appears to have been caused by runoff from the road located east of Pond 006a. **Pursuant to Rule 4.05.5(1)(c), the Operator shall address the erosion and repair the west bank.**

*Photo 5: Looking northeast at Pond 006a. The arrow points to the erosion on the north bank.*

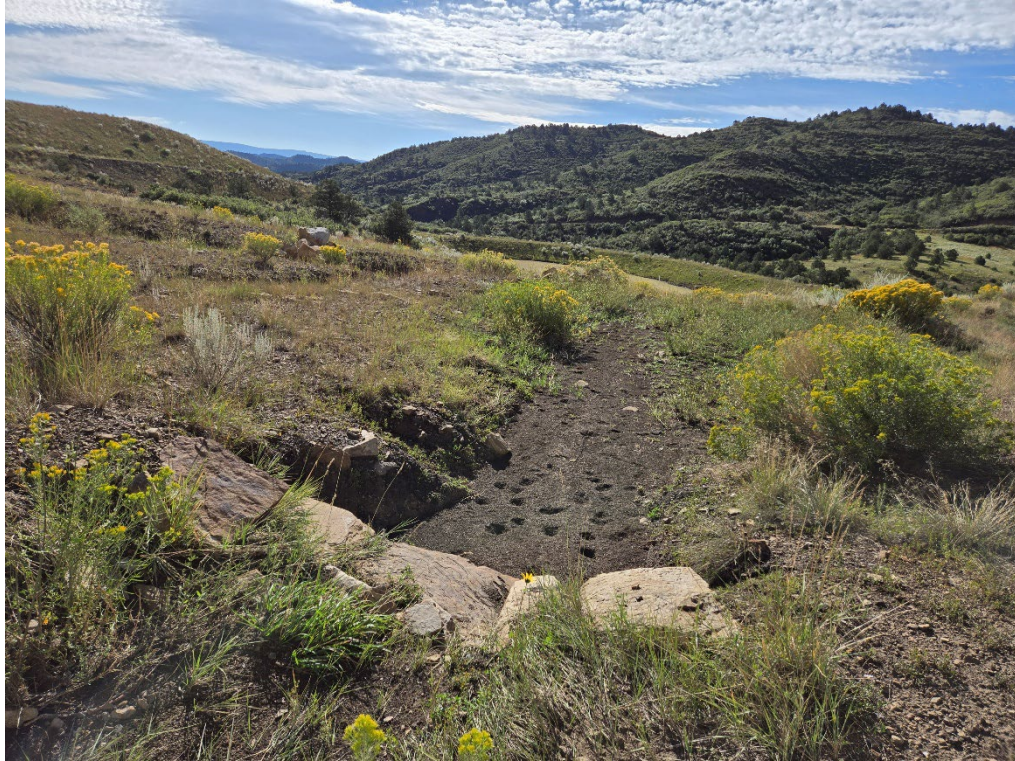
- **OMI:** (February 2024) The check dams leading to Pond 006a, within ditches D8 and D64, are nearly full of sediment. **Pursuant to Rules 4.05.3(1)(c)-(e) and 4.05.5, the Operator shall clean out the sediment from the check dams to prevent excess sediment from entering the pond.**

Photo 6: Full check-dams within ditch D8.

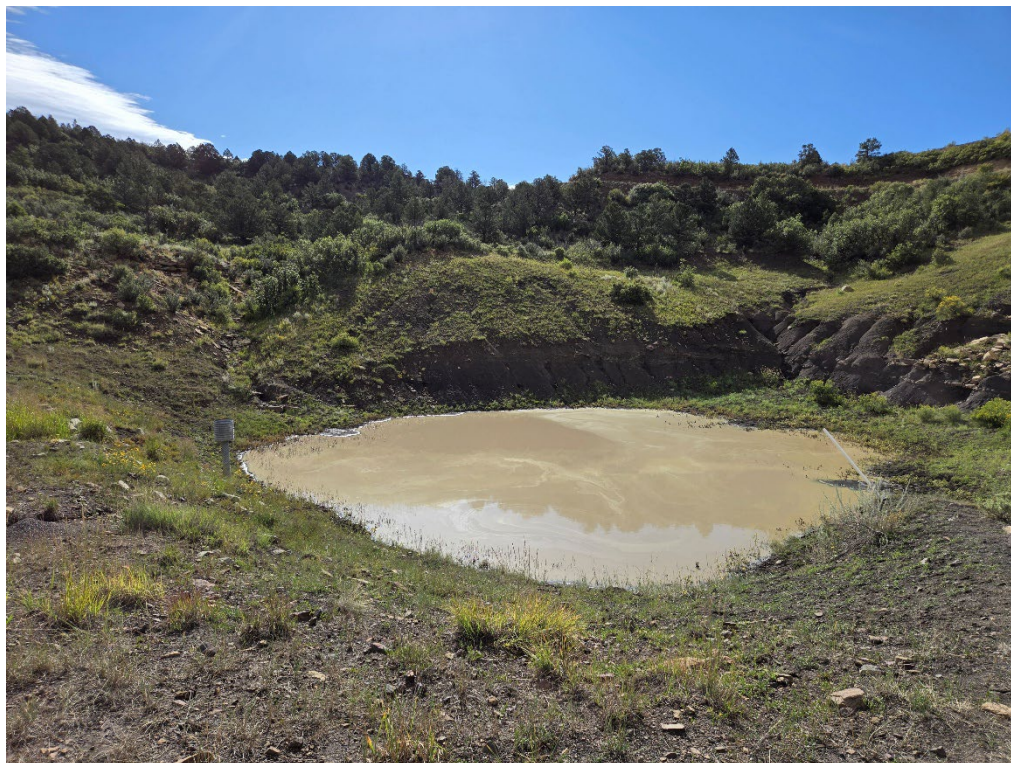
- Pond 009:
  - Pond 009 contained water at the time of the inspection. The principal and emergency spillways were clear.
  - **OMI:** (September 2024 report) The rills above the bank do not appear to have worsened, but the **Operator shall continue to monitor this area.**

*Photo 7: Pond 009*

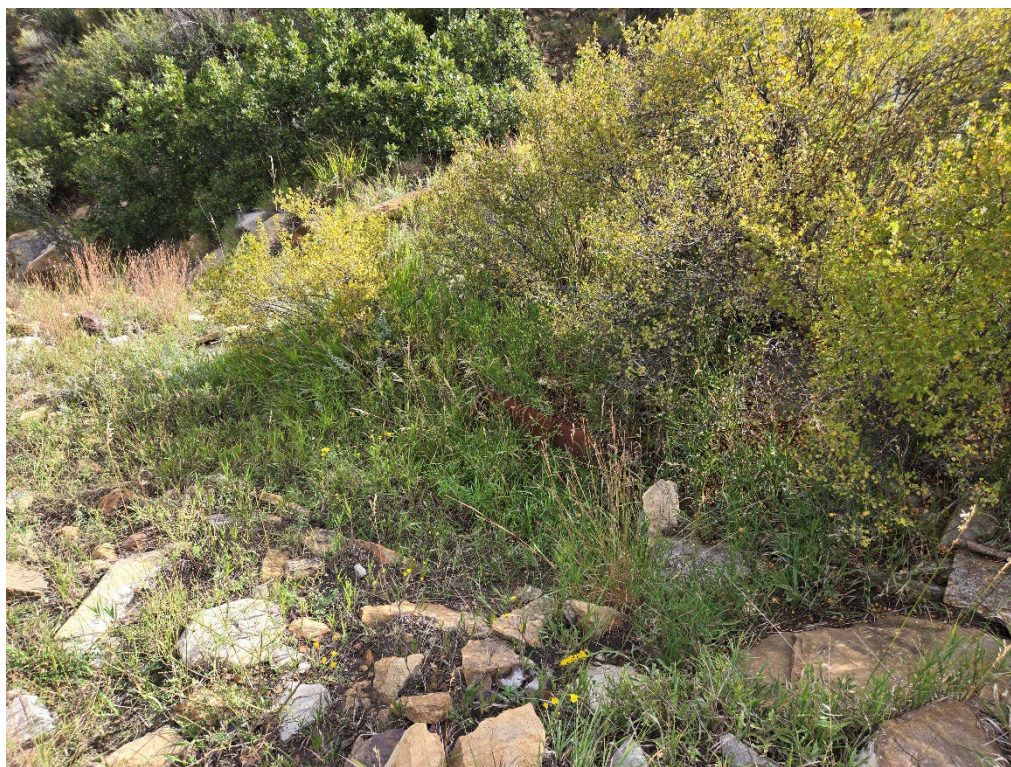
- **OMI:** (November 2024 report) Some vegetation has grown over and into the flume. The **Operator shall clear the excess plant material in the flume.**

*Photo 8: Flume for Pond 009*

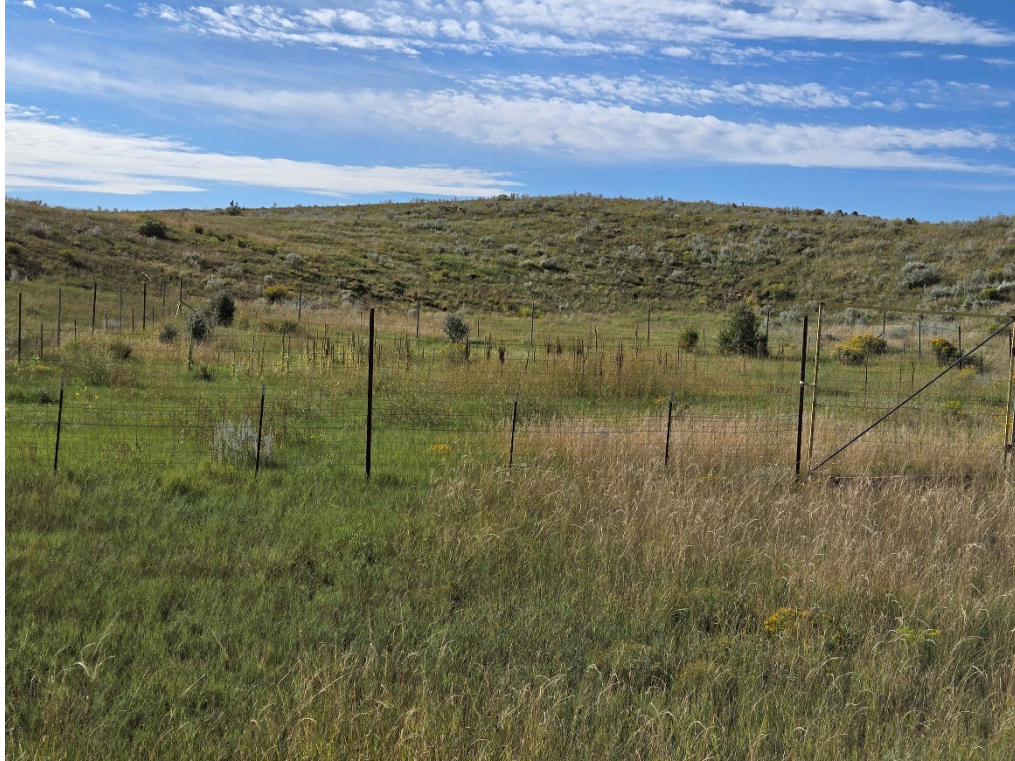
- **OMI:** (August 2024 report) The state listed noxious weed, Mullein, was observed:
  - by the Pond 005 spillway. **The Operator shall treat and/or remove Mullein in this area.**
  - in the field to the south and west of Pond 007a, within the permit boundary. **The Operator shall treat/remove Mullein within this area.**
  - along the west bank of Pond 008 where some of it was treated by the Operator during the June inspection. However, more weeds were observed during the August inspection. **The Operator shall treat/remove Mullein within this area**
  - in an area designated as a vegetation test plot. **The Operator shall treat and/or remove the Mullein within this area.**

*Photo 9: Mullein observed within the test plot south of "The Knob".*

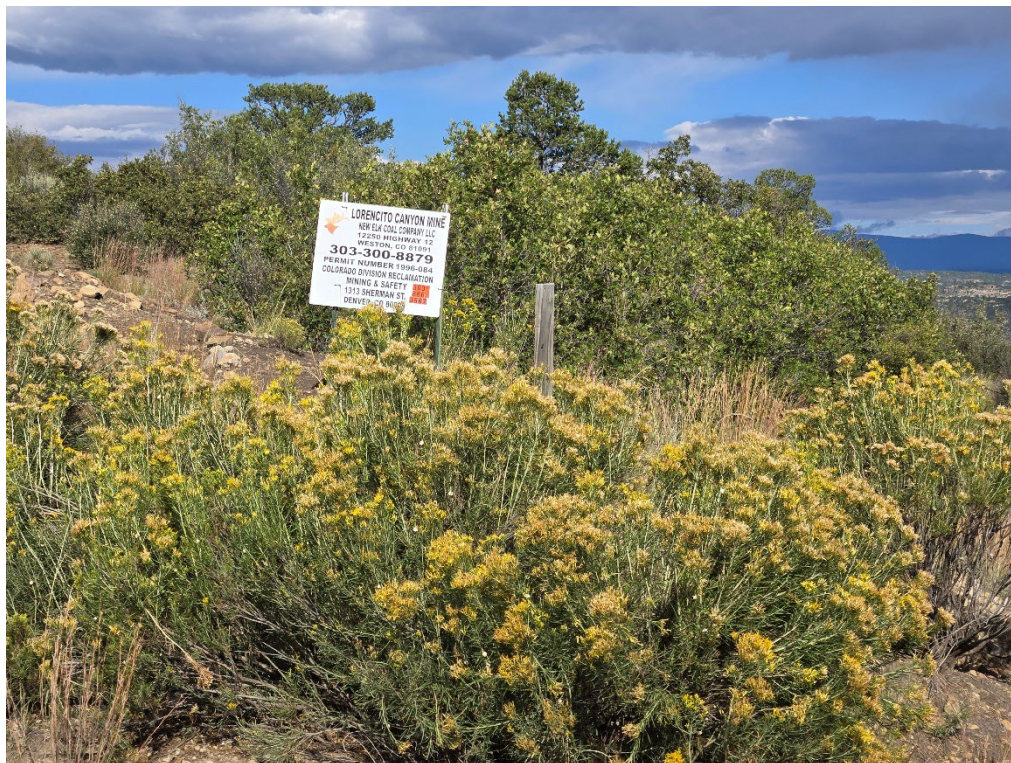
- Mine signs were posted at road entrances and at the entrance to the permit boundary in compliance with Rule 4.02.

*Photo 10: Mine sign posted at the permit boundary.*
