**PERMIT INFORMATION**

| <b>Permit Number:</b> C-1981-018<br><b>Mine Name:</b> Deserado Mine<br><b>Operator:</b> Blue Mountain Energy, Inc<br><b>Operator Address:</b><br>Mr Kurtis Blunt<br>3607 County Road 65<br>Rangely, CO, 81648 | <b>County:</b> Moffat, Rio Blanco<br><b>Operation Type:</b> Underground<br><b>Permit Status:</b> Active<br><b>Ownership:</b> Private |

| <b>Inspection Start Date:</b> September 10, 2025<br><b>Inspection Start Time:</b> 10:00<br><b>Inspection End Date:</b> September 10, 2025<br><b>Inspection End Time:</b> 14:00 | | <b>Inspection Type:</b> Coal Complete Inspection<br><b>Inspection Reason:</b> OSM Oversight Inspection<br><b>Weather:</b> Clear | |

This report documents the observations made by the Division during a complete inspection of the Deserado Mine on September 10, 2025. This inspection was an oversight inspection by OSM. The inspection was completed by Todd Jesse of the Division and Clayton Wien of the Division was also present. Daniel Mackinnon conducted the oversight inspection for OSM. Kurt Blunt represented Blue Mountain Energy during the inspection. The weather was mostly sunny with a temperature around 70 degrees F. The ground conditions we

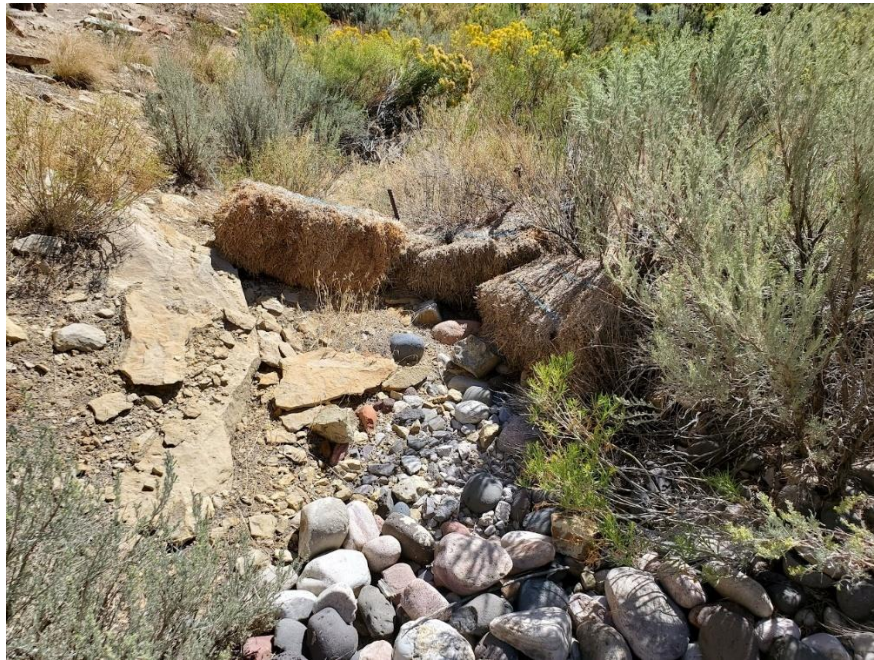
The explosives storage area for the Deserado Mine is located at the southern end of the main facilities area. The storage consists of a pad with a storage bunker for the explosives. The cut and fill slope of the pad was stable with no erosional features. Runoff from the pad is directed to an outlet at the southern end of the pad and

passes down a channel through straw bales. The bales appear to be in good condition and functioning as designed (Photo 1).

Photo 1: View to the east of explosive pad drainage.

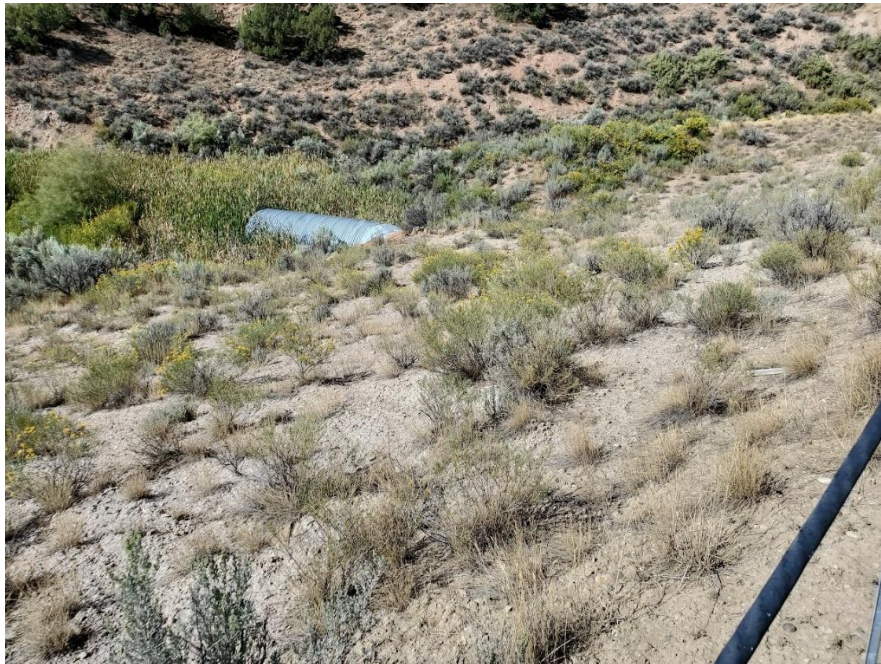
There are three ponds located in the main facilities area: the DP-1 Pond, the PP-1 Pond and the PP-2 Pond. The DP-1 Pond is located on the southern part of the lower facilities bench. DP-1 collects all runoff from the from the three facilities benches. The outlet structure was clear of debris and the pond was discharging at the time of inspection. The embankments appear stable with well-established vegetative cover (Photo 2). The emergency spillway has minor amounts of vegetation but still appears to be able to convey water and is well armored. There were no erosional concerns identified. The PP-1 Pond is located on the middle bench of the facilities area near the prep plant. The pond held minor amounts of water and was well below the discharge level (Photo 3). There were no erosion or stability issues identified in the PP-1 Pond. The PP-2 Pond is located on the upper facilities bench. The outlet structure was in good condition with no vegetation obscuring the outlet (Photo 4). No erosion or stability issues were identified on the PP-2 Pond. Water diversion ditches throughout the main facilities area were unobstructed and stable.

Photo 2: View to the southwest of the face of the DP-1 embankment.

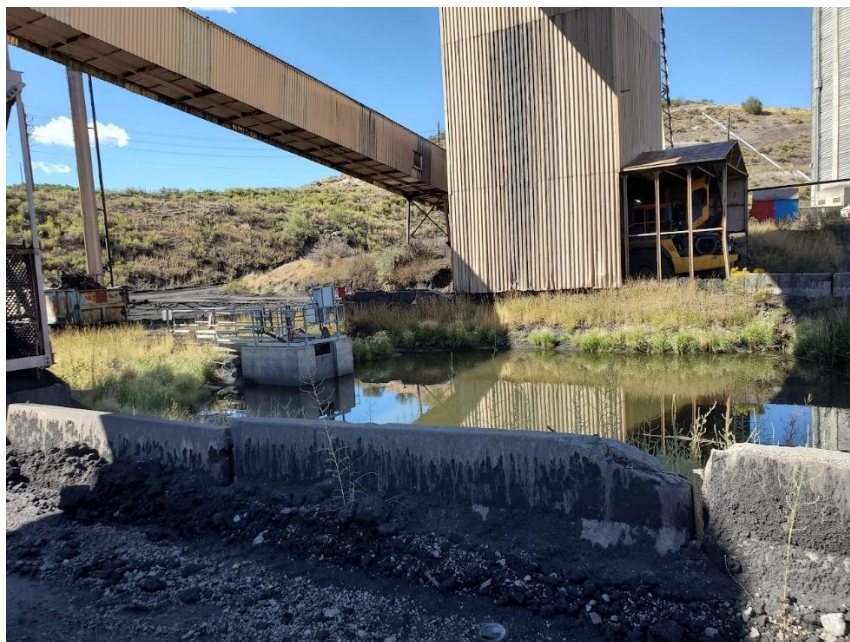
Photo 3: View to the southwest of the PP-1 Pond.

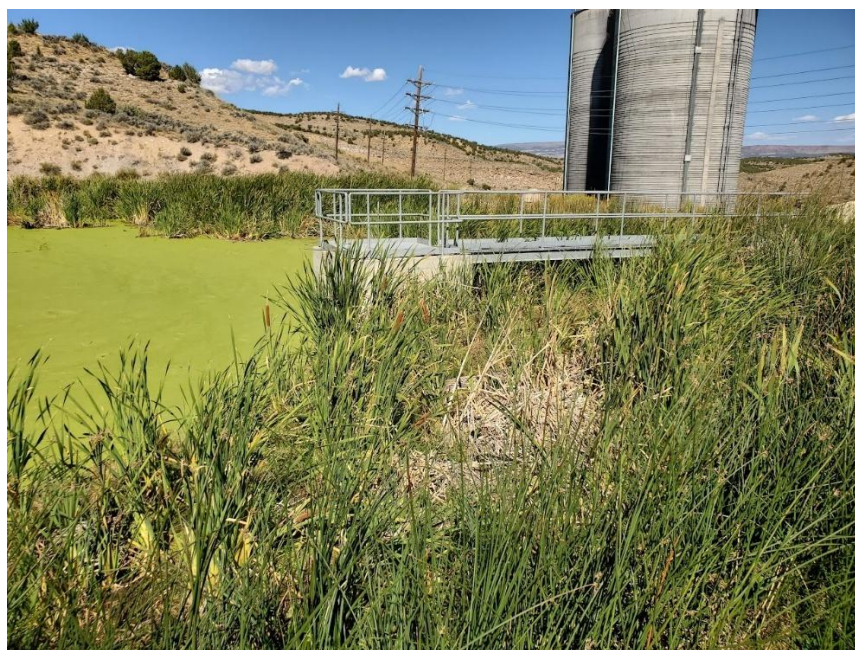
Photo 4: View to the west of outlet structure on PP-2 Pond.

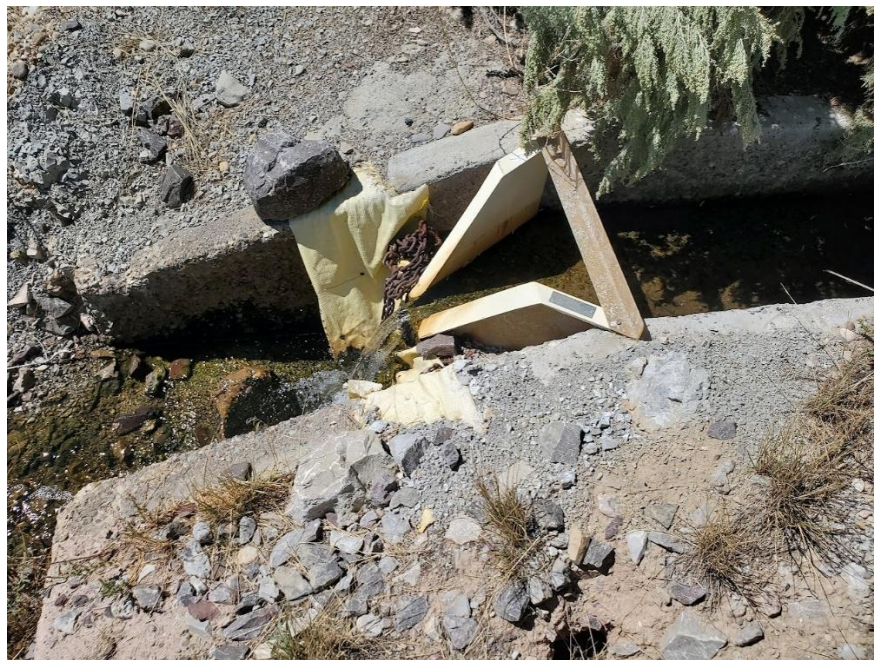
The B Seam Dewatering System No. 1 was active during the inspection. Cells were impounding water. The cells were stable with no erosional or other stability features noted. There was well established vegetation on the embankments of the cells. Vegetation above the discharge point on the Last Chance Pond is thick but does not appear to impair the flow of water and the vegetation is not in the flume. The cells were stable with no erosional or other stability features noted. The Last Chance Pond was discharging approximately 15 gpm at the time of the inspection (Photo 5).

Photo 5: View to the south of the discharge at Last Chance Pond.

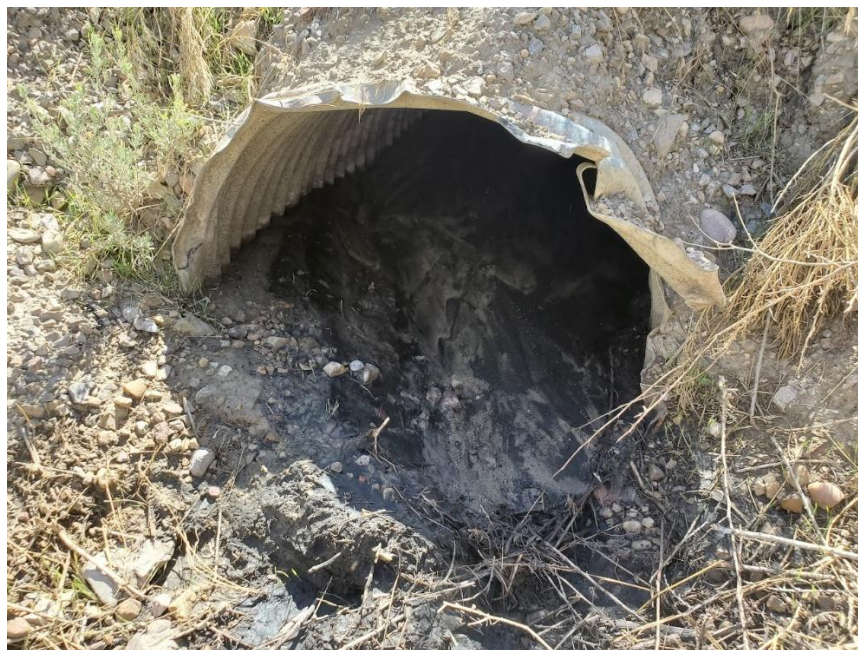
The SS-2 and SS-1 Ponds are located to the north of the Slot Storage Facility. The SS-2 Pond is located at the northwestern base of the Slot Storage Facility. The pond was dry at the time of the inspection. The embankments of the pond were well vegetated and stable with no indications of erosion. The SS-1 is located at the northeastern base of the slot storage. The pond was dry at the time of the inspection. **The culvert above the pond that conveys water under the road has partially filled with sediment (Photo 6). Please remove the sediment that has accumulated in the culvert.**

Photo 6: View to the south of the partially filled culvert above the SS-1 Pond.

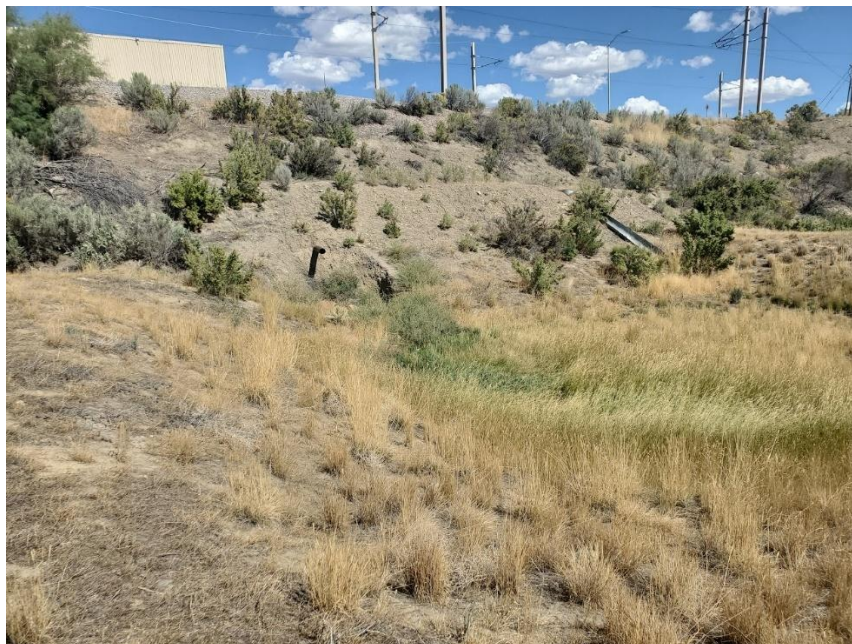
The RS-1 Sump and the RR-1 Pond are located at the south side of the Rail Loadout. The RS-1 Sump was dry. There were no indications of erosion around the sump. The RR-1 Pond was dry. The embankments of the pond seem stable. The erosion feature on the northern embankment that has been noted in previous inspection reports

does not appear to have grown in size (Photo 7). The Rail Loadout Storage South Ditch has vegetation debris but does not appear obstructed and is able to convey water.

Photo 7: View to the north of the erosion scar in the RR-1 Pond.

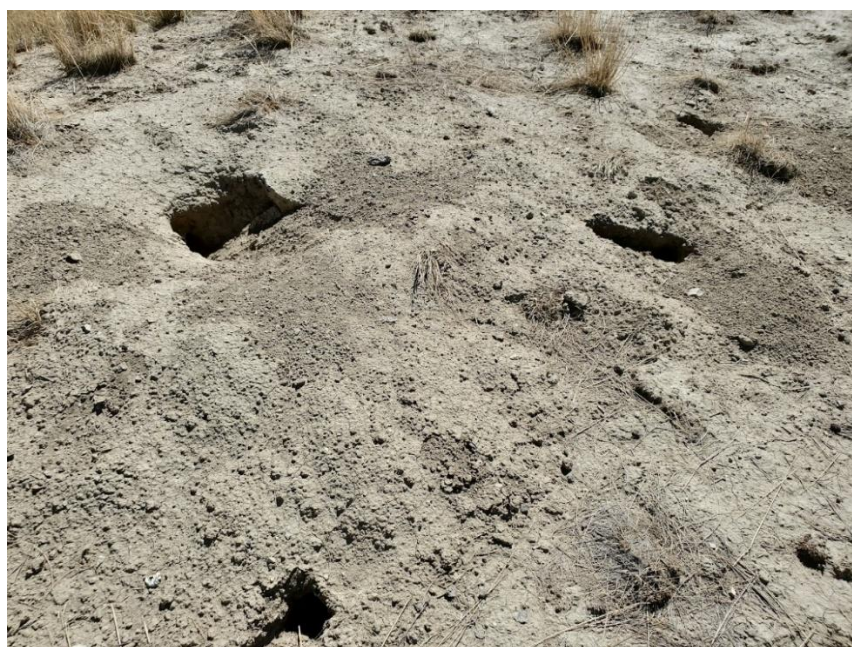
Two ponds are located at the northern base of Refuse Pile RP-2/3/4. The RP -2/3 Pond is located on the pile's northeast corner and was not inspected. The RP-4 Pond is located at the northwest base of the pile. The pond was dry during the inspection. The outlet for the RP-4 Pond is capped with a trash rack. The outlet was clear of debris. Animal burrows were in the embankments of the RP-4 Pond (Photo 8) and were filled during the inspection. Channels above the pond appear free of obstruction and able to convey water.

Photo 8: View to the south of animal burrows in the RP-4 Pond embankment.

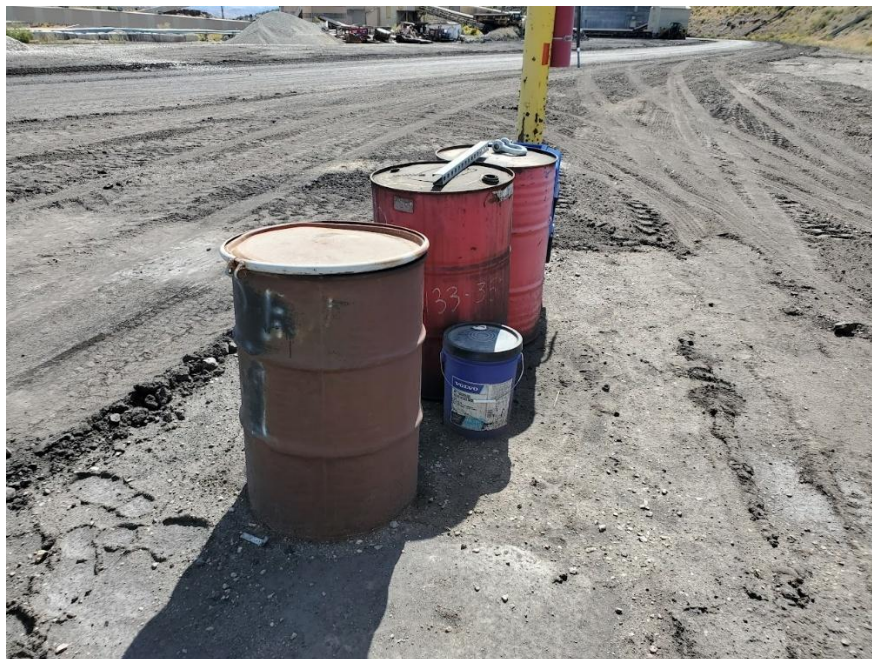
Fuel is stored in double walled tanks near the haul road leaving the facilities area. The fuel is stored in a bermed secondary containment area. There is a secondary containment sump around the couplings to refuel the tanks. Minor amounts of meteoric water were in the containment sump. **Bad fuel is stored in barrels next to the gas pumps outside of containment (Photo 9). Please place the barrels on a spill pallet or move the barrels into a location that has secondary containment.**

Photo 9: View to the southeast of barrels containing hydrocarbons outside of containment.

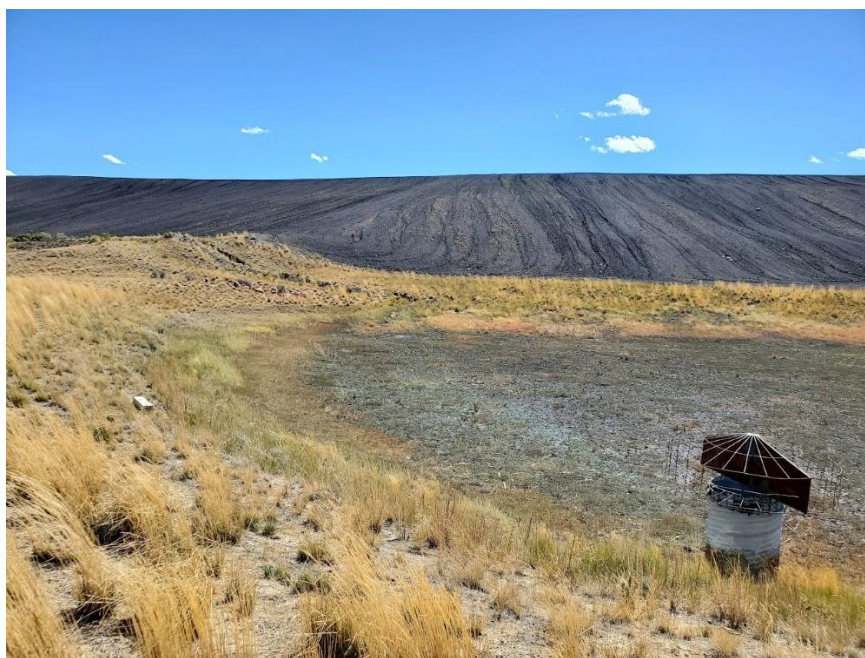
The RP-2/3/4 pile was stable. The operator graded the slopes of the stack to remove erosional rills the spring. Small rills have since reappeared in the slopes of the stack (Photo 10). However, the rills are not significant in size and do not appear to compromise the stability of the slope.

Photo 10: View to the south of the rills on the RP-2/3/4 Refuse Pile

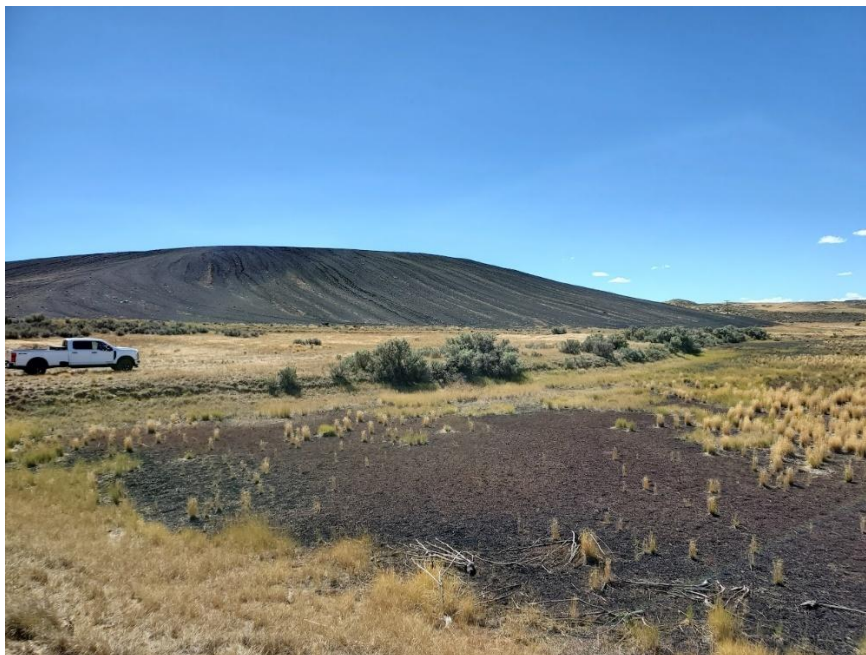
The RP-5a pile appeared stable during the inspection. Similar to the RP-2/3/4 pile, minor rills have appeared on the slopes of the pile since the operator graded in spring (Photo 11). The rills are not significant in size and do not appear to compromise the stability of the slope.

Photo 11: View to the southwest of the rills on the RP-5a Refuse Pile.

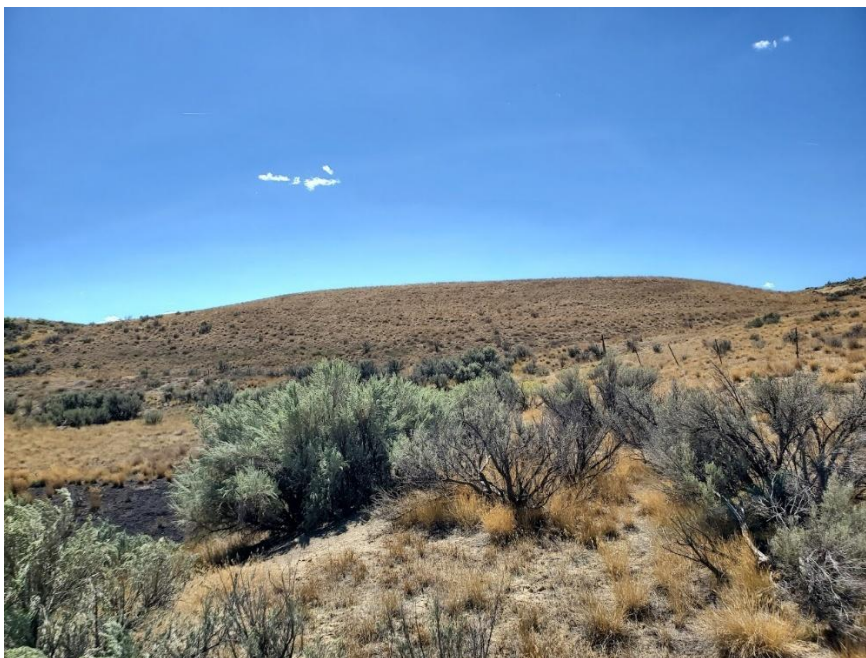
The RP-1 refuse pile has been reclaimed for several years. Vegetation is well established and protects the pile (Photo 12). No indications of instability or erosion were observed. The perimeter ditches appear stable with no erosion concerns.

Photo 12: View to the south of the reclaimed RP-1 Refuse Pile.

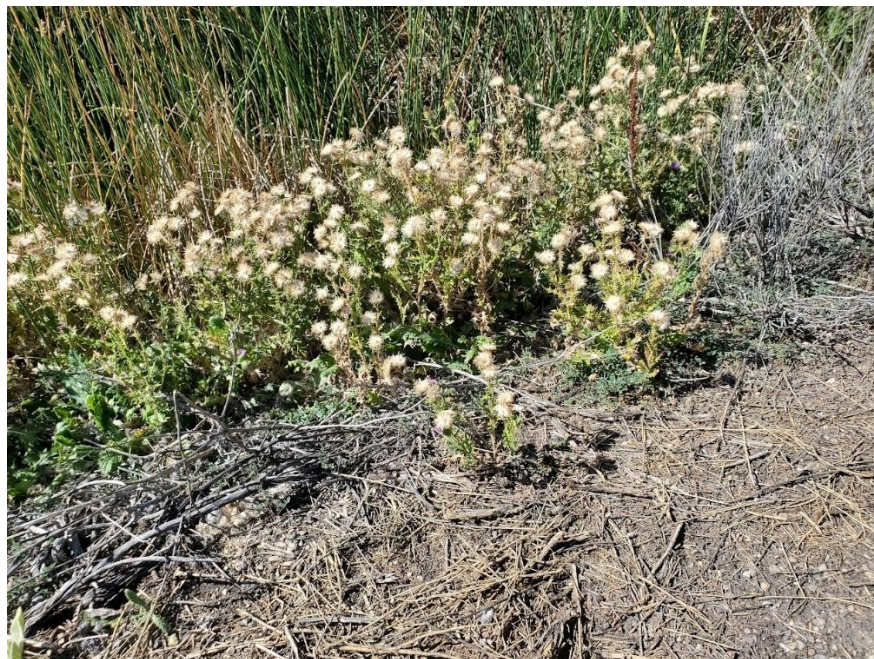
An infestation of thistle was observed around the banks of the PP-2 Pond (Photo 13). **Thistle is a B List Species on the Colorado Noxious Weed List. Please implement weed control methods to prevent the spread of weeds to other areas.**

Photo 13: View to the south of thistle around the PP-2 Pond.

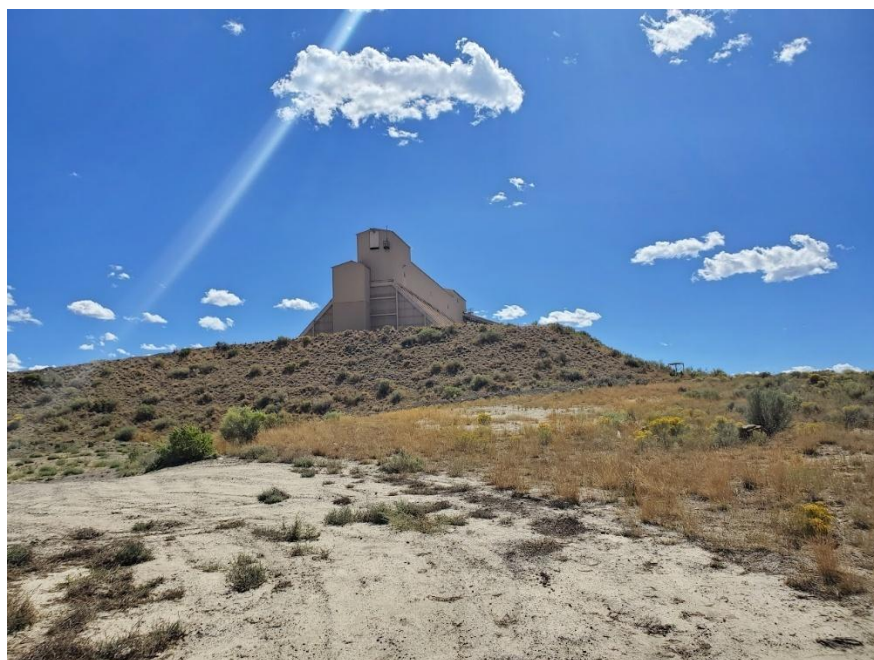
The Slot Storage Facility is located just to the south of the rail loadout. The pad that surrounds the Slot Storage is in good condition with a berm to control erosion. There were no erosional features noted on the embankments below the slot storage building (Photo 14).

Photo 14: View to the south of the slopes below the Slot Storage Facility.

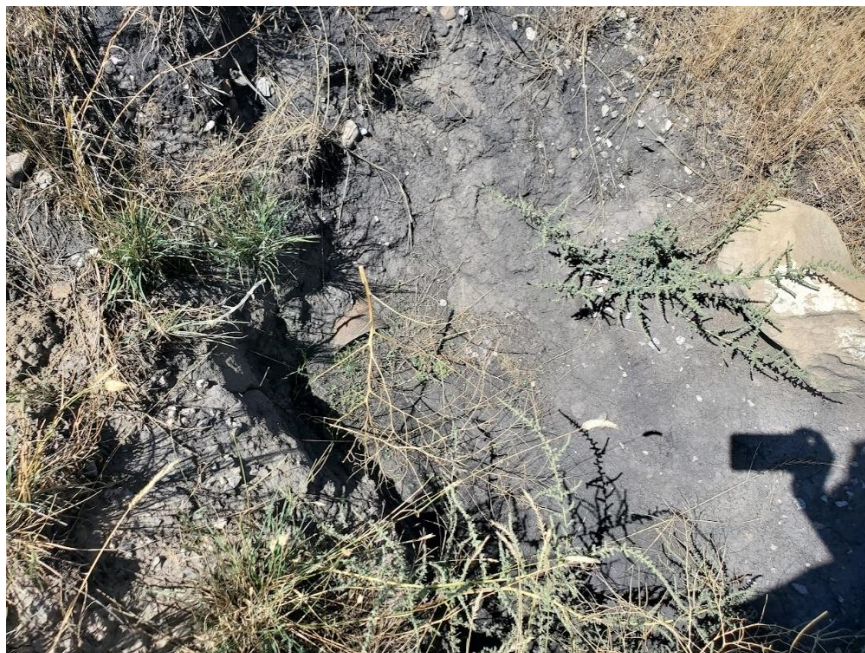
The Nitrogen Injection Plant is located just to the south of the Slot Storage Facility. The pad surrounding the building shows no signs of excessive erosion. **The culvert that conveys water under the access road to the plant is filled with sediment (Photo 15). Please remove the sediment from this culvert.**

Photo 15: View to the south of culvert filled with sediment under the access road to the Nitrogen Injection Plant.

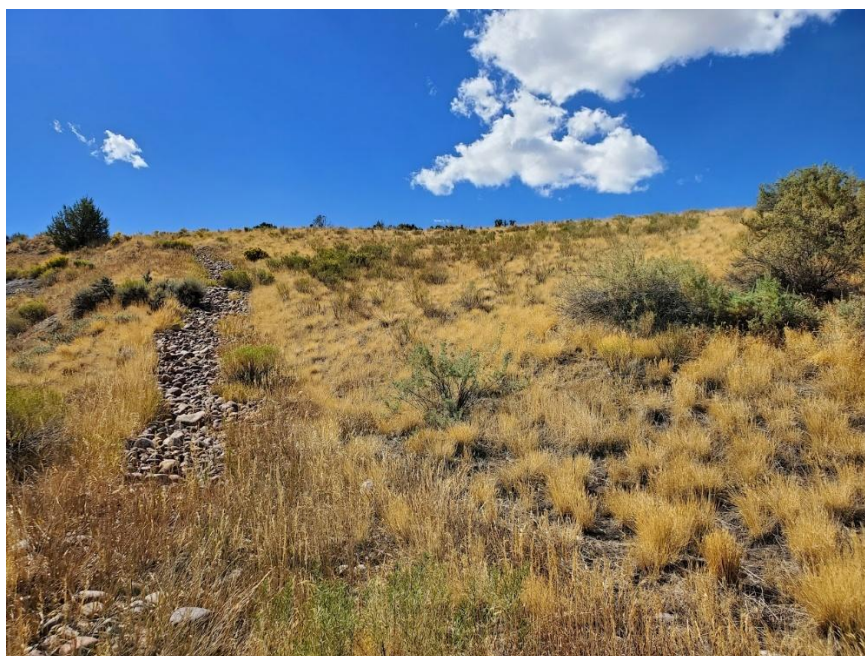
Topsoil stockpiles are located throughout the mine site. Topsoil stockpiles observed during this inspection include the facilities (Photo 16), B-Vent Shaft #1, and rail loop stockpiles. The stockpiles were protected by vegetation and showed no indications of erosion or instability. Topsoil piles that were observed had topsoil markers at the top of the pile. The markers are T-posts covered with pieces of white PVC. The markers were placed in visible locations and easy to spot. The facilities topsoil stockpile has armored channels that direct water. Channels are in good condition and show no signs of erosion.

Photo 16: View to the south of topsoil stockpile in the main facilities area.
