## McClane Canyon Mine, C-1980-004, September Complete Inspection Report

**PERMIT INFORMATION**

**INSPECTION INFORMATION**

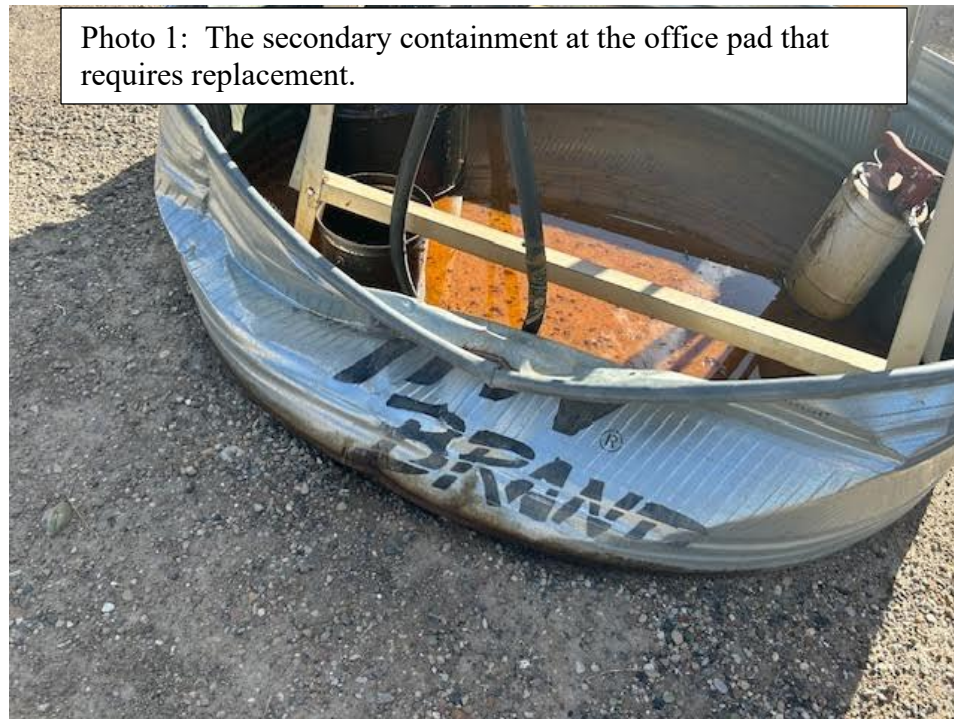
1. The secondary containment structure on the mine office pad requires replacement (Photo 1). The containment structure had been partly crumpled by equipment. The structure was functional with no leaks during the inspection but had reduced containment capacity.
2. The silt fence located at the outlet of the subsoil stockpile needed to be properly anchored (Photo 2). The bottom of the Silt fence was loose, and flow could bypass the fence.
  - The Afternoon of 9/9/2025, Mr. Selingo provided the Division of a photo of the completed maintenance of the subsoil stockpile sump's silt fence (Photo 3).
3. Two barrels stored within the shop needed to be moved to secondary containment.
  - Mr. Selingo moved the barrels into secondary containment during the inspection.

The mine office pad is located on the western portion of the disturbed area and on the east side of East Salt Creek. The pad was well kept and stable. There were no erosional features observed. The berm for the pad was intact and covered with vegetation. Equipment parked on the pad had catch pans observed to be placed underneath them (Photo 17 and 18). There were no contaminants observed on the pad. Hydrocarbons and fuel were stored within secondary containment. The secondary containment structure on the mine office pad requires replacement. The containment structure had been partly crumpled by equipment (Photo 1). The structure was functional with no leaks during the inspection but had reduced containment capacity.
