**MINERALS PROGRAM INSPECTION REPORT**  
**PHONE: (303) 866-3567**

| <b>MINE NAME:</b><br>Morrison Quarry | <b>MINE/PROSPECTING ID#:</b><br>M-1973-021 | <b>MINERAL:</b><br>Granite, granite gneiss | <b>COUNTY:</b><br>Jefferson |
| <b>INSPECTION TYPE:</b><br>Surety-Related Inspection | <b>WEATHER:</b> Clear | <b>INSP. DATE:</b><br>September 19, 2025 | <b>INSP. TIME:</b><br>09:30 |

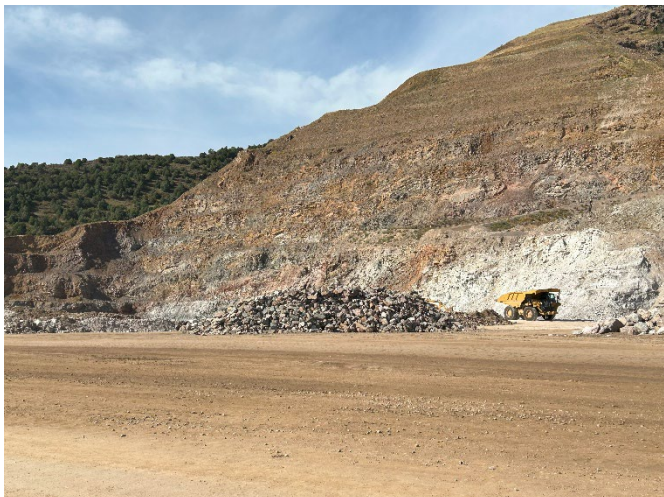
Photo 1: Current material stockpile area near the west quarry.

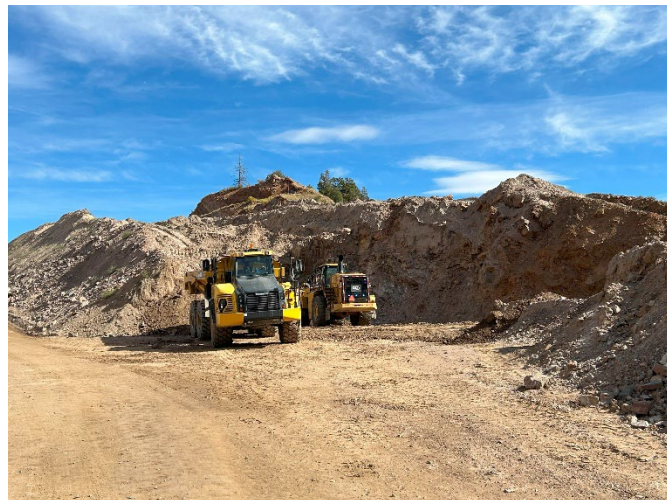
Photo 2: Plant growth medium stockpile area.

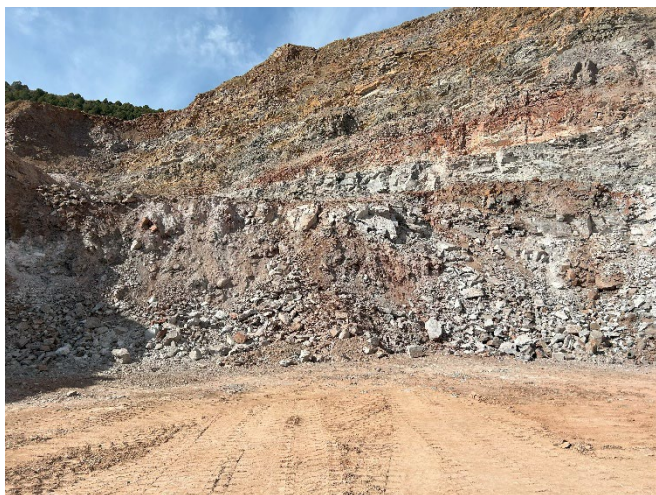
No issues related to the hydrologic balance were found during this inspection. No significant areas of standing water or exposed groundwater were observed, and the pit floor was observed to be above the maximum depth. Regarding adherence to the approved mining plan, no significant deviations were observed. Mining has progressed into the west quarry and continues to occur within the approved sections of the south quarry, and concurrent reclamation was underway during this inspection. The established reclamation appears health and trending toward total vegetation cover.

Photo 3: Maximum pit depth.

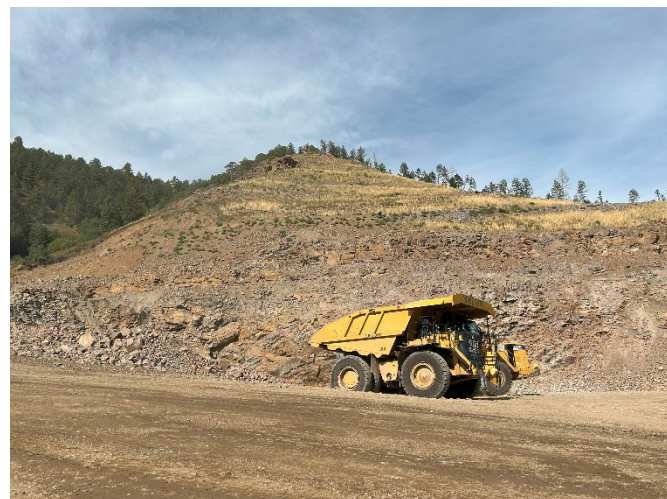
Photo 4: Western quarry reclaimed area.

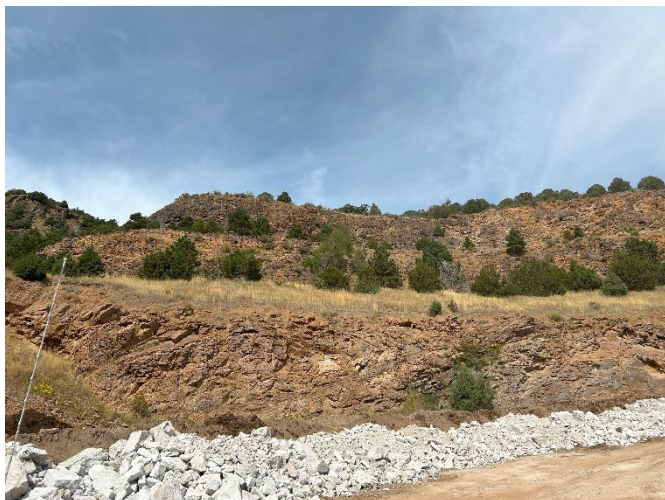
Photo 5: Old reclaimed slope, with potential to be released.

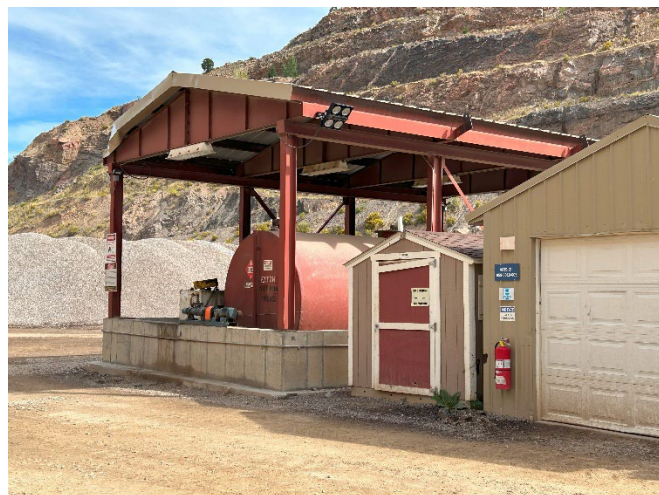
Photo 6: Diesel storage area. Note double lined containment.
