**MINERALS PROGRAM INSPECTION REPORT**  
**PHONE: (303) 866-3567**

| <b>MINE NAME:</b><br>Valco T Pit | <b>MINE/PROSPECTING ID#:</b><br>M-2004-043 | <b>MINERAL:</b><br>Sand and gravel | <b>COUNTY:</b><br>Las Animas |
| <b>INSPECTION TYPE:</b><br>Surety Release Inspection | <b>WEATHER:</b><br>Cloudy | <b>INSP. DATE:</b><br>September 12, 2025 | <b>INSP. TIME:</b><br>08:15 |

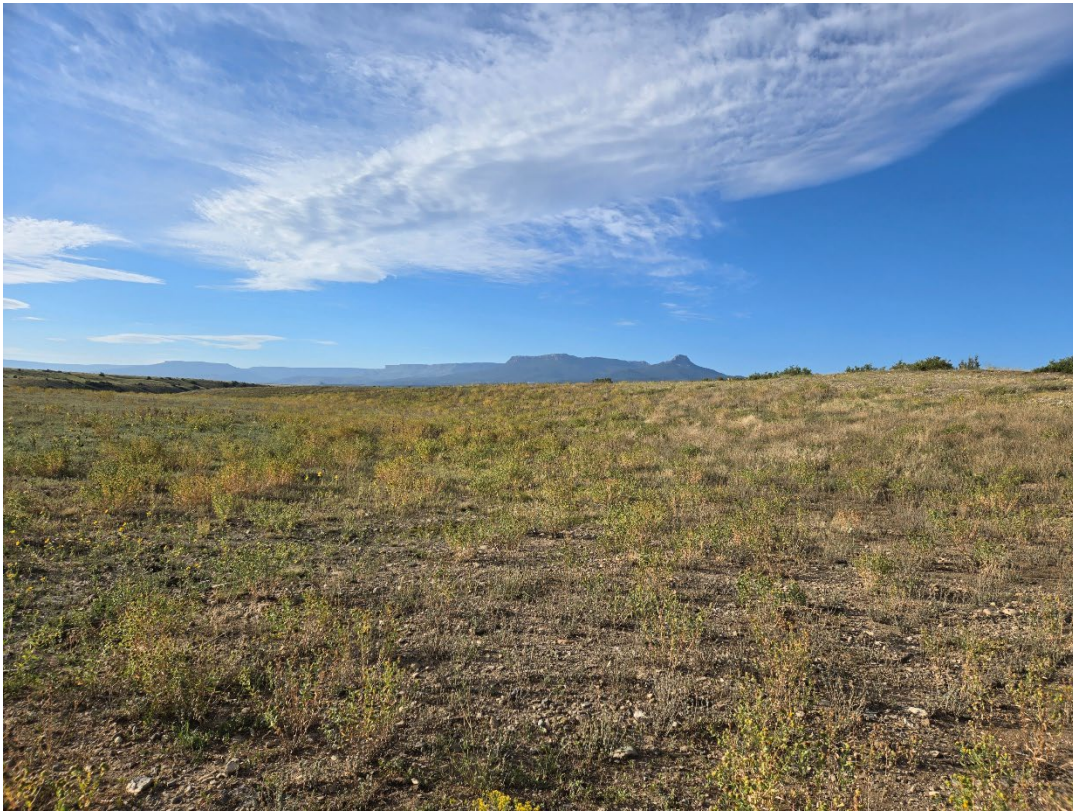
**Photo 1:** Looking south across the reclaimed pit floor and western highwall.

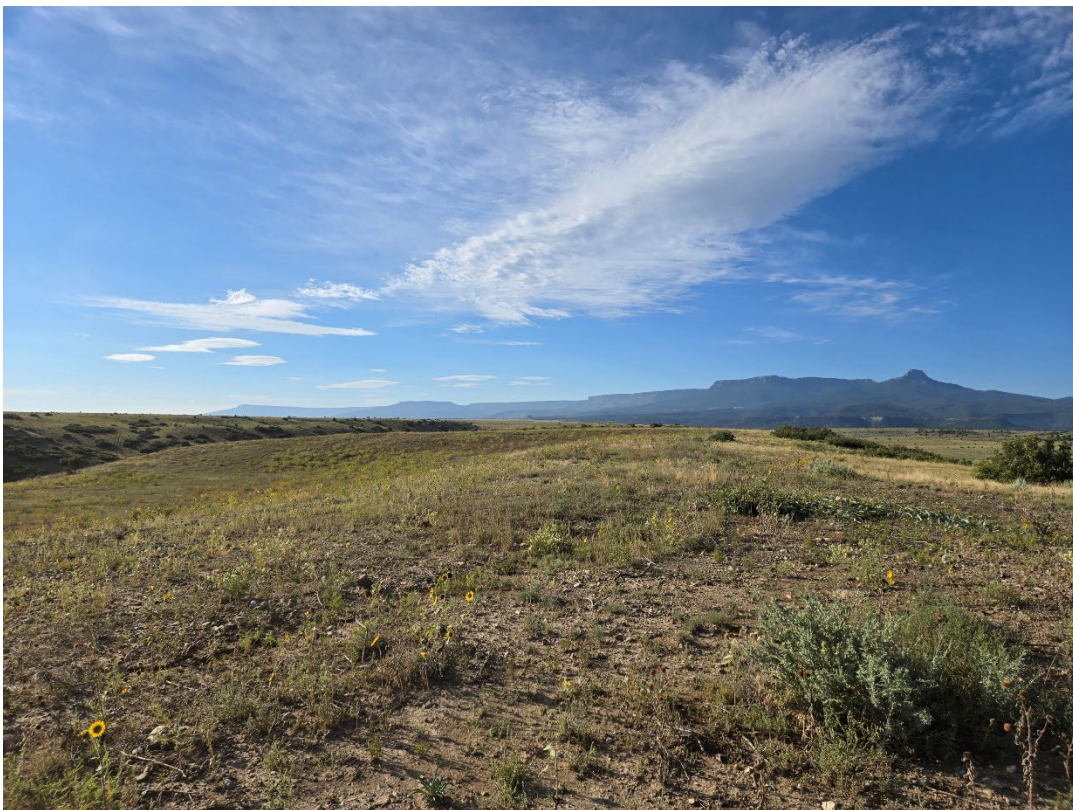
**Photo 2:** Looking south from the top of the reclaimed highwall at the reclaimed slopes.

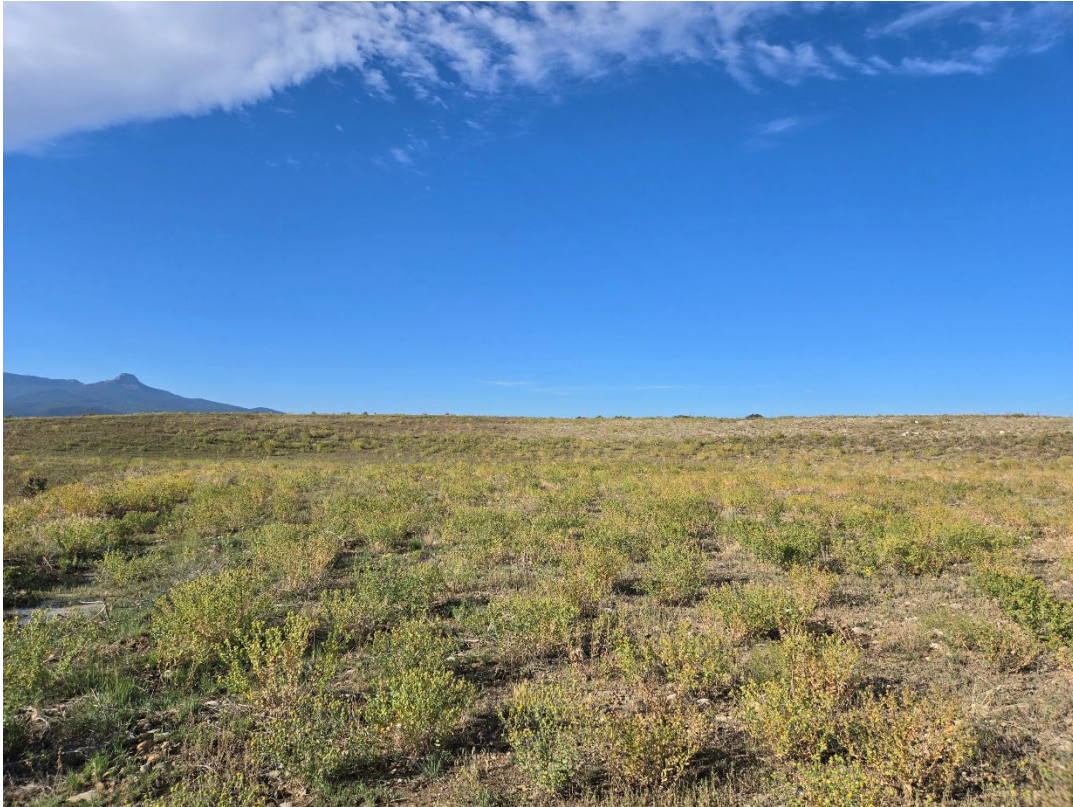
**Photo 3:** Looking west at a portion of the reclaimed western slopes and the reclaimed pit floor.

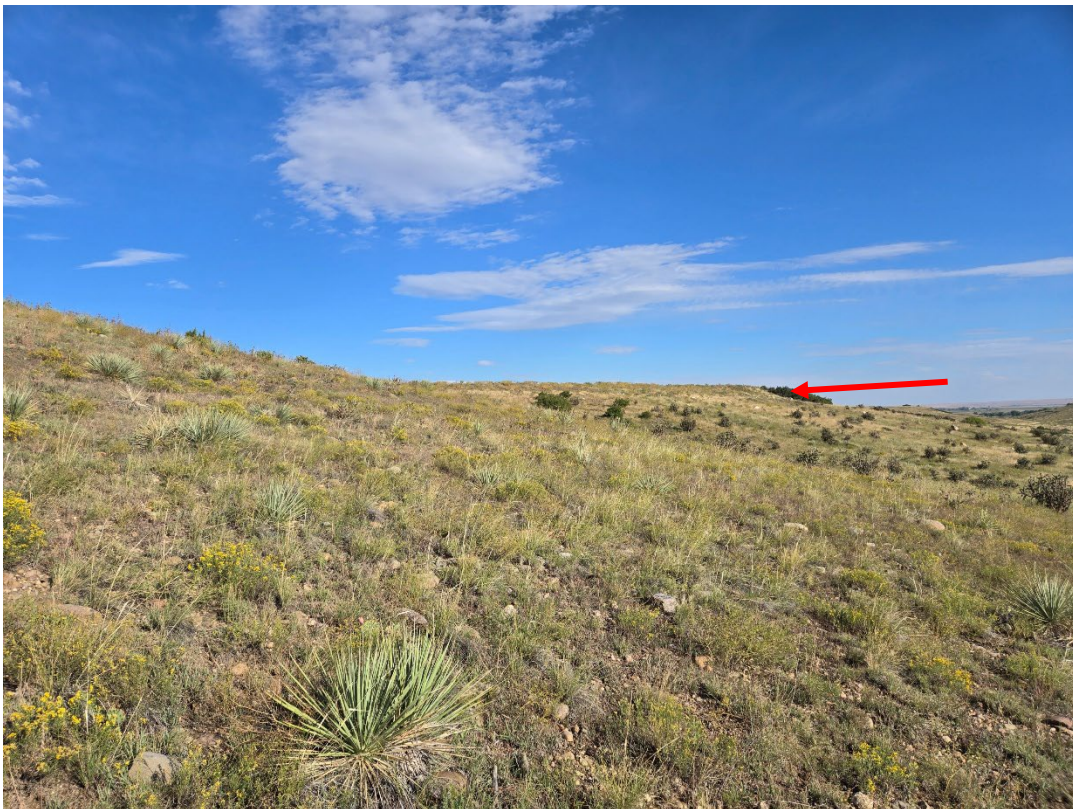
**Photo 4:** Looking northwest at the outer edge of the reclaimed slopes on the east side of the pit area.

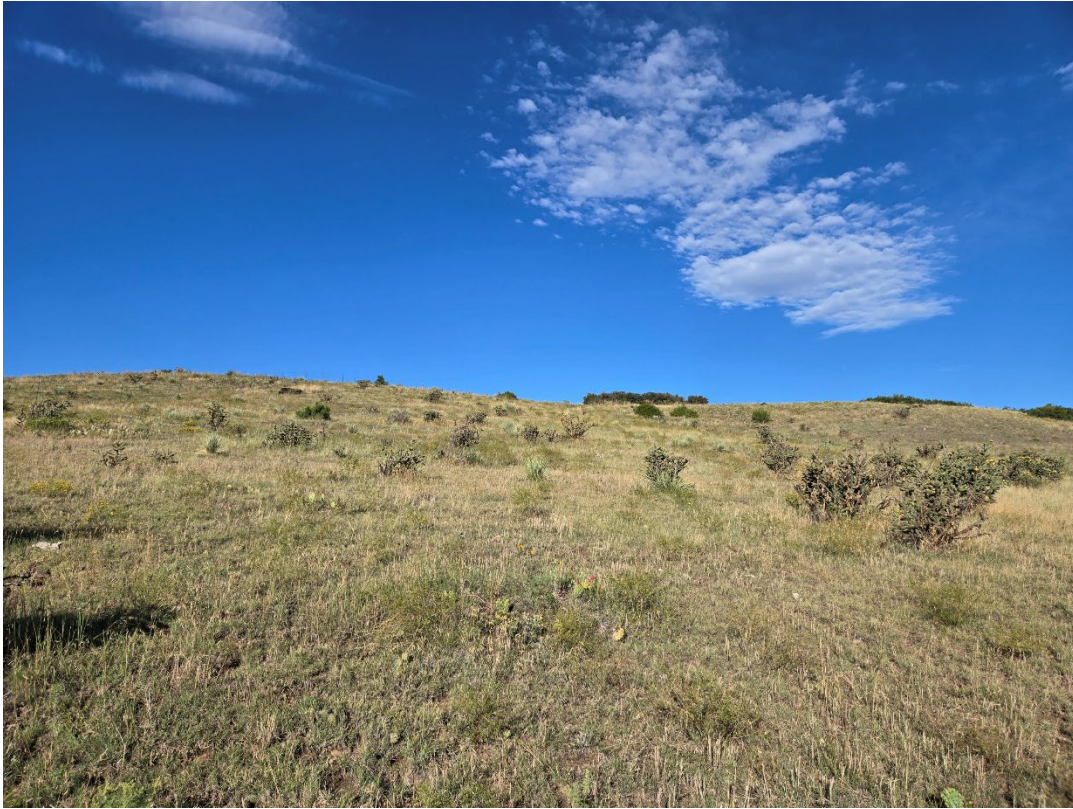
**Photo 5:** Looking west at native slopes within the southern portion of the permitted area.

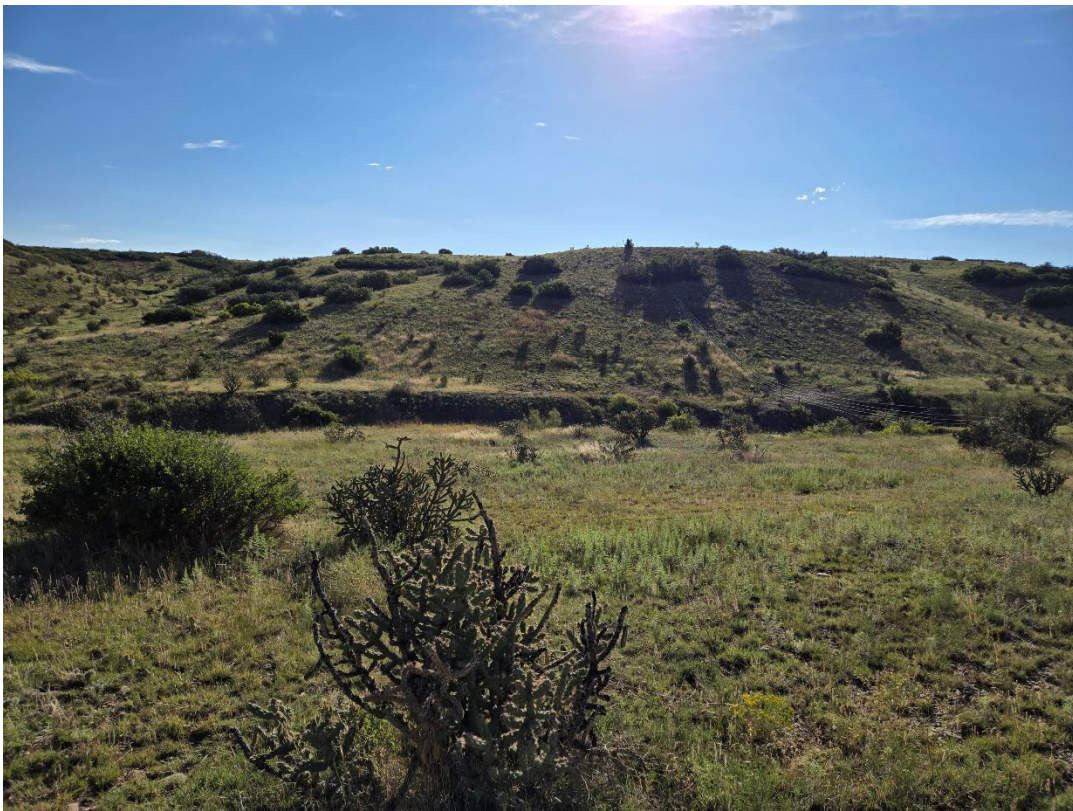
**Photo 6:** Looking east at the undisturbed arroyo and native slopes in the southwest side of the permit area.

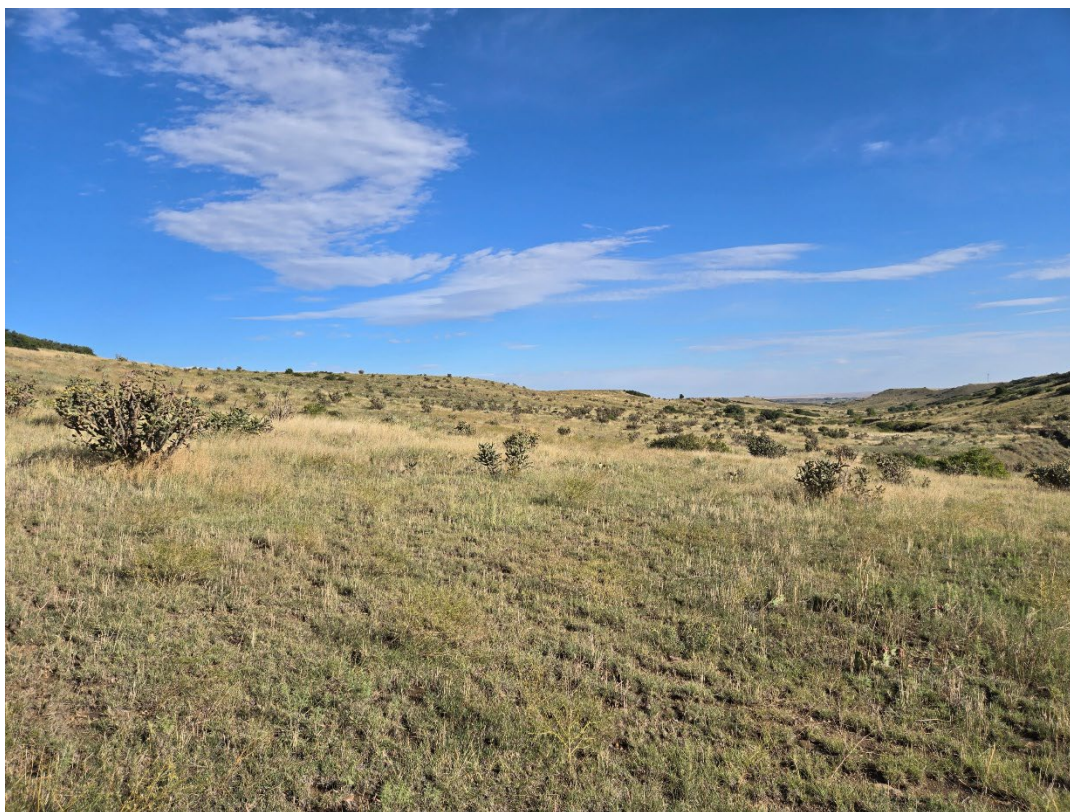
**Photo 7:** Looking north at undisturbed areas within the center of the permit area.

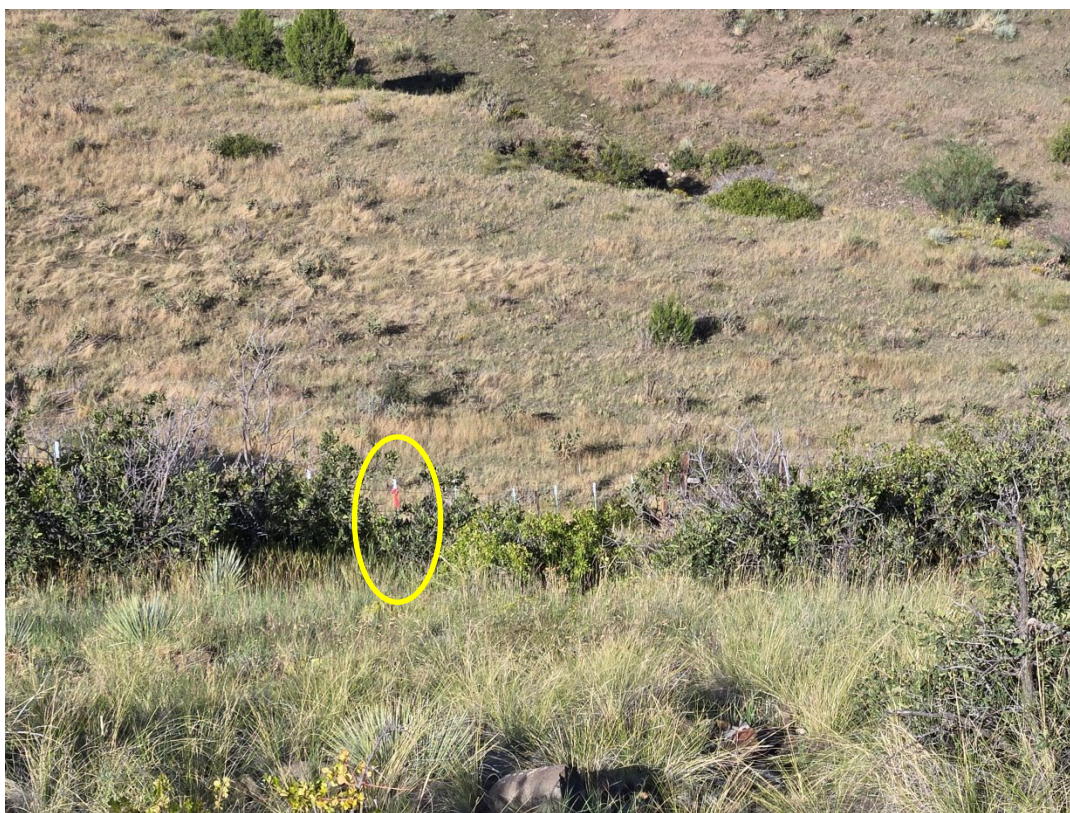
A permit sign was posted at the entrance to the site in compliance with Rule 3.1.12(1). T-posts with red tops marked the permit boundary and were posted at each corner of the site. The site is marked in compliance with Rule 3.1.12(2).

**Photo 8:** Looking southwest at the southwest permit boundary marker.

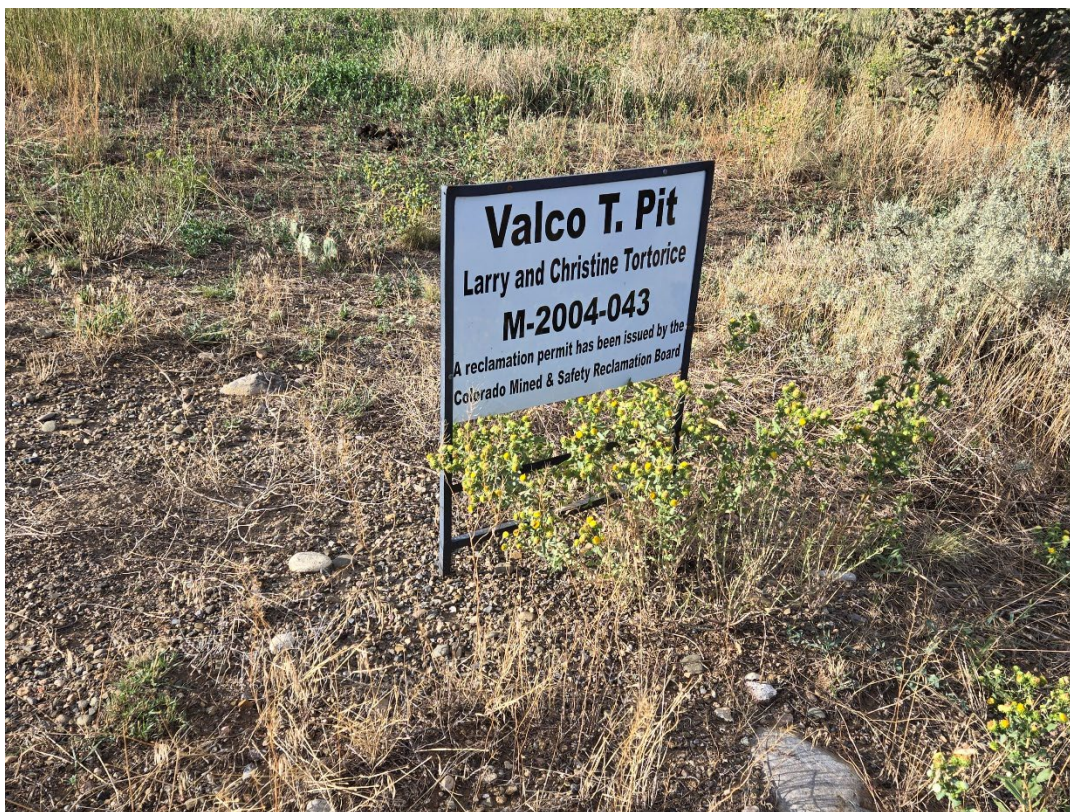
**Photo 9:** Mine sign posted at the access road to the site, located on the south side of Highway 160.

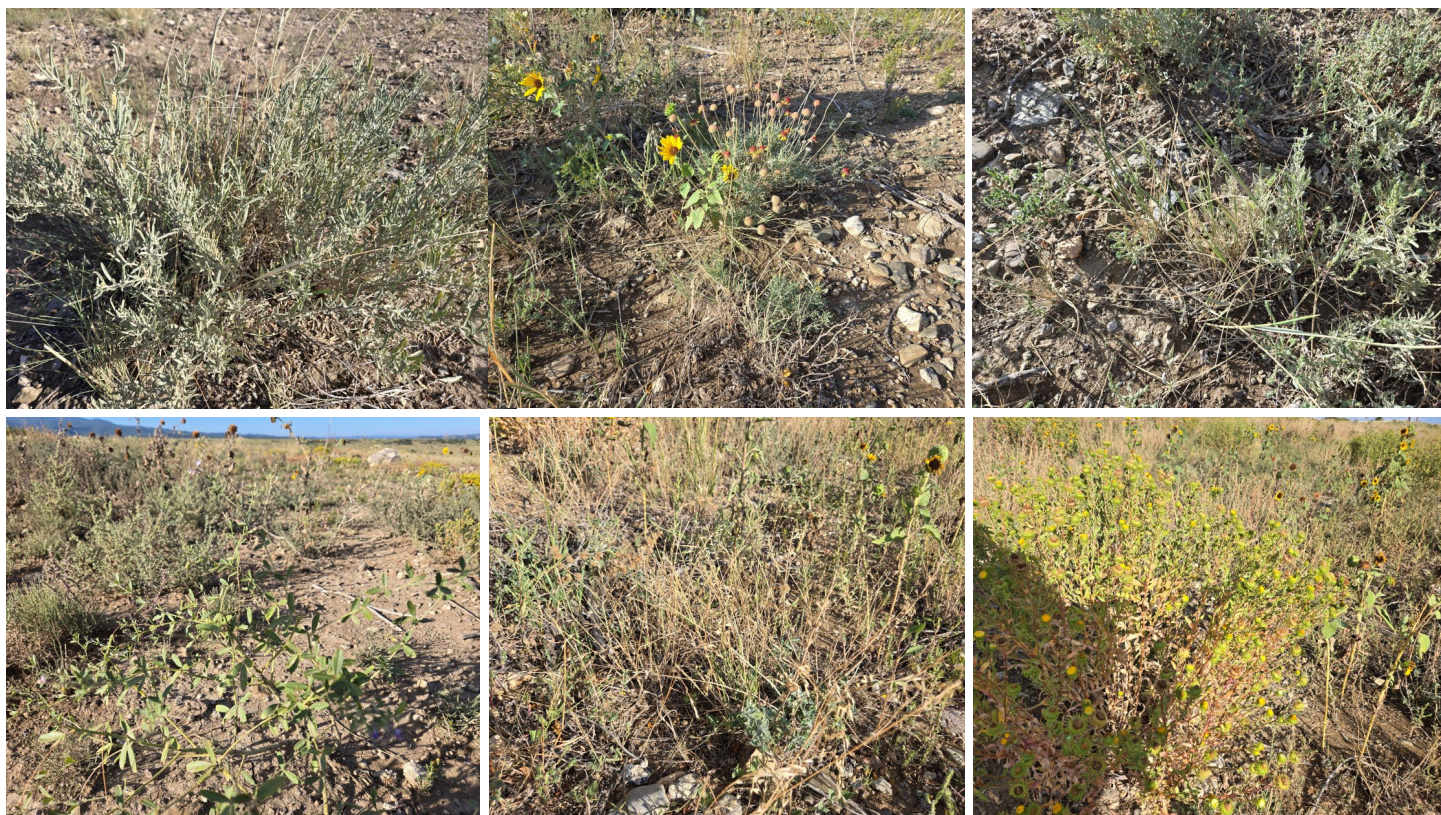
Since the Division's last inspection, the site has been fully reclaimed. The highwall has been backfilled, graded, topsoiled, and revegetated. All slopes onsite have been graded to a 3H:1V slope or shallower. No stockpiles, nor equipment, remain on the site. The pit floor had also been topsoiled and revegetated. During this 2025 inspection, the extent of the affected area was walked. The Inspector observed a diverse establishment of vegetation across the affected area. The vegetation observed included a variety of grasses and bunch grasses, as well as native plants that have volunteered into the area such as sunflowers, gumweed, and Winterfat. No noxious weeds were observed during the inspection. The Inspector and Permittee also walked around the unaffected areas and verified that they were undisturbed. Across the native slopes at the site, it was evident that topsoil is shallow sitewide, and that the amount of topsoil salvaged and applied on the affected areas appears to be consistent with the native conditions.

**Figure 1:** The photos above highlight some of the diverse established vegetation within the previously affected area.

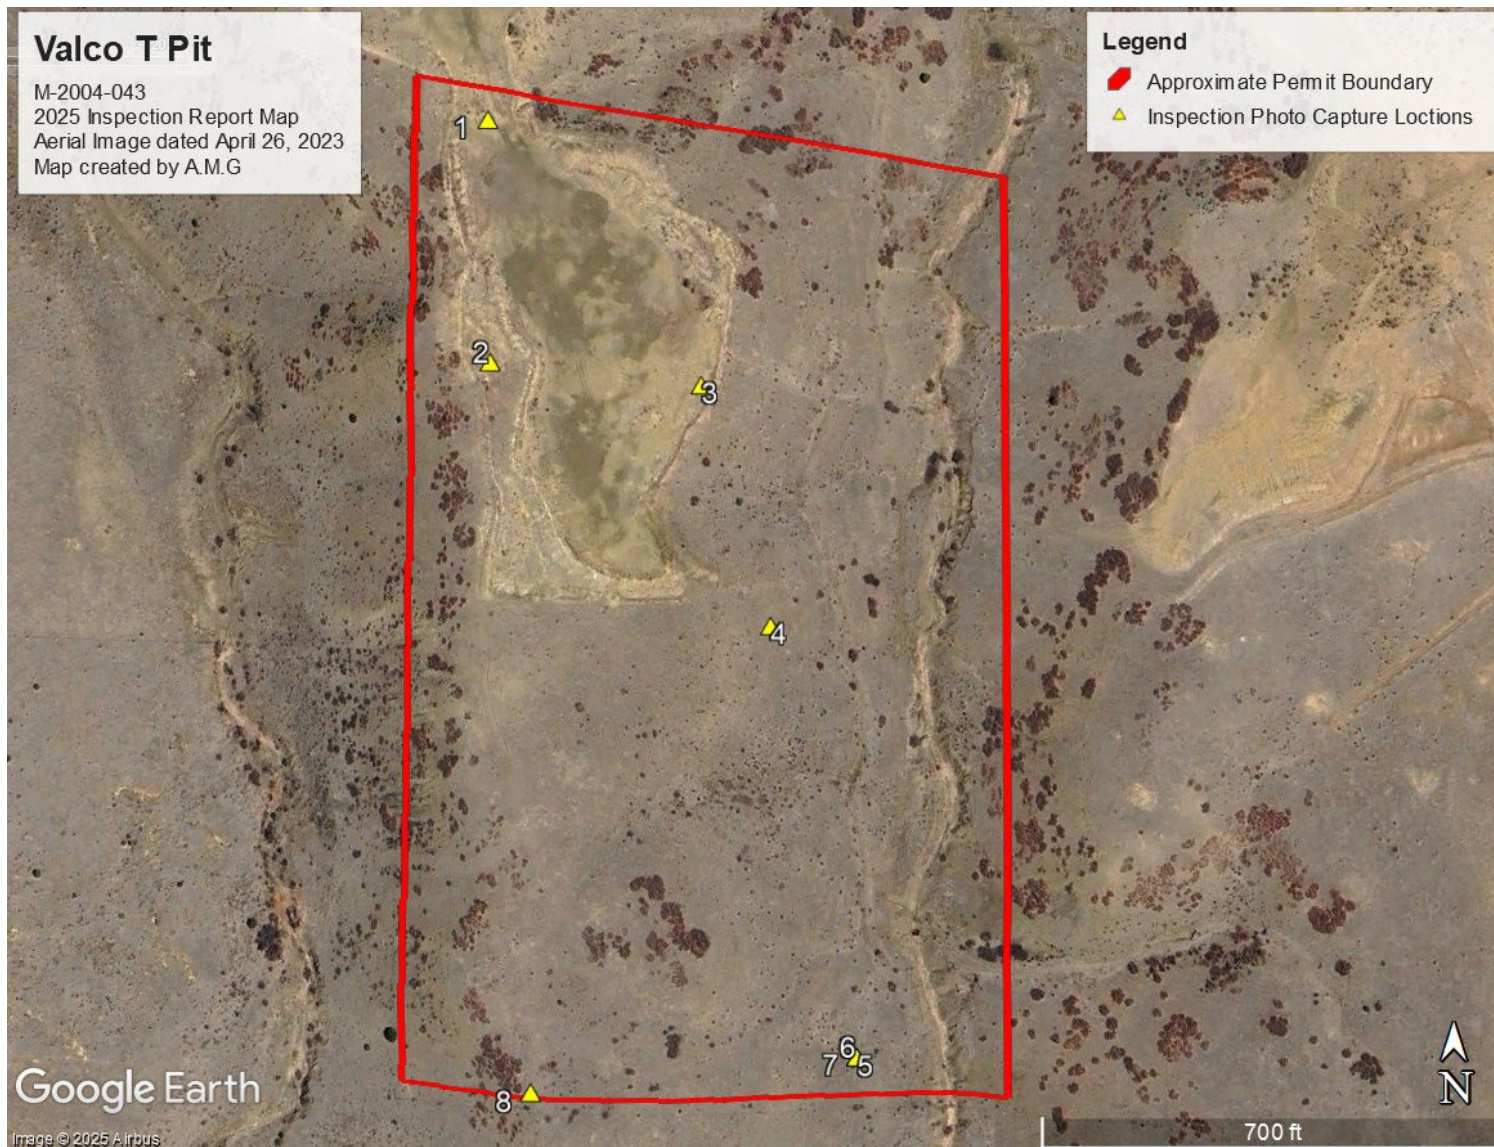
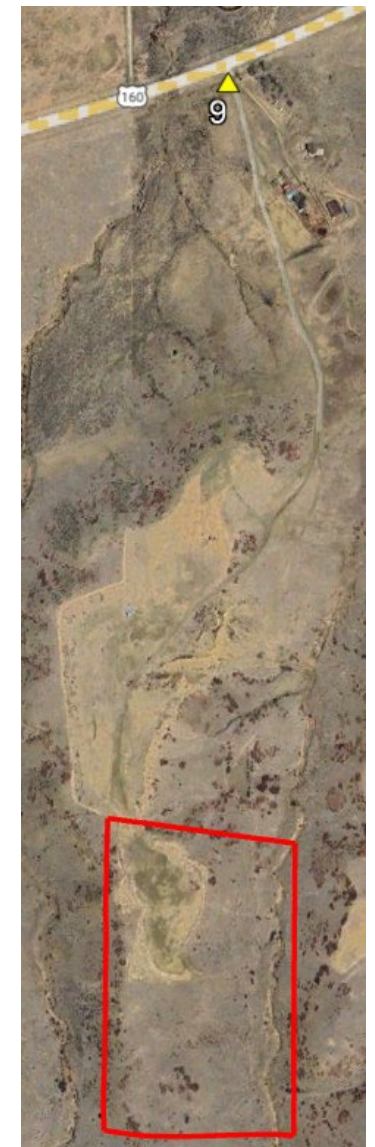
**Map 1:** Inspection Report Map generated using Google Earth Pro. The aerial image is dated April 16, 2023. The highwall appears to have still been present at that time. However, as seen in the inspection report photos, the highwall and pit floor have been reclaimed since this photo was taken. The yellow triangle icons correspond with the photos in this report with the same numbers. The thin image on the right shows the access location for the pit, and the location where the mine sign is posted.
