**MINERALS PROGRAM INSPECTION REPORT**  
**PHONE: (303) 866-3567**

| <b>MINE NAME:</b><br>Granger Pit | <b>MINE/PROSPECTING ID#:</b><br>M-2025-034 | <b>MINERAL:</b><br>Sand and gravel | <b>COUNTY:</b><br>Rio Grande |
| <b>INSPECTION TYPE:</b><br>Preoperation Inspection | <b>WEATHER:</b> Cloudy | <b>INSP. DATE:</b><br>August 25, 2025 | <b>INSP. TIME:</b><br>14:00 |

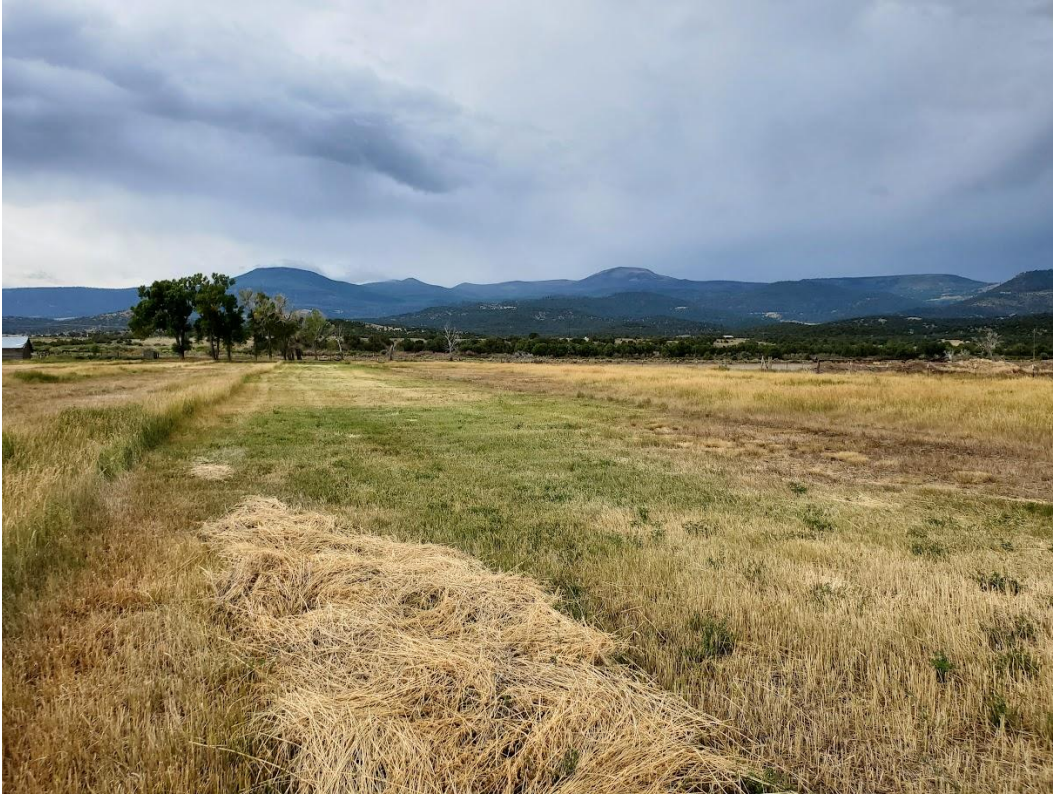
The eastern portion of the permit area is currently a hay field. The western portion of the permit area is a mix of desirable pastureland species and non-noxious weeds such as Russian thistle.

Photo 1: View to the south of hay field in eastern portion of the permit area.

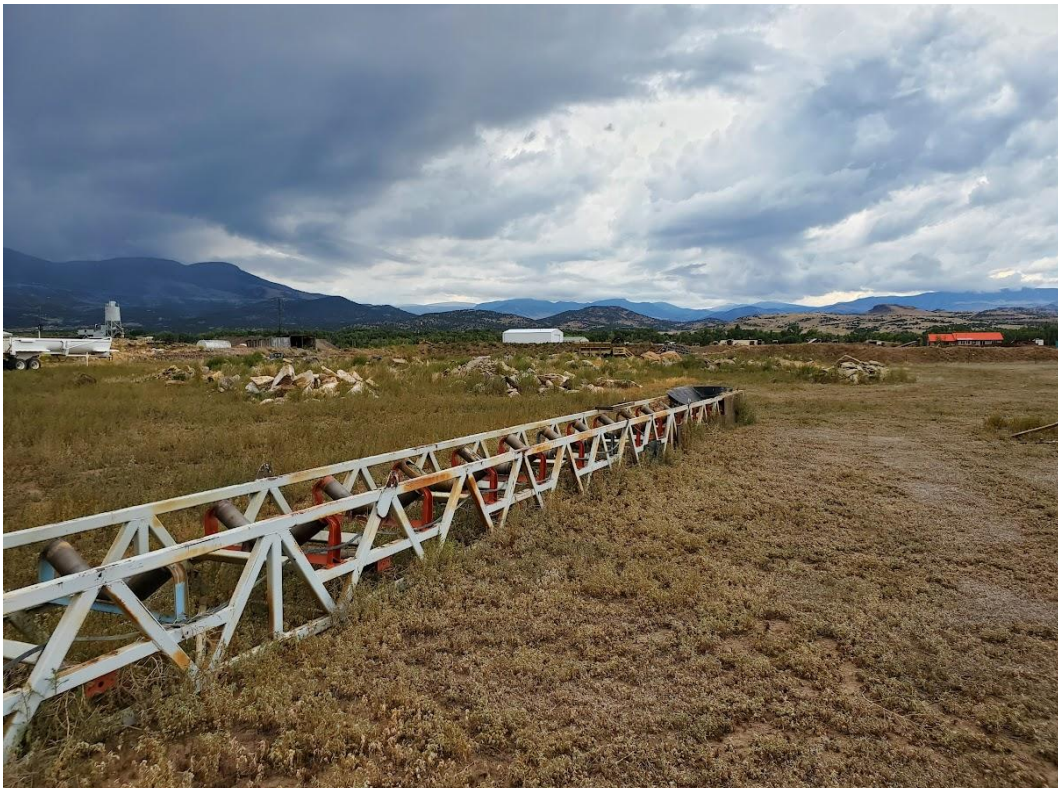
There are no facilities or the northwest portion of the permit area is currently being used as a stockpile and laydown yard. There are tailers and

Photo 2: View to the northwest of laydown yard with stockpiles.

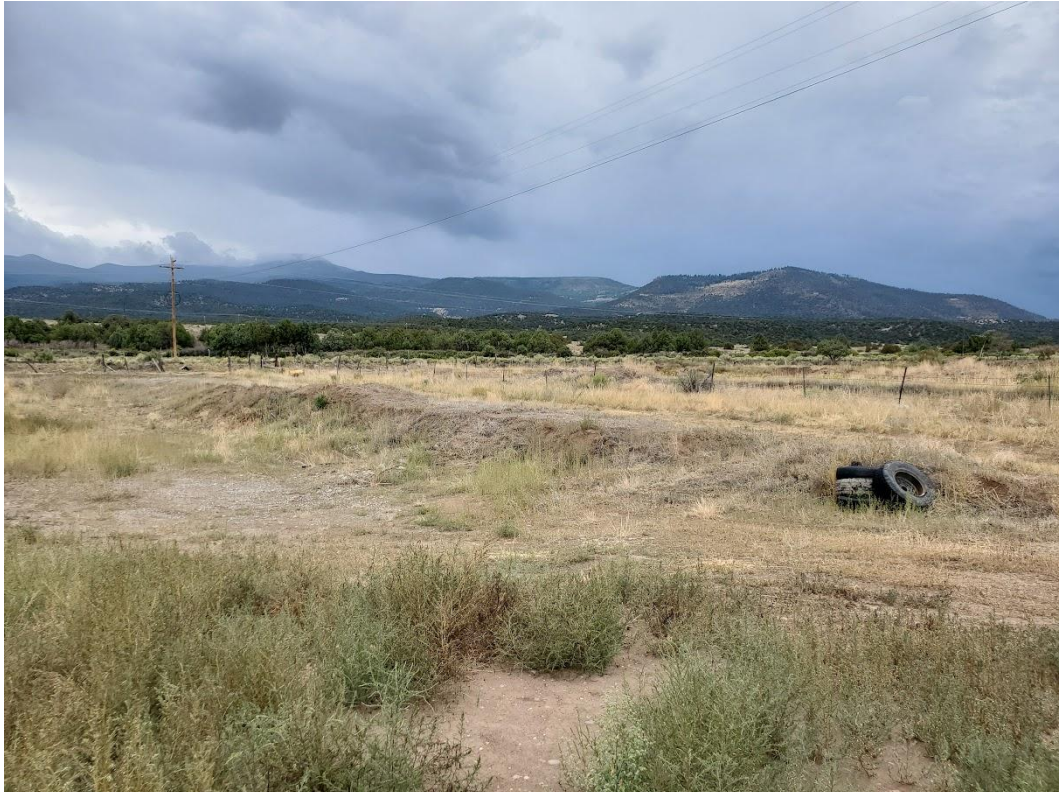
Photo 3: View to the southwest of the western permit boundary. Russian thistle can be seen in the foreground.

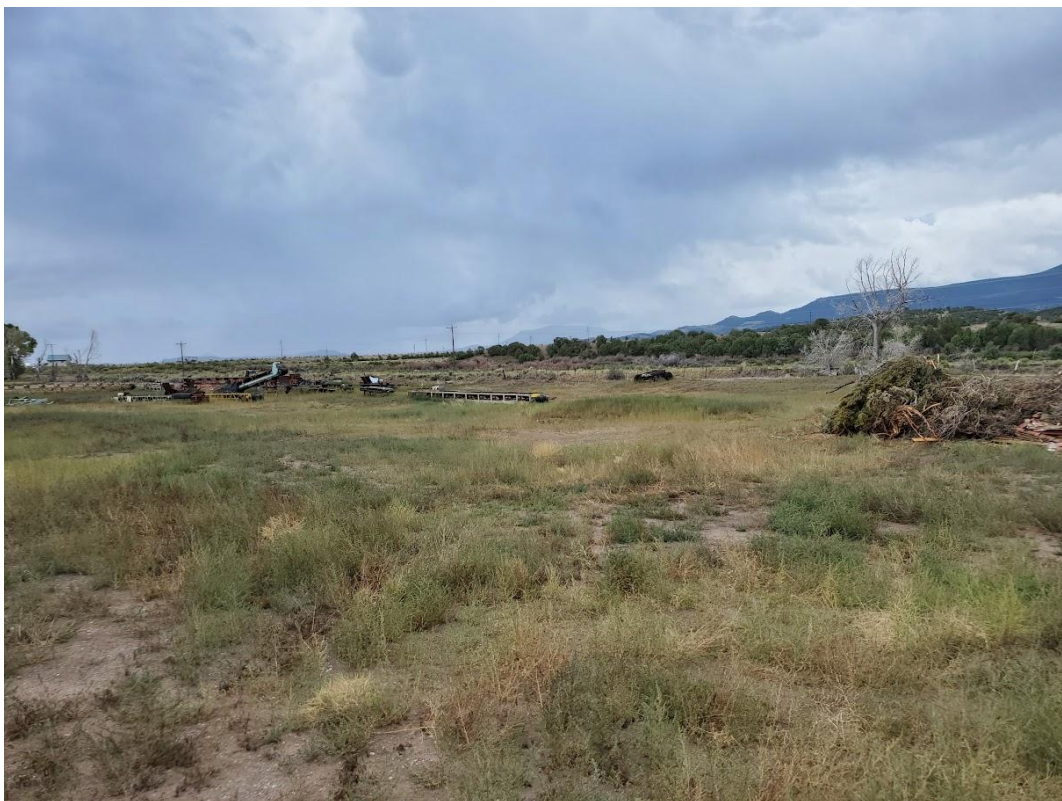
Photo 4: View to the southeast of the laydown yard.
