C-1981-035 King Coal September 2025 Partial Inspection Report

PERMIT INFORMATION

Permit Number: C-1981-035 Mine Name: King Coal Mine Operator: GCC Energy, LLC Operator Address: Mr Jordan McCourt 6473 County Road 120 Hesperus, CO 81326	County: La Plata Operation Type: Underground Permit Status: Active Ownership: Private
	Operator Representative Present: Wade Wymore
Operator Representative Signature: (Field Issuance Only)

Inspection Start Date: September 16, 2025 Inspection Start Time: 14:05 Inspection End Date: September 16, 2025 Inspection End Time: 16:06	Inspection Type: Coal Partial Inspection Inspection Reason: Normal I&E Program Weather: Clear
Joint Inspection Agency: None	Joint Inspection Contacts:
Post Inspection Agency: None	Post Inspection Contacts:
Inspector(s): Lucas West	Inspector's Signature:

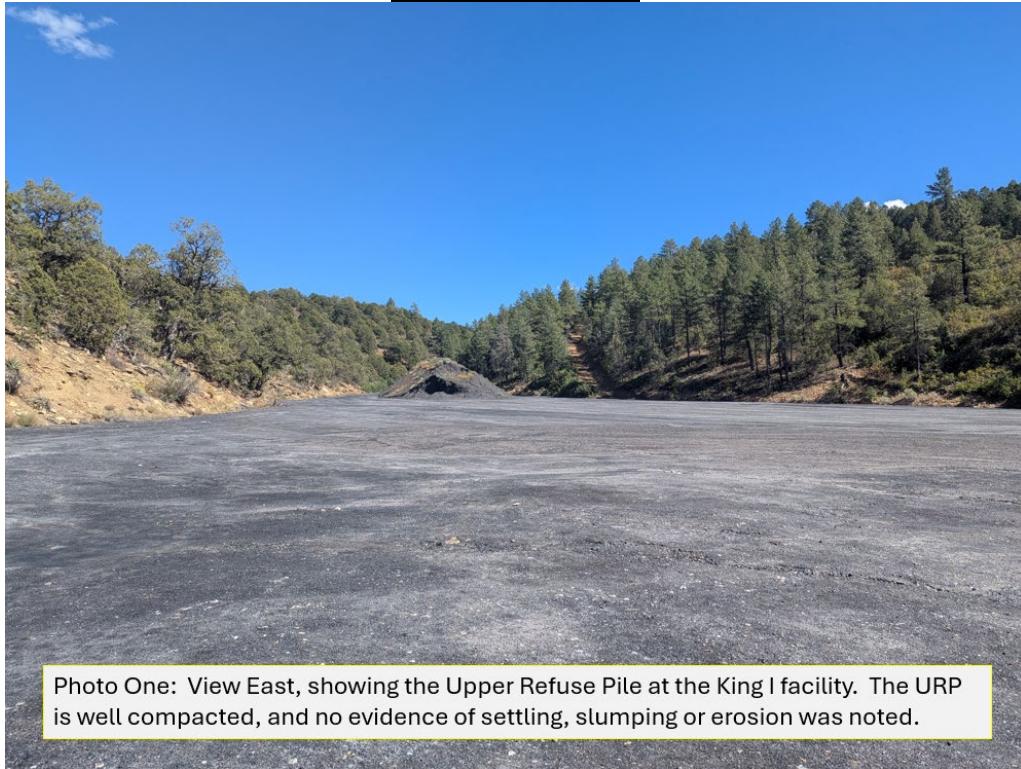
During this inspection, both the Upper and Lower Refuse Piles were observed at the King I facility. The Upper Refuse Pile (URP) was found to be in good condition. The surface of the pile is well compacted and material size appears to be within design specifications. No evidence of settling, slumping or erosion was noted. The stockpile located at the back of the pile, awaiting placement, appeared to be stable at the time of the inspection. The stockpile does not show signs of recent removal and is in similar condition to the Division's previous inspections. The pile demonstrates positive drainage and no impounded stormwater was observed despite recent storms. The out slopes of the pile are also in good condition and no evidence of erosion was noted. The URP can be seen in Photo One. The Lower Refuse Pile (LRP) was also found to be in good condition. The surface of the pile is well compacted and material appears to be within the design specifications. No signs of settling, slumping or erosion was noted on the surface of the refuse pile. The small stockpile of material awaiting placement appeared to be stable and no evidence of erosion of the stockpile was noted. The out slopes of the LRP also appeared stable at the time of the inspection and no erosion was noted. A small pool of collected stormwater was noted in the Northwest corner of the pile, however is not considered a problem at this time. The LRP can be seen in Photo Two.

Photo One: View East, showing the Upper Refuse Pile at the King I facility. The URP is well compacted, and no evidence of settling, slumping or erosion was noted.

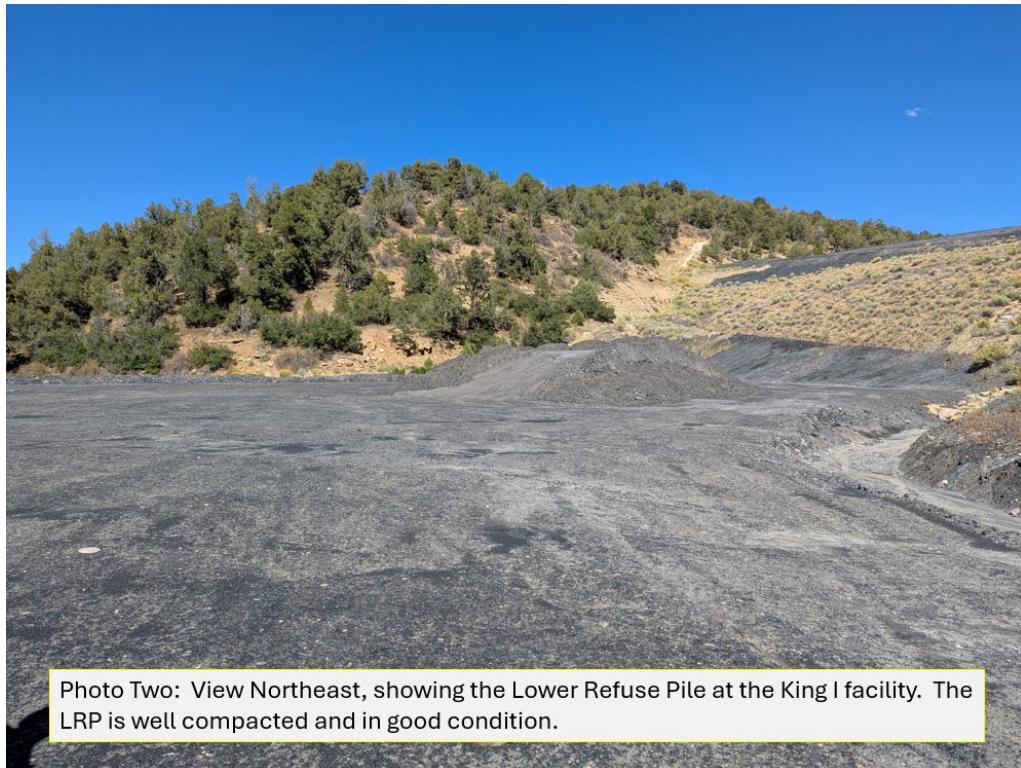
Photo Two: View Northeast, showing the Lower Refuse Pile at the King I facility. The LRP is well compacted and in good condition.

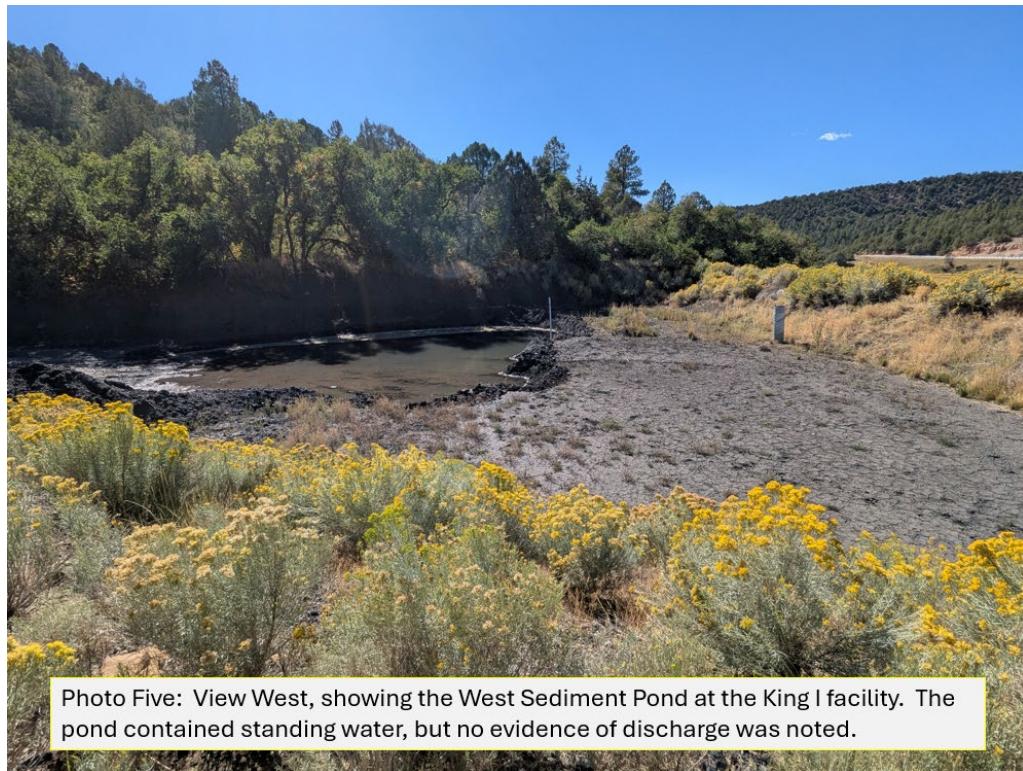
Photo Five: View West, showing the West Sediment Pond at the King I facility. The pond contained standing water, but no evidence of discharge was noted.

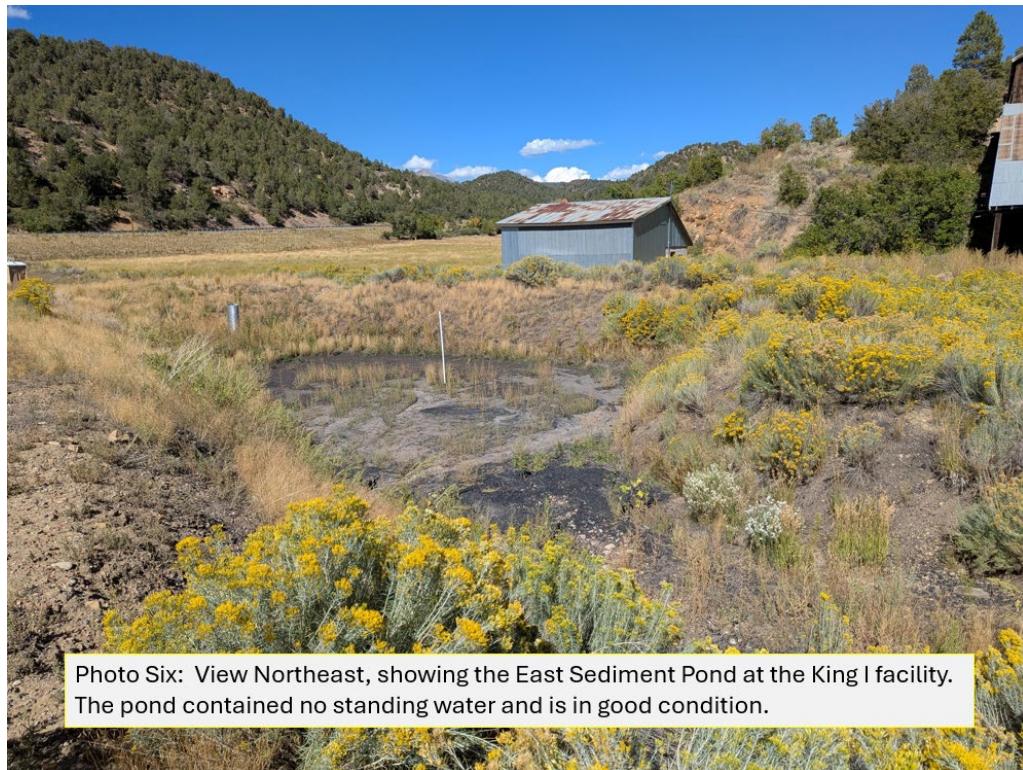
Photo Six: View Northeast, showing the East Sediment Pond at the King I facility. The pond contained no standing water and is in good condition.

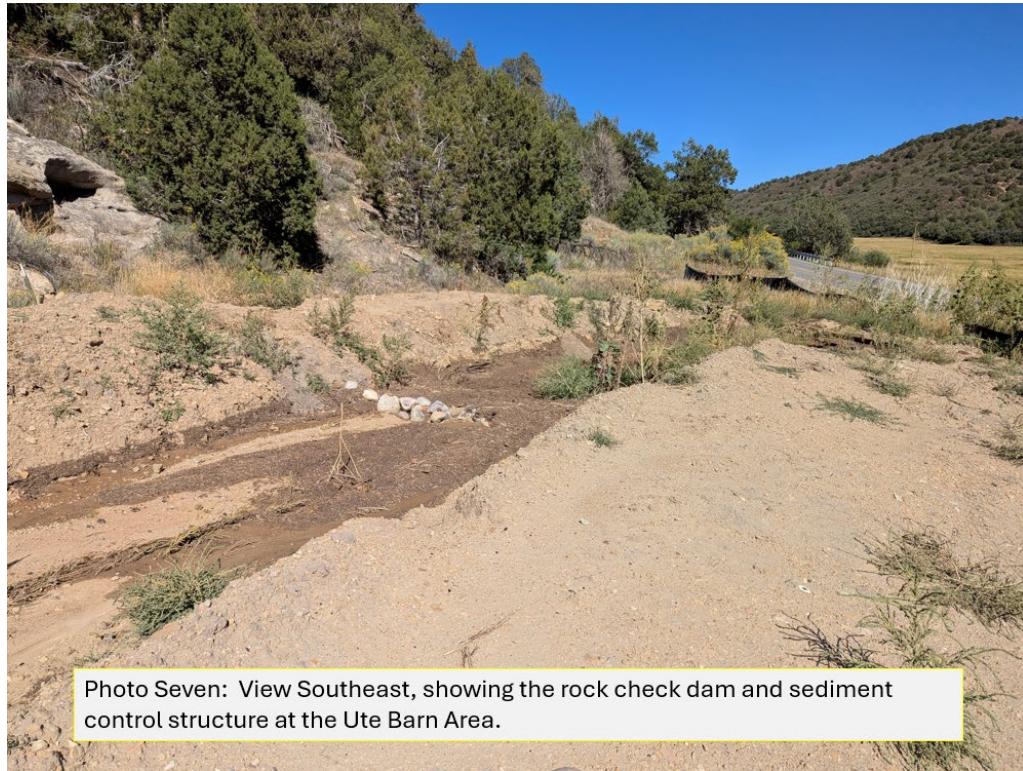
At the Ute Barn area, the main sediment control structure adjacent to the access road was observed. The structure contained standing water from recent precipitation events, however showed no signs of overtopping. The rock check dams appear to be functioning as designed however are becoming silted in. The Operator should consider cleaning them out soon, but at this time it is not considered a maintenance item. The area can be seen in Photo Seven.

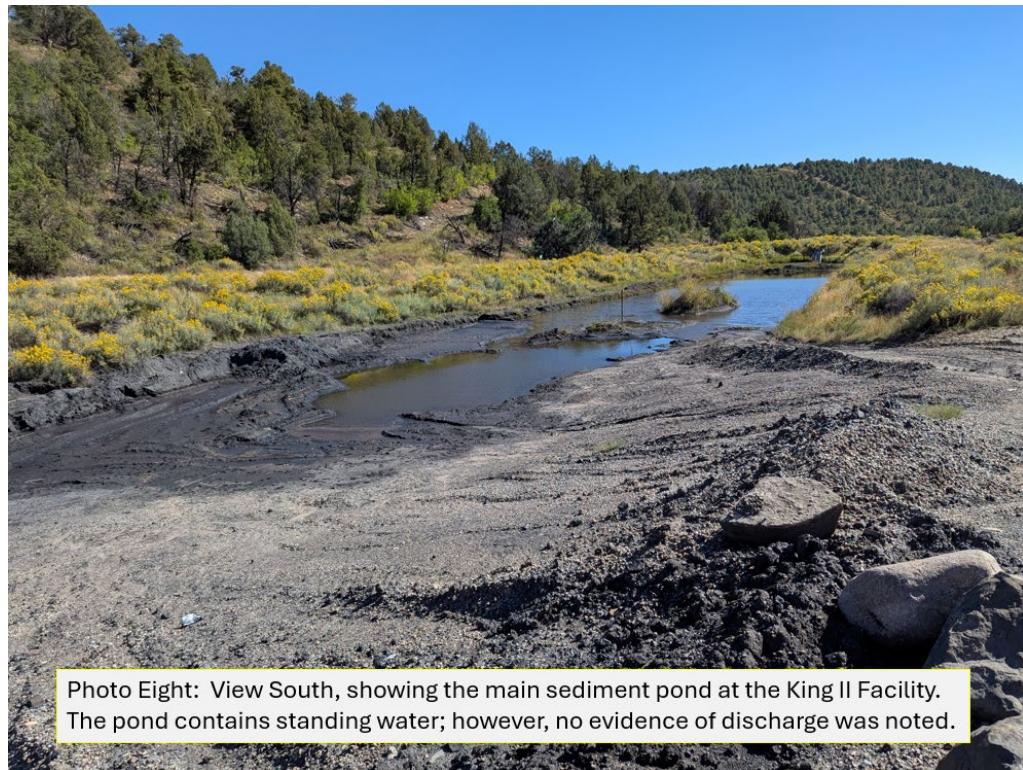
At the King II Area, the main sediment pond was observed as seen in Photo Eight. The pond contained standing water, however no evidence of discharge was noted. The sediment levels are well below the cleanout elevations on the indicator post. The banks of the pond are well vegetated and appeared stable at the time of the inspection. Both inlet culverts were observed to be free from obstruction and actively flowing during the inspection. All internal drainage ditches were observed around the processing and shop areas. All of the observed ditches were free from obstruction and appeared to be able to function as designed. Located in the processing area, at various locations are sumps feeding the internal drainage pipes that lead to the sediment pond. All sumps were clear and functioning as designed. An example of the sumps can be seen in Photo Nine. All culverts associated with the internal drainage systems were found to be free flowing and functioning as designed.

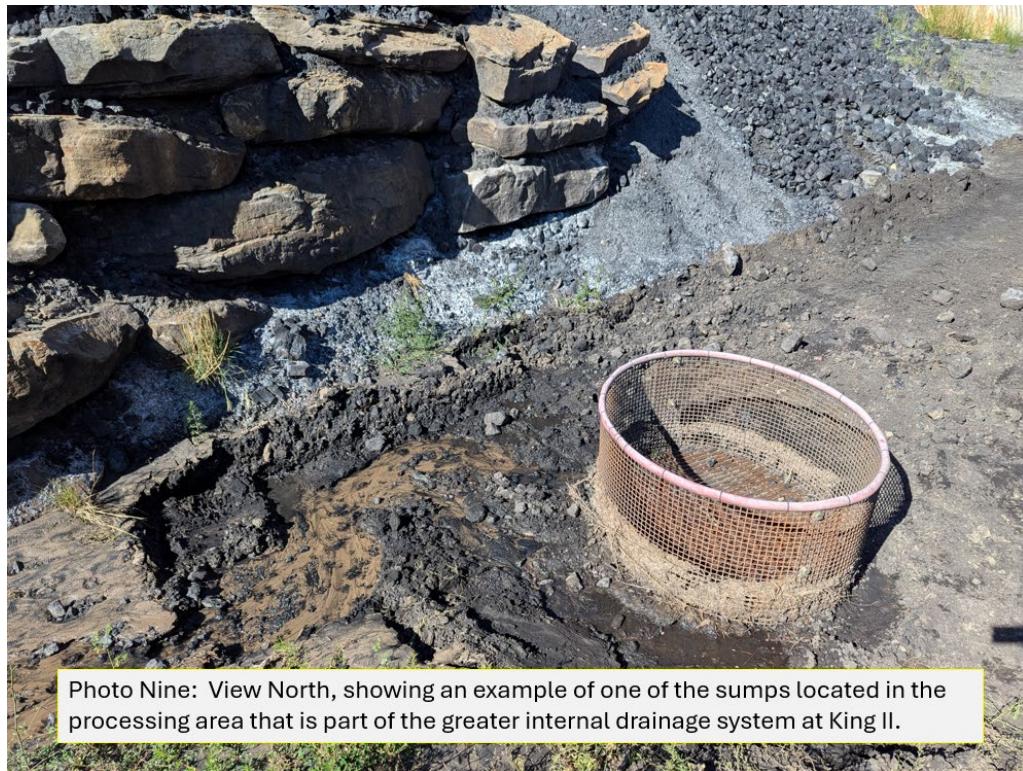
Photo Nine: View North, showing an example of one of the sumps located in the processing area that is part of the greater internal drainage system at King II.
