**MINERALS PROGRAM INSPECTION REPORT**  
**PHONE: (303) 866-3567**

| <b>MINE NAME:</b><br>Bulldog Mine Operation | <b>MINE/PROSPECTING ID#:</b><br>M-1977-215 | <b>MINERAL:</b><br>Lead and silver | <b>COUNTY:</b><br>Mineral |
| <b>INSPECTION TYPE:</b><br>Monitoring | <b>WEATHER:</b> Cloudy | <b>INSP. DATE:</b><br>August 26, 2025 | <b>INSP. TIME:</b><br>08:00 |

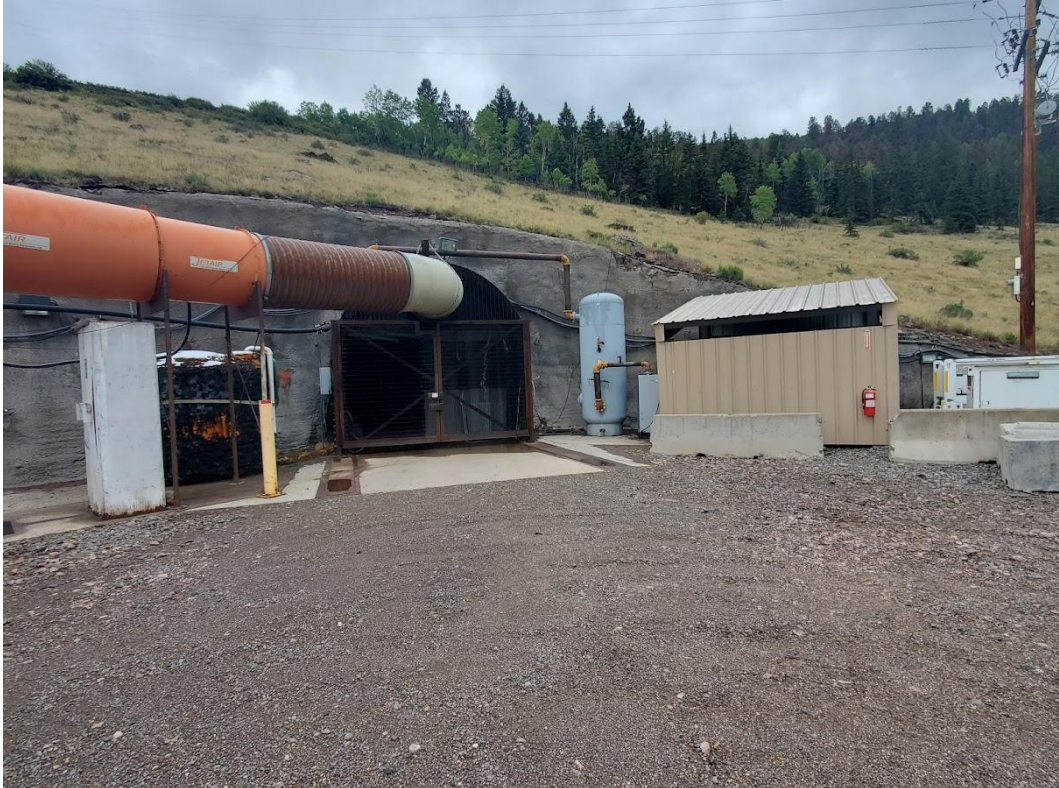
The site was not active at the time of the inspection. The 9400 Level portal is the main access and ore removal for underground workings (Photo 1). The main portal was closed at the time of the inspection. The portal door is in excellent condition and shows no signs of damage or vandalism. The vent fan and electrical equipment (Photo 2) is in good condition and appears well maintained. There are no signs of settling, slumping, or erosion above or around the portal.

Photo 1: View to the west of 9400 Level Portal.

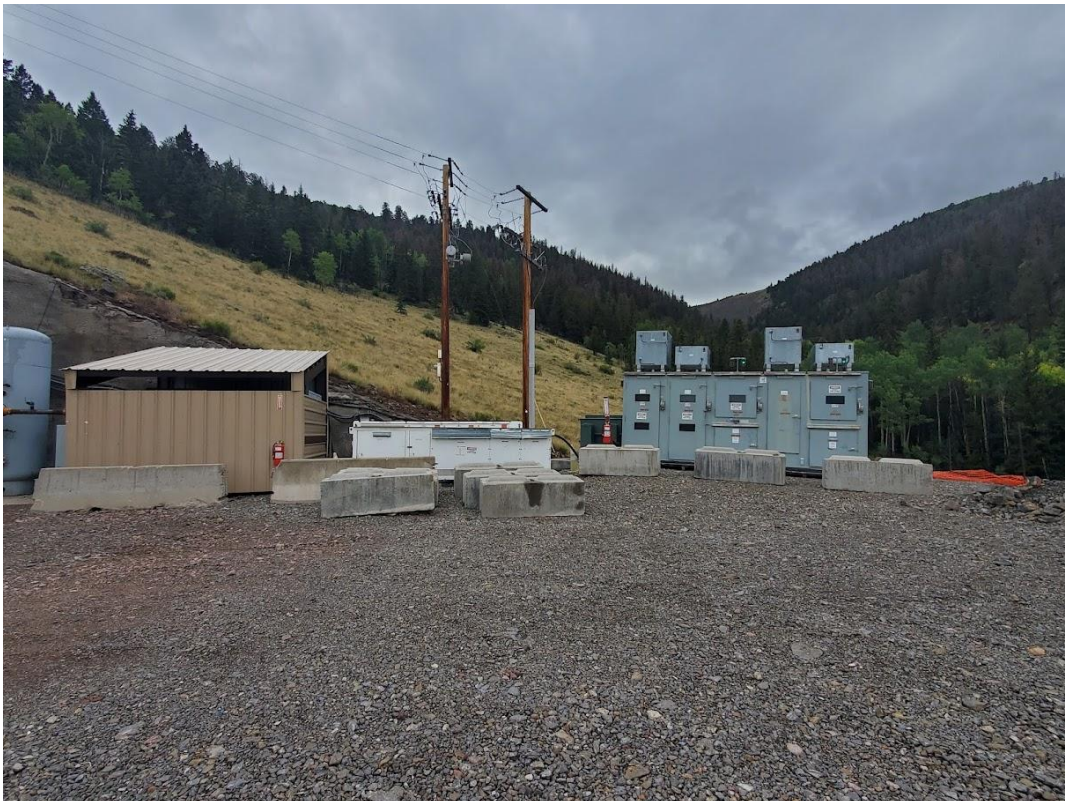
Photo 2: View to the north of electrical equipment at the 9400 Level Portal.

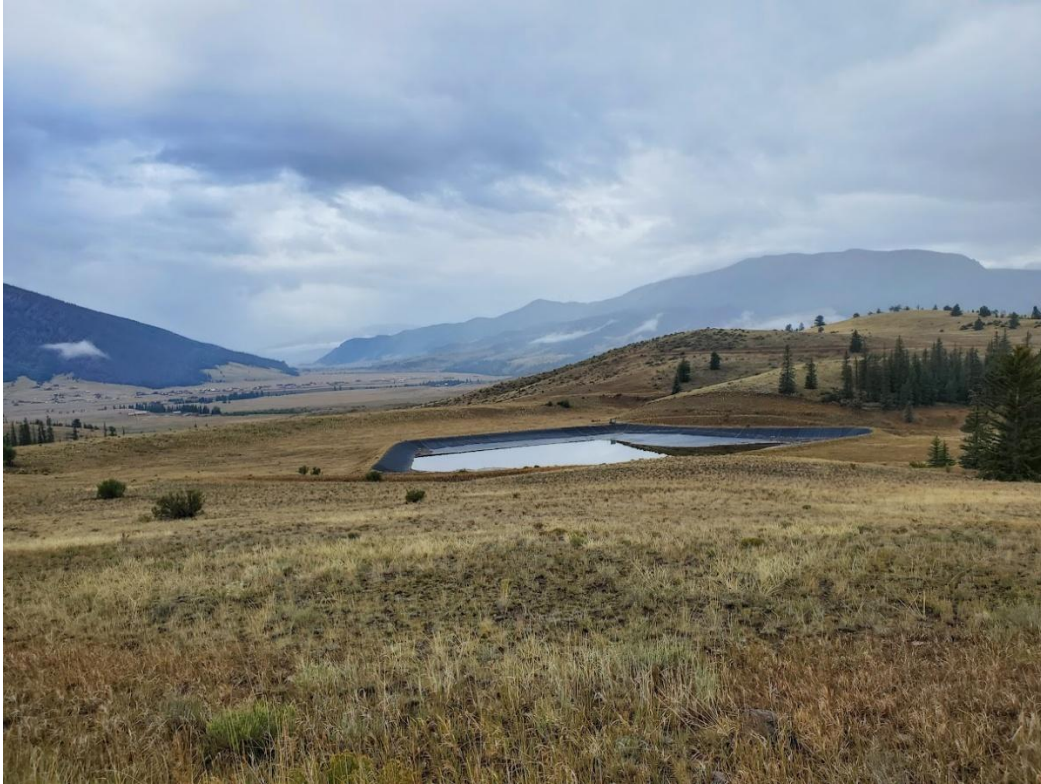
The Tailings Pond 2 (TP-2) area lies approximately 1.5 miles to the south of the main facilities and office area. This area consists of the lined Tailing Storage Facility (TSF) that was utilized during active mining operations. Active tailings deposition in this facility has not occurred in some time. The TSF shows no signs of structural instability such as displacement cracking or erosion. Within the TP-2 facility lies a lined contact water pond that was used to help dewater the mine during maintenance. There is still water in the pond even though the mine is not being actively dewatered (Photo 3). The pond is lined with HDPE liner that still appears to be good condition after winter snows. Adjacent to the TSF is a cleared pad utilized to store core samples from recent drilling projects. The pad is well kept with no signs of instability.

Photo 3: View to the southwest of TP-2.

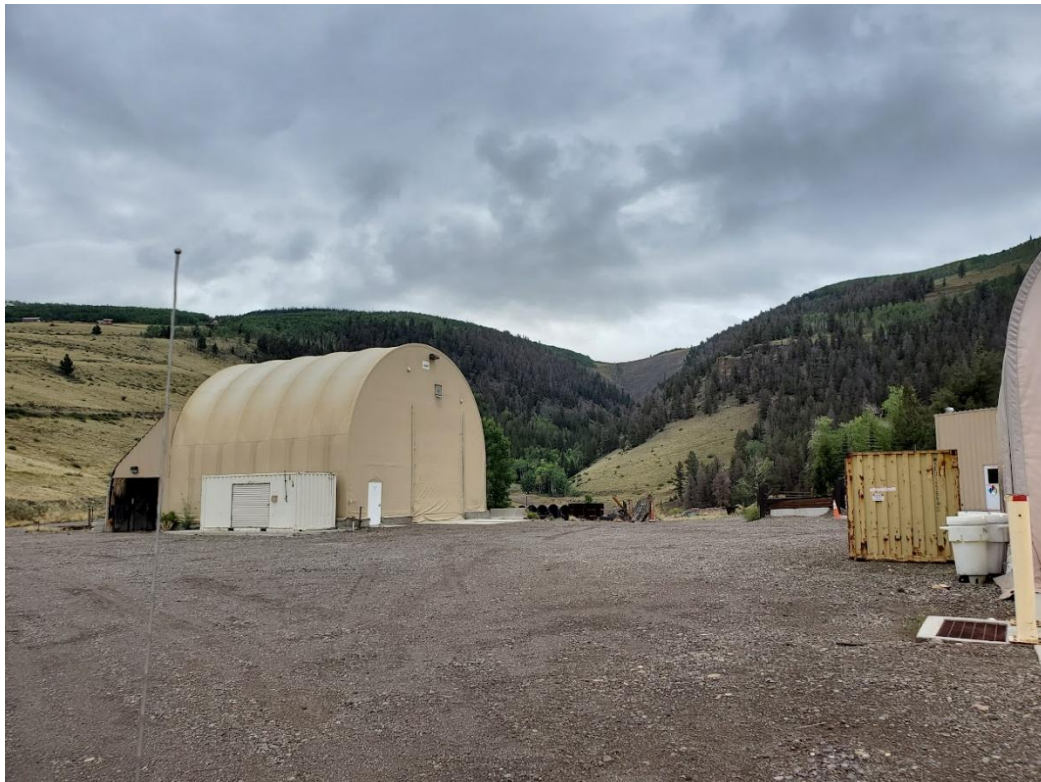
Facilities observed include the maintenance shop, fuel storage building, laydown yard and Windy Gulch Vent Shaft. All other structures in the facilities area are in good condition and very well kept (Photo 4). The laydown yard in the main facilities area is also very well organized. The Windy Gulch Vent Shaft is surrounded by chain link fence with a locked gate to prevent unauthorized entry and vandalism (Photo 5). The shaft is in good condition. The collar and closure show no evidence of displacement, settling, slumping, or erosion.

Photo 4: View to the northwest of facilities area.

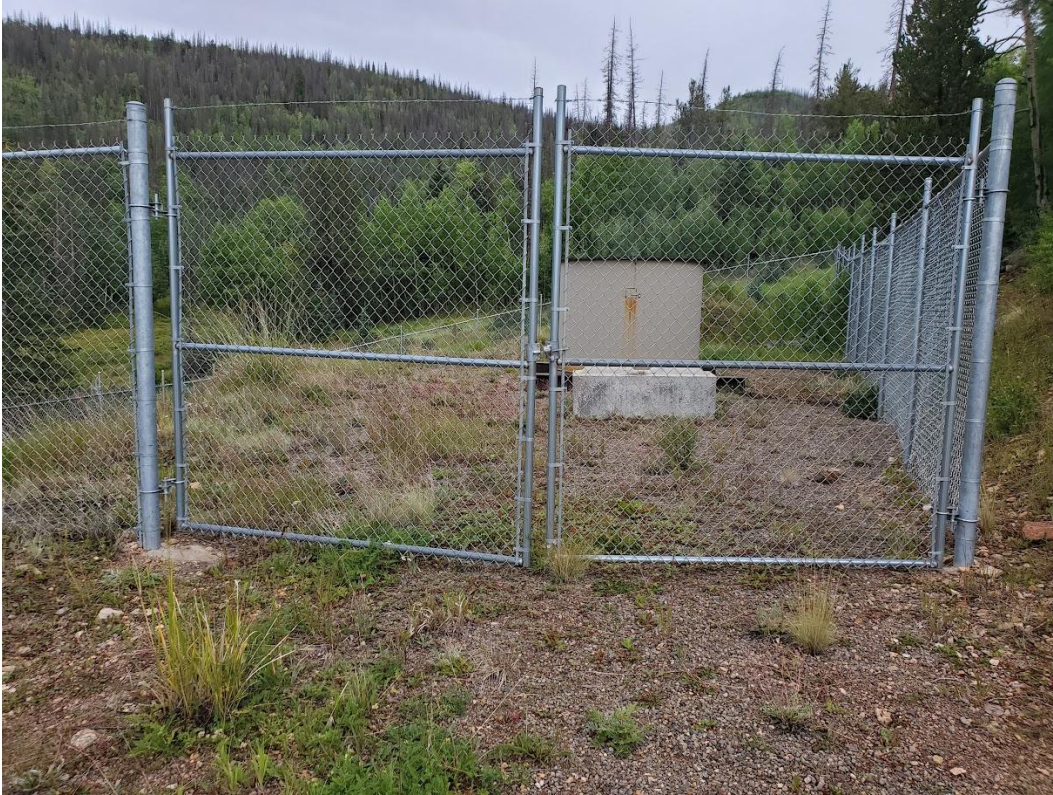
Photo 5: View to the northwest of Windy Gulch Vent Shaft

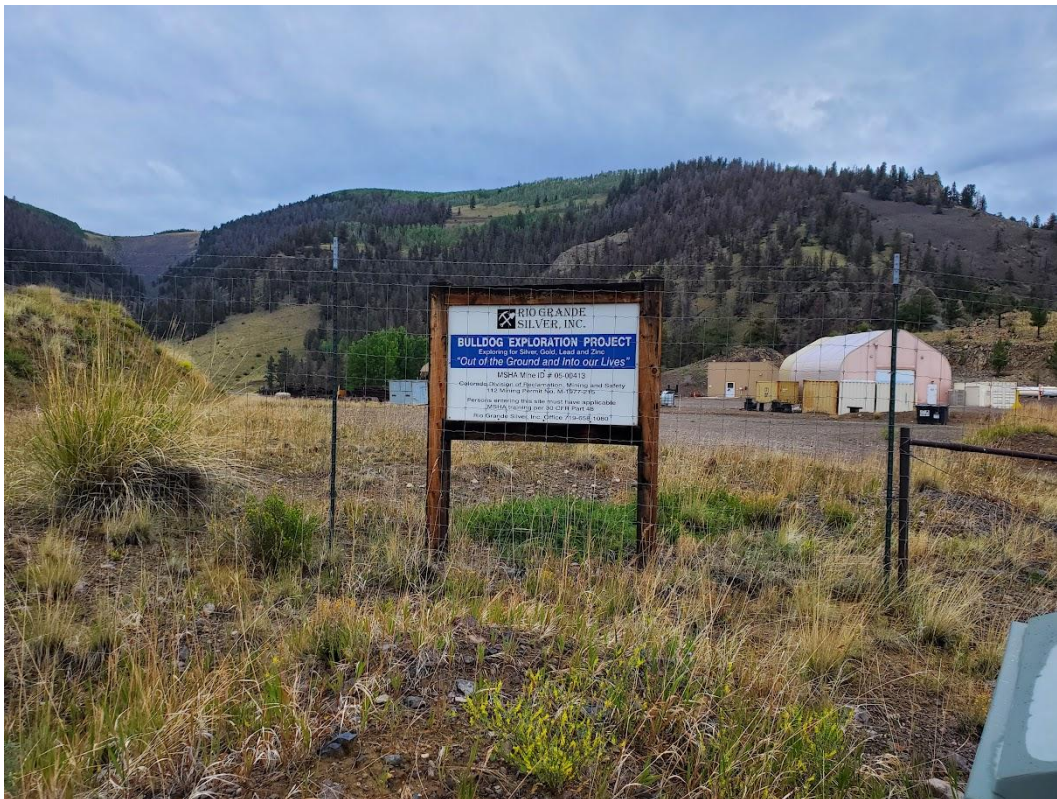
The proper Mine Identification Sign was posted at the entrance to the site (Photo 6) and throughout the various areas of the permit boundaries. Public access to the site is controlled by a locked gate along the access road to the office and facilities area, as well as a series of locked gates along the access roads of the auxiliary facilities located across the permitted area.

Photo 6: View to the north of mine ID sign.
