**MINERALS PROGRAM INSPECTION REPORT**  
**PHONE: (303) 866-3567**

| <b>MINE NAME:</b><br>Equity Exploration Project | <b>MINE/PROSPECTING ID#:</b><br>P-2011-010 | <b>MINERAL:</b><br>Silver, gold, lead and | <b>COUNTY:</b><br>Mineral |
| <b>INSPECTION TYPE:</b><br>Monitoring | <b>WEATHER:</b> Cloudy | <b>INSP. DATE:</b><br>August 26, 2025 | <b>INSP. TIME:</b><br>09:00 |

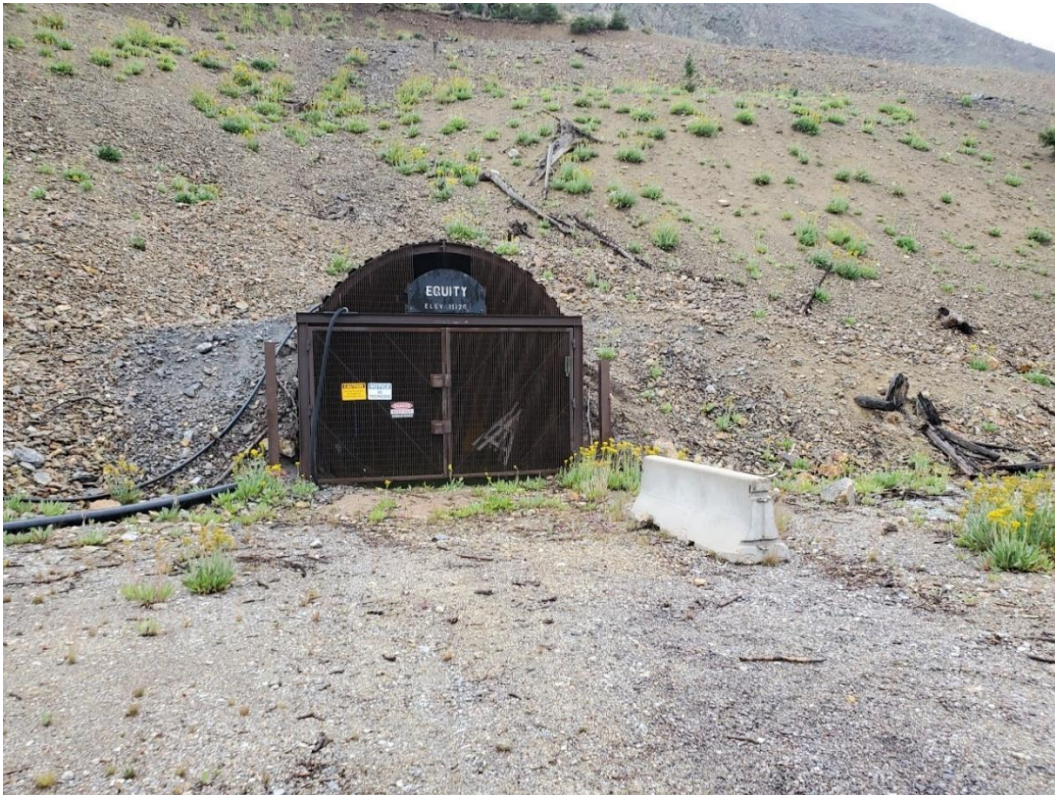
There was no discharge from either portal at the time of the inspection (Photo 1). No signs of impounded meteoric water were observed on site. The entrance road to the site crosses over West Willow Creek. The culvert that conveys water is free of obstruction and functions properly. Fuel tanks have been removed from site and no hydrocarbons are present.

Photo 1: View to the east of the Equity Portal.

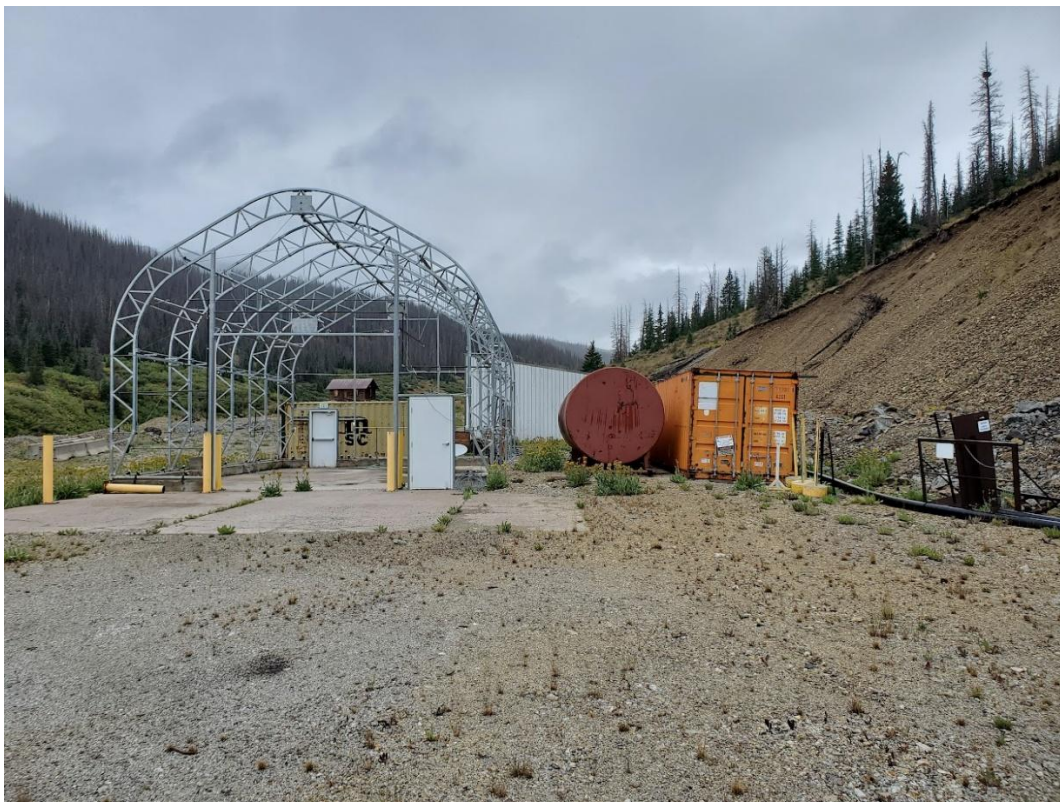
Photo 2: View to the north of maintenance shop skin, water tank, and Connex.

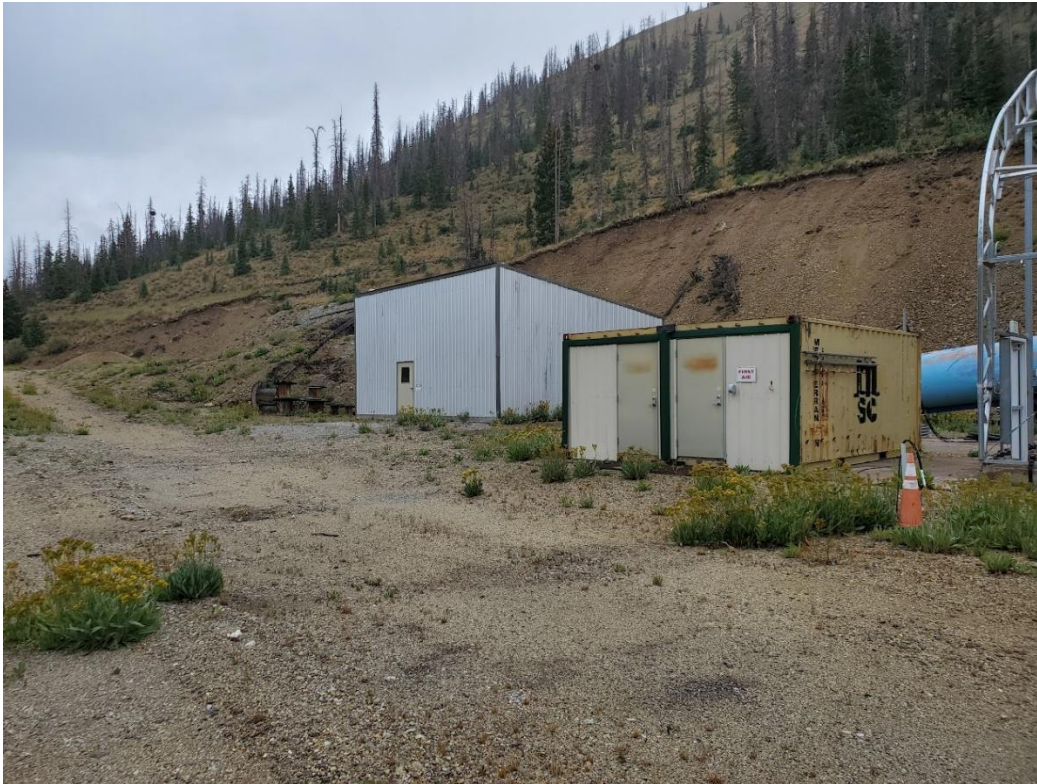
Photo 3: View to the northeast of the empty Fuel Storage Building.

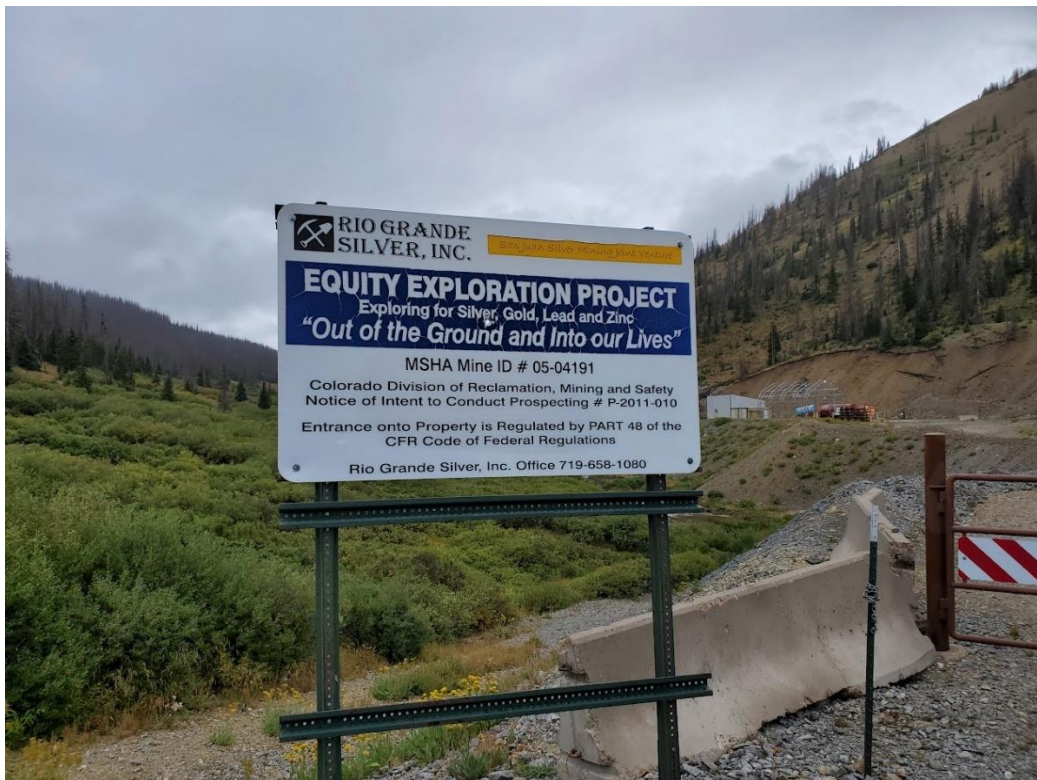
An NOI identification sign was posted at the entrance to the site (Photo 4). Public access to the site is controlled by a locked gate along NFSR 503. No signs of damage or vandalism is present on site.

Photo 4: View to the north of identification sign at the entrance to the site.
