**MINERALS PROGRAM INSPECTION REPORT**  
**PHONE: (303) 866-3567**

| <b>MINE NAME:</b><br>Coyote Ridge | <b>MINE/PROSPECTING ID#:</b><br>M-2000-052 | <b>MINERAL:</b><br>Sand and gravel | <b>COUNTY:</b><br>Fremont |
| <b>INSPECTION TYPE:</b><br>Surety-Related Inspection | <b>WEATHER:</b><br>Clear | <b>INSP. DATE:</b><br>September 4, 2025 | <b>INSP. TIME:</b><br>09:00 |

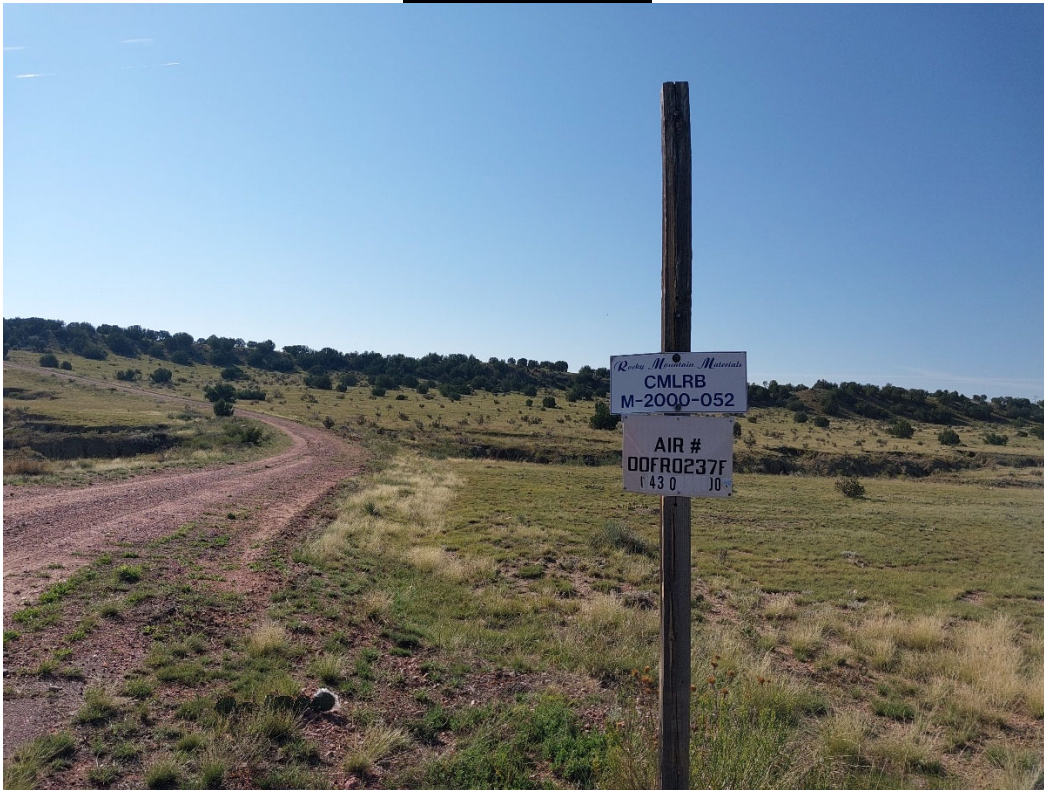
There is a posted sign at the mine entrance, see Photo #1, and the permit boundary is marked with T-posts, see Photo #2.

Photo #1: Mine sign posted at the entrance of the site, on the east side of Hwy 67.

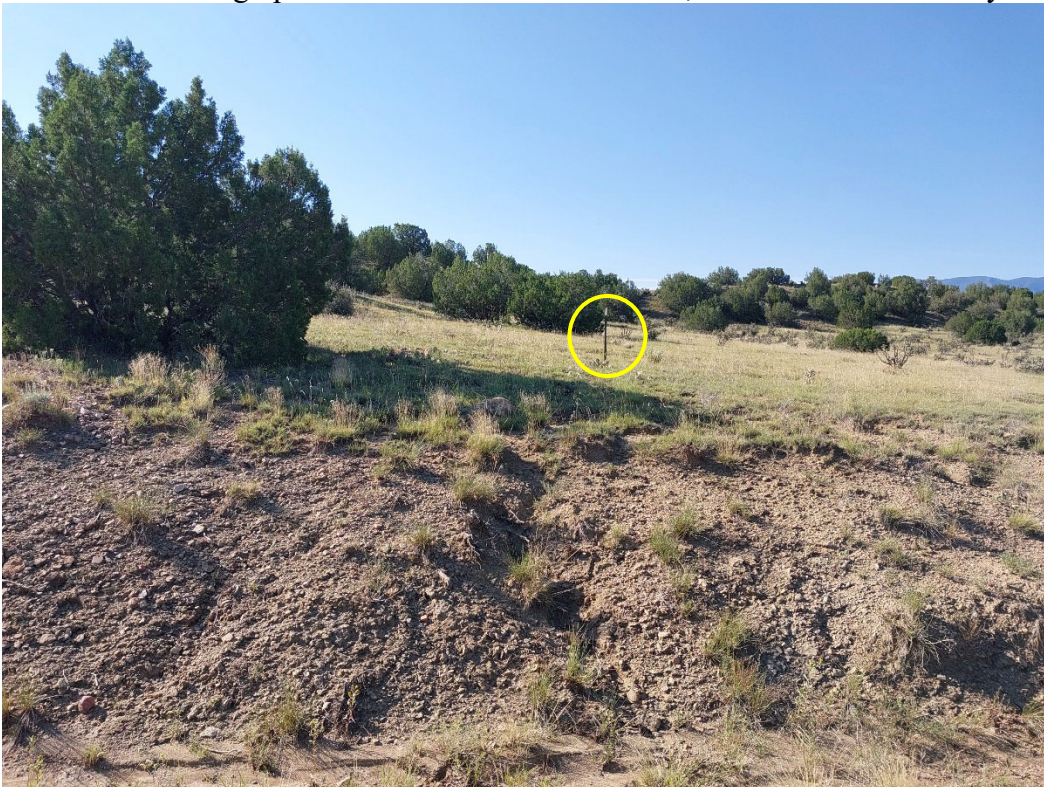
Photo #2: Permit boundary marker, circled in yellow; a T-post with a white top.

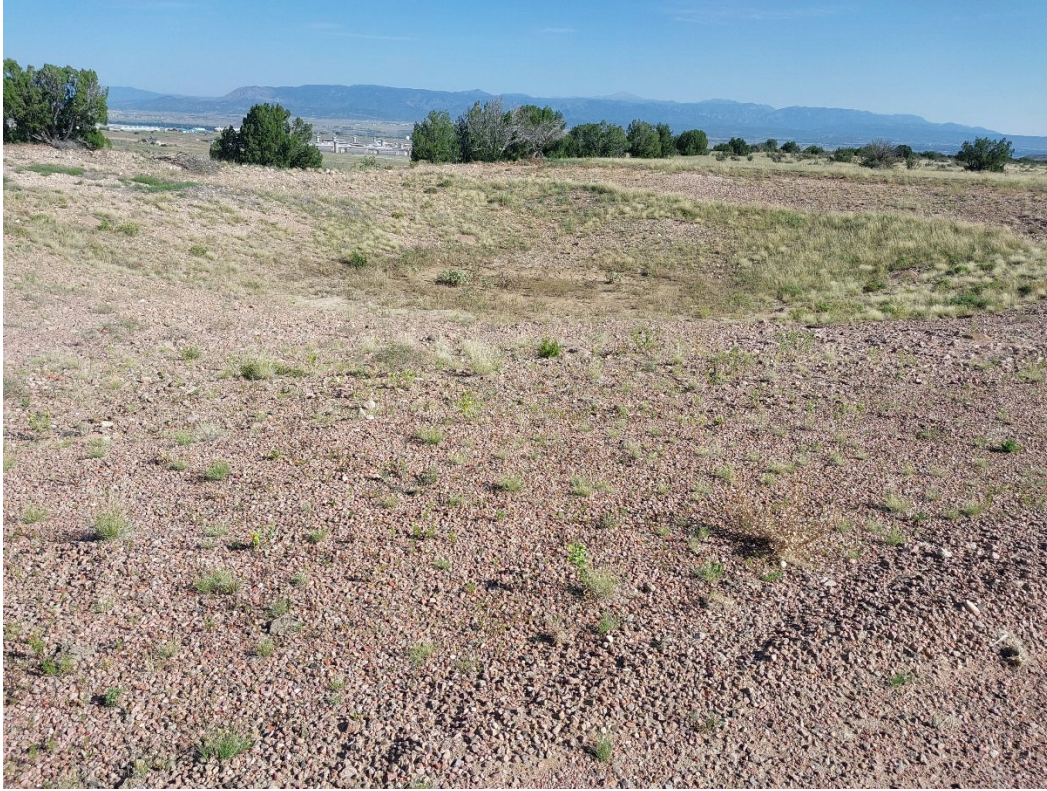
Photo #3: The pit area where mining will commence after the operation becomes active again; looking to the north.

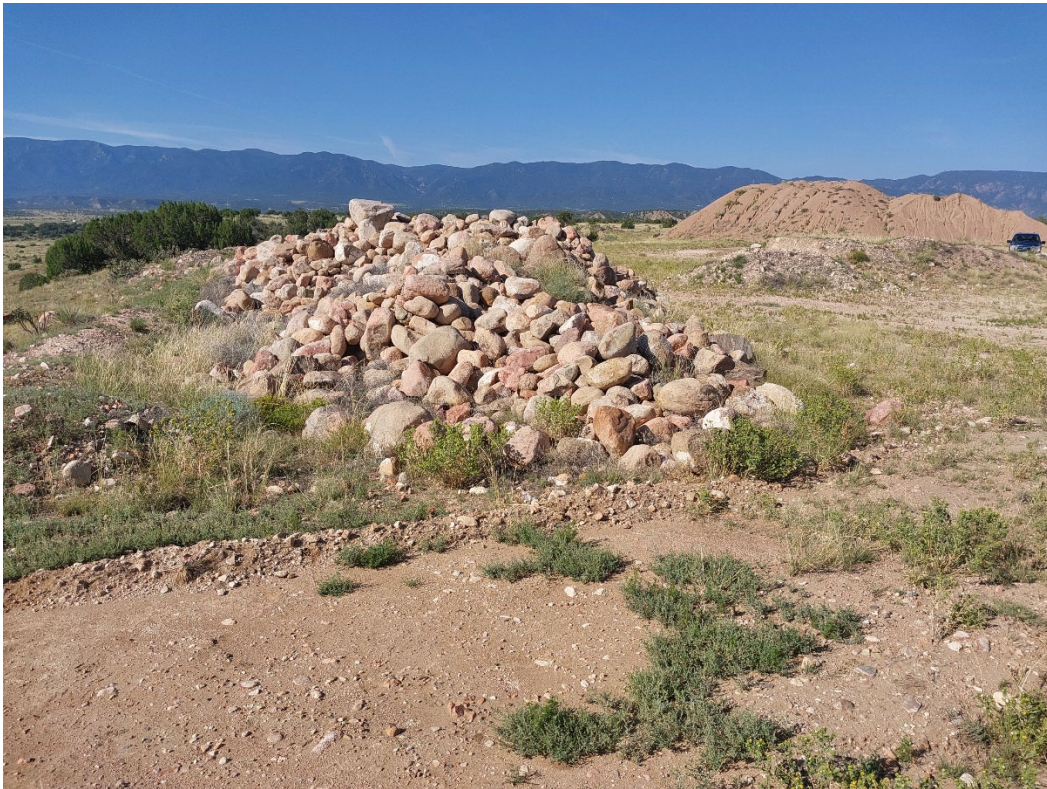
Photo #4: Stockpiles of boulders in the foreground and a stockpile of gravel in the background; looking to the west-southwest.

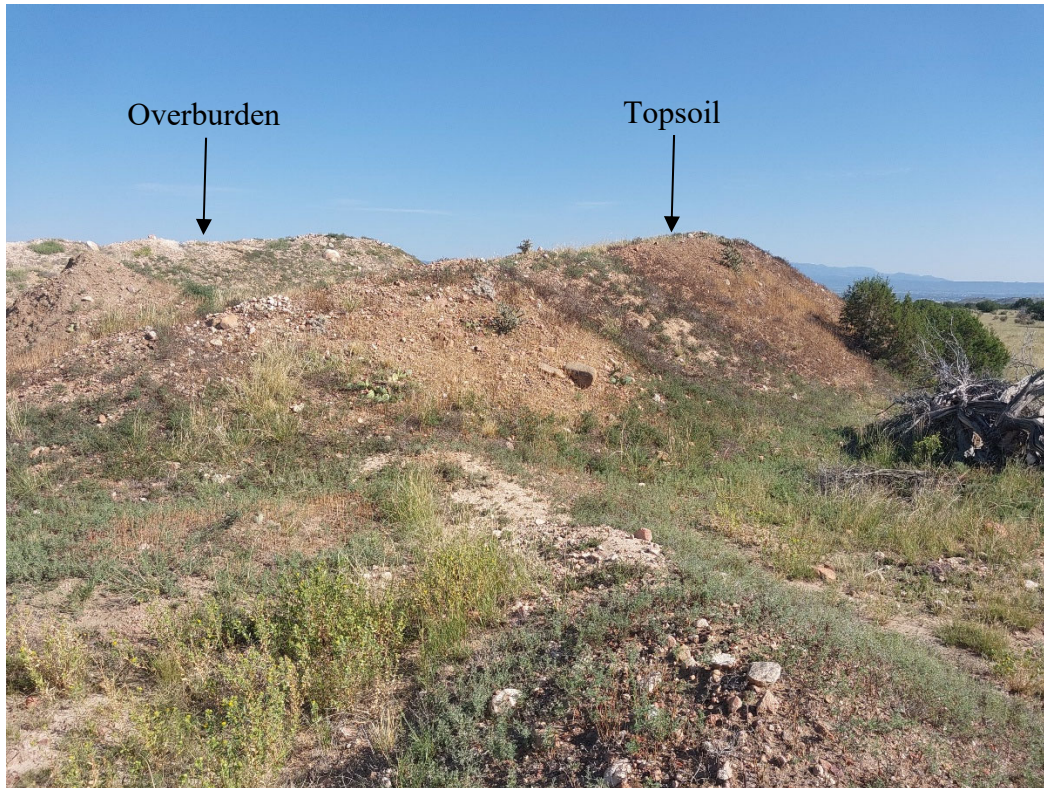
The topsoil stockpile appeared to be well vegetated and stable, see Photos #5 and #6. There did not appear to be any issue with erosion or loss of material occurring.

Photo #5: Overburden and topsoil stockpiles, looking to the north.

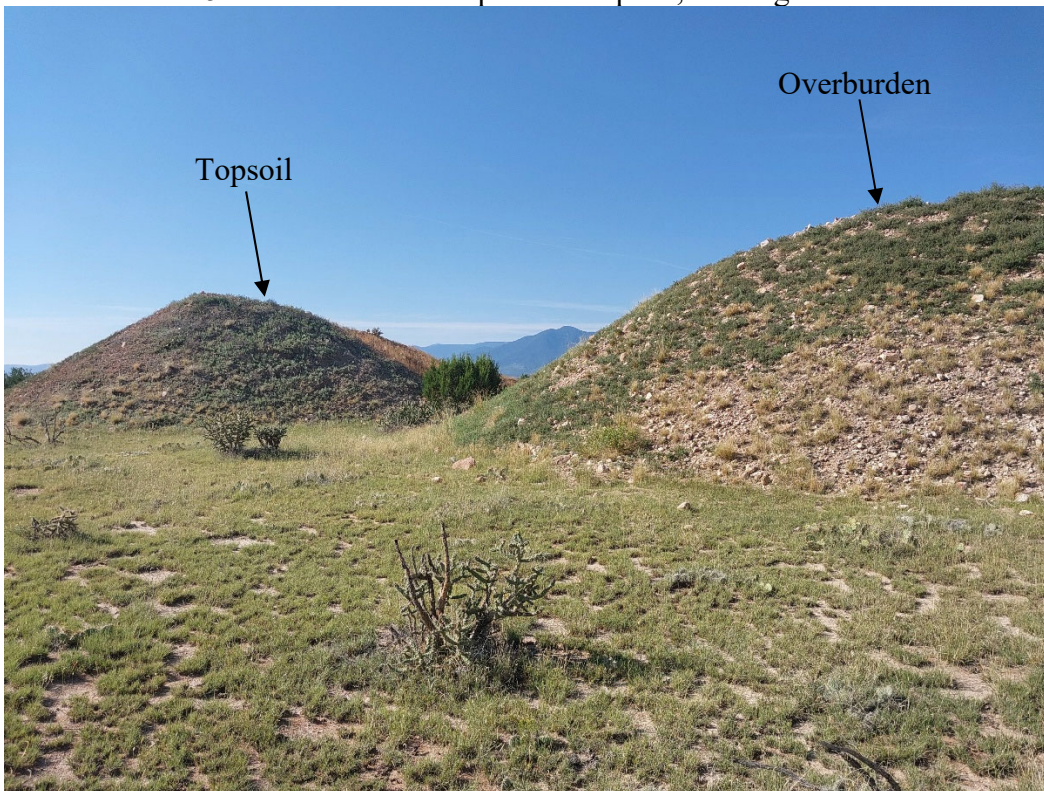
Photo #6: Overburden and topsoil stockpiles, looking to the south.

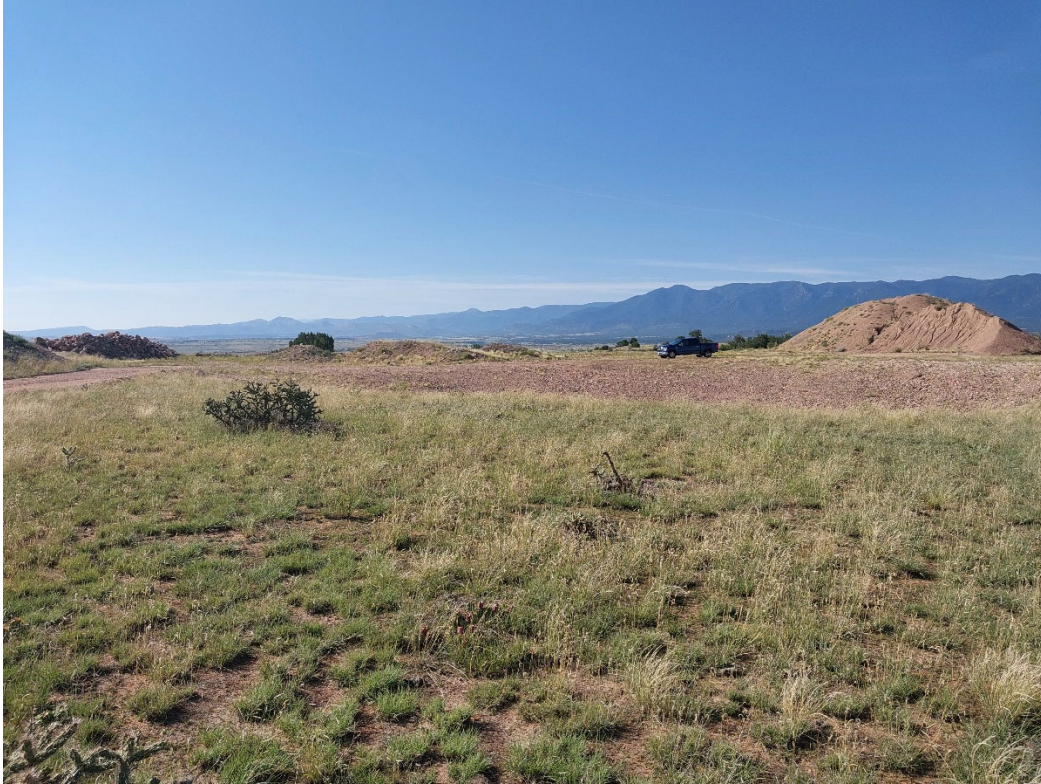
Photo #7: View of the current extraction pit and the product stockpile, looking to the south.

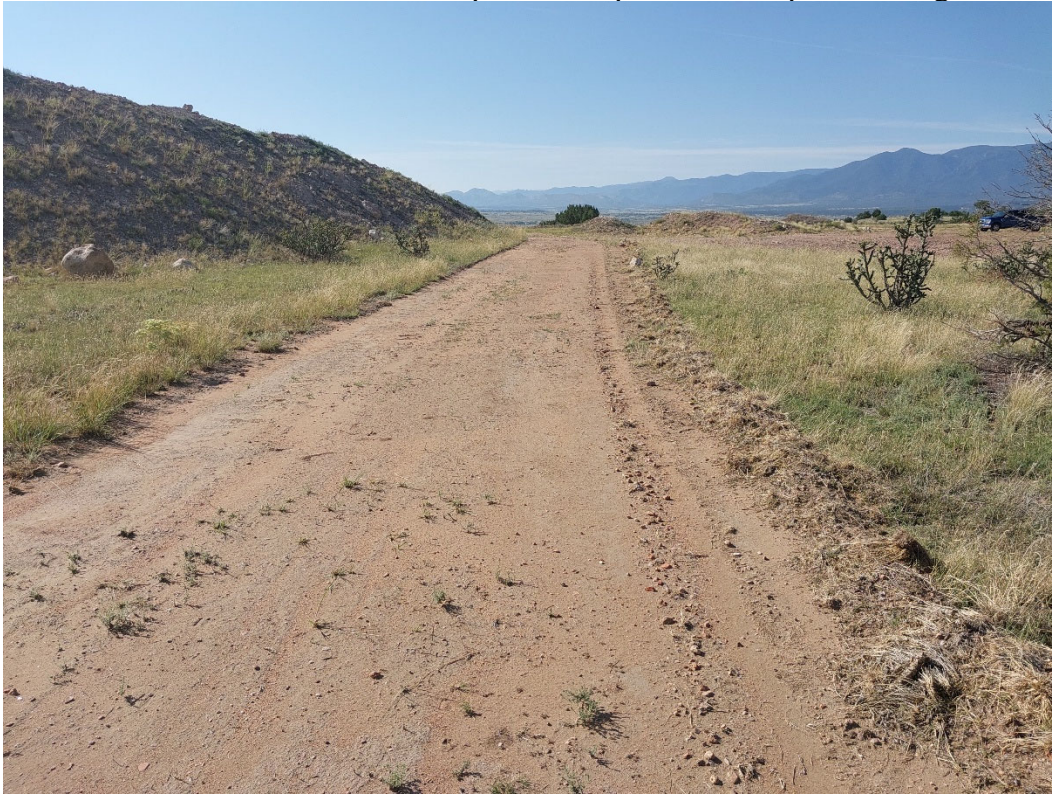
The access road and the internal haul road appear to be in great condition, see Photo #8. They have been well maintained during cessation.

Photo #8: Internal haul road, looking to the south, the overburden stockpile on the left side of the road.

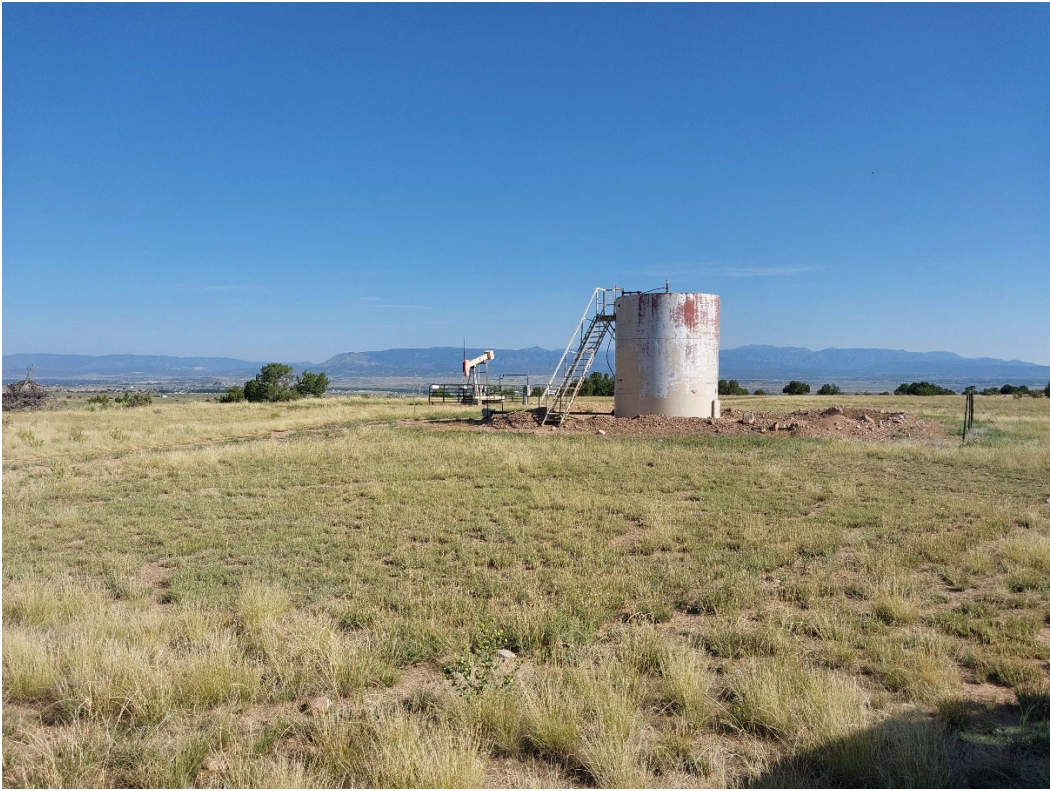
There are no acid or toxic generating materials on site in association with the mining operation. There is an oil derrick and tank within the permitted area, see Photo #9. They are not associated with the mining operation, and there did not appear to be any leaks.

Photo #9: Oil derrick and tank located on the permitted area.

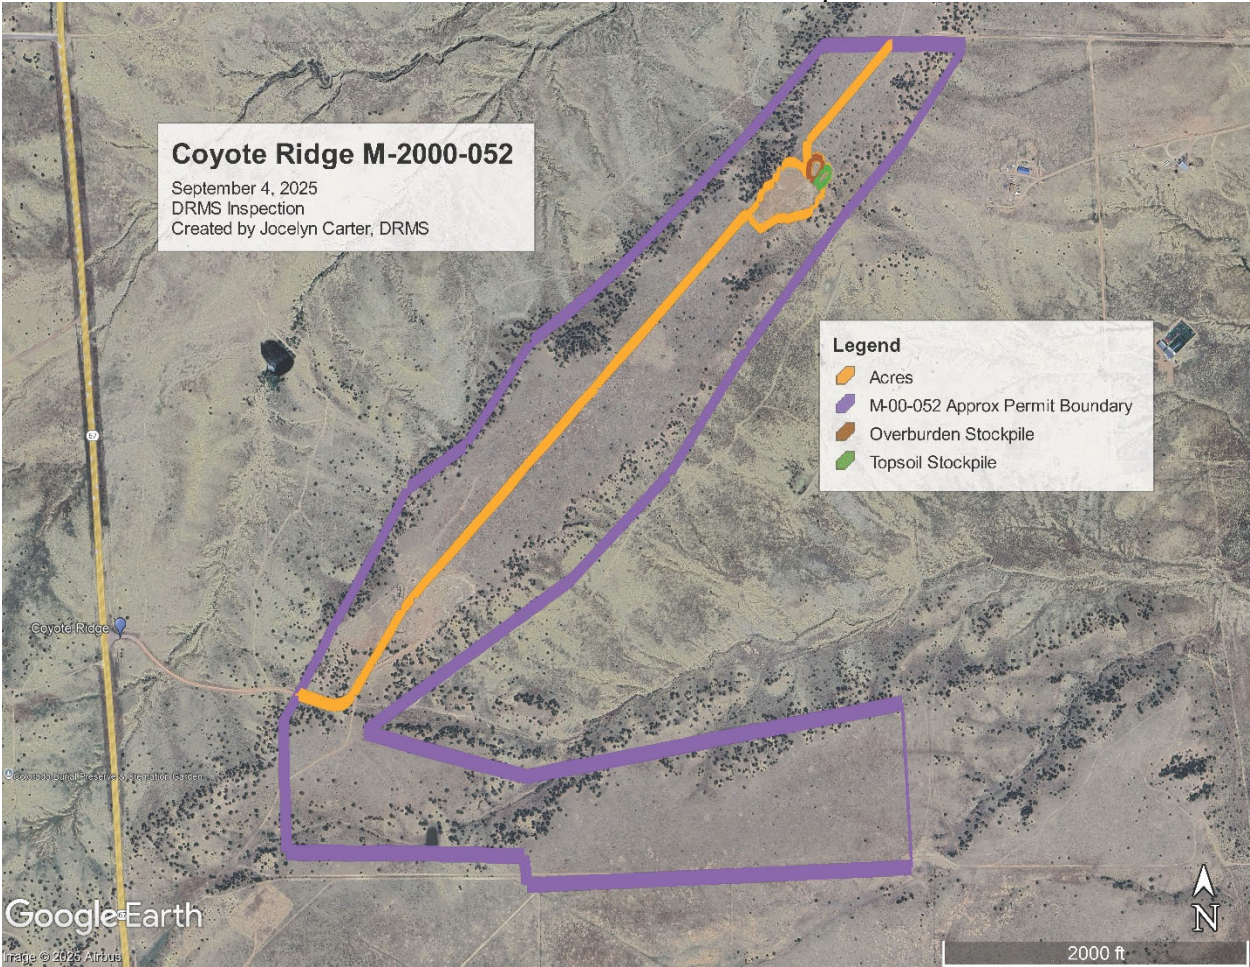
The required financial warranty was calculated based on the disturbance observed during the inspection. A map of the observed disturbances was created and used to calculate the required financial warranty, see Figure 1 below. The required financial warranty was calculated to be \$64,566; this is an increase of \$32,166 to the current \$32,400 being held by the Division. The Division issued a Surety Increase (SI-1) to address this on September 19, 2025.

Figure 1: Map created showing observed disturbances. The purple polygon is the permit boundary, the orange areas are the affected areas including the internal haul roads, the brown area is the location of the overburden stockpile, and the green area is the topsoil stockpile.
