MINERALS PROGRAM INSPECTION REPORT PHONE: (303) 866-3567

MINE NAME:	MINE/PROSPECTING ID#:	MINERAL: CO	OUNTY:
Section 20 Gravel Mine	M-2022-001	Sand and gravel We	eld
INSPECTION TYPE:	WEATHER: Clear	INSP. DATE: IN	SP. TIME:
Monitoring		September 24, 2025 11	:30
OPERATOR:	OPERATOR REPRESENTATIVE:	TYPE OF OPERATION	N:
Red Tierra Equities, L.L.C.	Kyle Regan	112c - Construction Regular Operation	
REASON FOR INSPECTION:	BOND CALCULATION TYPE:	BOND AMOUNT:	
Normal I&E Program	Partial Bond	\$50,658.00	
DATE OF COMPLAINT:	POST INSP. CONTACTS:	JOINT INSP. AGENCY	<i>I</i> :
NA	None	None	
INSPECTOR(S):	INSPECTOR'S SIGNATURE:	SIGNATURE DATE:	
Patrick Lennberg	Patrick IS	September 26, 2025

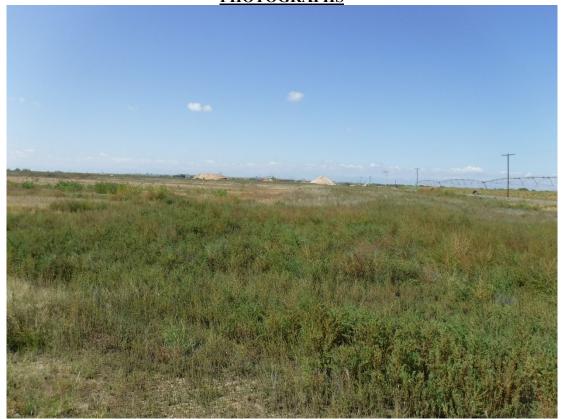
Photo 1: Looking west from the mine entrance across the northern portion of the 43 acre disturbed area

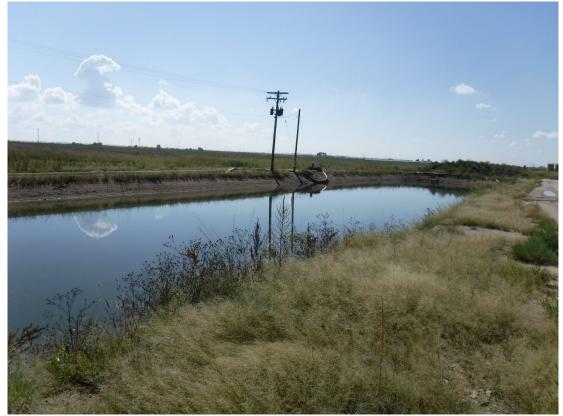
Photo 2: Irrigation pond located at mine entrance

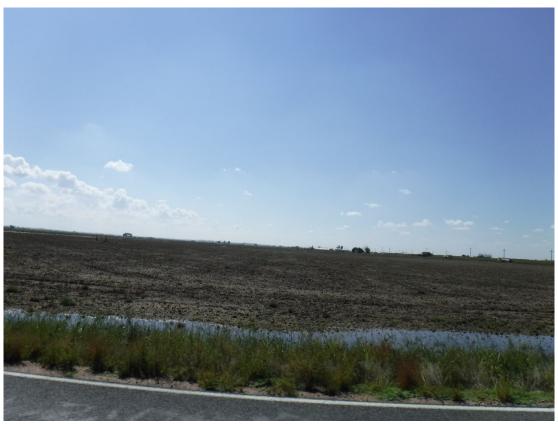
Photo 3: Typical agricultural field that makes up the current permit area
