## Robins Consolidated Pit M1991133- Inspection Report

**MINERALS PROGRAM INSPECTION REPORT**  
**PHONE: (303) 866-3567**

| <b>MINE NAME:</b><br>Robins Consolidated Pit | <b>MINE/PROSPECTING ID#:</b><br>M-1991-133 | <b>MINERAL:</b><br>Sand and Gravel | <b>COUNTY:</b><br>Conejos |

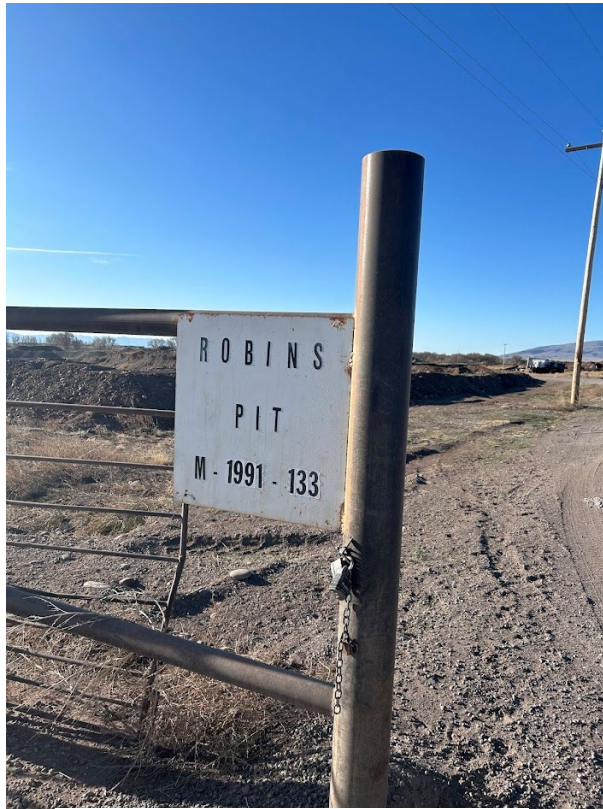
The Robins Consolidated Pit, also known as the Valdez Pit, is a 112c sand and gravel operation with a permitted area of 45.85 acres. The site is located approximately 2 miles south of Antonito, CO. The San Antonio River meanders along the eastern boundary of the permit. A mine entrance sign was observed in accordance with Rule 3.1.12 (see Photo 1). The permit boundary is marked with a fence.

Photo 1: Mine entrance sign.

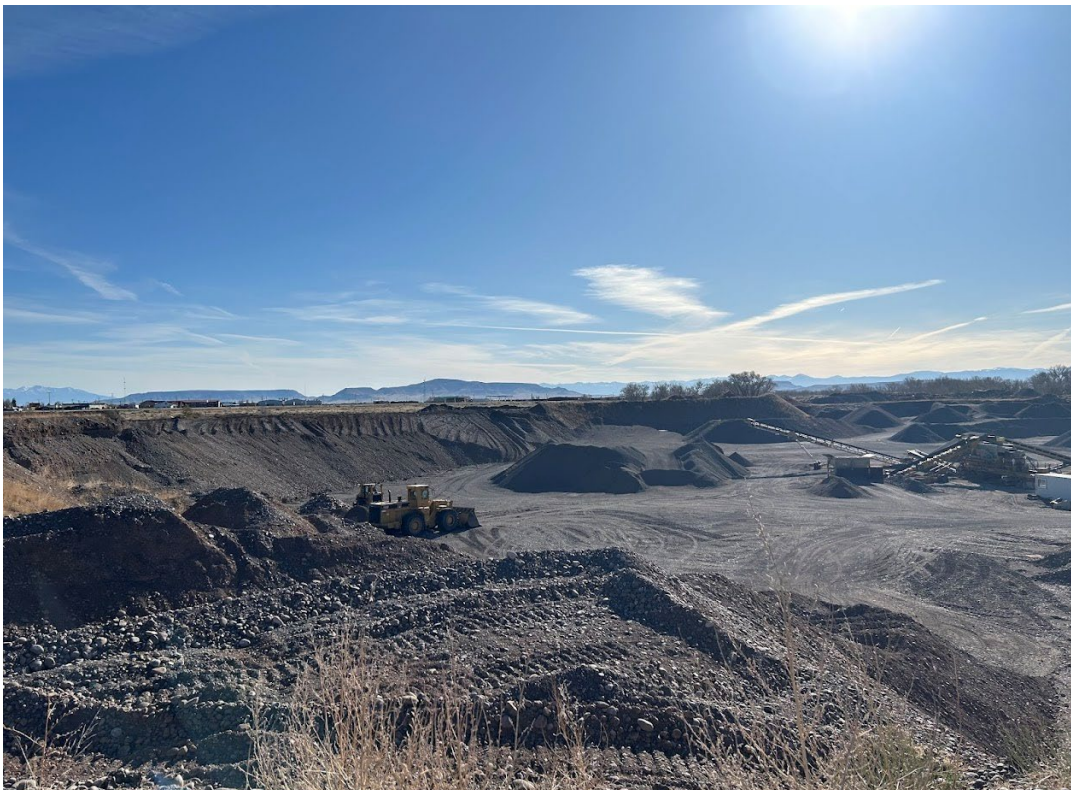
Access to the permit area is from a gate along County Road 13. Within the original permit area, the Operator is conducting excavation of the highwall on the northern side of the pit within the Phase I area in accordance with the approved mining plan. The highwall maintains side slopes close to a 3:1 horizontal to vertical configuration, and the pit floor was approximately thirty (30) feet in depth (see Photo 2). Minimal amount of erosion was observed along the pit slopes. No ponding or exposed groundwater was observed on the pit floor. Stockpiles of material were observed on the pit floor, as well as a portable crusher and screen plant. A topsoil berm approximately four (4) feet in height surrounds the pit in accordance with the approved mining plan. The Phase 1 area also contained a laydown area with several trailers, a track excavator, a wheel loader, and a portable crusher (see Photo 3).

Photo 2: Primary working pit with material stockpiles and processing plant, facing northeast within the northern portion of the permit area.

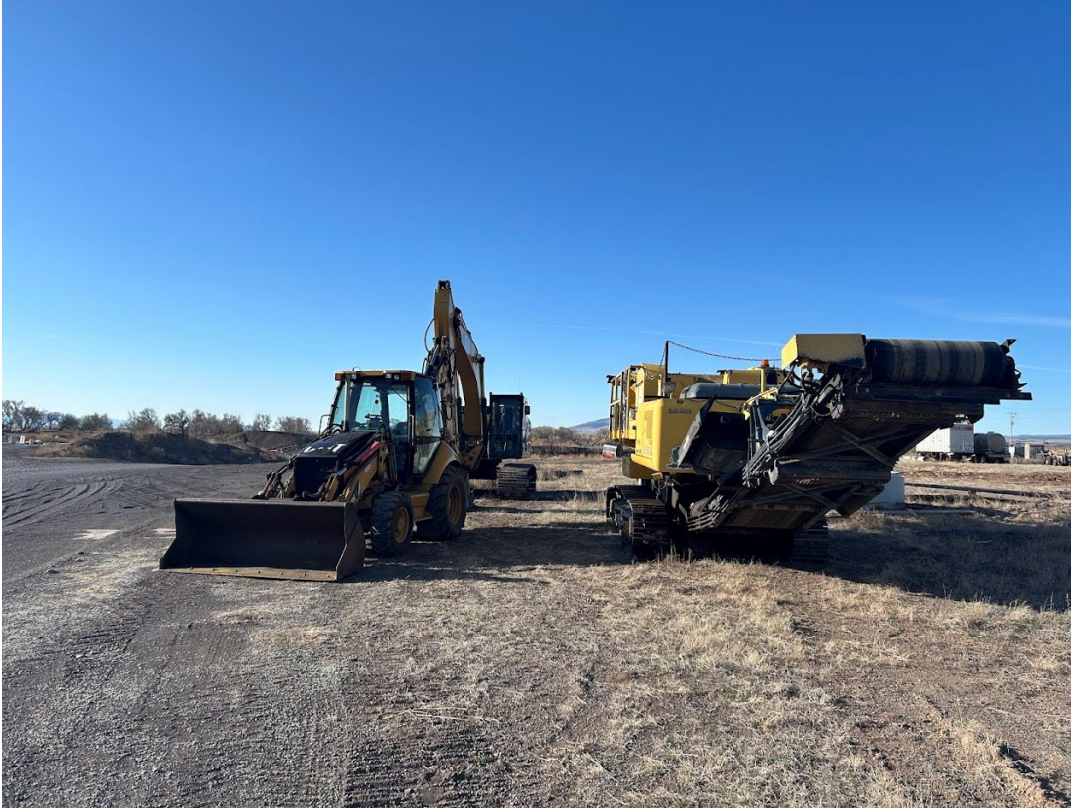
Photo 3: Mining equipment within laydown area adjacent to the southwest of the primary working pit, facing south.

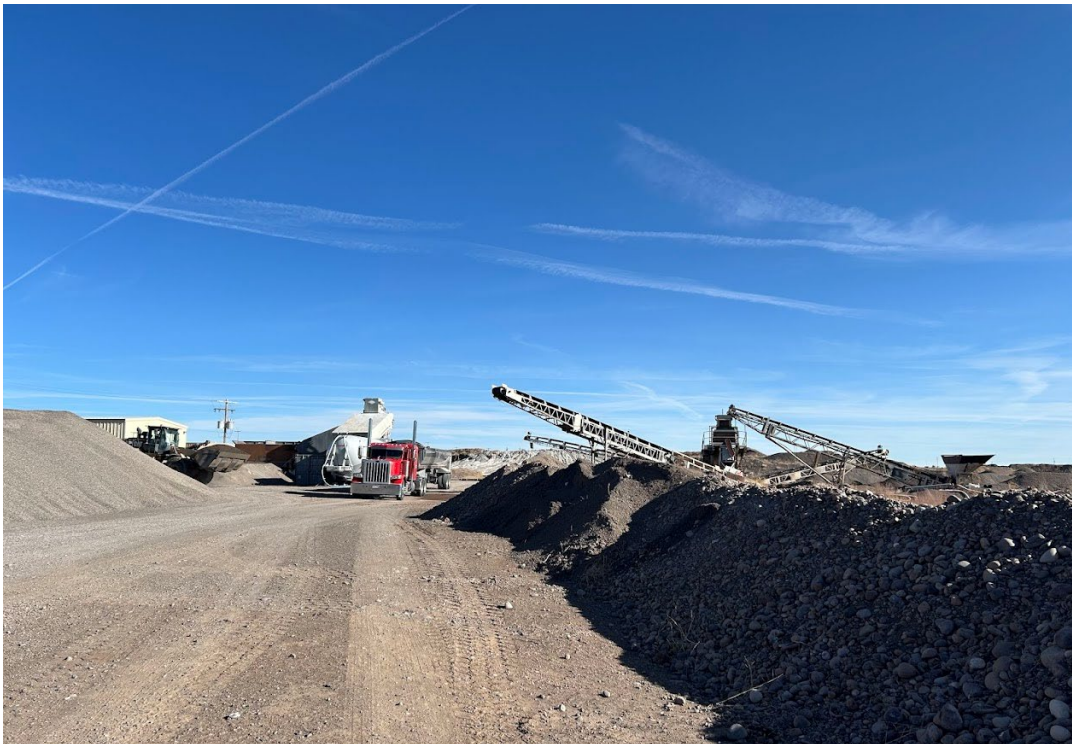
A hot mix asphalt and concrete batch plant is operational in the southern portion of the permit as approved via Technical Revision (TR) 2 (see Photos 4 and 6). The batch plant area contains a sediment pond, which is sealed with clay embankments (see Photo 5). No erosion was observed along the embankments of the pond. The batch plant was active at the time of the inspection, with several haul trucks, loaders, and dozers being used. The Operator maintains a well permit under DWR Case No. 2 W-953, in which water is used for the batch plant operation. The permit does not allow for the exposure of groundwater via mining. After previous inspection reports indicated excess amounts of trash within the permit boundary, the site was in good condition during this inspection and contained no trash.

Photo 4: View of the batch plant and processing area within the southern portion of the permit area, facing north.

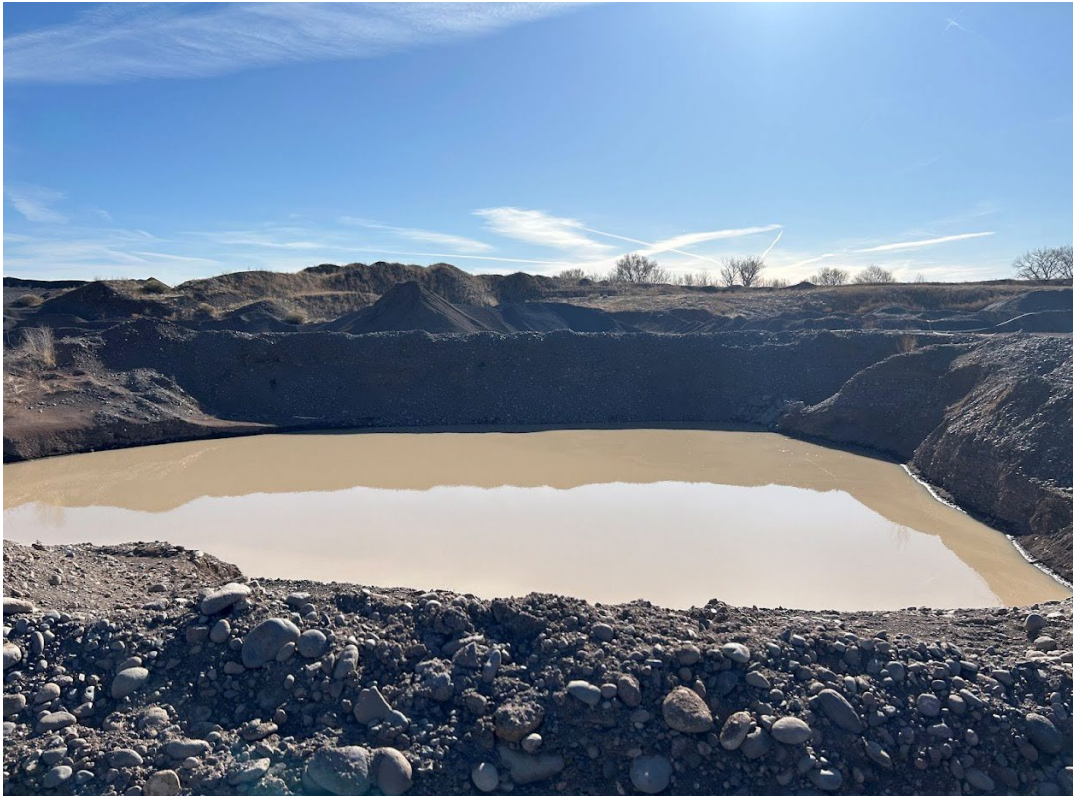
Photo 5: View of the sediment pond and clay embankments adjacent to the batch plant, facing east.

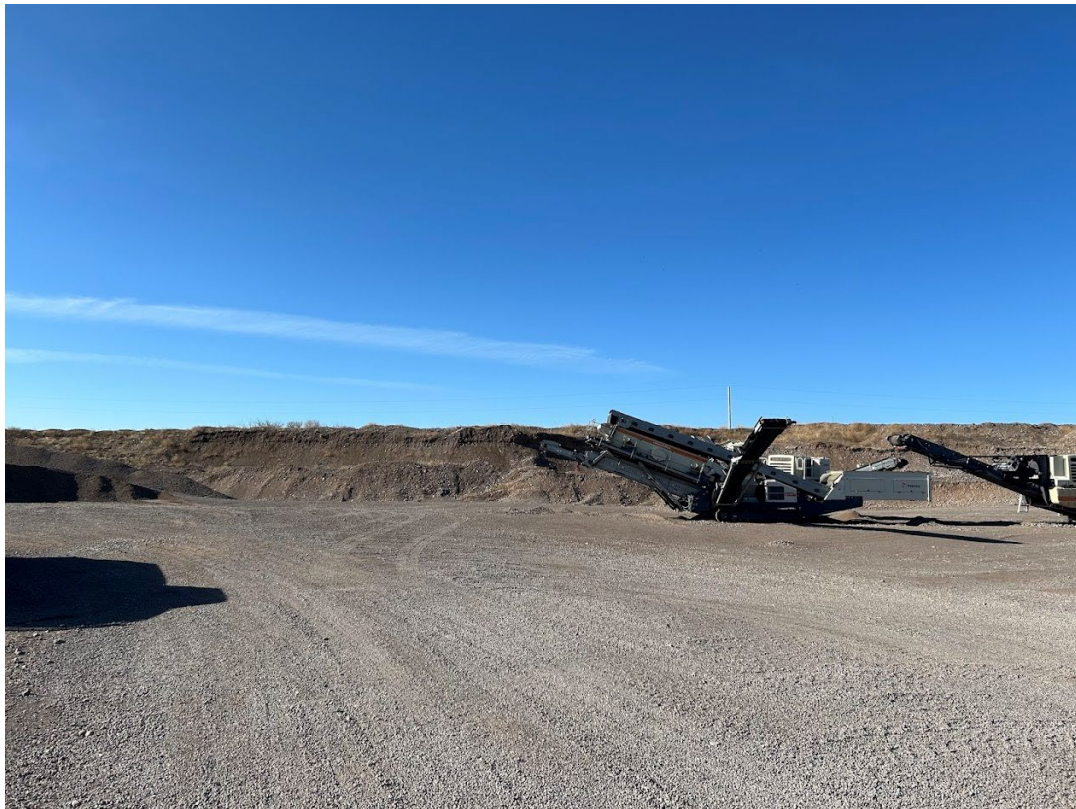
Photo 6: View of a stone crusher along the southern edge of the permit boundary, facing south. A vertical highwall exists along the southern permit boundary.

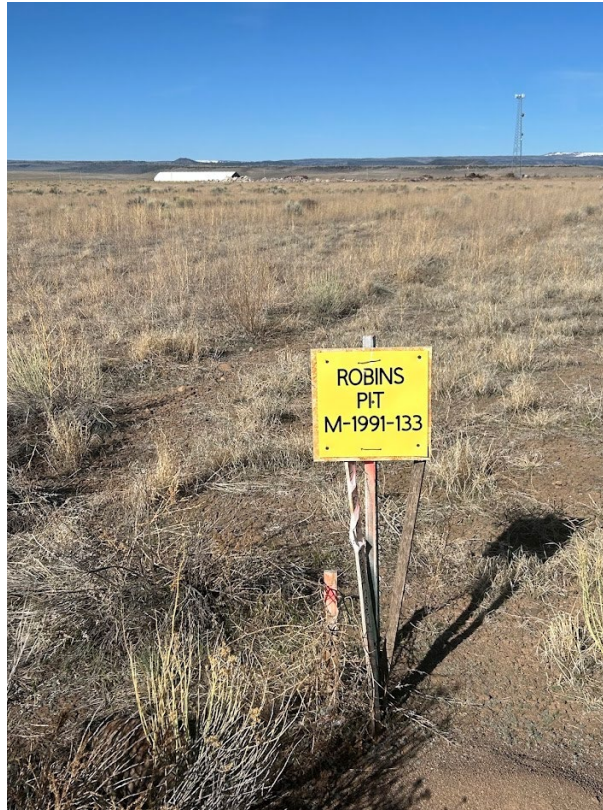
The AM-2 application was submitted by the Operator to increase the permit acreage from 68.35 acres to 114.2 acres and change the post-mine land use to rangeland. The expansion area is located to the southwest of the original permit area to the west of County Road 13. A notice sign for the amendment area was observed in accordance with Rule 1.6.2(1)(b). The Division inspected the proposed AM-2 area, which is divided into ten (10) new mining phase areas. T-posts were observed, denoting the locations of the corners of the AM-2 area (see Photo 7). Most of the expansion area is flat, undisturbed grasses, except for a small area with various equipment located adjacent to the El Coda Ditch in the Phase 2 area. The ditch was dry during the inspection and typically remains dry according to the Operator. Within Phase 8 of the expansion area, the Operator maintains an augmentation groundwater recharge pit (see Photo 9).

Photo 7: View of northeast boundary marker for the AM-2 area, facing southwest.

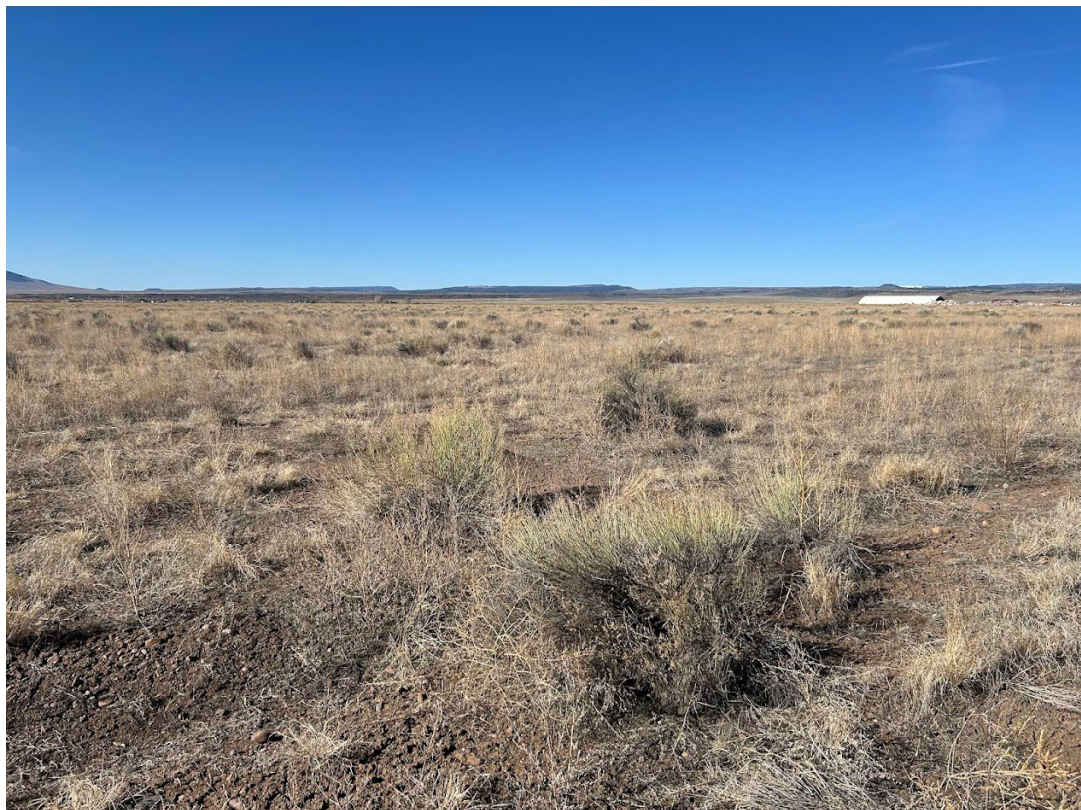
Photo 8: View of native grasses within the AM-2 expansion area, facing southwest.

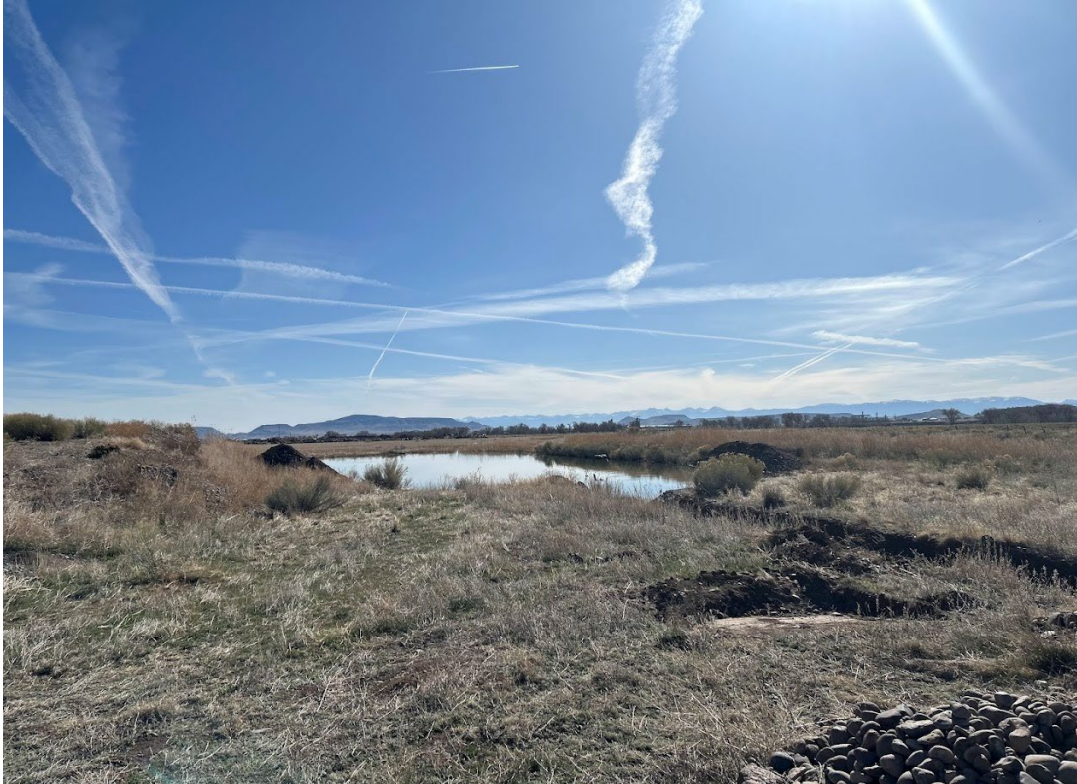
Photo 9: View of the groundwater recharge pond within the southwest corner of the AM-2 expansion area.
