## MINERALS PROGRAM INSPECTION REPORT

| <b>MINE NAME:</b><br>Higgins Pit II | <b>MINE/PROSPECTING ID#:</b><br>M-2012-013 | <b>MINERAL:</b><br>Borrow material for | <b>COUNTY:</b><br>Lincoln |
| <b>INSPECTION TYPE:</b><br>Monitoring | <b>WEATHER:</b> Clear | <b>INSP. DATE:</b><br>September 17, 2025 | <b>INSP. TIME:</b><br>12:30 |

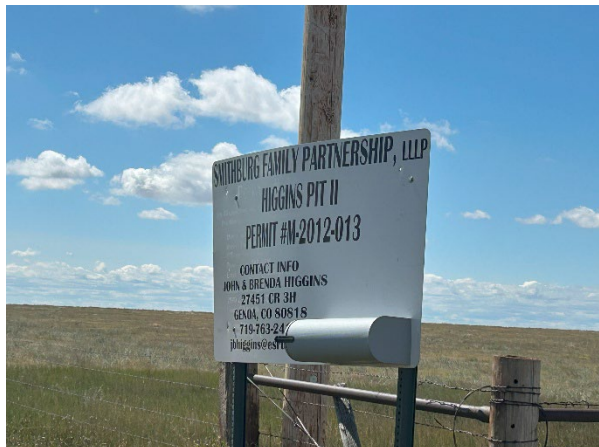
Photo 1: Posted mine ID sign.

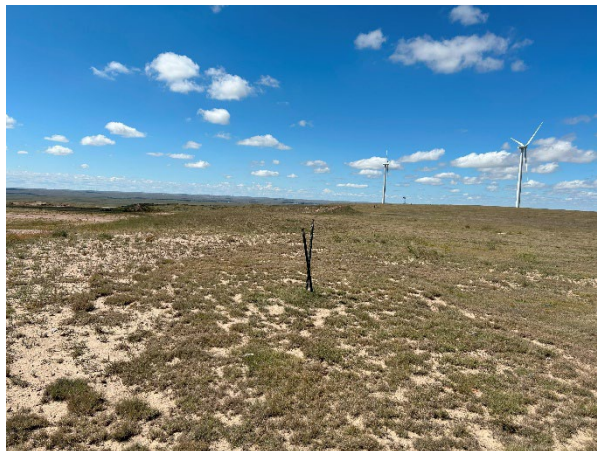
**PROBLEM/POSSIBLE VIOLATION:** Problem: The affected area boundary markers are missing or incorrectly placed. This is a problem for failure to maintain boundary markers around the affected area as required by Section 3.1.12(2) of the rule.

As included in this report, an effort was taken to identify the location of the site's boundary markers, and only one could be found located at the northeast corner of the site. No other boundary markers have been identified and this has been cited as a problem within this report. Please provide photographic evidence and gps coordinates of the replacement markers. GPS data and the operator's provided annual report map was used later to verify that no outside disturbance has occurred at this site.

Photo 2: Observed boundary marker.

**CORRECTIVE ACTIONS:** The operator shall conduct a survey and replace the boundary markers in the correct location(s). The operator shall provide proof to the Division that this has been done by the corrective action date.

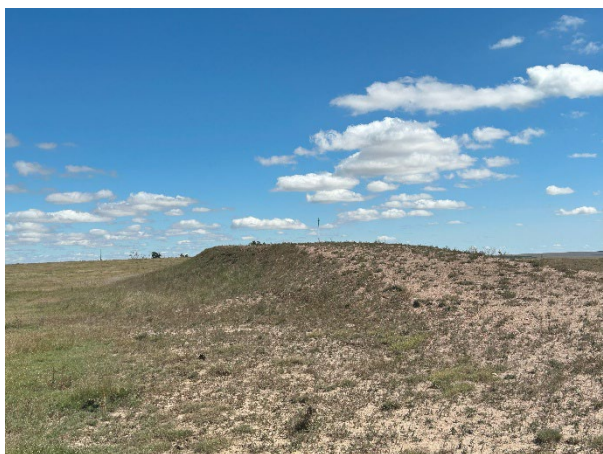
A topsoil berm was located near the northern site boundary, and appeared to be stable and seeded at the time of inspection. Mining appears to have occurred relatively recently, and product stockpiles were present in the center of the site. No reclamation is currently taking place, and no significant impact to the surrounding hydrologic balance was observed. No other issues were identified.

Photo 3: Topsoil berm facing east.

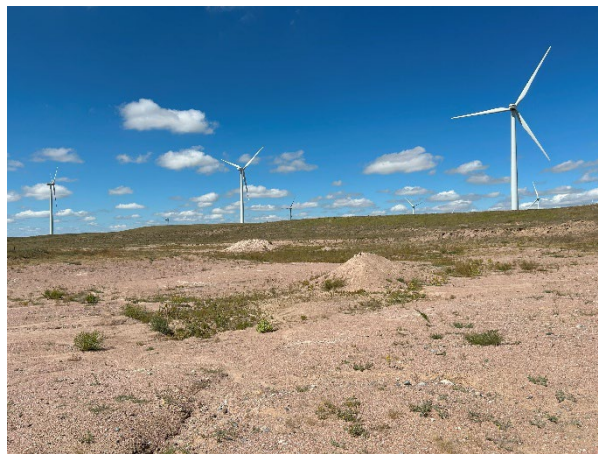
Photo 4: Primary pit floor, facing northwest.

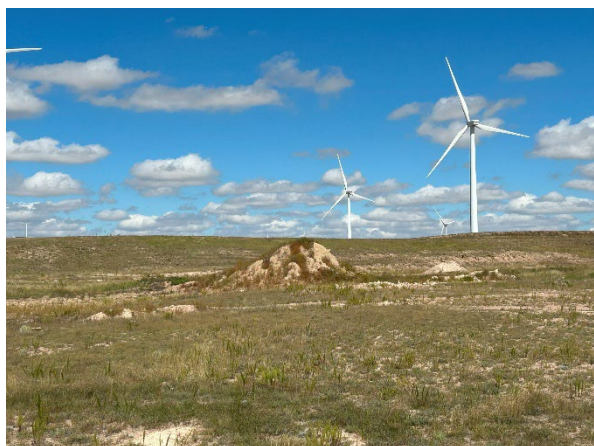
Photo 5: Product stockpile and mining area facing north.
