**MINERALS PROGRAM INSPECTION REPORT**  
**PHONE: (303) 866-3567**

| <b>MINE NAME:</b><br>Franciscotti Pit #2 | <b>MINE/PROSPECTING ID#:</b><br>M-2018-058 | <b>MINERAL:</b><br>Sand and gravel | <b>COUNTY:</b><br>Huerfano |
| <b>INSPECTION TYPE:</b><br>Monitoring | <b>WEATHER:</b><br>Partly cloudy | <b>INSP. DATE:</b><br>September 10, 2025 | <b>INSP. TIME:</b><br>12:40 |

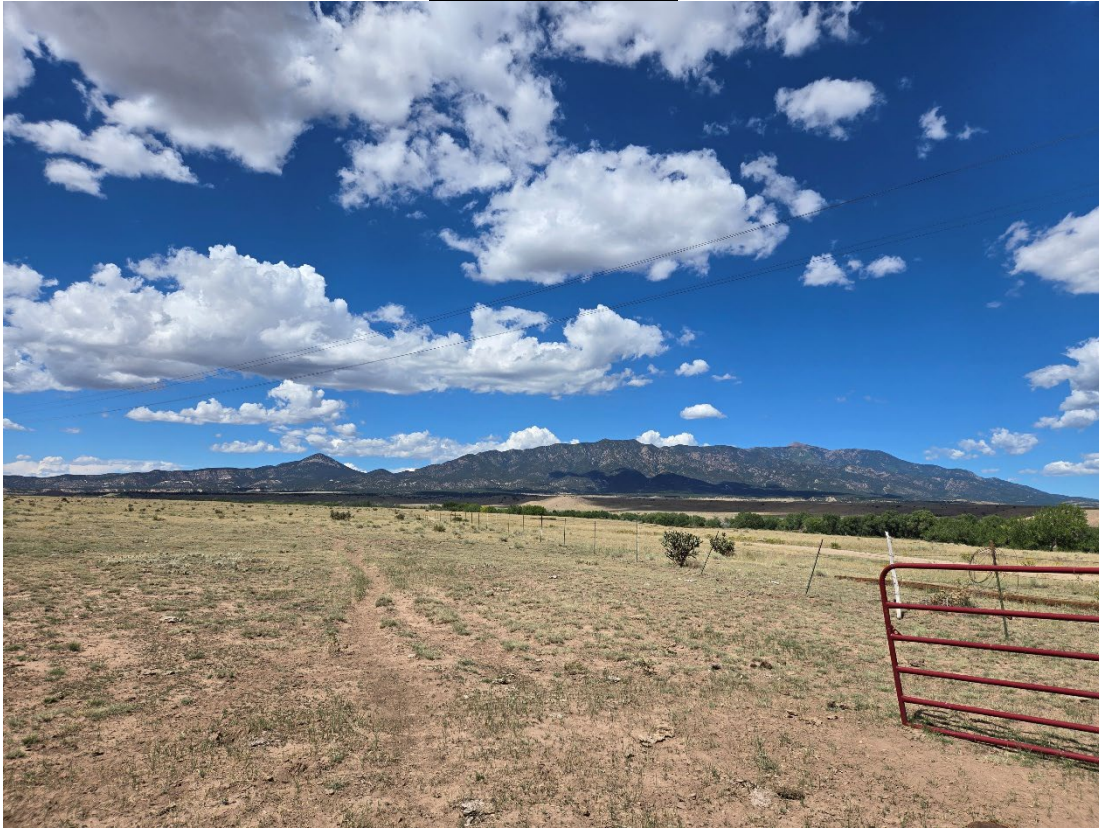
**Photo 1:** Looking northwest from the permit entrance.

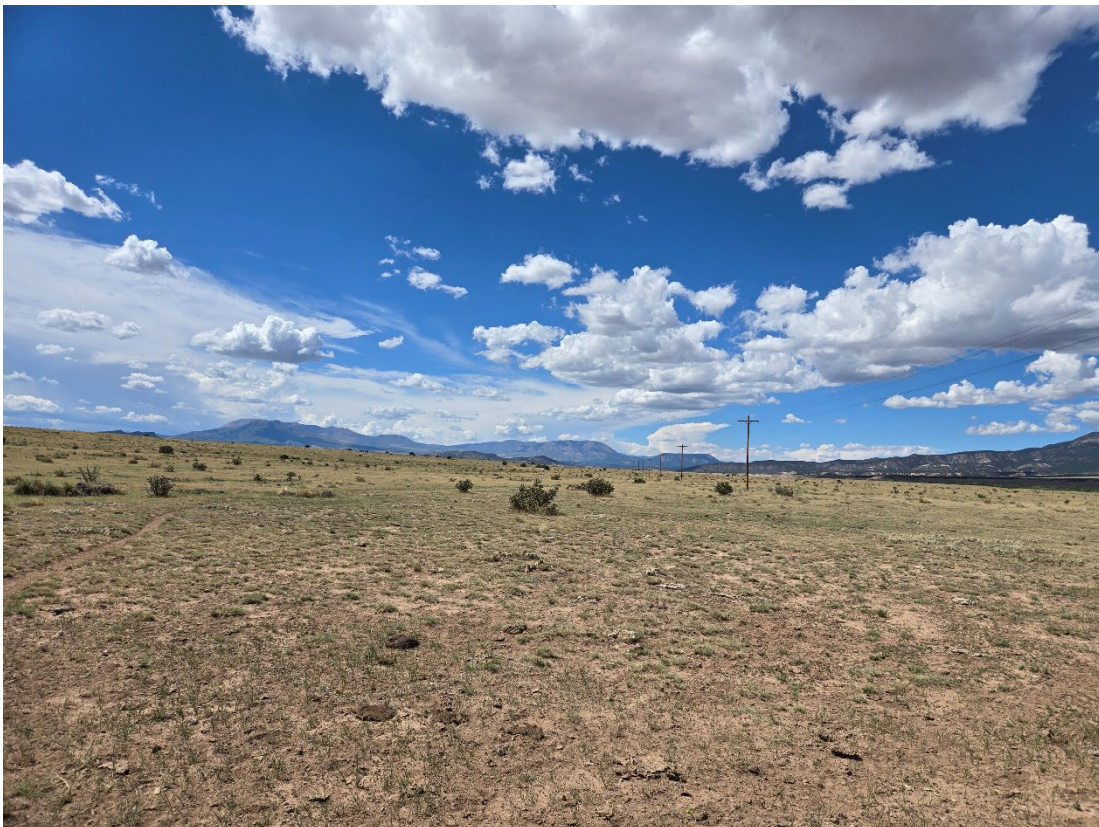
**Photo 2:** Looking southwest from the permit entrance.

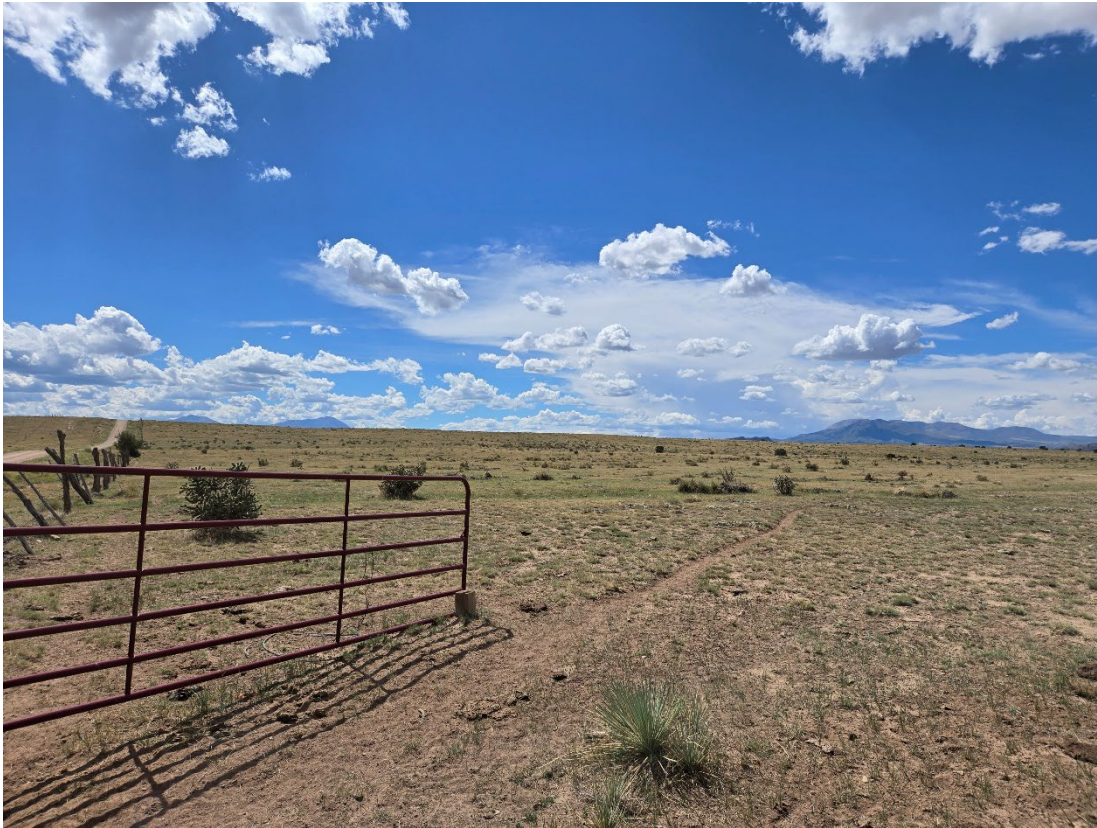
**Photo 3:** Looking south from the permit entrance.

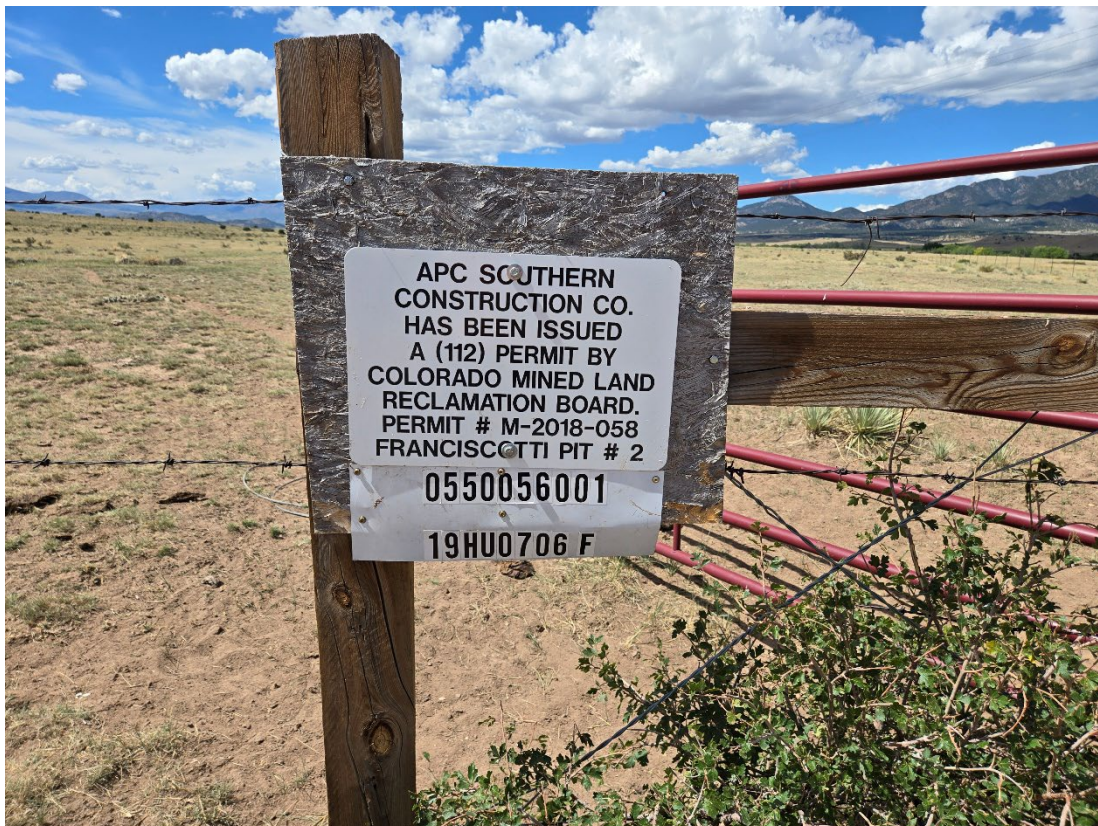
A mine sign was posted at the entrance to the site in compliance with Rule 3.1.12(1). The affected land boundary markers were not visible from the entrance at the time of the inspection. The Division's 2019 inspection report stated that the proposed boundary had been marked with two-inch PVC casing painted yellow with orange flagging. These markers were not observed at the time of the 2025 inspection. The Operator was reminded that prior to the initiation of operations, the affected land boundary must be marked in compliance with Rule 3.1.12(2).

**Photo 4:** Mine sign posted at the entrance.
