MINERALS PROGRAM INSPECTION REPORT PHONE: (303) 866-3567

| MINE NAME: | MINE/PROSPECTING ID#: | MINERAL: | COUNTY: |
|---|---|---|---|
| Pitch Project | M-1977-004 | Uranium | Saguache |
| Monitoring | Clear | September 30, 2025 | 10:30 |
| Homestake Mining Company | David Wykoff | 112d-3 - Designated Mining Operation | |

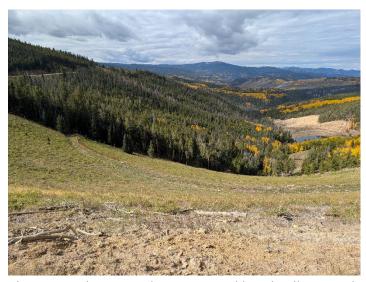
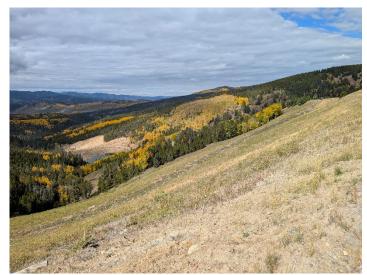
Tie Camp Rock Dump – Slopes appear stable and well vegetated. Noxious weed infestations were not observed. No problems were noted.

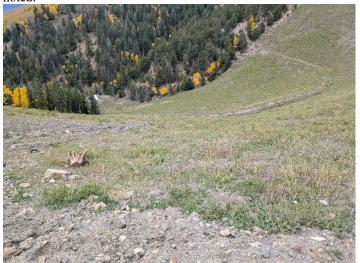
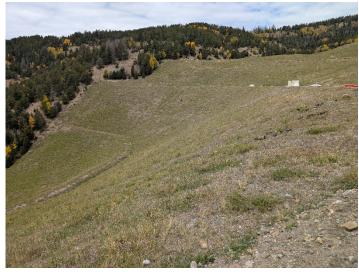
Indian Rock Dump - Slopes appear stable and well vegetated. Noxious weed infestations were not observed. No problems were noted.

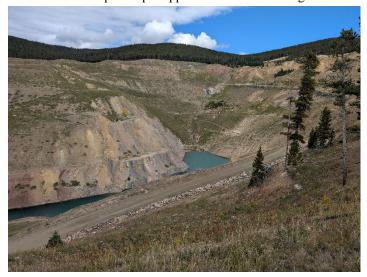
View of the North Pit from the south side

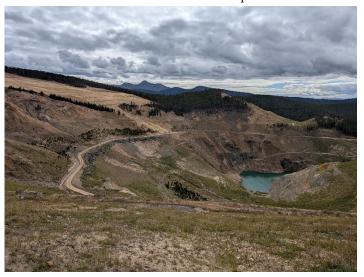
Landslide area above the North Pit viewed from the north side of the pit

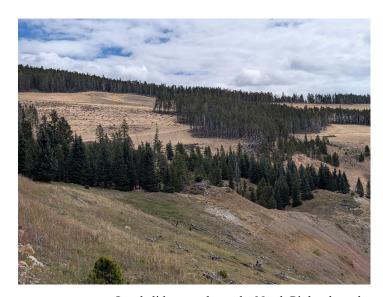
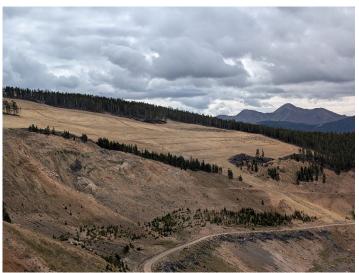
Land slide area above the North Pit has been logged and regraded with drainage features installed.

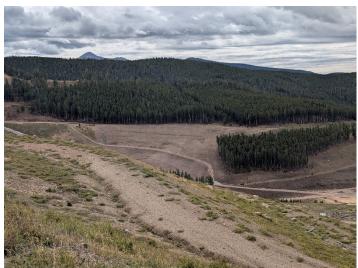
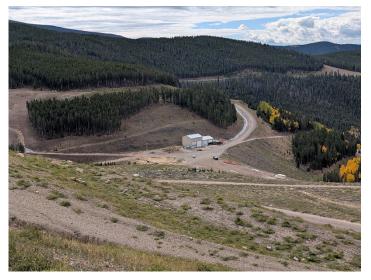
Slope above the Mine Shop has been regraded for stablization. A drainage channel and French drains were added.

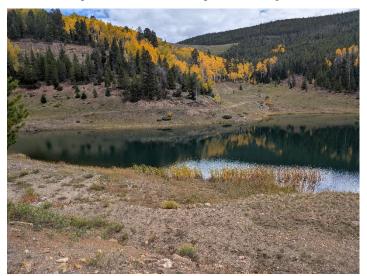
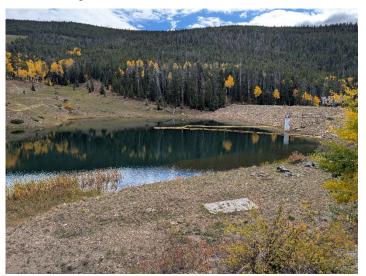
No problems were noted at the sediment pond.

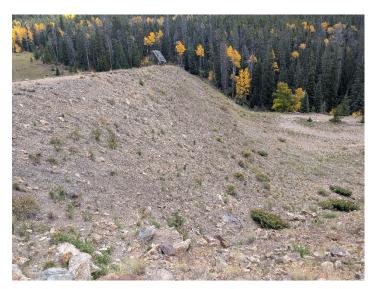
Sediment Pond dam appears stable. No seepage or stablility concerns were observed.

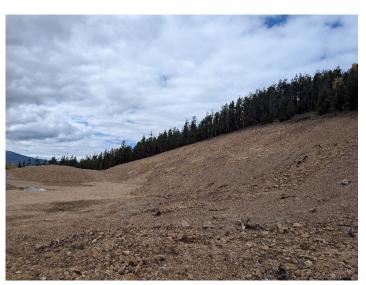
Sandstone Quarry slope has been regraded.
