**MINERALS PROGRAM INSPECTION REPORT**  
**PHONE: (303) 866-3567**

| <b>MINE NAME:</b><br>Pino Pit | <b>MINE/PROSPECTING ID#:</b><br>M-2000-118 | <b>MINERAL:</b><br>Sand and gravel | <b>COUNTY:</b><br>Huerfano |
| <b>INSPECTION TYPE:</b><br>Monitoring | <b>WEATHER:</b><br>Clear | <b>INSP. DATE:</b><br>September 10, 2025 | <b>INSP. TIME:</b><br>11:20 |

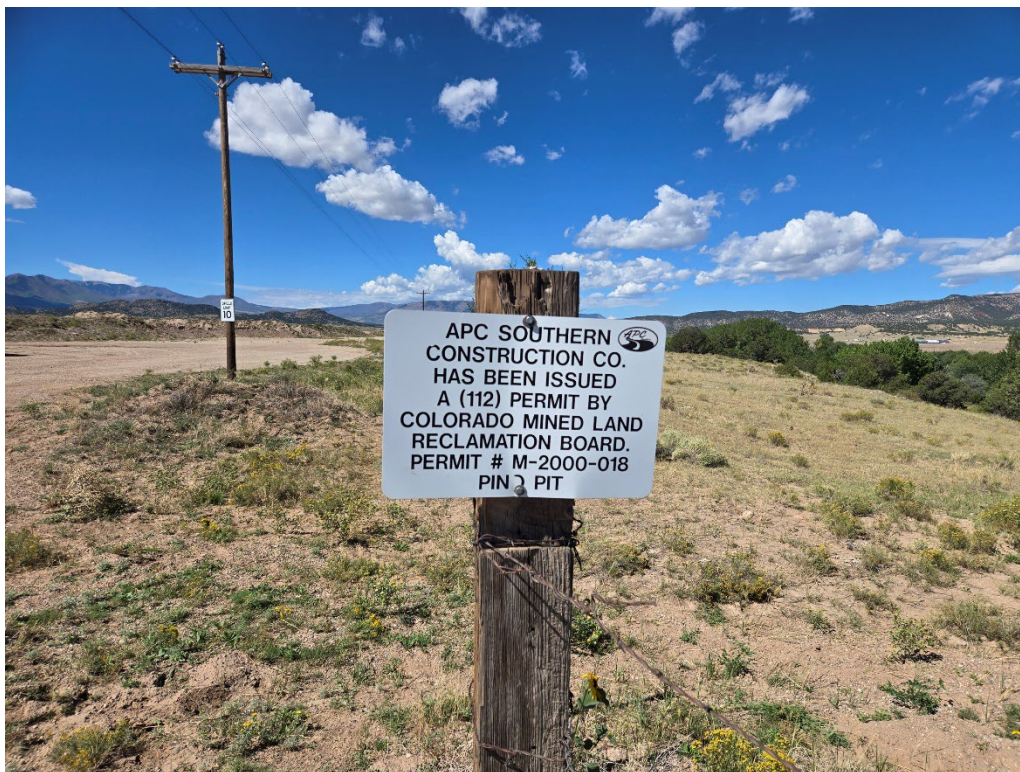
A mine sign was posted at the entrance to the site in compliance with Rule 3.1.12(1). A mix of t-posts, white PVC pipes, large concrete blocks, and boulder piles all act as permit boundary markers (see Photo 2). The Operator stated that they used a mix of items to help prevent markers being pushed down/removed by cattle. The site appears to be marked in compliance with Rule 3.1.12(2).

**Photo 1:** Mine sign posted at the entrance.

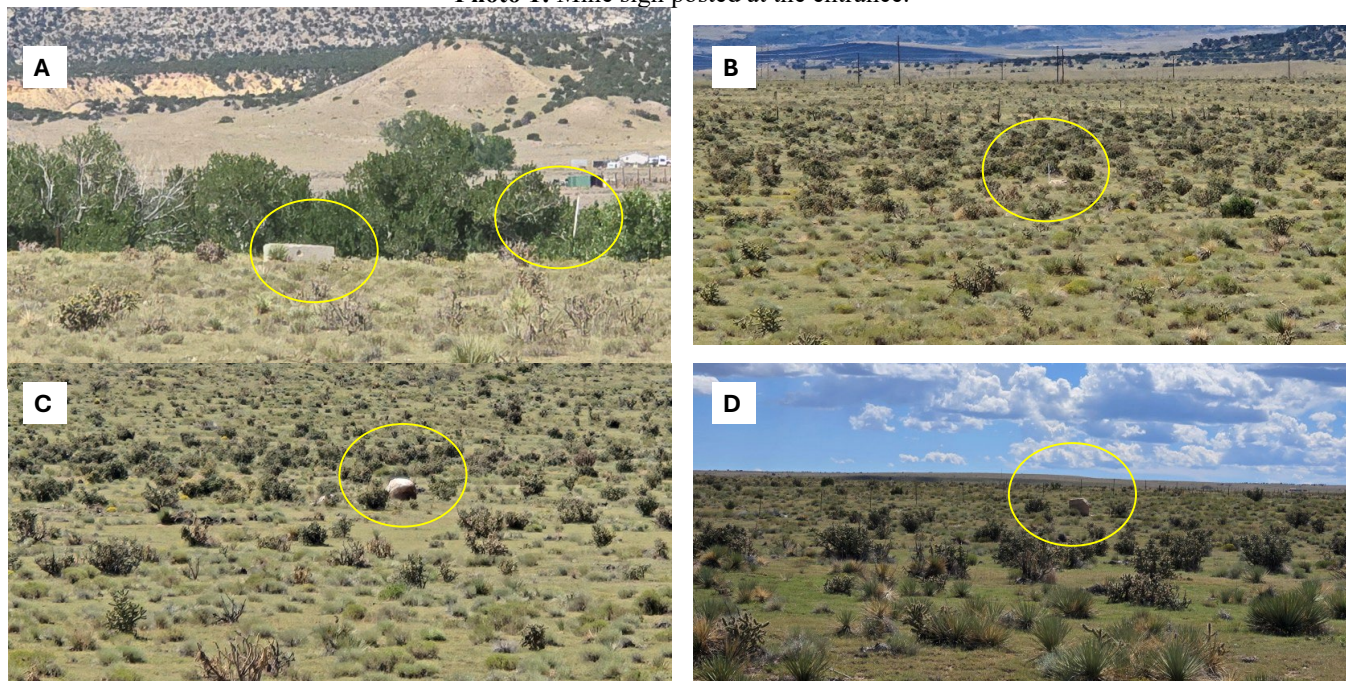
**Photo 2:** Examples of markers placed around the site. 2A shows where a t-post marks the boundary, but a concrete block has been inset from the boundary to be conservative. 2B shows a small PVC pipe next to a pile of rocks. 2C is a pile of boulders. 2D is also a pile of boulders.

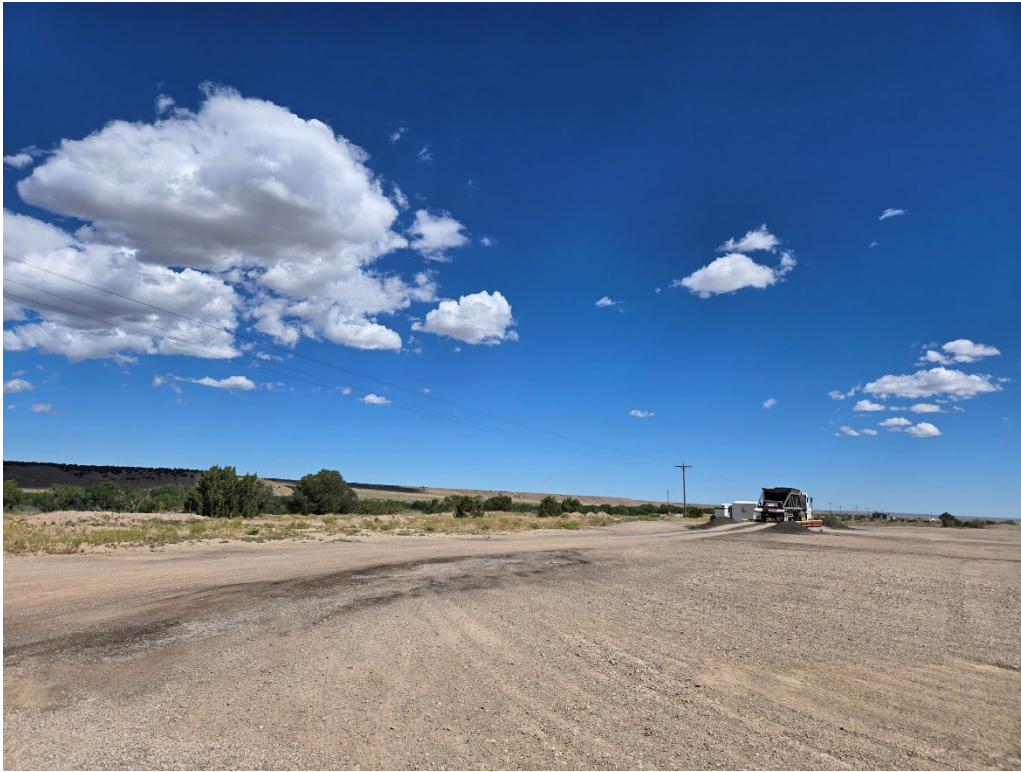
**Photo 3:** Looking northeast at the truck scale located within the northern portion of the disturbed area.

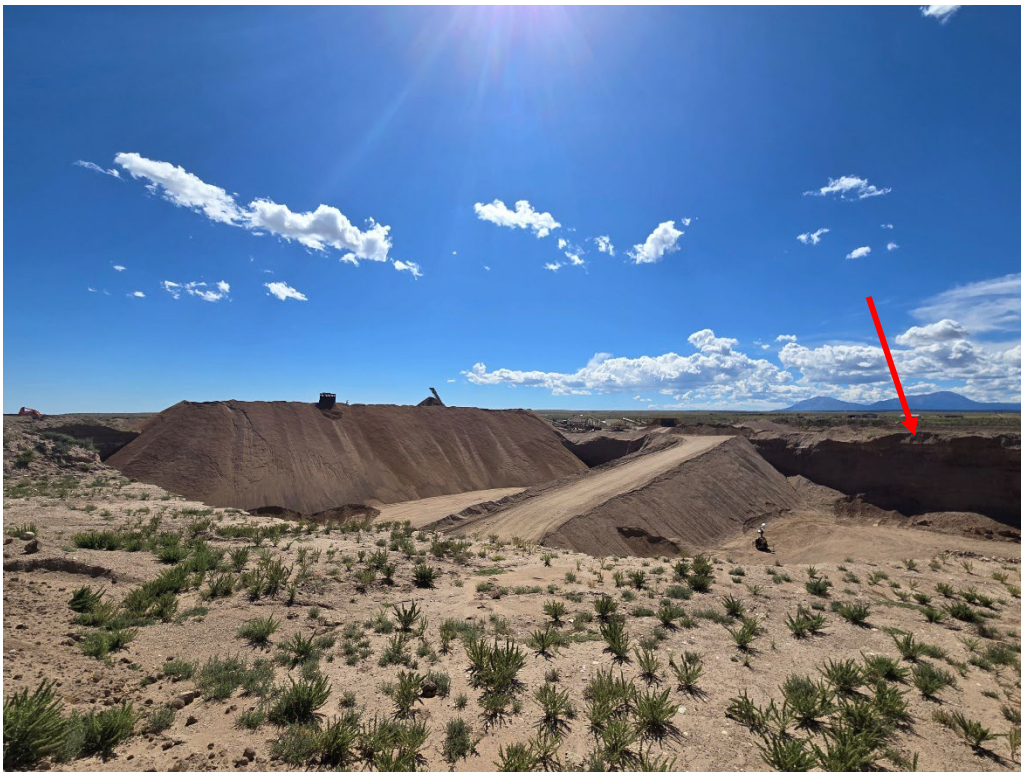
The site was active at the time of the inspection. In addition to the East pit mentioned in the section above, there are two more active pits – a western pit and a central pit (see Map 1 below). Mining in the west pit has reached its southern limit, as the operation encountered too much clay to make further mining to the south economic. Mining will continue to the west within the western pit. The central pit had been a processing area, and then was topsoiled and seeded during the Division's 2021 inspection (see Photo 5 in the Division's 2021 inspection report). This area has been excavated and the plan is to connect the south wall of the center pit, with the north wall of the west pit (the central pit has excavated further to the west since the aerial photo was taken in March

**Photo 4:** Looking southeast at the central pit. The arrow shows where the central pit and the west pit will be combined.

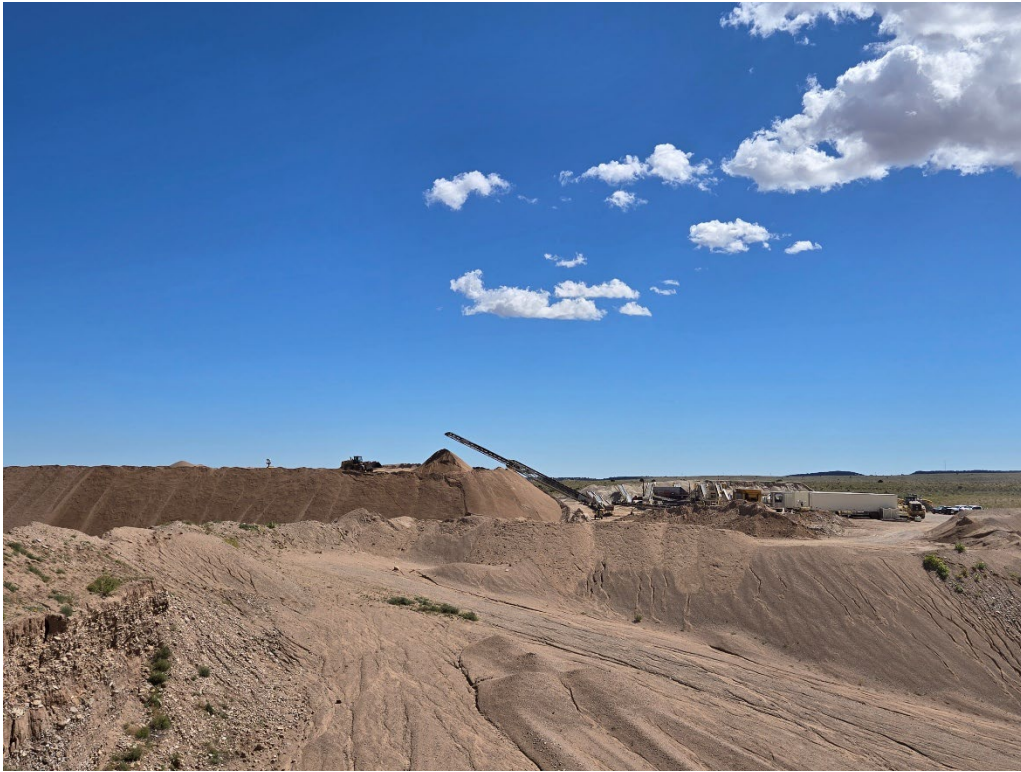
**Photo 5:** Looking east across where the central pit and west pit will be combined. (West pit accidentally not pictured).

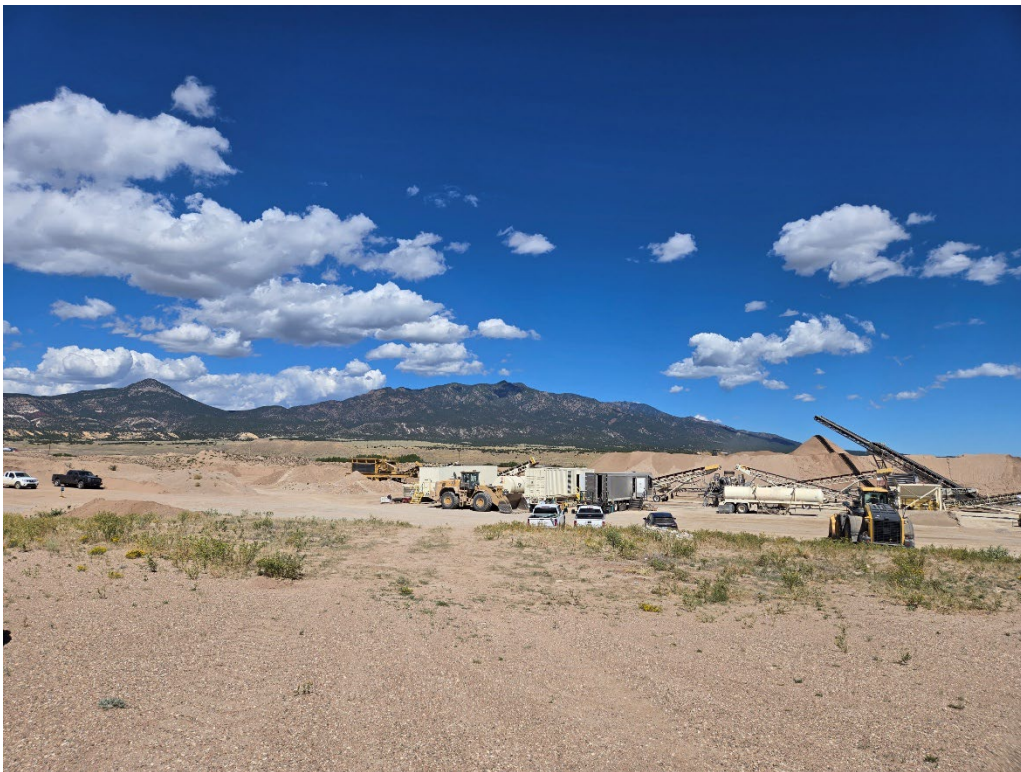
The processing area is located on the south side of the central pit. Various equipment, including portable crushers, screeners, trailers, water tanks, excavating equipment, etc. were onsite during the inspection. All fuel onsite is contained in a double walled tank and is placed within additional containment berms. Product stockpiles were observed throughout the processing area. There was also a truck scale located within the northern portion of the disturbance boundary.

**Photo 6:** Looking northwest at some of the processing area.

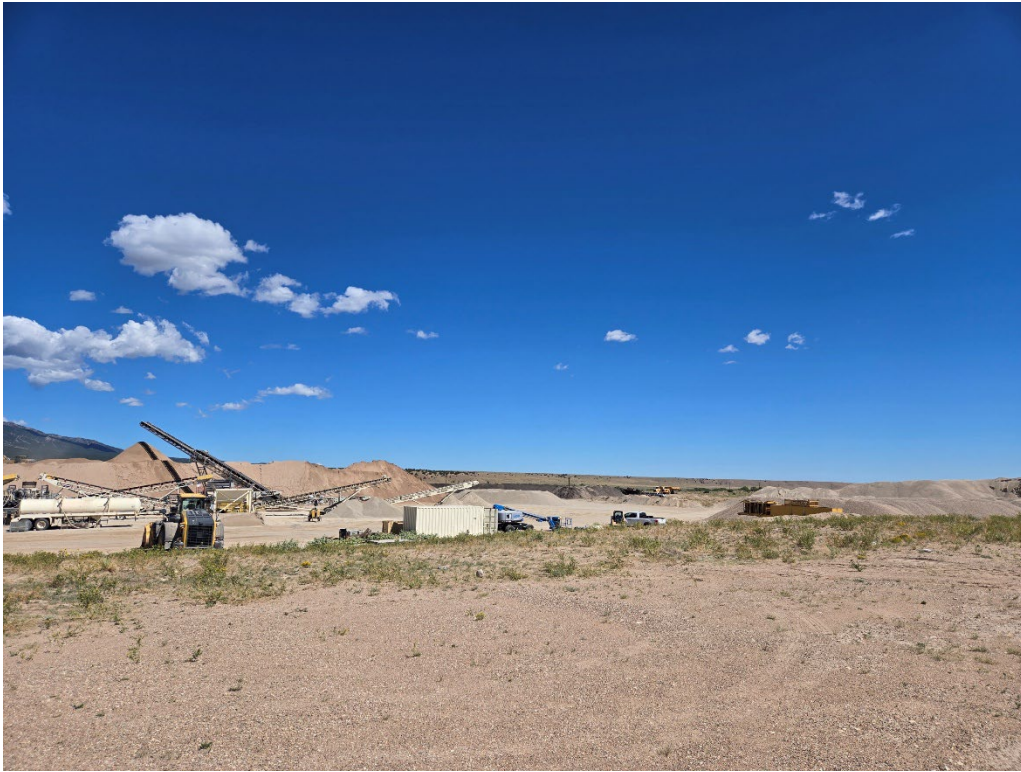
**Photo 7:** Looking northeast at some of the processing area.

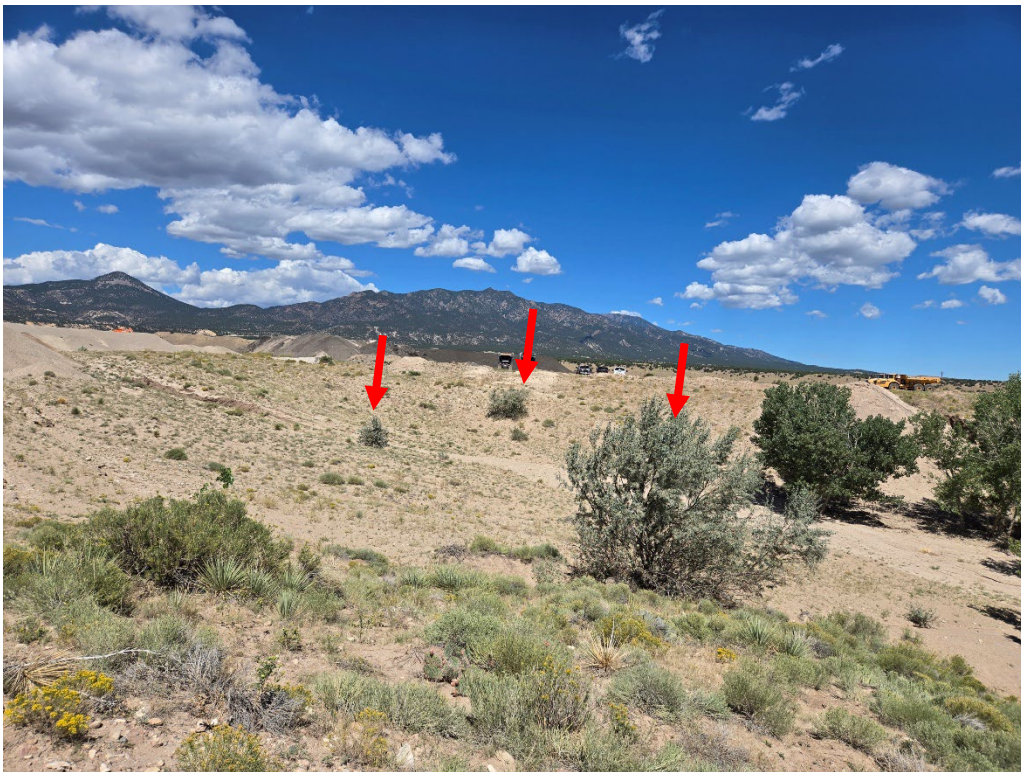
A few Russian Olive trees (a B-listed State Noxious weed) were observed in the East Pit during the inspection. The Operator stated that they would remove them in accordance with their current weed management plan approved through Technical Revision no. 1 (TR1). Prior to the issuance of this inspection report, Ms. Weimer sent an email showing that the trees have been removed. The photos are enclosed at the end of this report.

**Photo 8:** Looking north across the east pit. The arrows point to Russian Olive trees that were present at the time of the inspection.

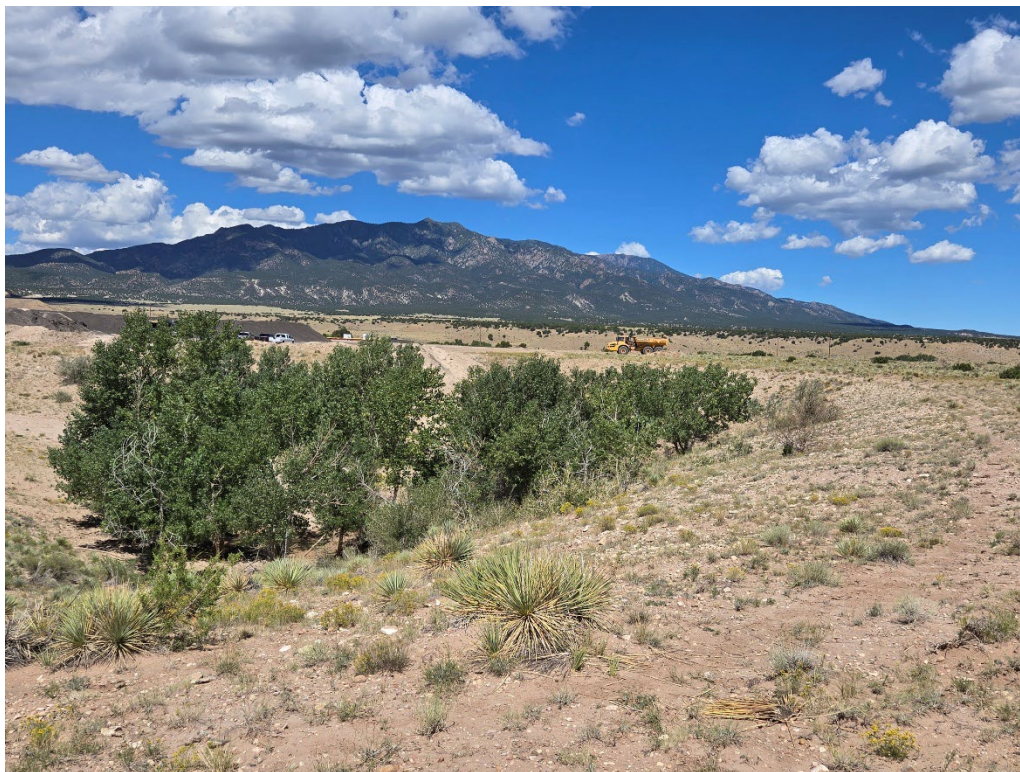
The East Pit is graded to a 3H:1V or shallower on the west side, 3H:1V on the east side, and 2H:1V on the remaining sides. As mentioned above, all of the slopes around the East Pit will need to be returned to a 3H:1V or shallower. No final grading, topsoiling, or seeding has been conducted at this site. To minimize the amount of acres disturbed at anyone time, the Operator is advised to begin final reclamation on areas that have been deemed mined-out.

**Photo 9:** Looking north across the east slope within the east pit.

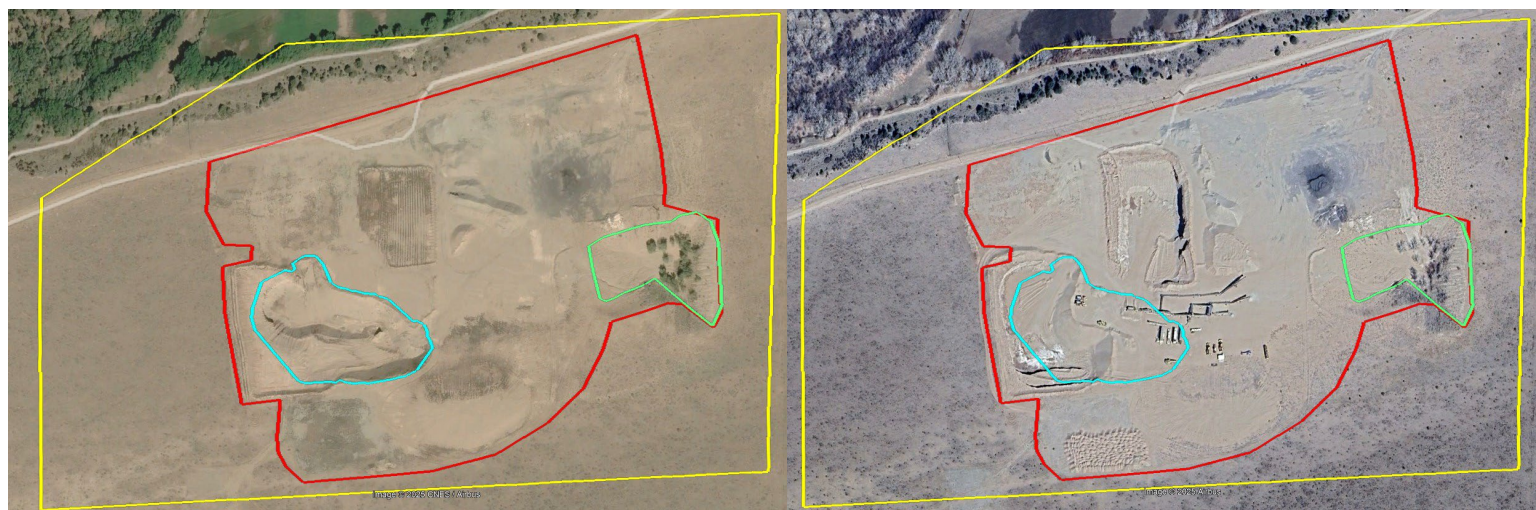
This permit allows for a maximum of 35 acres to be disturbed at any one time. Following the inspection, the Division estimated that approximately 40 acres are currently disturbed (based off Google Earth imagery and field observations). **This has been cited as a problem above.** This 35-acre maximum was to include 5 – 10 acres in reclamation. As there are no areas currently in final reclamation, the Operator shall submit a Technical Revision to increase the maximum affected area that can be disturbed at any-one-time by the corrective action date. As part of a routine inspection, the financial warranty for the site has been re-calculated, and with this observation, the reclamation liability has been increased to account for the additional affected acres.

**Figure 1:** (Left) Polygons from the Division's 2021 inspection report. The aerial imagery is dated September 27, 2019. (Right) The same polygons depicted over aerial imagery dated March 15, 2025. The central pit in the right image was an area that had previously been a processing area that was backfilled and seeded. The piles in the southwest portion of the disturbed area are the new topsoil piles.

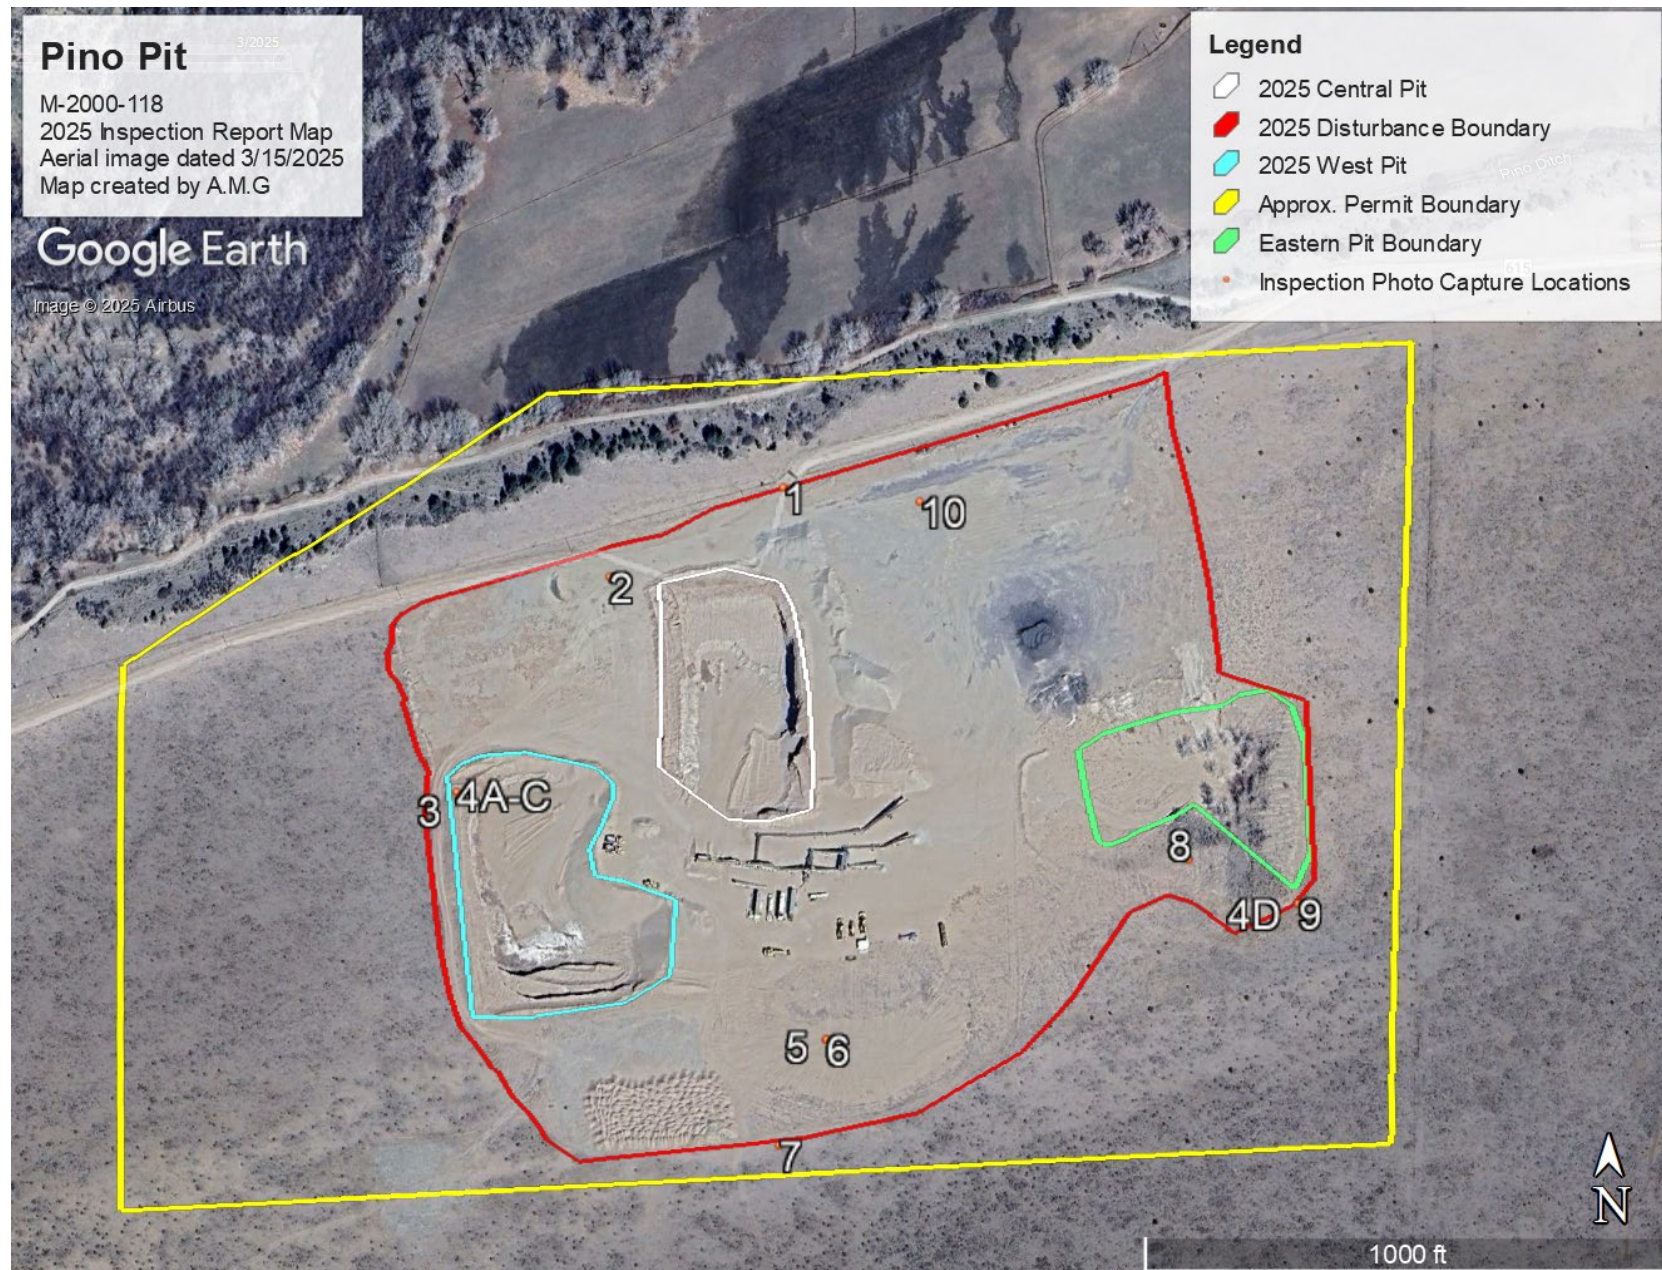
**Map 1:** 2025 Inspection Map. The numbers next to the red icons correspond to the photo captions within this report.
