### PERMIT INFORMATION

<b>Permit Number:</b> C-1994-082 <b>Mine Name:</b> Yoast Mine <b>Operator:</b> Seneca Property LLC <b>Operator Address:</b> Mrs. Miranda Kawcak 29515 Routt County Road No. 27 Oak Creek, CO 80467	<b>County:</b> Routt <b>Operation Type:</b> Surface <b>Permit Status:</b> Permanent Cessation <b>Ownership:</b> Private
	<b>Operator Representative Present:</b>  Mike Howard
<b>Operator Representative Signature: (Field Issuance Only)</b>

### INSPECTION INFORMATION

<b>Inspection Start Date:</b> September 24, 2025 <b>Inspection Start Time:</b> 14:30 <b>Inspection End Date:</b> September 24, 2025 <b>Inspection End Time:</b> 16:00	<b>Inspection Type:</b> Coal Partial Inspection <b>Inspection Reason:</b> Normal I&E Program <b>Weather:</b> Clear
<b>Joint Inspection Agency:</b>  None	<b>Joint Inspection Contacts:</b>  NA
<b>Post Inspection Agency:</b>  None	<b>Post Inspection Contacts:</b>  NA
<b>Inspector(s):</b>  Nikie Gagnon  Jared Ebert	<b>Inspector's Signature:</b>  <i>Nikie Gagnon</i>  <b>Signature Date:</b>  10/8/2025

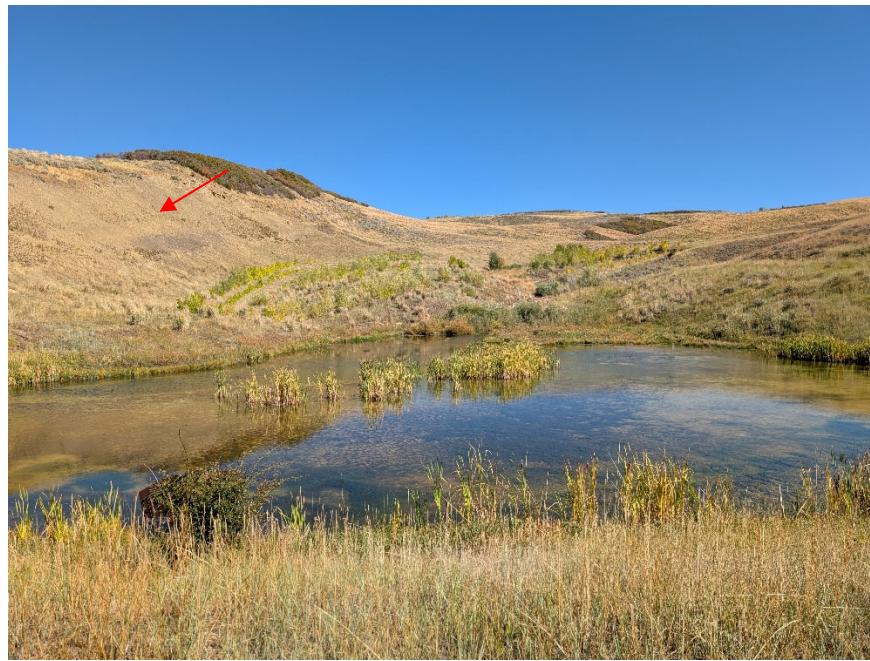
- Pond 12 was holding water and discharging a small stream of clear water through the flume below the embankment (Photos 1-2). The embankment is stable and well vegetated with grasses. Cattails were observed around the perimeter and in the center of the pond. The emergency spillway was stable, dry and vegetated with a few bunchgrasses.

- The slope above Pond 12 appeared stable at the time of inspection (Photo 1). No rills or evidence of movement was noted.

Photo 1: Looking east across Pond 12. Steep slope above the north side of the pond appeared stable (red arrow).

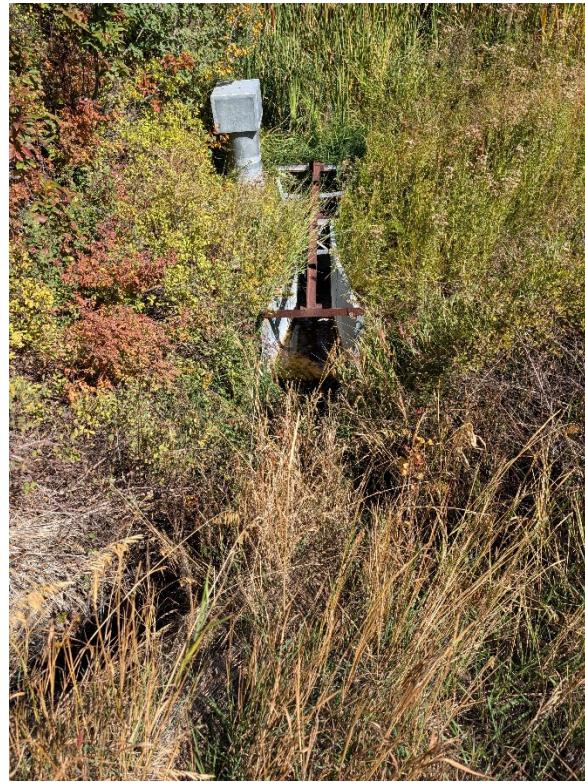
Photo 2: Water discharging out of flume below Pond 12.

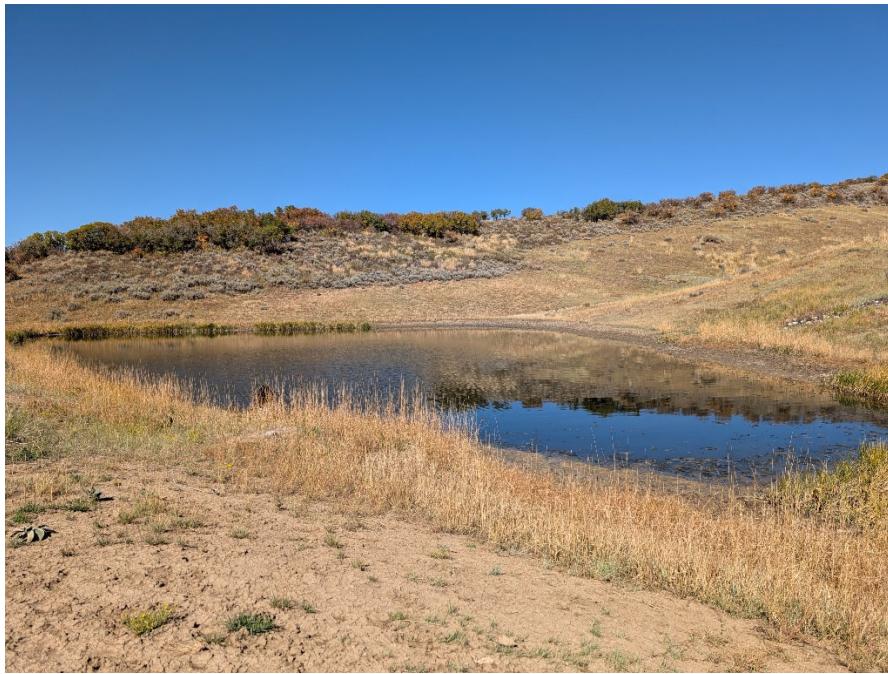
- Pond 13 was holding water and not discharging from the culvert at the time of inspection (Photo 3). The water in the pond was clear. The spillway was dry and vegetated with grasses (Photo 4). A few houndstongue plants were noted in the spillway and the embankment.

Photo 3: Looking northeast across Pond 13.

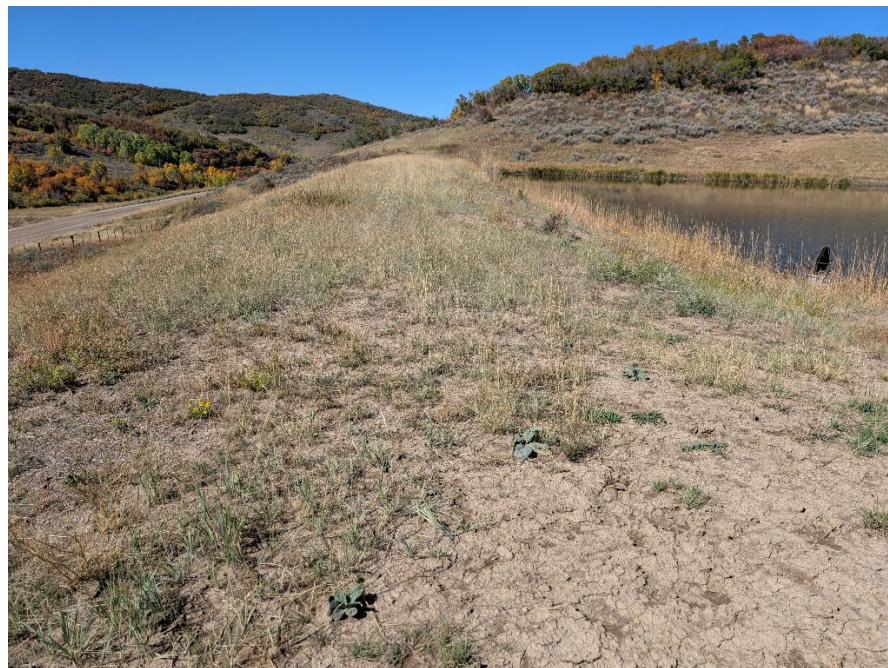
Photo 4: Vegetated embankment on Pond 13. A few houndstongue plants were observed in this area.

- The area remaining in the permit boundary is well vegetated and stable. **A few houndstongue plants were observed on the tops of embankments and within the spillways, specifically at Pond 11 and Pond 13. The operator should apply the appropriate weed control in these areas.**

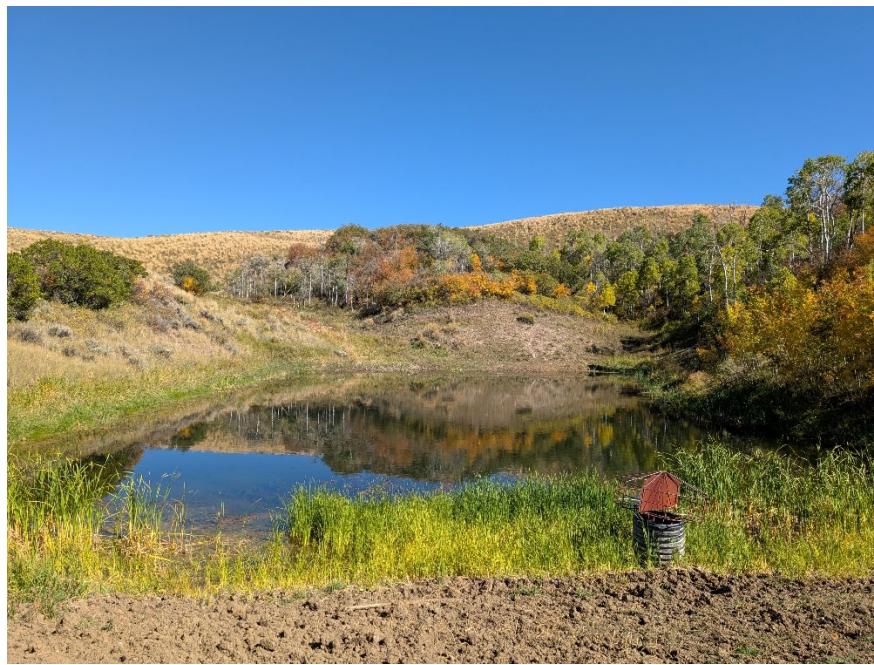
- Pond 14 was holding water and not discharging at the time of inspection (Photo 5). The water in the pond was clear. The operator recently repaired the cracks across the top and down the embankment. The area has been regraded and seeded (Photo 6).

Photo 5: Looking east across Pond 14.

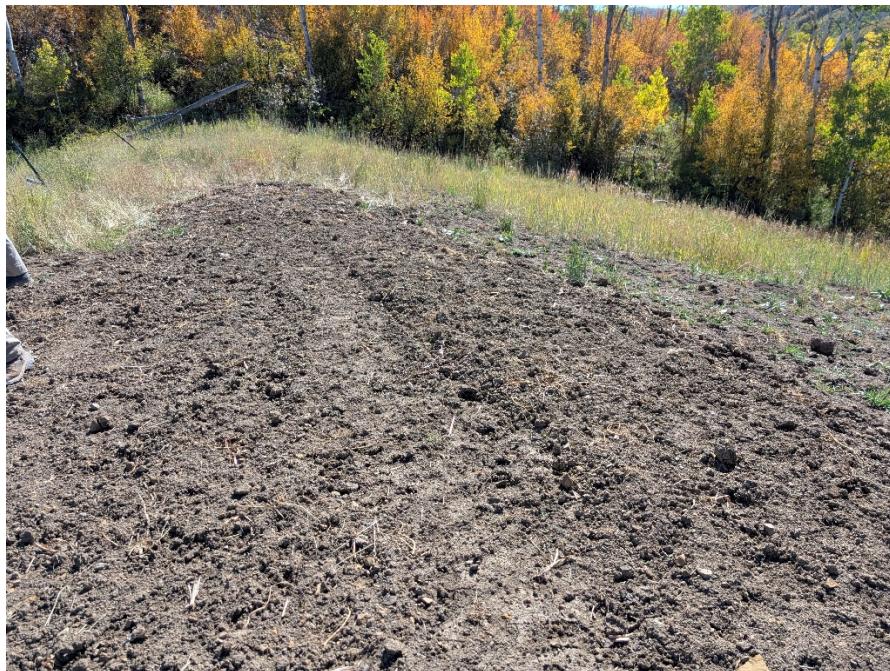
Photo 6: Top of the embankment on Pond 14. Cracks in the embankment were recently repaired across and down the slope here.

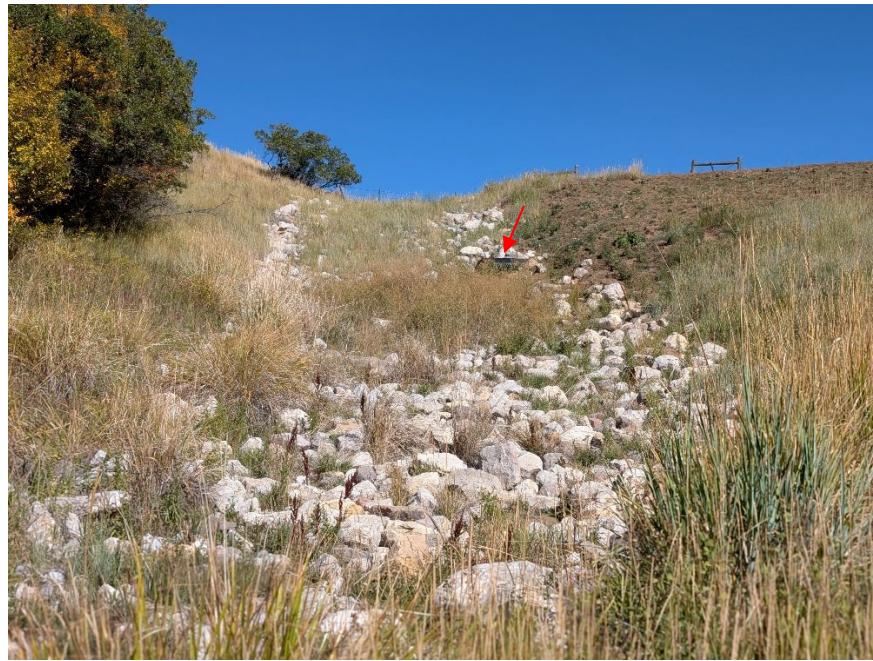
Photo 7: Spillway below Pond 14. No discharge at the time of inspection. Culvert noted by red arrow.

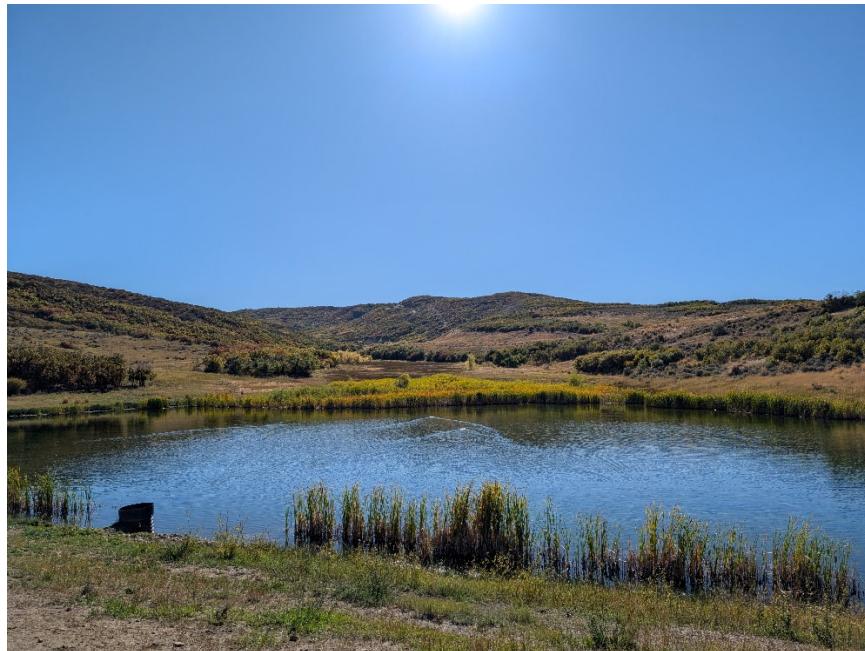
- Pond 10 was holding water and not discharging out of the culvert below the dam at the time of inspection (Photo 8). The water in the pond was clear. Cattails were observed around the perimeter of the pond. The embankment was stable and the sideslopes and shorelines are vegetated with grasses. Bare ground was noted along the top of the embankment which is utilized by maintenance vehicles.

- Waterfowl was observed in Pond 10 during the inspection (Photo 8).

Photo 8: Looking west across Pond 10.

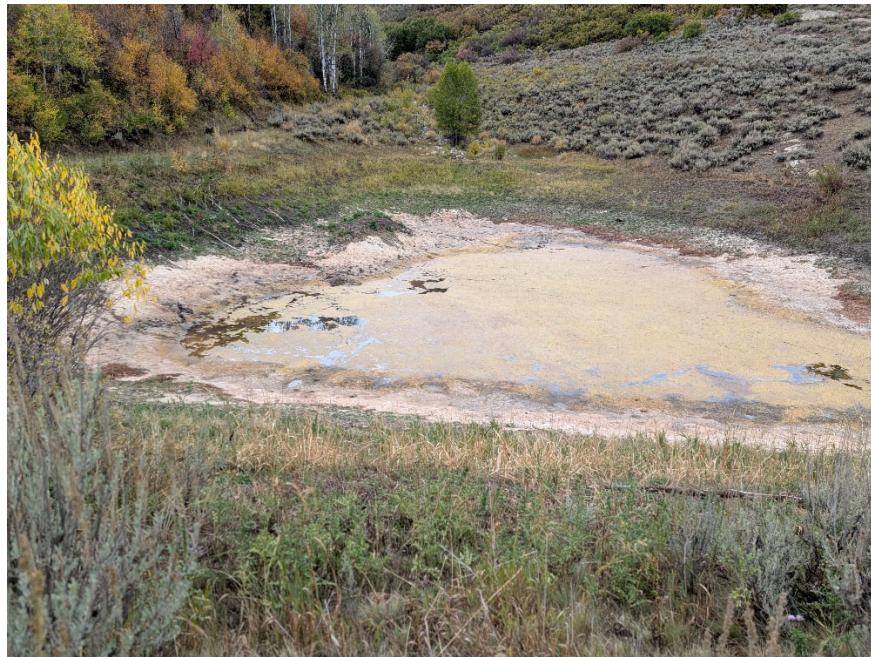
- Pond 11 was holding a few inches of water in the bottom at the time of inspection (Photo 9). Some thistle and houndstongue was observed in the emergency spillway (Photo 10). A couple of animal burrows were noted in the embankment. The operator should monitor these and fill as necessary.

Photo 9: Looking north at Pond 11.

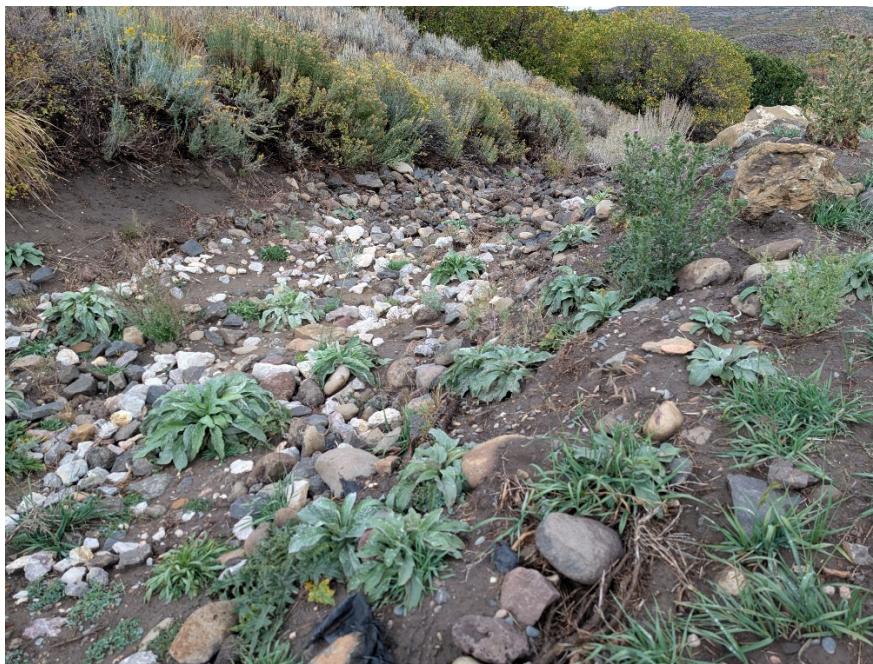
Photo 10: Houndstongue and thistle weeds noted in the spillway of Pond 11.
