**RE: 23 ¼ West Pit, Permit No. M-2020-035, Unresolved Problem(s) Noted in a Past Inspection Report**

**MINERALS PROGRAM INSPECTION REPORT**  
**PHONE: (303) 866-3567**

| <b>MINE NAME:</b><br>23 1/4 West Pit | <b>MINE/PROSPECTING ID#:</b><br>M-2020-035 | <b>MINERAL:</b><br>Sand and gravel | <b>COUNTY:</b><br>Mesa |

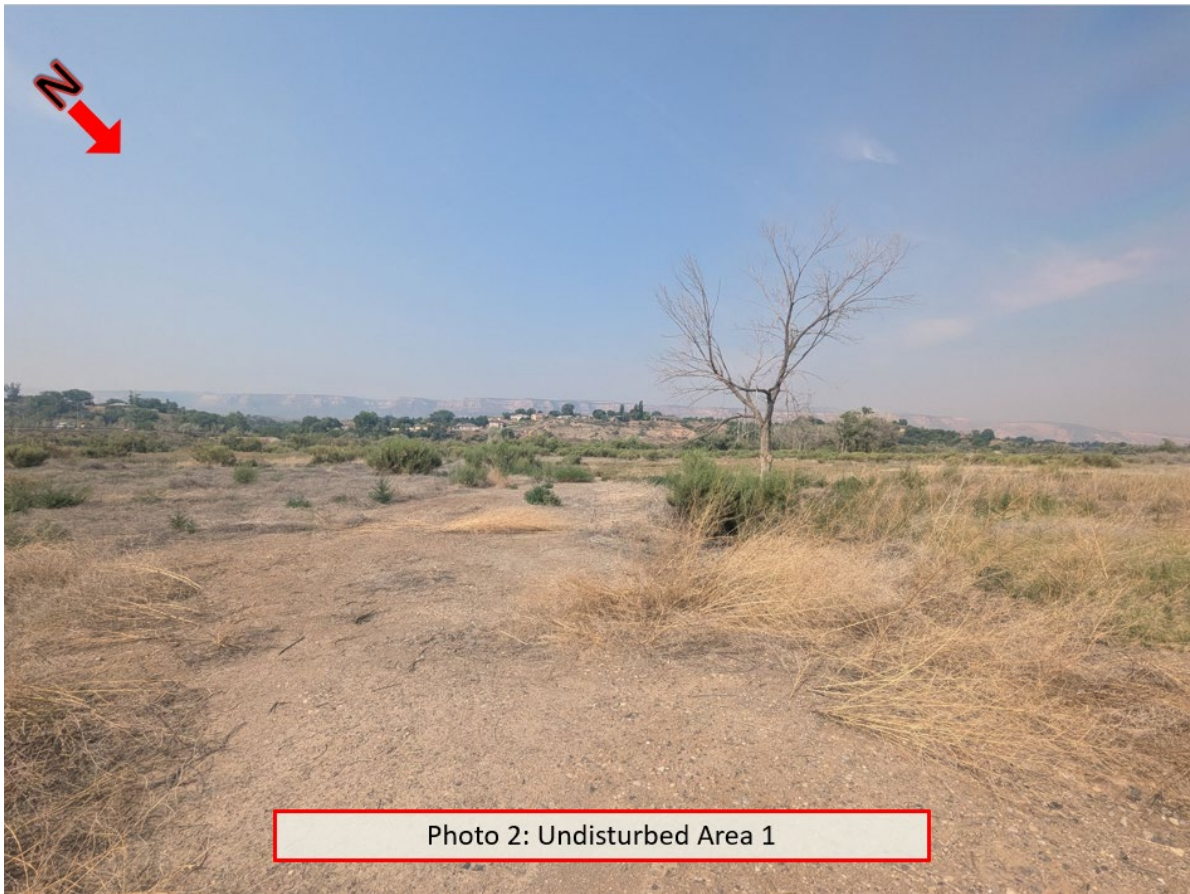
No excavations or grading have taken place in Area 1.

Photo 2: Undisturbed Area 1

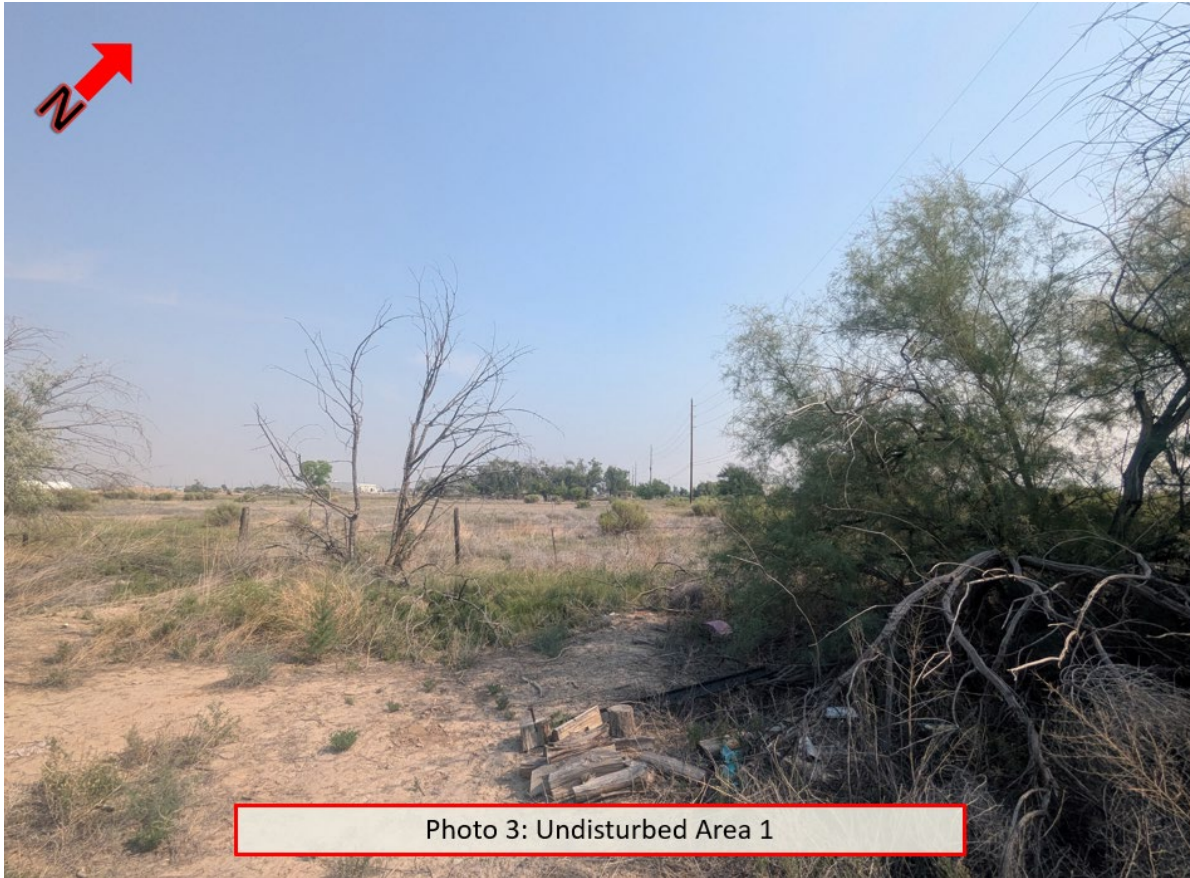
Photo 3: Undisturbed Area 1

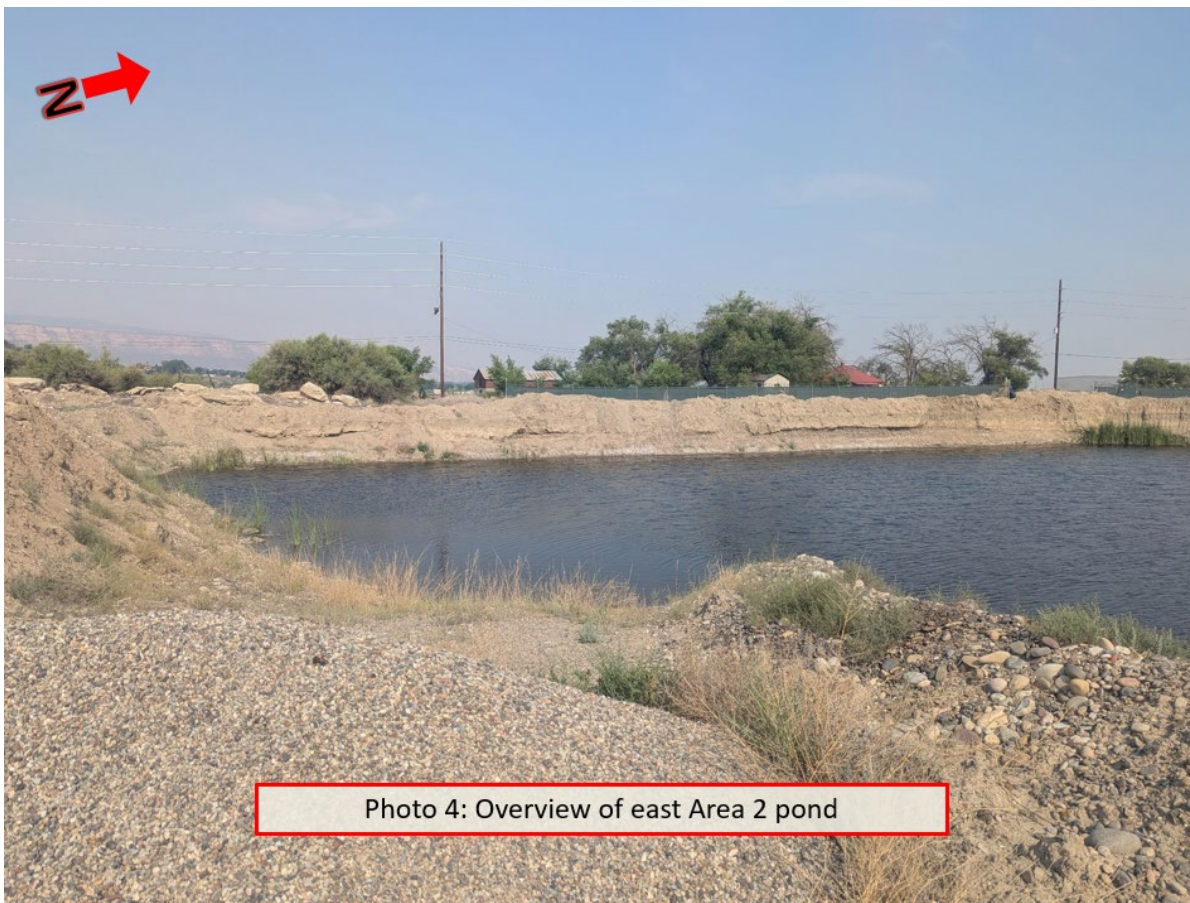
Two ponds have been created within Area 2 by exposing ground water. The Eastern pond is estimated to be 10 acres and the west is estimated to be 1.23 based on the Mesa County Accessors website. Dewatering will be required prior to backfill. Groundwater depth varies from 2 ft in some areas to approximately 10 feet in other areas.

Photo 4: Overview of east Area 2 pond

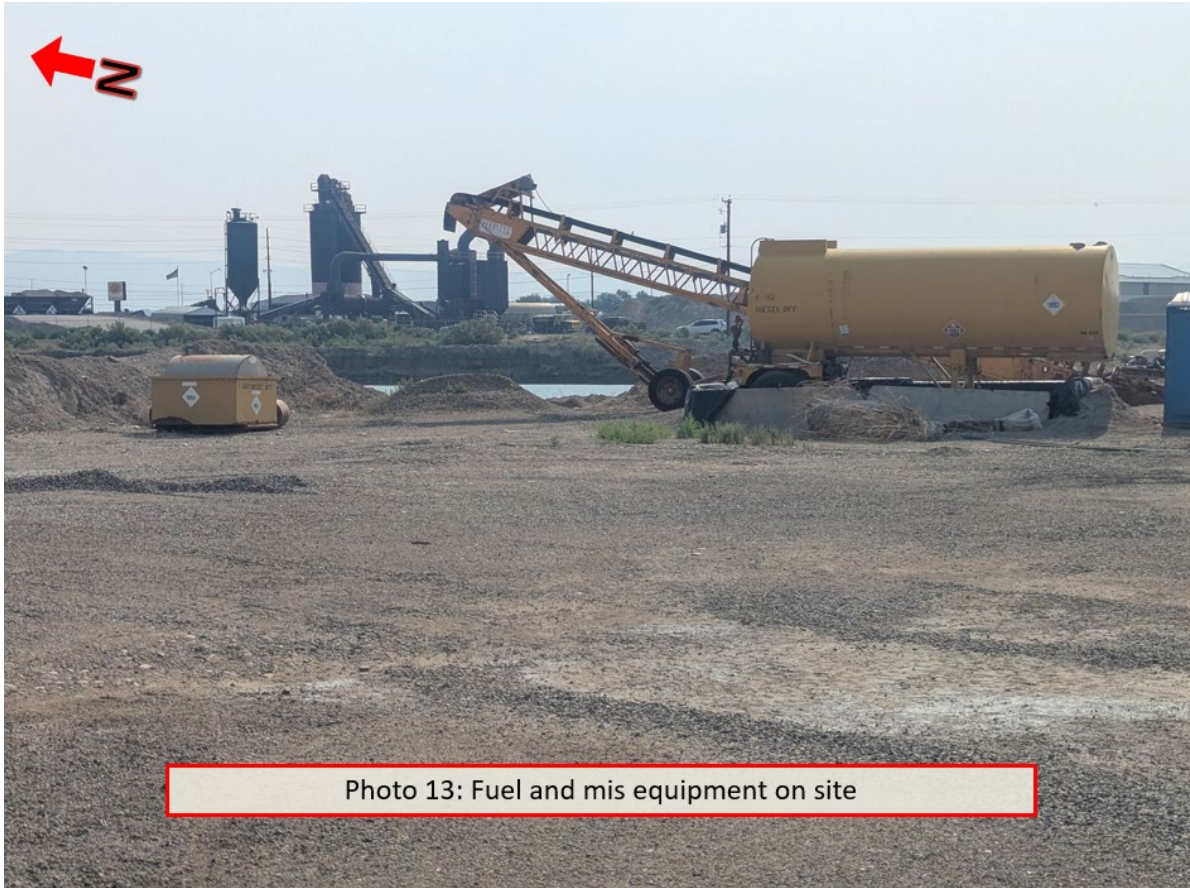
Two fuel tanks are located within secondary containment. They are to the south of the Area 2 pond and on the permit boundary line.

Photo 13: Fuel and mis equipment on site
