## Bowie #1 inspection report

### PERMIT INFORMATION

<b>Permit Number:</b> C-1981-038 <b>Mine Name:</b> Bowie No. 1 Mine <b>Operator:</b> Bowie Resources, LLC <b>Operator Address:</b> Mr. Art Etter P.O. Box 1488 Paonia, CO 81428	<b>County:</b> Delta <b>Operation Type:</b> Underground <b>Permit Status:</b> Active <b>Ownership:</b> Private
	<b>Operator Representative Present:</b> None
<b>Operator Representative Signature: (Field Issuance Only)</b>

<b>Inspection Start Date:</b> October 1, 2025 <b>Inspection Start Time:</b> 11:45 <b>Inspection End Date:</b> October 1, 2025 <b>Inspection End Time:</b> 13:00	<b>Inspection Type:</b> Coal Partial Inspection <b>Inspection Reason:</b> Normal I&E Program <b>Weather:</b> Clear
<b>Joint Inspection Agency:</b> None	<b>Joint Inspection Contacts:</b>
<b>Post Inspection Agency:</b> None	<b>Post Inspection Contacts:</b>
<b>Inspector(s):</b> Robert Zuber, P.E.	<b>Inspector's Signature:</b>

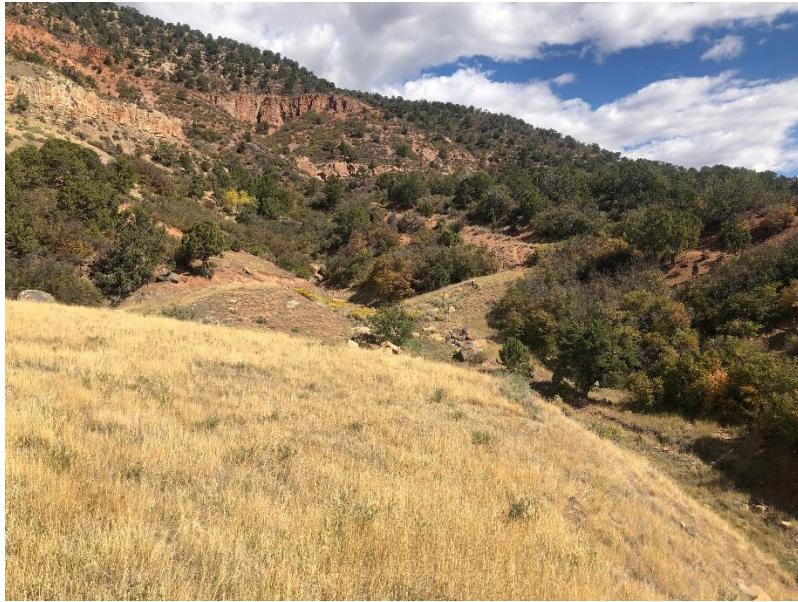
**Area of reclaimed Pond 1 at East Mine**

No problems were identified with the reclamation at Ponds 1, 2, 3, and 4 at the East Mine.

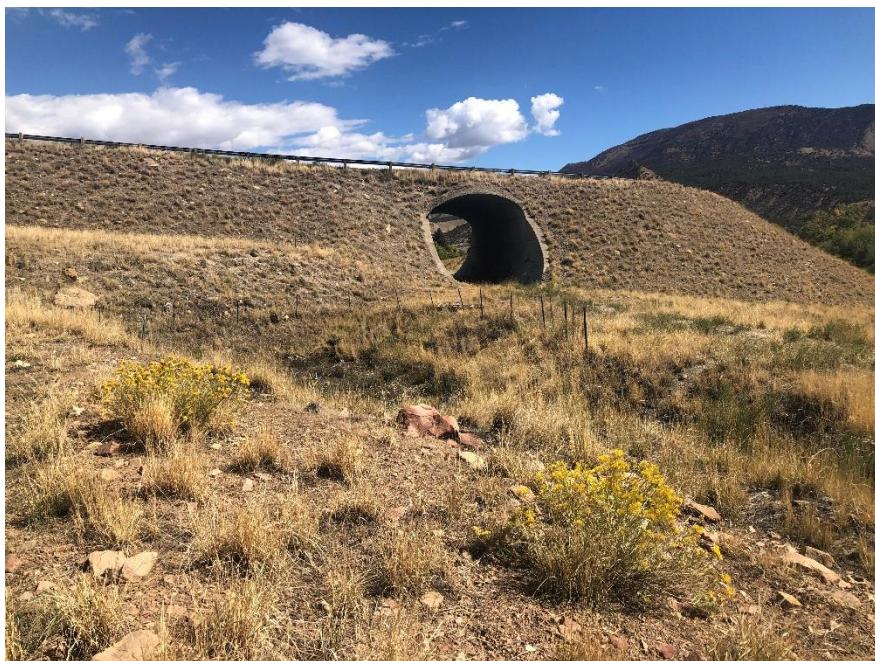
**Pond at coal storage area by Highway 133**

The ponds at the loadout and the coal storage area by Highway 133 contained no water. No discharges or signs of discharges were observed. No problems were identified with embankments, spillways, or other aspects of these ponds. As noted in September, vegetation has been removed from the loadout pond.

The only weed problems that were observed at any of the locations that were inspected is cheat grass at the coal storage area by Highway 133.

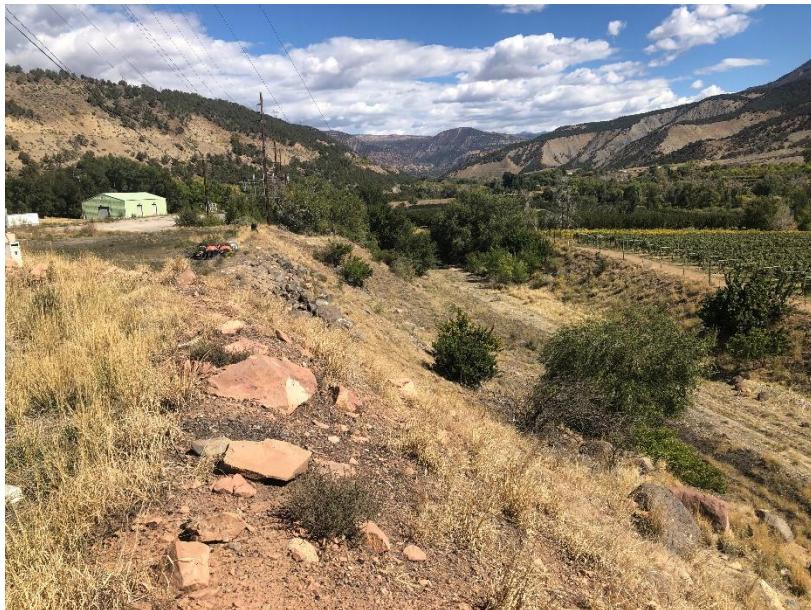
**Slope below substation at loadout**

Water was seen and heard in the small, steep channel that is west of the substation at the loadout. No problems were observed with this channel.

No erosion was seen at the loadout, including the steep slope between the loadout and the orchard below. The trestle across the river appears stable.

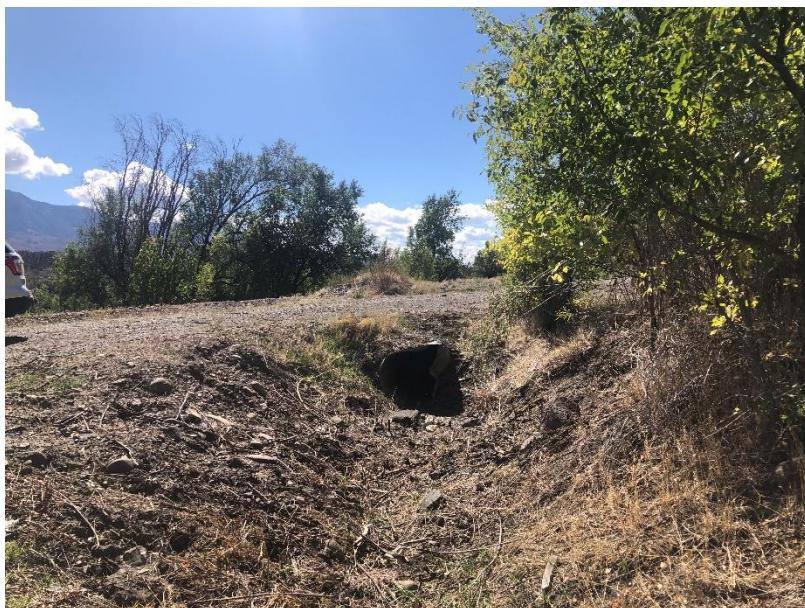
**Lower end of 36-inch diameter culvert for ditch that flows to pond**

No problems were identified with the large culvert (that carries the Farmers Ditch) or the other ditches and culverts at the loadout. The Farmers Ditch was flowing about half full in the culvert.
