**RBK Pit No. 30 M-1990-106 Inspection Report**

### MINERALS PROGRAM INSPECTION REPORT

| <b>MINE NAME:</b><br>RBK Pit No. 30 | <b>MINE/PROSPECTING ID#:</b><br>M-1990-106 | <b>MINERAL:</b><br>Gravel | <b>COUNTY:</b><br>Pueblo |

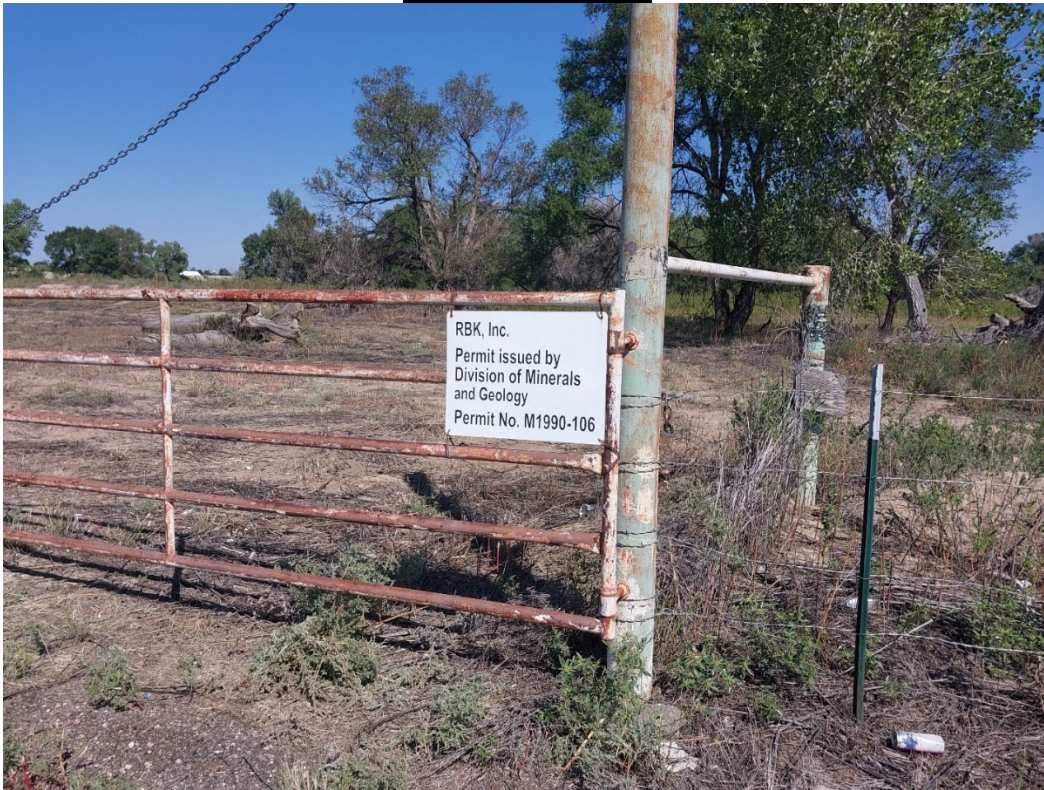
There is a sign posted at the mine entrance in accordance with Rule 3.1.12(1), see Photo #1. The pit area is marked by white PVC posts, see Photo #2. The permit boundary is unclear for this permit due to illegible maps in the digitized original permit and the issues with the annual maps discussed above.

Photo #1: Mine sign at the entrance of the permit area.

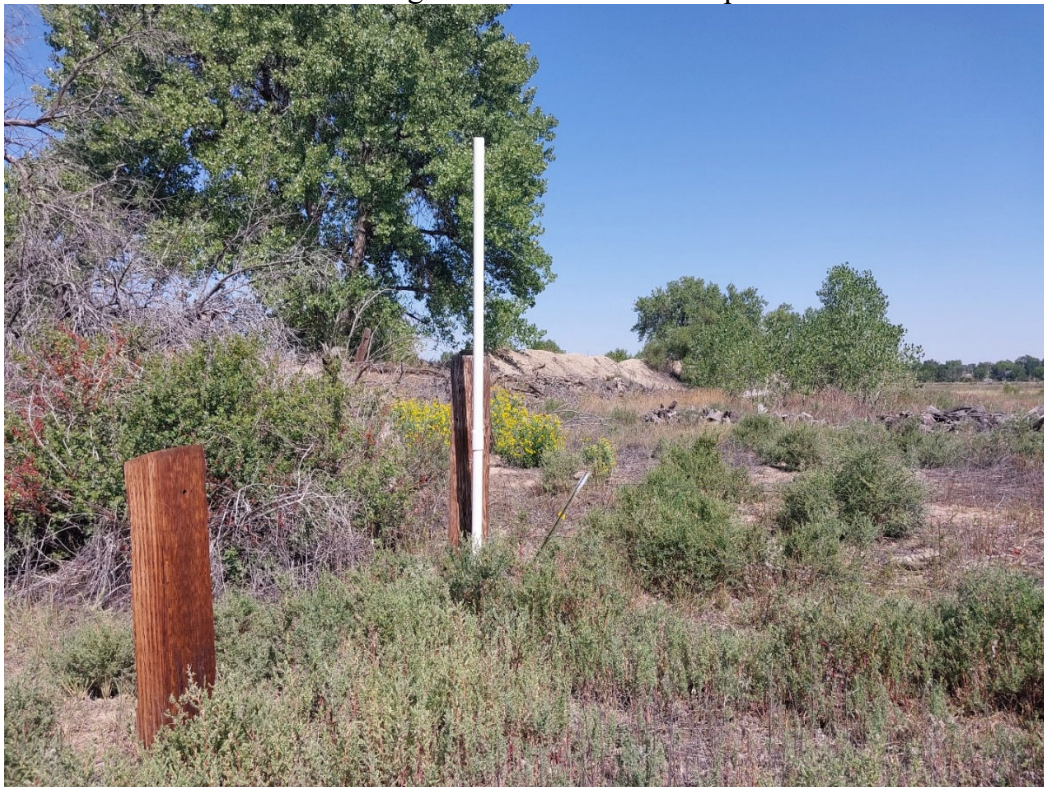
Photo #2: Example of a white PVC tube used to mark the permit boundary.

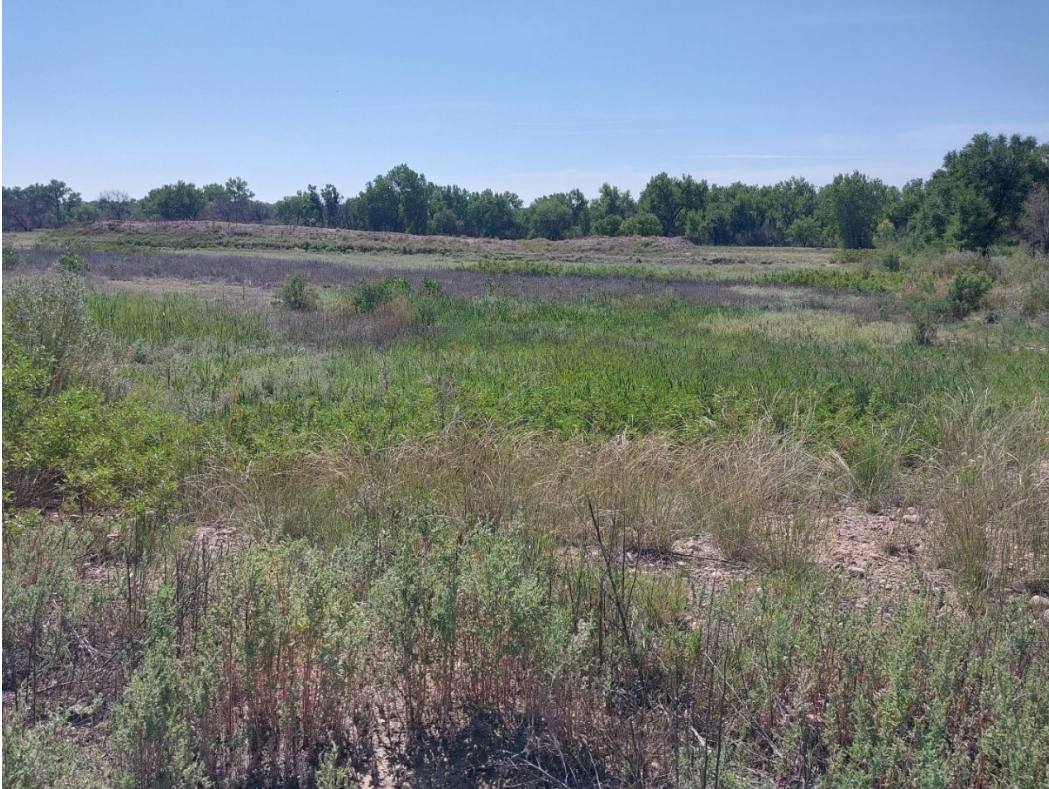
There did not appear to be an issue with the hydrologic balance in the area. A pit holding exposed groundwater located along the north side of the permitted area has been backfilled, see Photo #3. There was a second pond located in the southeast corner of the disturbed area that has also been backfilled. There was no standing water observed on the site at the time of the inspection.

Photo #3: View of the pond along the northern portion of the permit area that has been backfilled; looking to the southeast.

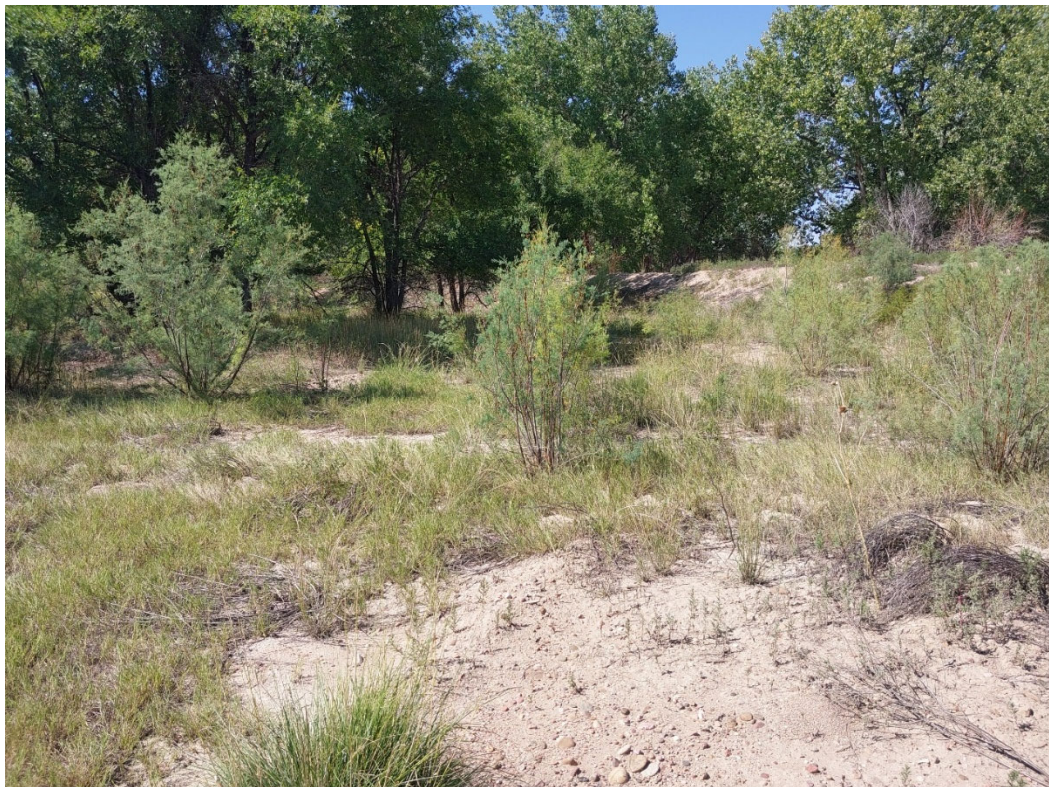
**PROBLEM #2:** Tamarisk (salt cedar) trees are present within or have volunteered into the permit area and are becoming established. This is a problem for failure to employ weed control methods for a state listed noxious weed species within the permitted area, and to reduce the spread of weeds to nearby areas as required by Section 3.1.10 (6) of the rule.

Salt cedar, a List B noxious weed species, was observed on the site at the time of the inspection, see Photo #4. This is being cited as a problem, see **Problem #2** for the corrective action details and due date.

Photo #4: Example of the occurrence of Salt cedar on the permitted area.

**CORRECTIVE ACTIONS:** The operator shall implement the existing weed control plan in accordance with Rule 3.1.10 (6). Documentation of the implementation of the approved weed management control shall be submitted to the Division by the given due date.

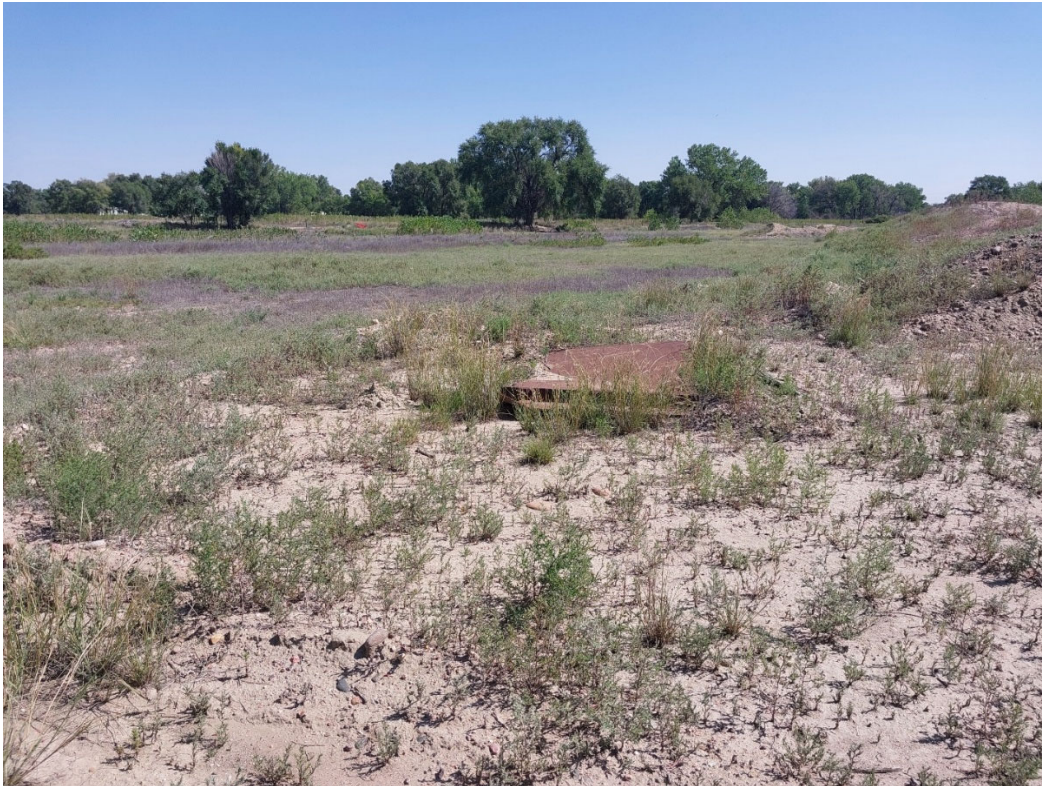
**PROBLEM #1:** Trash and refuse was noticed on the site. This is a problem at this time for failure to dispose of refuse in a manner that controls unsightliness or deleterious effects of such refuse pursuant to C.R.S. 34-32.5-116(4)(e).

There are some discarded items observed on the permitted area, including a metal panel, broken plaster pieces, and PVC piping; see Photos #5 - #7 below. These items need to be cleaned up and properly discarded in accordance with Rule 3.1.5(5). A problem is being cited for this, see **Problem #1** above for the corrective actions and the due date.

Photo #5: The discarded metal panel

**CORRECTIVE ACTIONS:** The operator shall submit a written notice to the Division with photo documentation, that the trash has been removed from the site by the corrective action date.

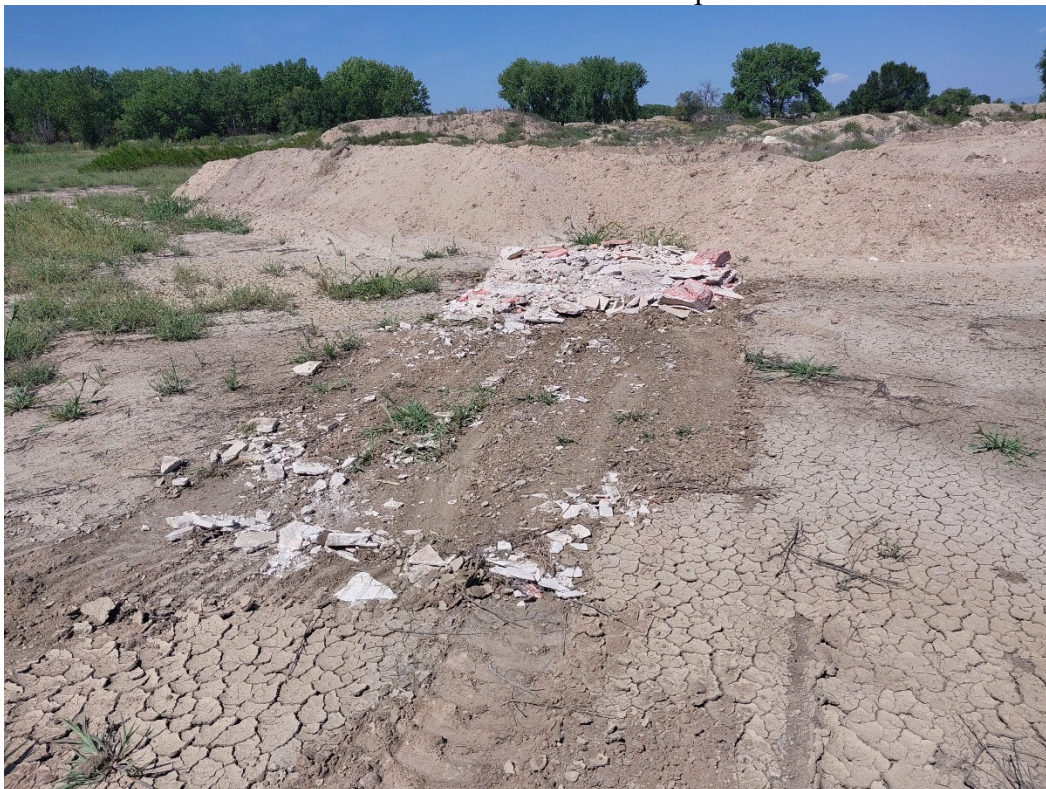
Photo #6: What appeared to be a plaster panel that has been broken and discarded on the site.

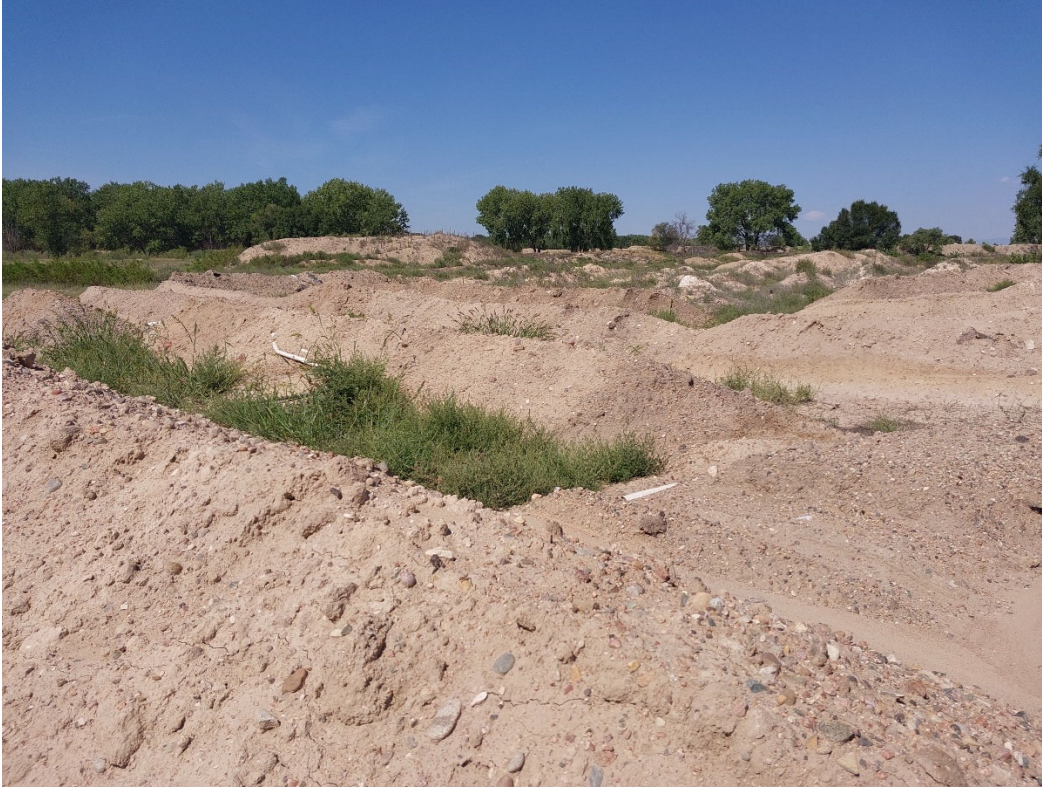
Photo #7: View of multiple small stockpiles; discarded white PVC pipes can be seen in the material.

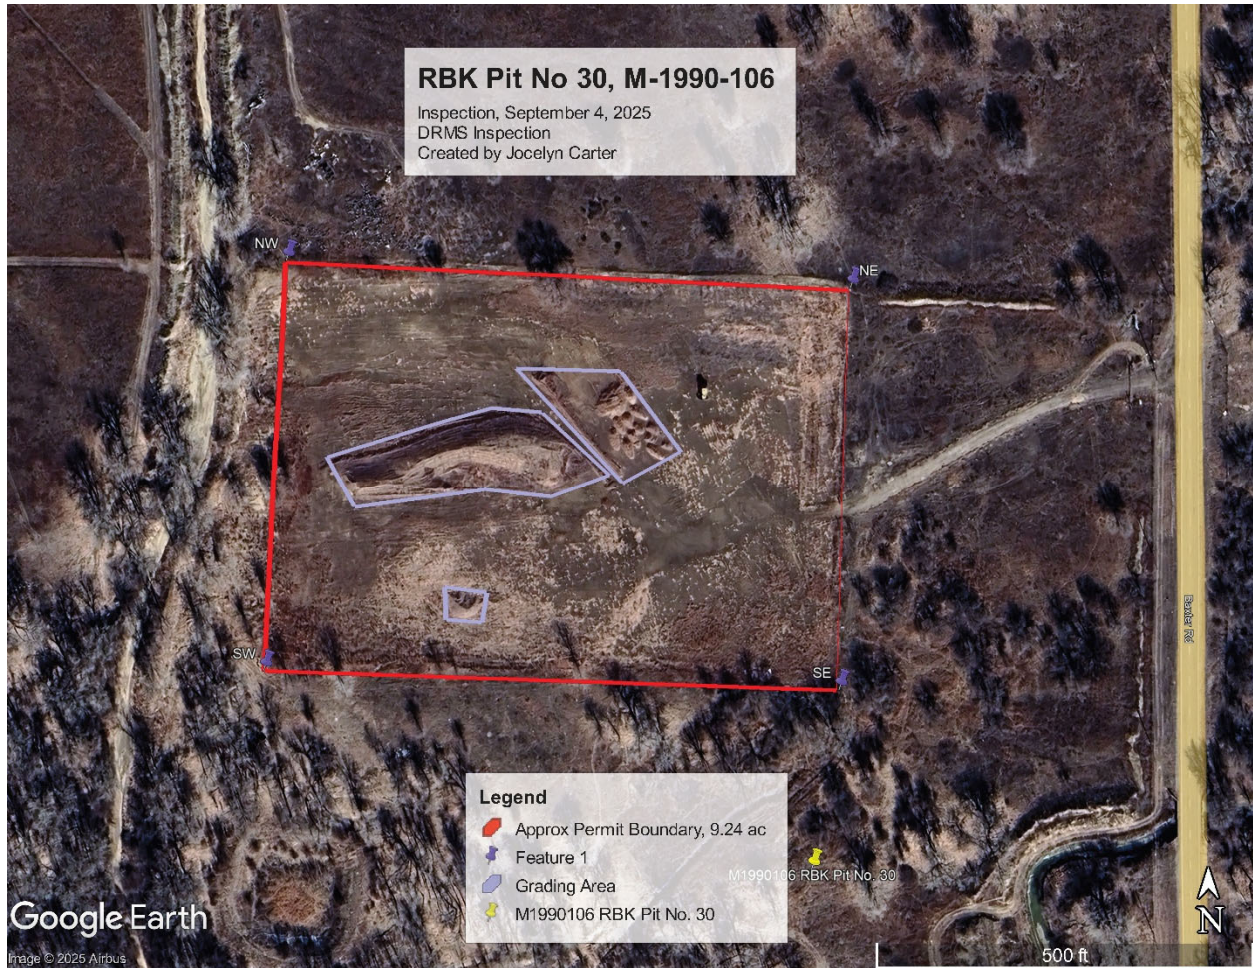
The disturbances observed on the site included multiple small stockpiles of material located northeast of the center of the permit area, a larger stockpile of material located in the west central area of the permit area, and a single stockpile of material that appeared to be well sorted located in the southwestern portion of the permit area. These areas are shown in the inspection map created below.

Image #1: Map created by DRMS. The approximate permit boundary is shown in red; the permit boundary was created based on the GPS coordinates collected in the field of the boundary markers which are marked by the dark purple pins. The disturbances observed on the site are shown in light purple.
