Bowie #2 inspection report

Permit Number: C-1996-083 Mine Name: Bowie No. 2 Mine Operator: Bowie Resources, LLC Operator Address: Mr. Art Etter P.O. Box 1488 Paonia, CO 81428	County: Delta Operation Type: Underground Permit Status: Active Ownership: Private
	Operator Representative Present: Tom Troyer
Operator Representative Signature: (Field Issuance Only)

Inspection Start Date: October 1, 2025 Inspection Start Time: 13:10 Inspection End Date: October 1, 2025 Inspection End Time: 16:00	Inspection Type: Coal Partial Inspection Inspection Reason: Normal I&E Program Weather: Clear
Joint Inspection Agency: None	Joint Inspection Contacts:
Post Inspection Agency: None	Post Inspection Contacts:
Inspector(s): Robert Zuber, P.E.	Inspector's Signature:

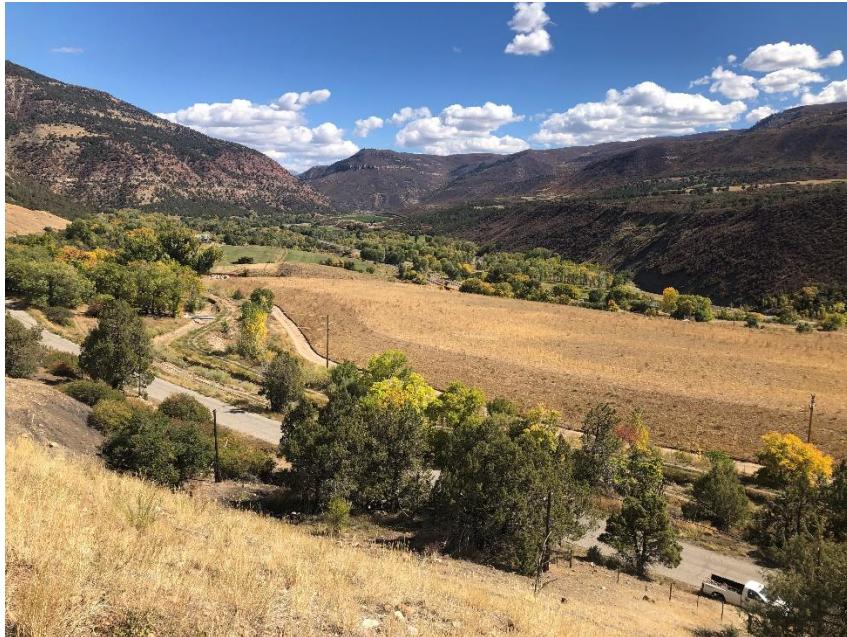
Gob Piles 1, 2, 3, and 4 appeared stable, and no significant erosion was observed. A large amount of kochia (an undesirable species but not a State-listed noxious weed) was seen on Gob Pile #3.

Gob Pile #3, looking east from road above

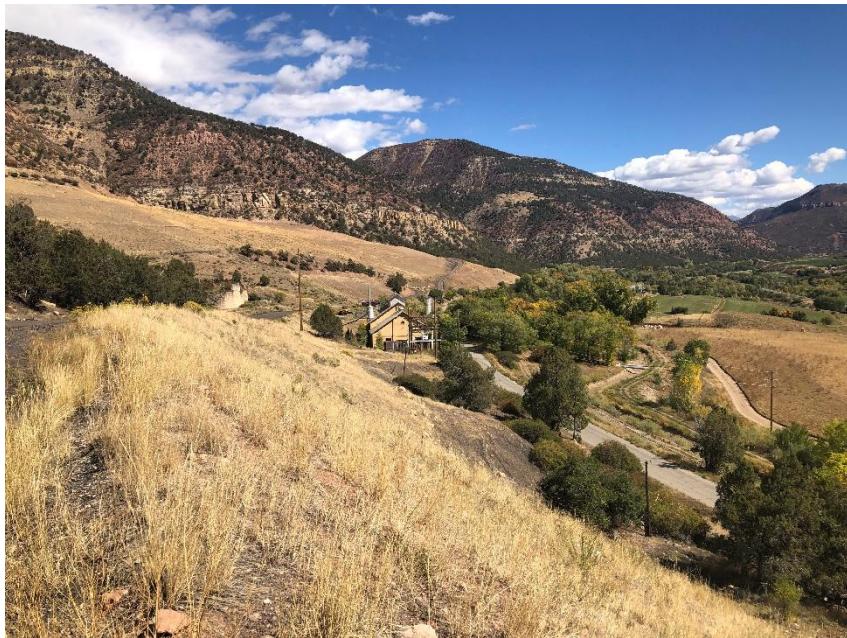
Old power plant and surrounding area

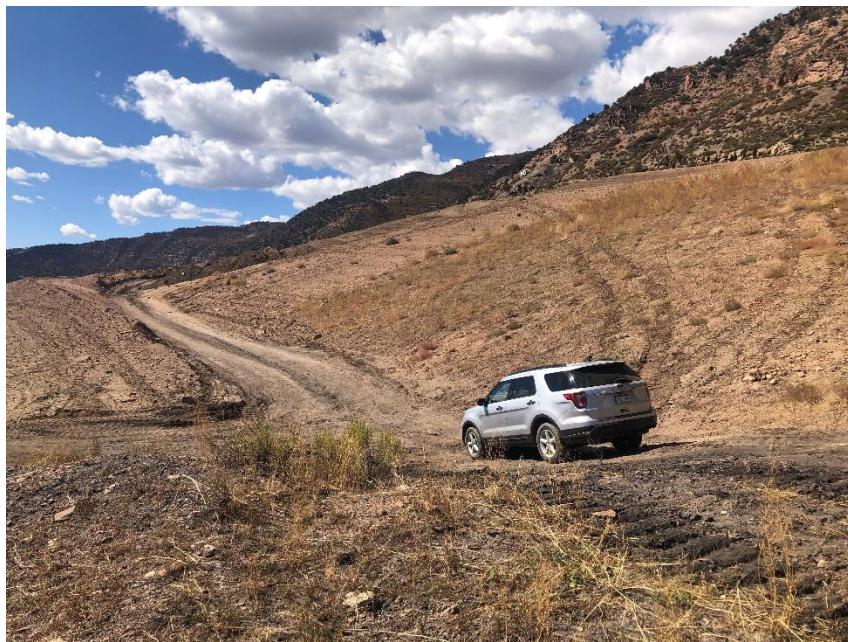
On the upper part of Gob Pile #2 (the un-reclaimed portion), no problems were seen, but BRL needs to re-cut the small ditches that move runoff away from the pile.

Gob Pile #2, recently graded area

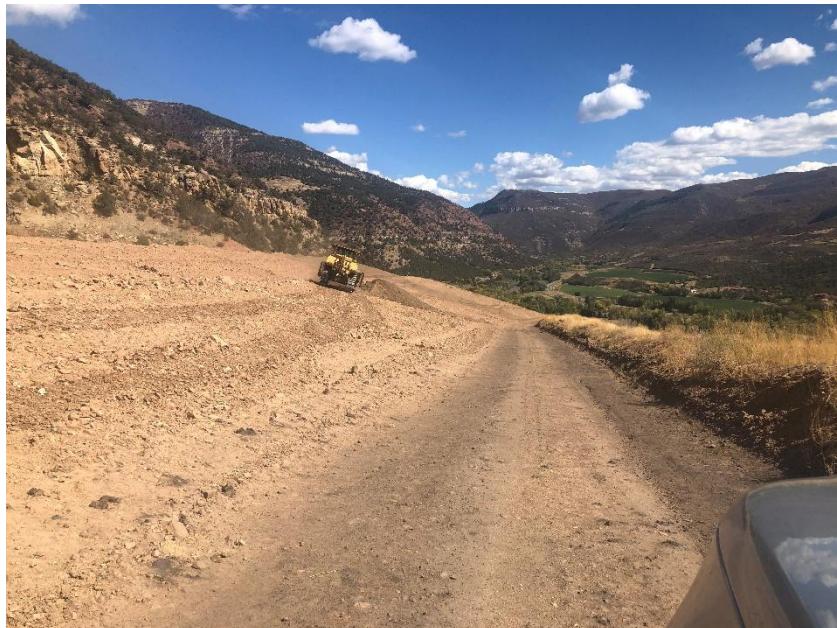
A partial inspection was conducted by Rob Zuber of DRMS on October 1, 2025. One BRL representative, Tom Troyer, was present at Gob Pile #2. He was grading the slopes with a dozer.

BRL staff grading area on Gob Pile #2

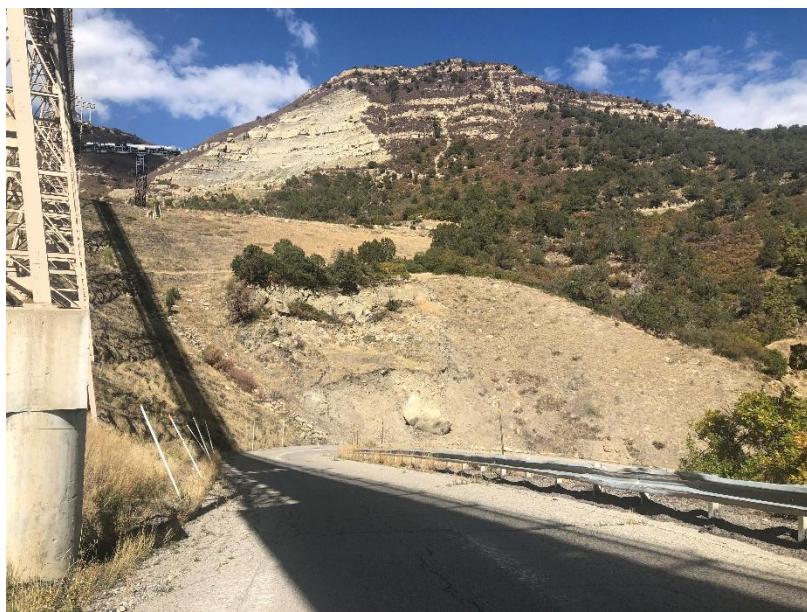
No problems were seen on the slopes above and below the benches. The slumps above the B Portal Bench, above the D Portal Bench, and Curve 11 (noted in the past) look stable. The slide above Curve Number 10 also looked stable, compared to photographs taken in recent months.

Slide at Curve 10

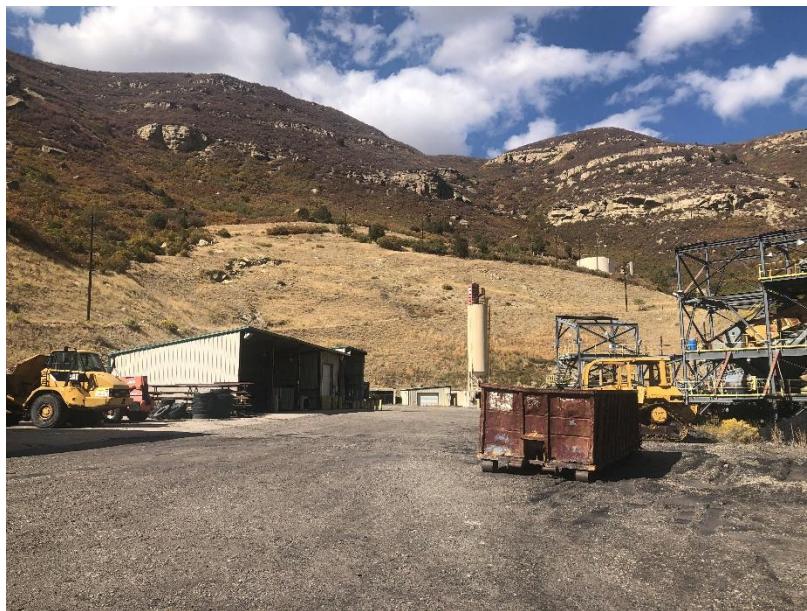
Slump above the D Portal bench

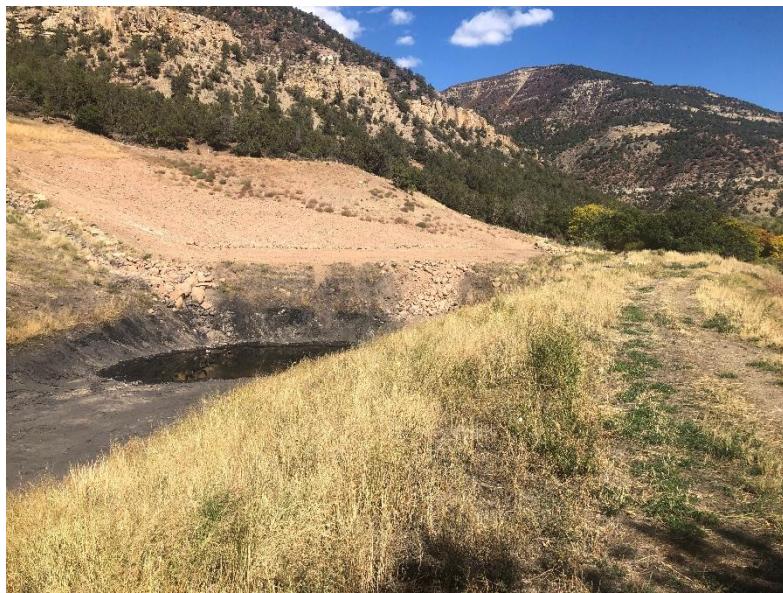
Pond F

Six sediment ponds were inspected: B, C, D, F, J, and K. None of the ponds were close to discharging. Most of them were dry; the exceptions, Ponds D and F, held a very small amount of water. No significant problems were identified with embankments, spillways, inlet channels, or other features of the ponds.

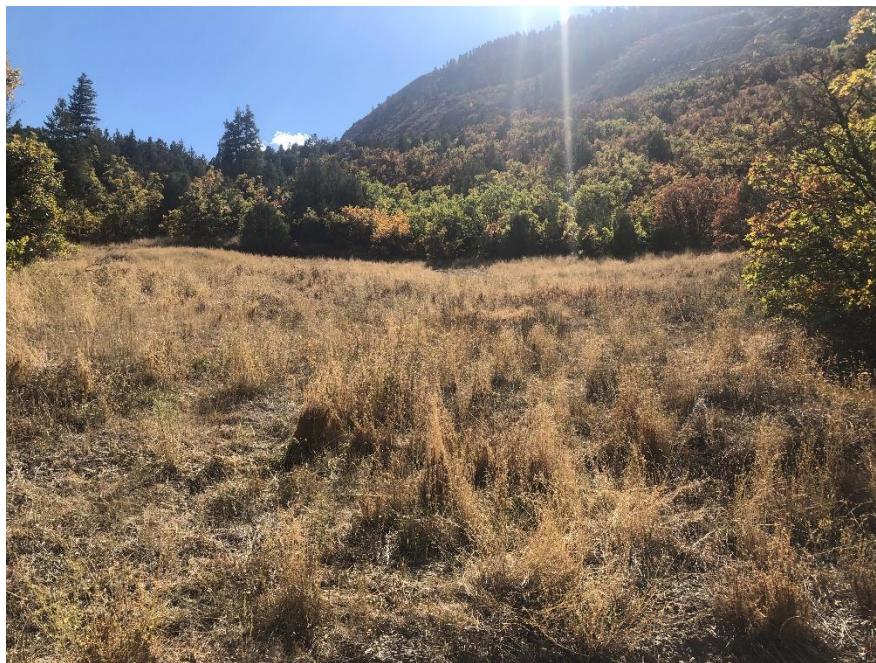
No problems were noted at the Hubbard Creek facilities. Many trees remain at the Vent Shaft pad. Grass cover was very good at the Rock Laydown area.

Rock Laydown area adjacent to road along Hubbard Creek

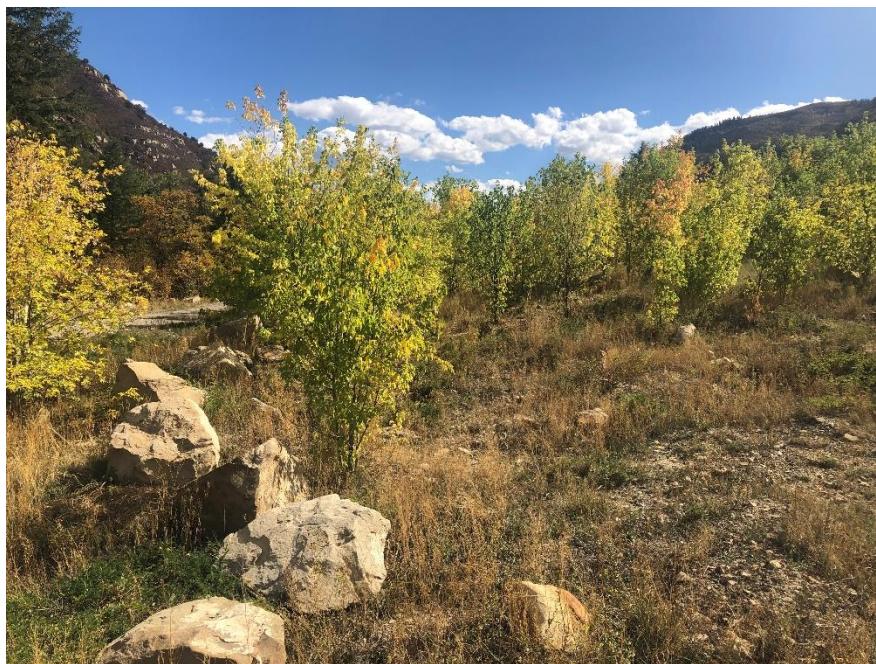
Trees on reclaimed pad for Hubbard Creek Vent Shaft
