### MINERALS PROGRAM INSPECTION REPORT

| <b>MINE NAME:</b><br>Velarde Pit | <b>MINE/PROSPECTING ID#:</b><br>M-2002-118 | <b>MINERAL:</b><br>Sand and gravel | <b>COUNTY:</b><br>Huerfano |
| <b>INSPECTION TYPE:</b><br>Monitoring | <b>WEATHER:</b><br>Cloudy | <b>INSP. DATE:</b><br>September 10, 2025 | <b>INSP. TIME:</b><br>12:53 |
| <b>OPERATOR:</b><br>Oldcastle SW Group, Inc. | <b>OPERATOR REPRESENTATIVE:</b><br>Sara Weimer and Kurt Wasinger | <b>TYPE OF OPERATION:</b><br>112c - Construction Regular Operation | |

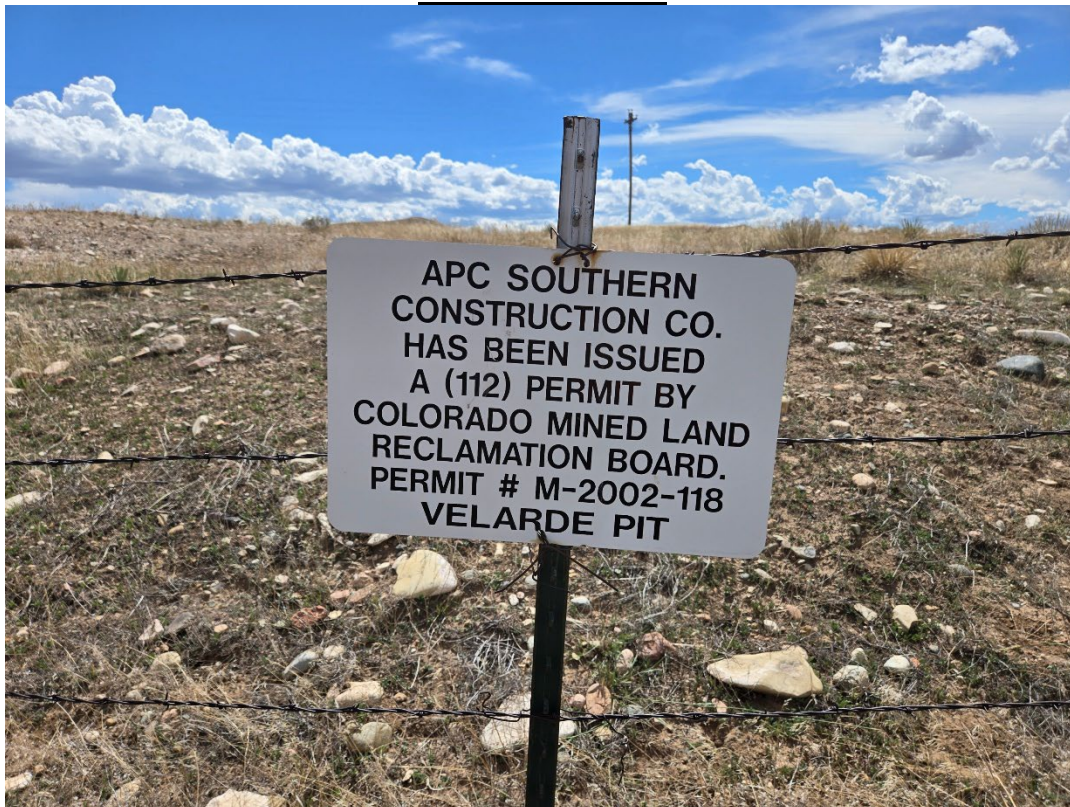
A mine sign was posted at the entrance to the site, but lists the previous Permittee. **This has been cited as a problem above.** The Operator shall update and/or replace the sign to reflect the current Permittee. A couple white PVC posts serving as permit boundary markers were observed during the inspection. However, the markers appeared to be incorrectly placed, as they were within 200' of the Landowner's fences. Prior to the inspection, the Division attempted to georeference the approved mining plan map, but had difficulty aligning markers depicted on the map with aerial imagery. Additionally, the map polygon appears to be at least 30 acres larger than what is actually permitted. Due to these discrepancies, **this has been cited as a problem above.** The Operator shall conduct a survey to identify the accurate permit boundary and replace the affected boundary markers in compliance with Rule 3.1.12(2).

**Photo 1:** Mine sign posted at the entrance to the site.

**CORRECTIVE ACTIONS:** The Operator shall update and/or replace the mine sign to reflect the current Permittee, and conduct a survey and replace the boundary markers in the correct locations. The Operator shall provide proof to the Division that this has been done by the corrective action date.

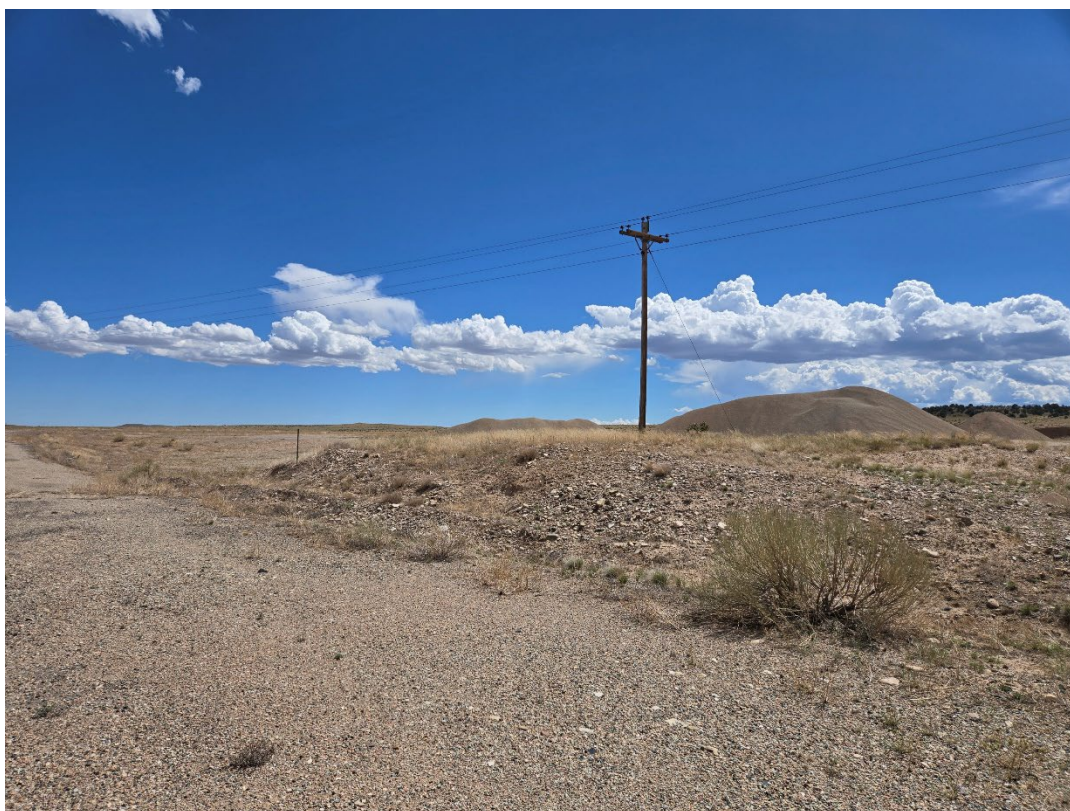
land within the northern buffer area consists of a portion of the processing area and an internal road. The affected land within the eastern buffer area also consists of a portion of the processing area and internal road, as well as part of a stormwater berm, and an area where a portable truck scale was located but has since been removed (see Photos 2, 3, and 12-14.)

**Photo 2:** Looking southeast at the internal road running east-west along the north side of the affected area, and at some of the product stockpiles in the processing area.

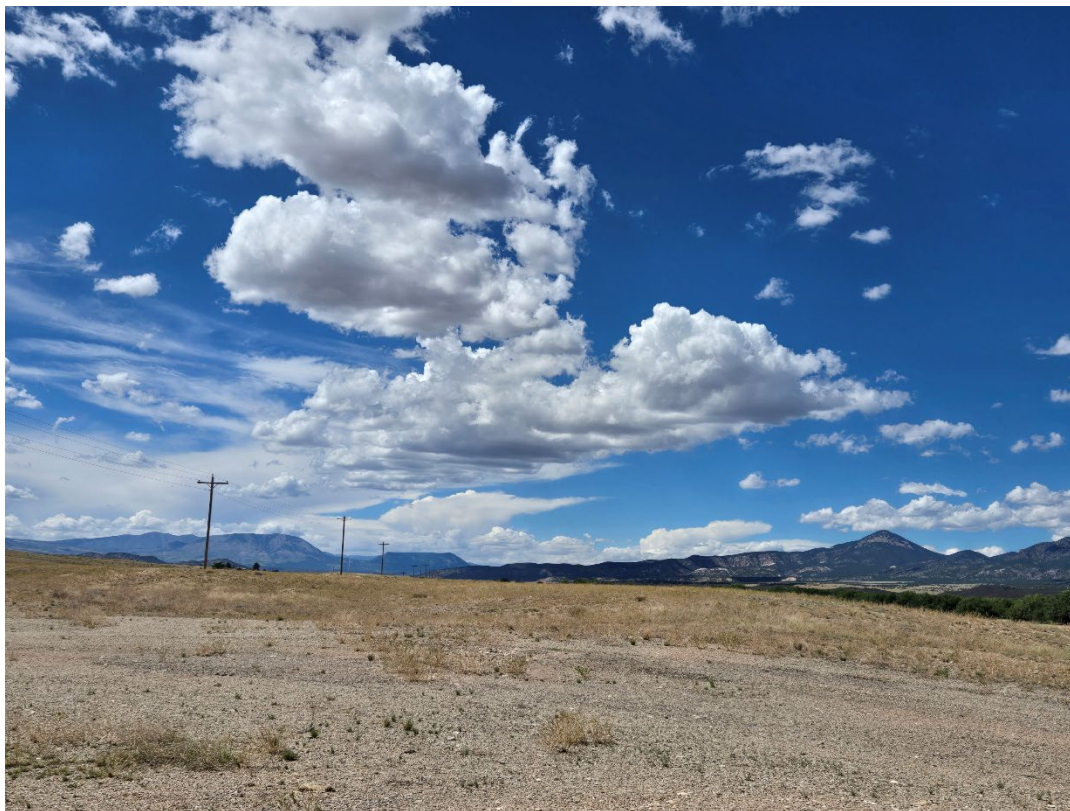
**Photo 3:** Looking west at a graveled area along the north portion of the site.

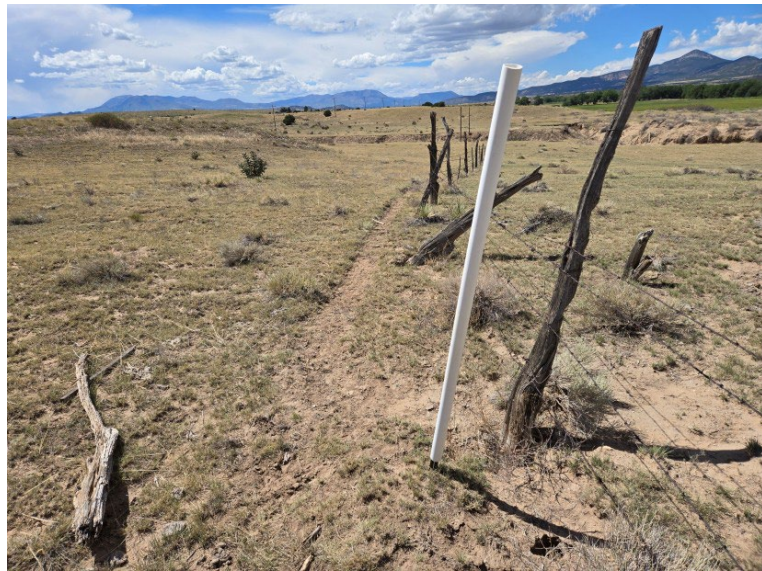
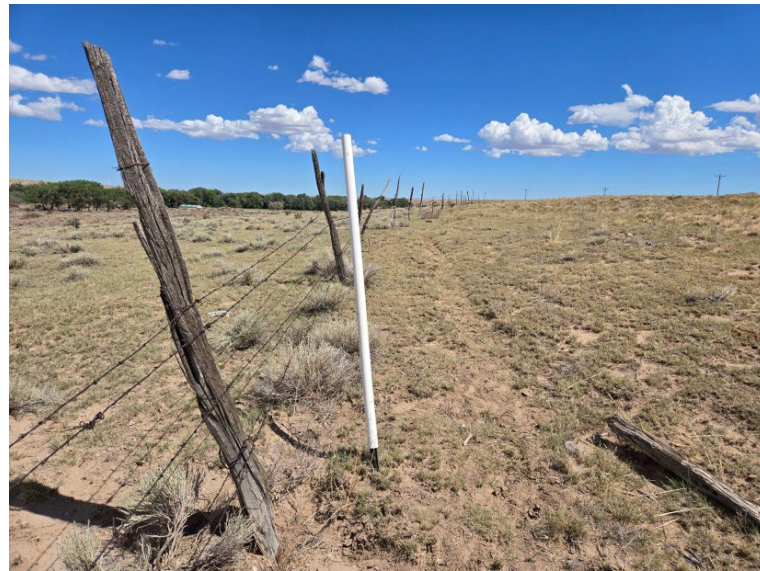
**Photo 4:** (Left) Looking west at a permit boundary marker placed along the northern fence. The arroyo that runs through the permitted area is seen in the background. (Right) Looking east at a permit boundary marker placed along the northern fence. A stockpile within the processing area can be seen in the background of the right side of the image.

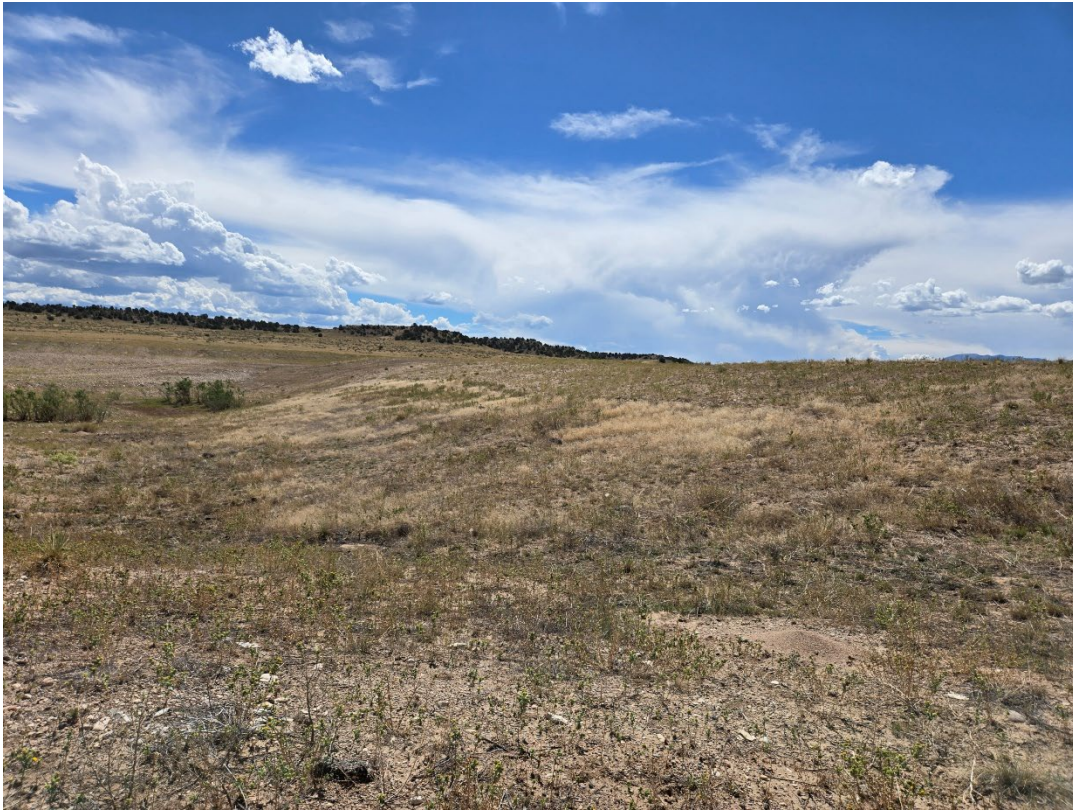
**Photo 5:** Looking south at the western graded slope within the pit area.

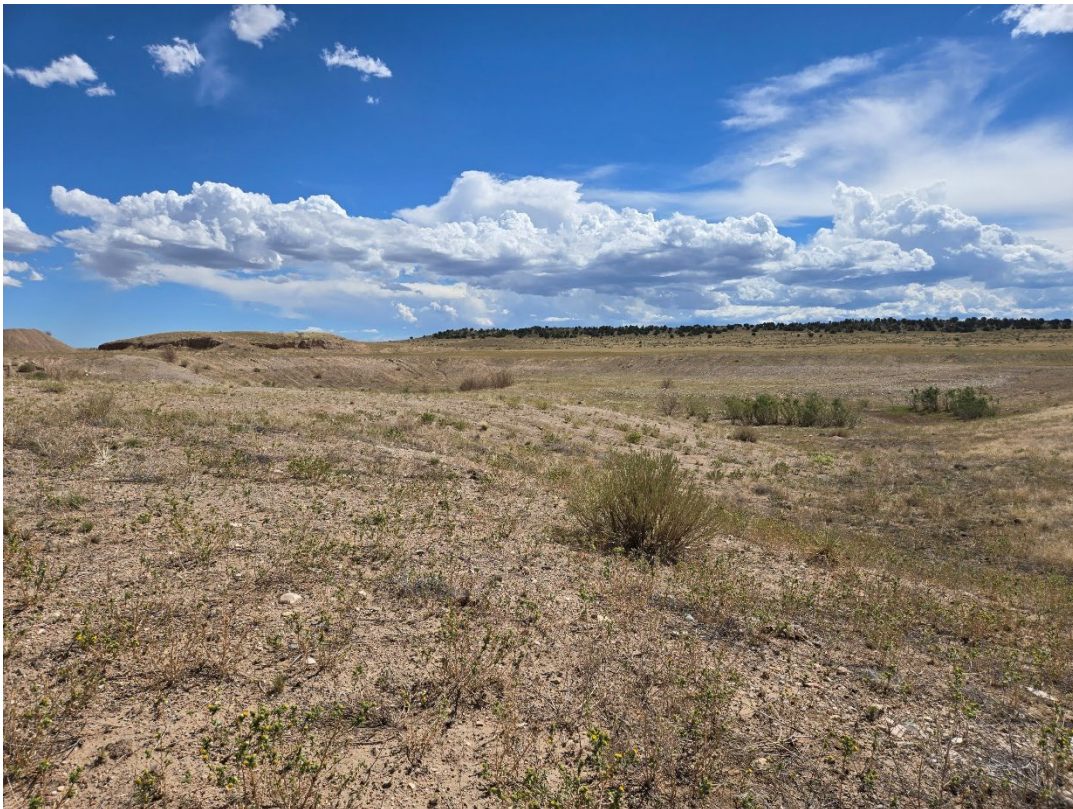
**Photo 6:** Looking southeast at the east and south graded slopes around the pit area. Some small erosion rills are apparent on the eastern slope.

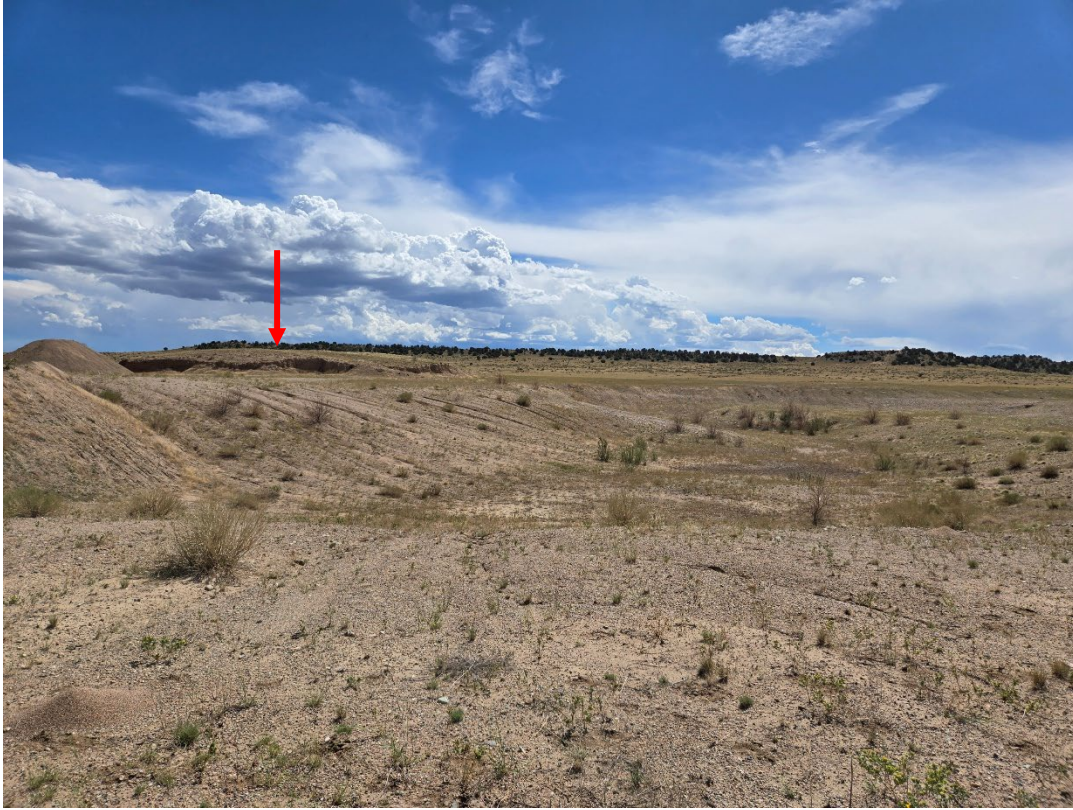
**Photo 7:** Looking southeast at the east and south graded slopes around the pit area. Some small erosion rills are apparent on the eastern slope. The arrow points to the topsoil pile in the background.

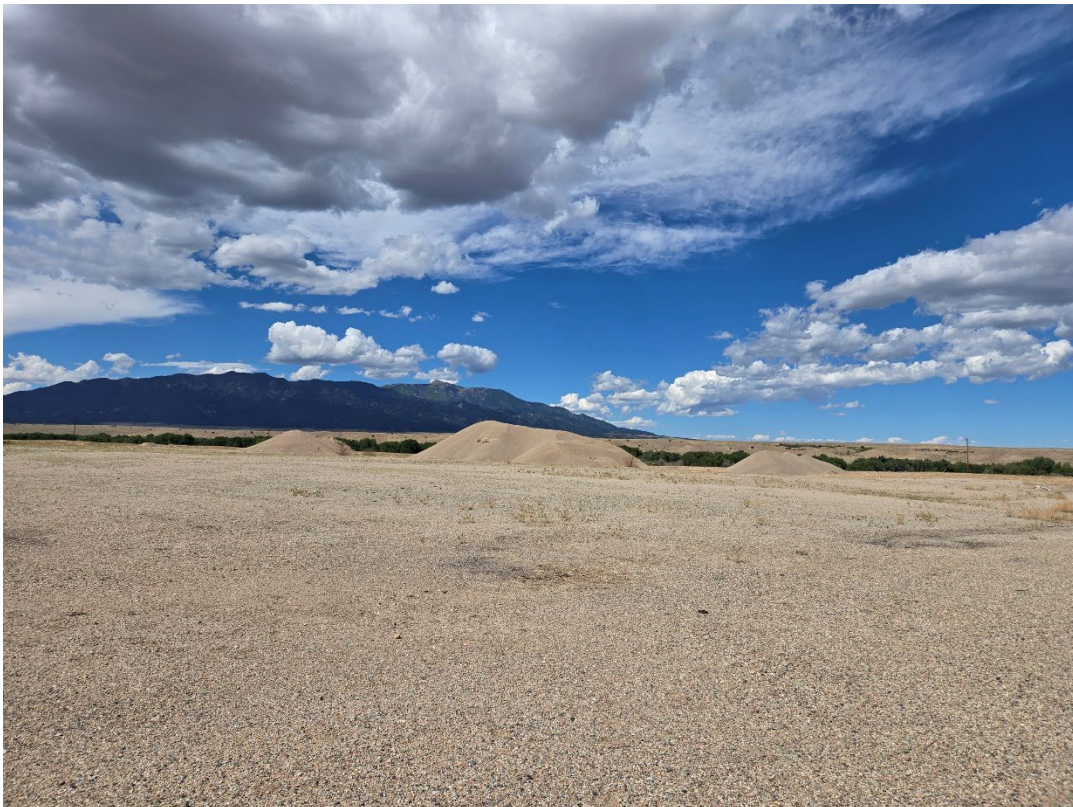
**Photo 8:** Looking north at the remaining product stockpiles within the processing area.

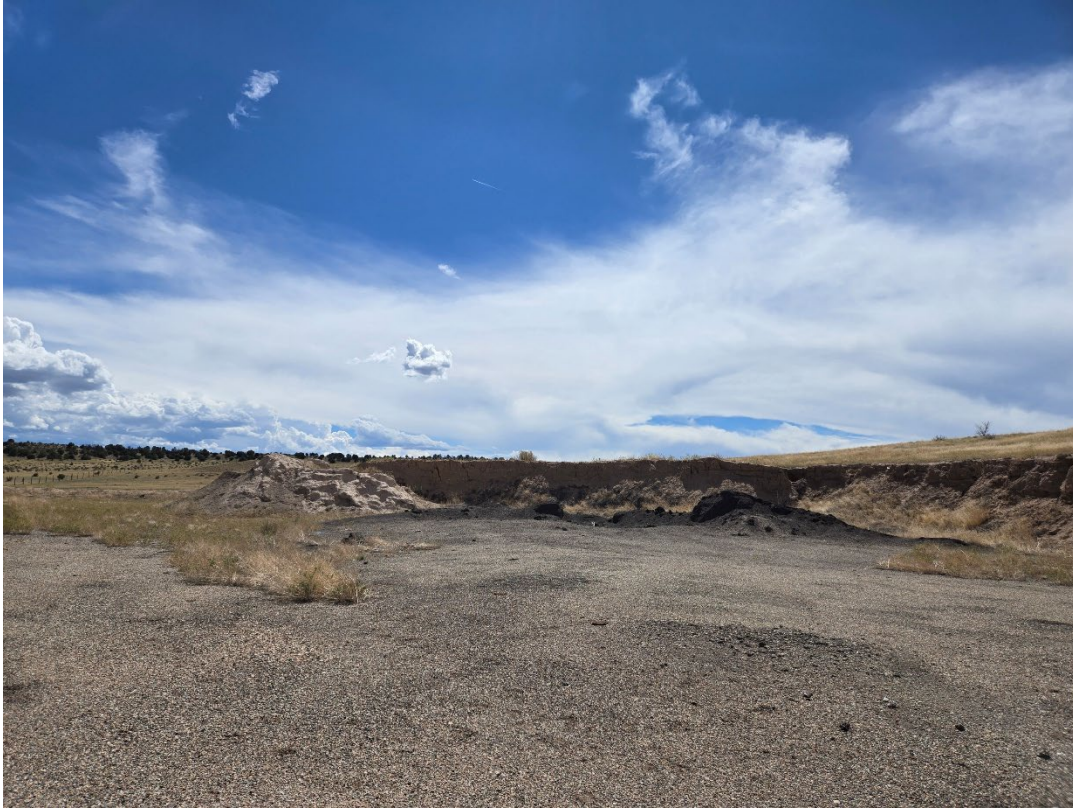
**Photo 9:** Looking south at a small amount of recycled asphalt, overburden, and topsoil pile on the south side of the processing area.

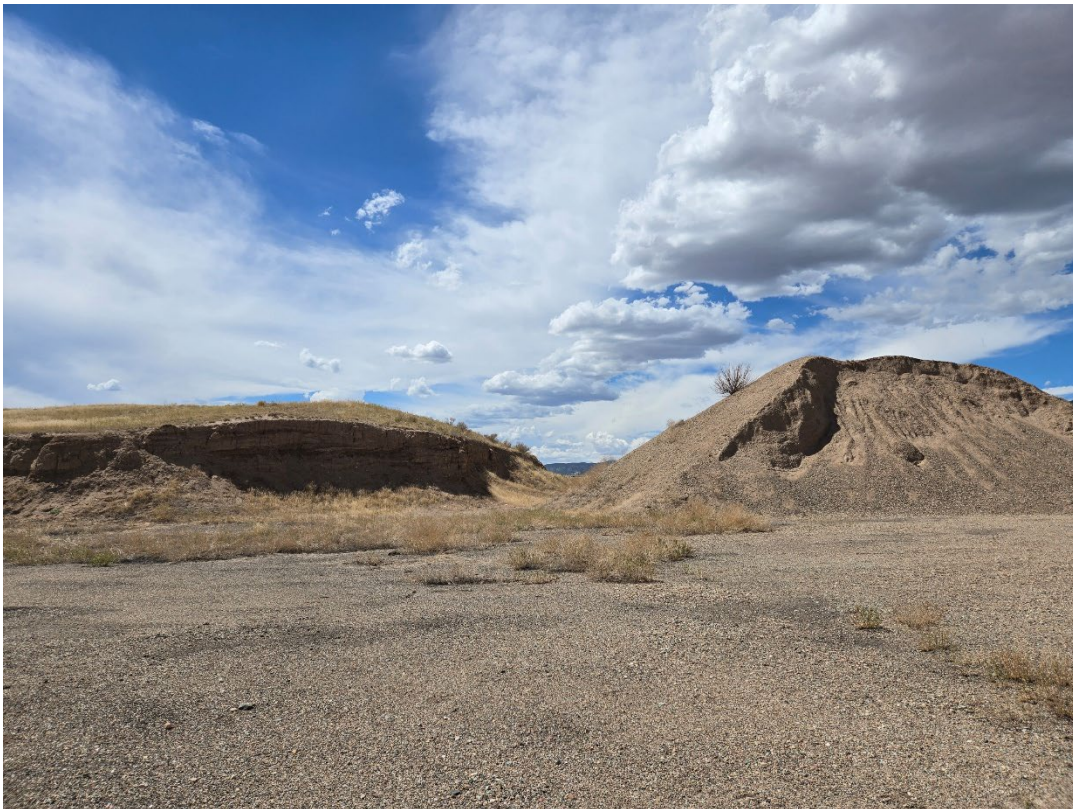
**Photo 10:** Looking west at the topsoil stockpile (left) and at a product stockpile (right).

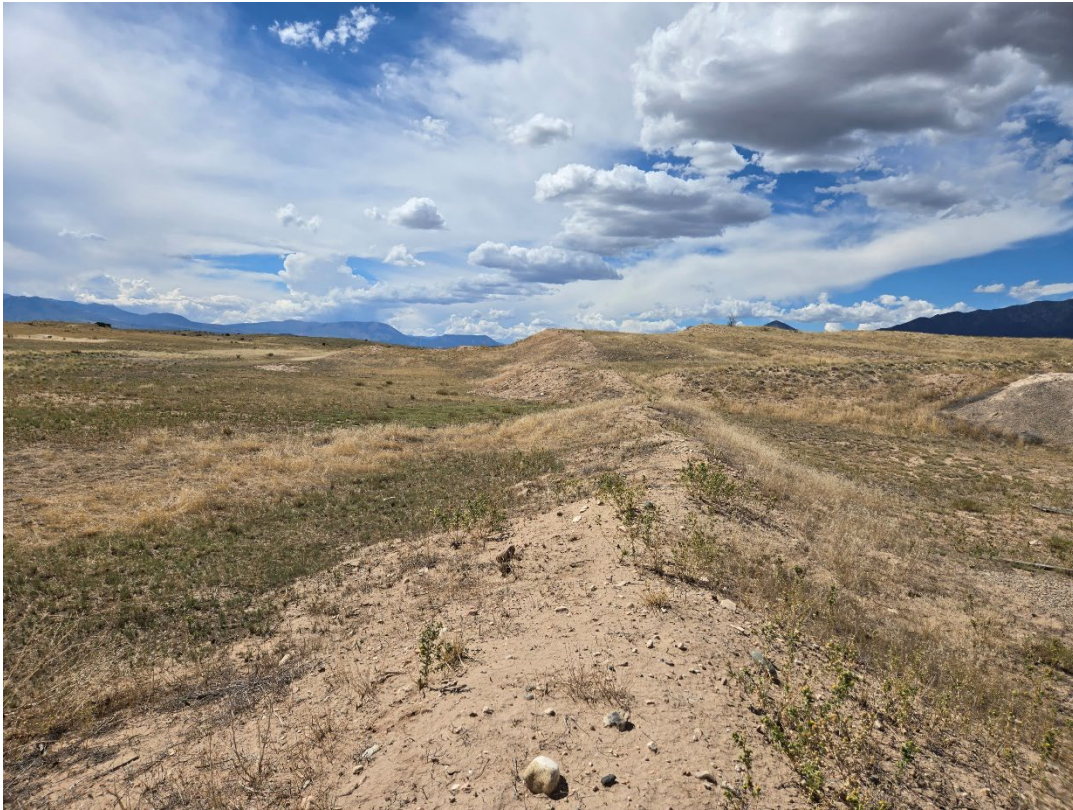
**Photo 11:** Looking west along the stormwater berm that marks the south side of the disturbed area.

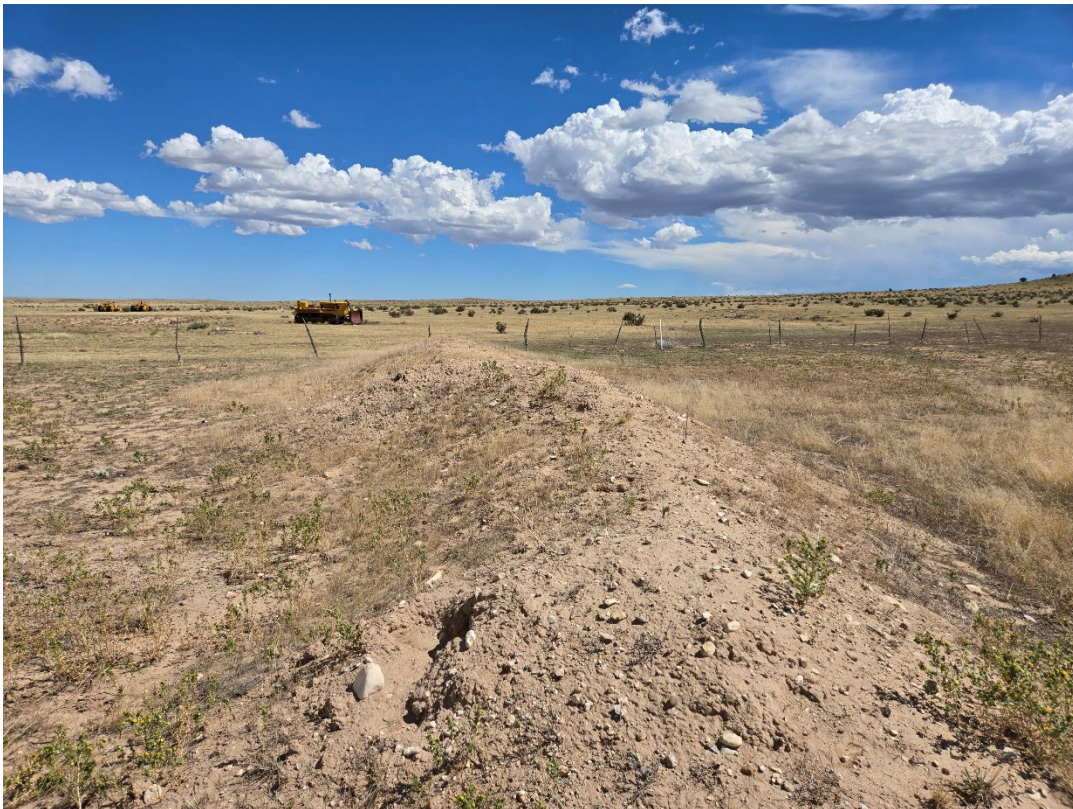
**Photo 12:** Looking east along the stormwater berm that marks the south side of the disturbed area.

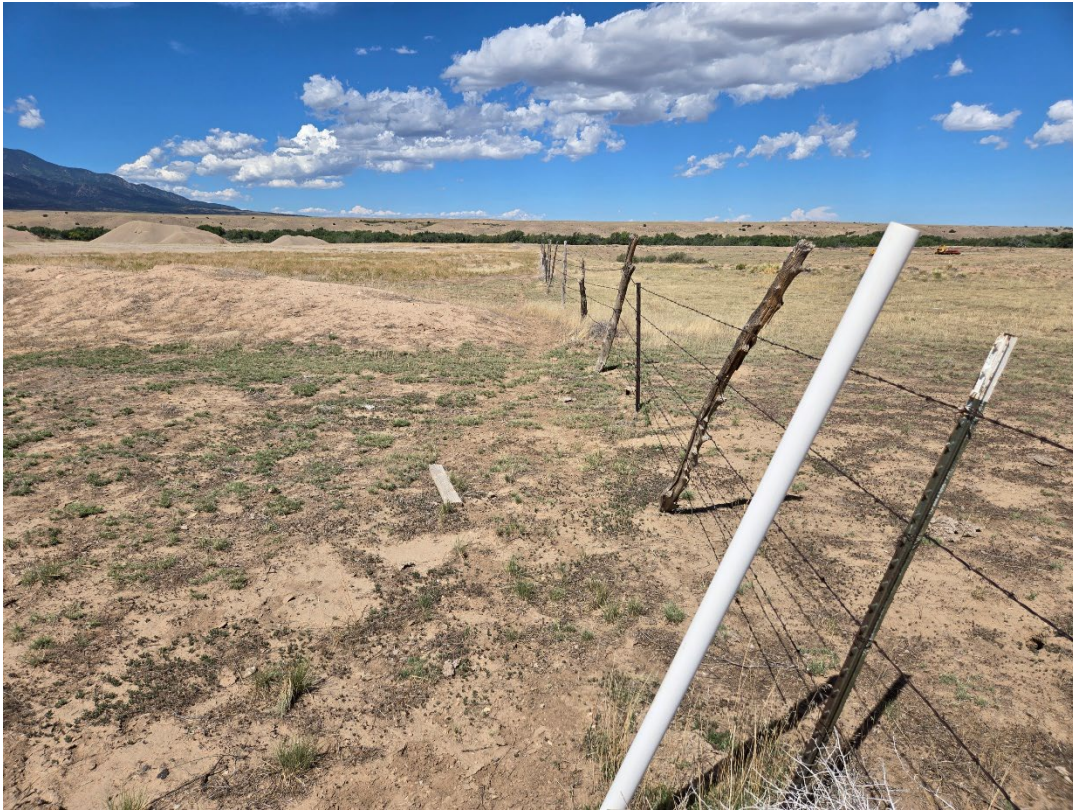
**Photo 13:** Looking north from the permit boundary marker located along the eastern fence.

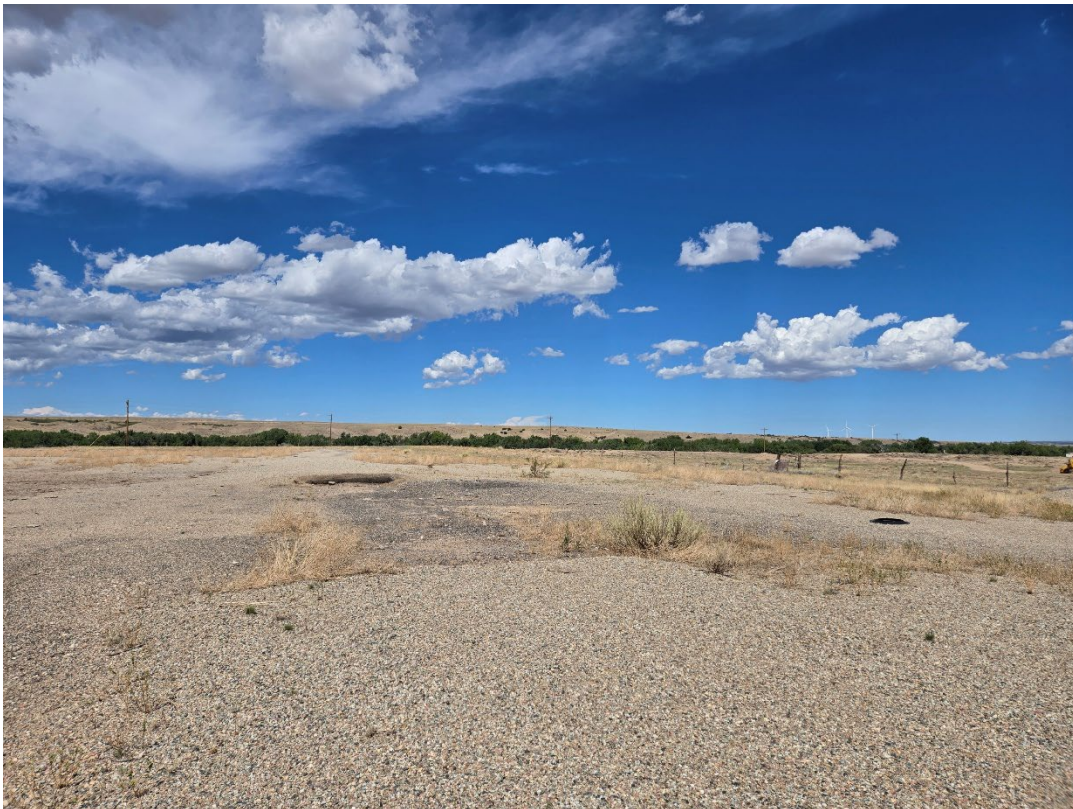
**Photo 14:** Looking at where the portable truck scale had been located on the eastern side of the processing area.

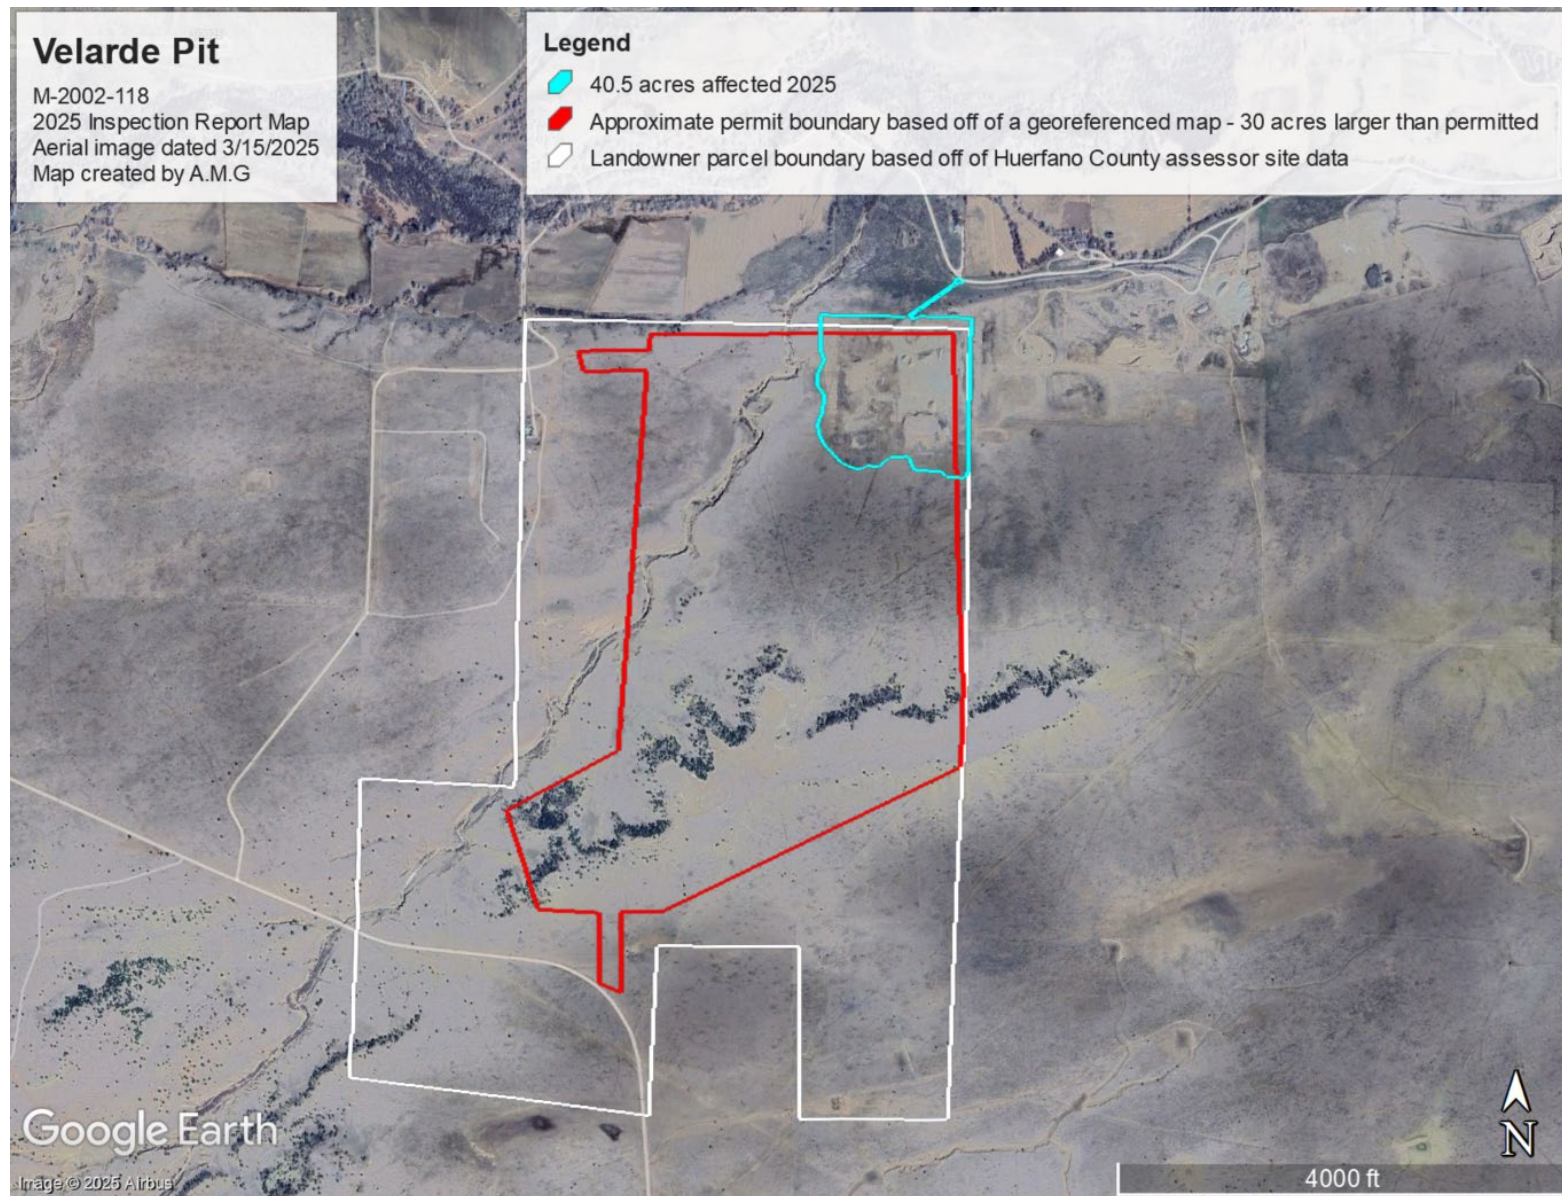
**Map 1:** 2025 Inspection report map. The permit boundary was approximated from georeferencing the approved mining plan map (see Figure 2 below). However, the shapes depicted on the approved map do not directly correspond with the aerial imagery. Also, the polygon depicted on Map 1 is approximately 30 acres larger than the 300 acres approved for this permit.

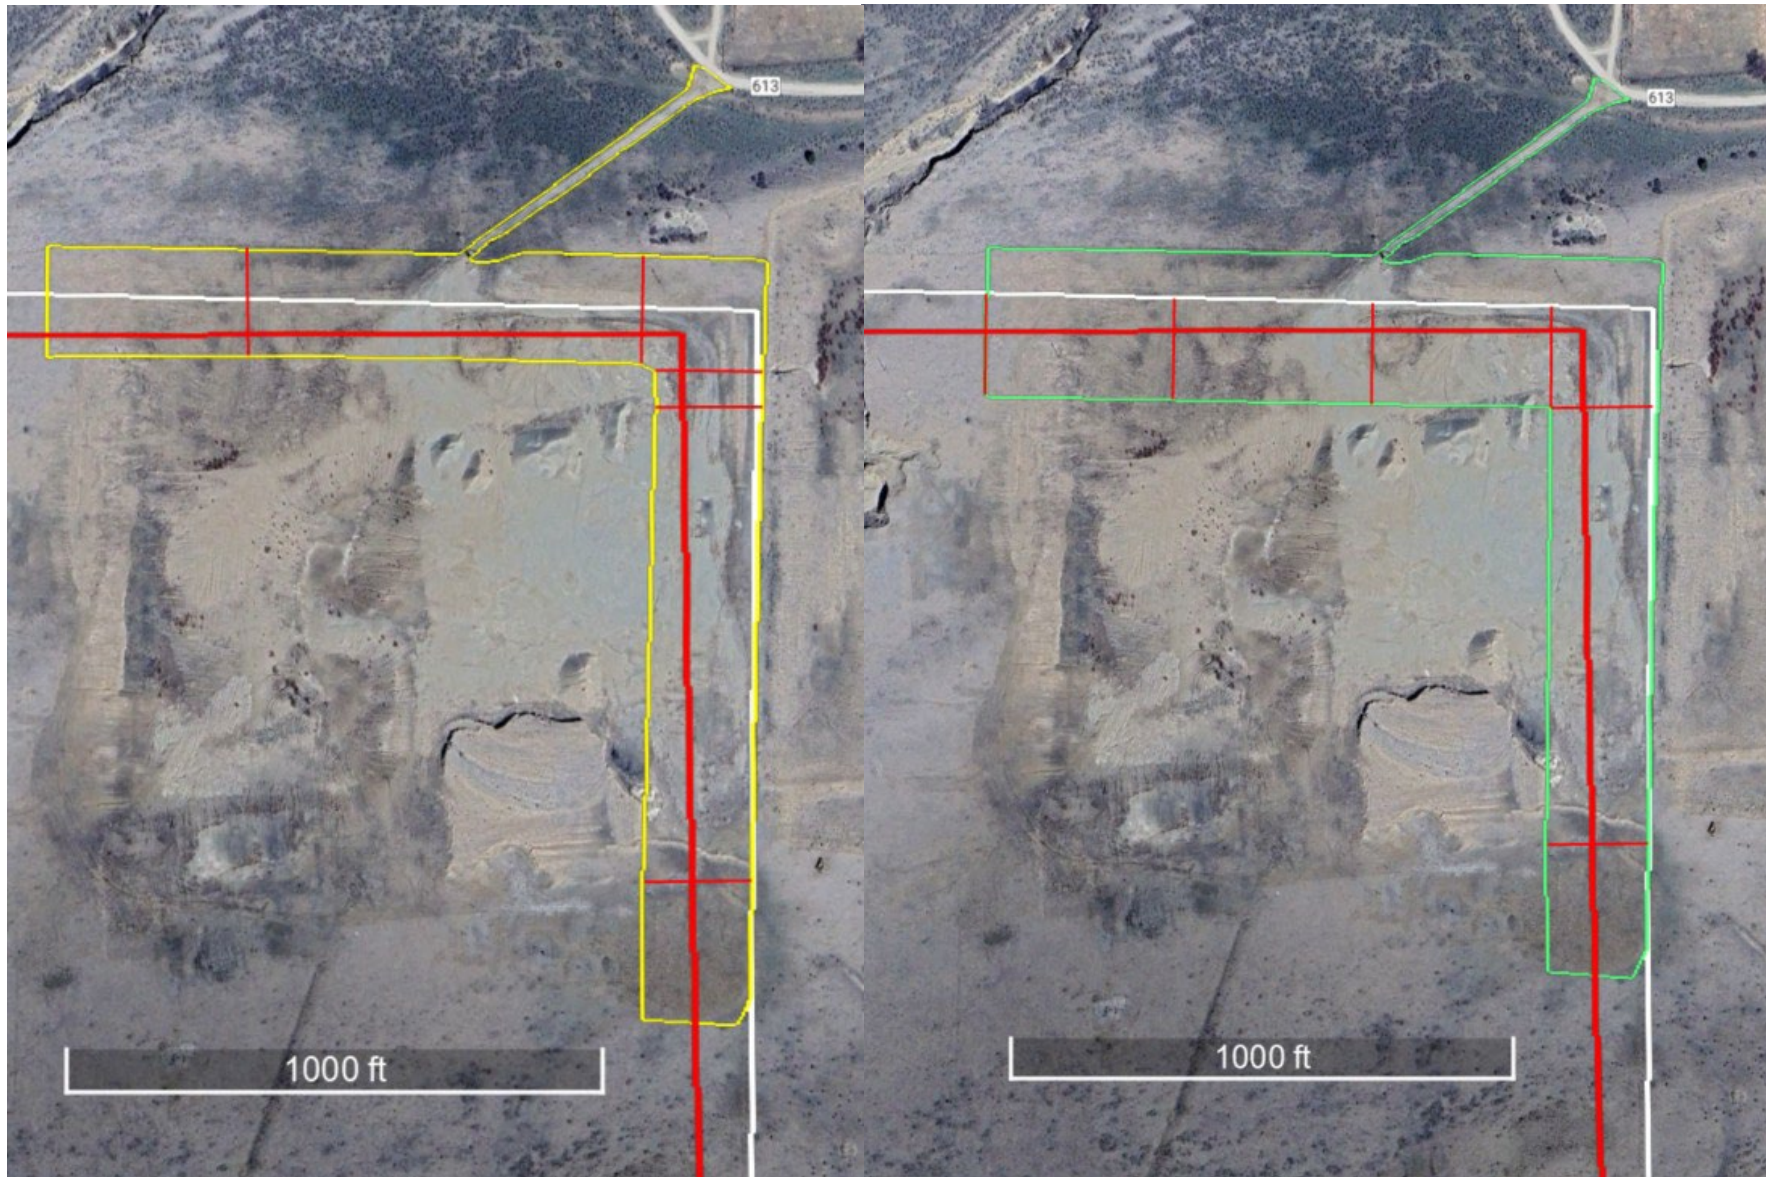
- 200-foot Landowner buffer area  
Per the approved Pre-Mining and Mining Plan maps, there is to be a 200-foot buffer area between the Landowner's boundary, and the affected land boundary. During pre-inspection review, it appeared that there is a discrepancy between the Landowner's fenced boundary and the parcel boundary location depicted on the Huerfano County Assessor website. The parcel boundary appears to closely follow the fence line on the east side of the permitted area, but the north parcel boundary is located further south than the north fence line. Regardless of which boundary correctly depicts the Landowner's boundary, the land within the 200-foot buffer area has been affected by mining (see Figures 1 and 2). The affected

- If the fence line accurately depicts the Landowner's boundary, the Division estimates that the 200-foot buffer zone and unapproved haul road total about 12 acres of offsite impact.
- If the parcel data from the Huerfano County Assessor accurately depicts the Landowner's boundary, the Division estimates that the 200-foot buffer zone and unapproved haul road total about 14.7 acres of offsite impact.

**Figure 1:** The images above depict where land has been affected offsite. (Left) The yellow polygon depicts the estimated 12 acres of offsite disturbance, based on a 200-foot buffer zone where the fence line depicts the Landowner's boundary. (Right) The green polygon depicts the estimated 14.7 acres of offsite disturbance, based on a 200-foot buffer zone where the parcel boundary sourced from the Huerfano County Assessor site depicts the Landowner's boundary.

Because areas have been affected outside of the permit boundary, **this has been cited as a possible violation.** The Division will bring this matter before the Mined Land Reclamation Board (MLRB/Board) for a hearing for consideration of a possible violation pursuant to C.R.S. 34-32.5-116(4)(i) for failure to protect areas outside of the approved affected land from slides or damages. The schedule and other details for the MLRB hearing will be provided under a separate document to be sent via certified mail to the Operator. The results of this hearing will also determine the appropriate revision required to address the additional disturbed area in excess of the 30-acre maximum allowed disturbance.

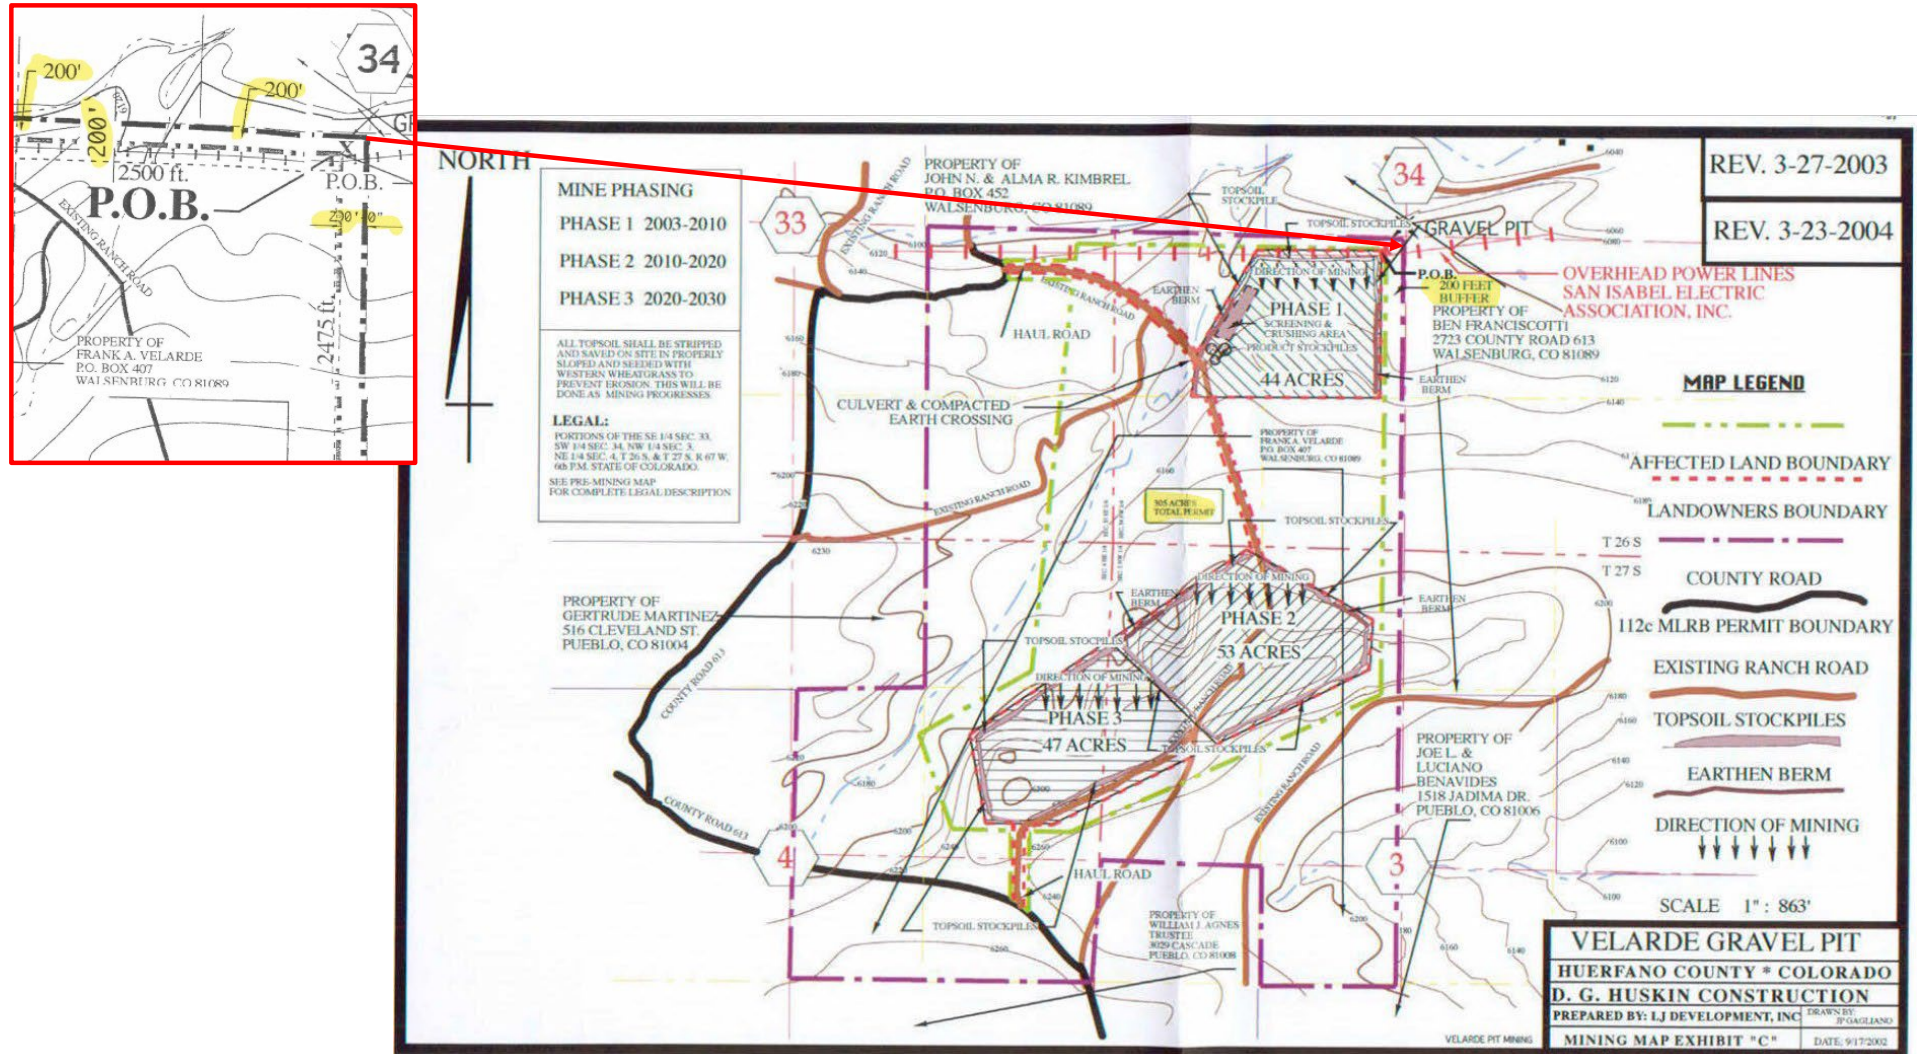
**Figure 2:** The large image is the approved Mining Plan Map for the Velarde Pit. The small square on the right is from the approved Pre-Mining Plan Map. Both maps depict a 200-foot offset between the Landowner's boundary and the permit boundary/affected land boundary in the northeast portion of the site. Additionally, the approved Mining Plan Map incorrectly depicts the permit boundary as totaling 305 acres.
