## Williams Fork Mine September Inspection Report

**PERMIT INFORMATION**

**INSPECTION INFORMATION**

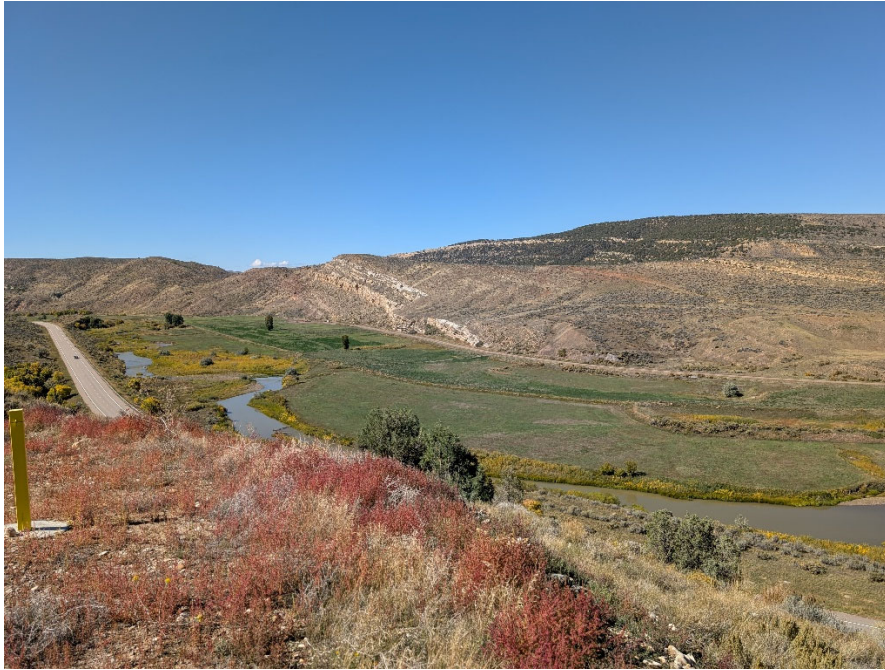
Photo 1: Looking southwest across the reclaimed croplands around the #5 Portal.

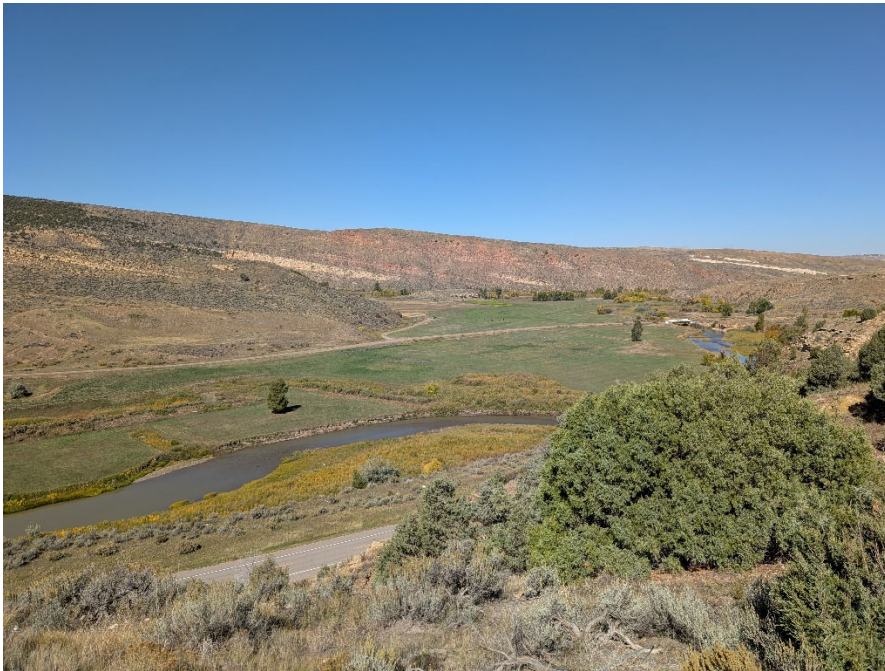
Photo 2: Looking northwest across the reclaimed croplands around the #5 Portal and Rail Spur.

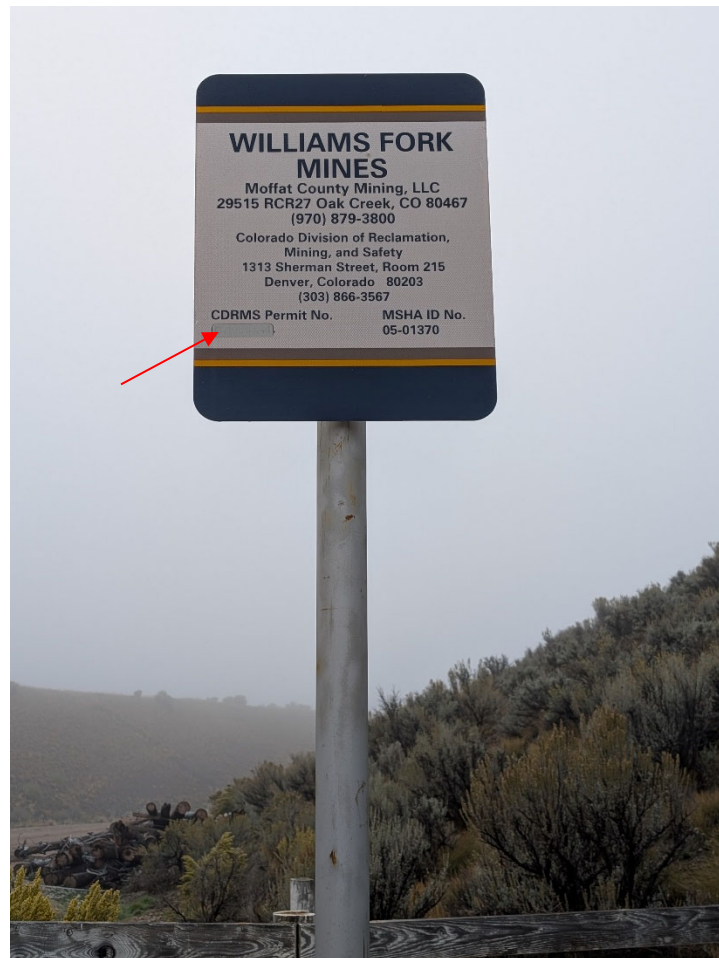
- The mine sign was in place at the site entrance and included the mine name, operator name, address, and phone number, however, the DRMS permit number is not illegible. **The Operator needs to replace or repair the sign to ensure the DRMS permit number is legible.**
- Topsoil stockpiles observed. Topsoil piles are marked with t-posts. Section 4.02.7 in the permit states that stockpiled topsoil will be marked with signs reading “topsoil”. The Division observed signs that have fallen off the posts that need to be reinstalled and, in some cases, no topsoil marker signs were observed. **The operator needs to reinstall topsoil signs on the stockpiles.**
- Stream buffer zone along the Williams Fork River in the cropland area is marked with white plastic stakes.
- Metal t-posts painted white with red tops mark the permit boundary throughout the site.

Photo 3: Mine sign posted at the entrance. DRMS permit number is illegible.

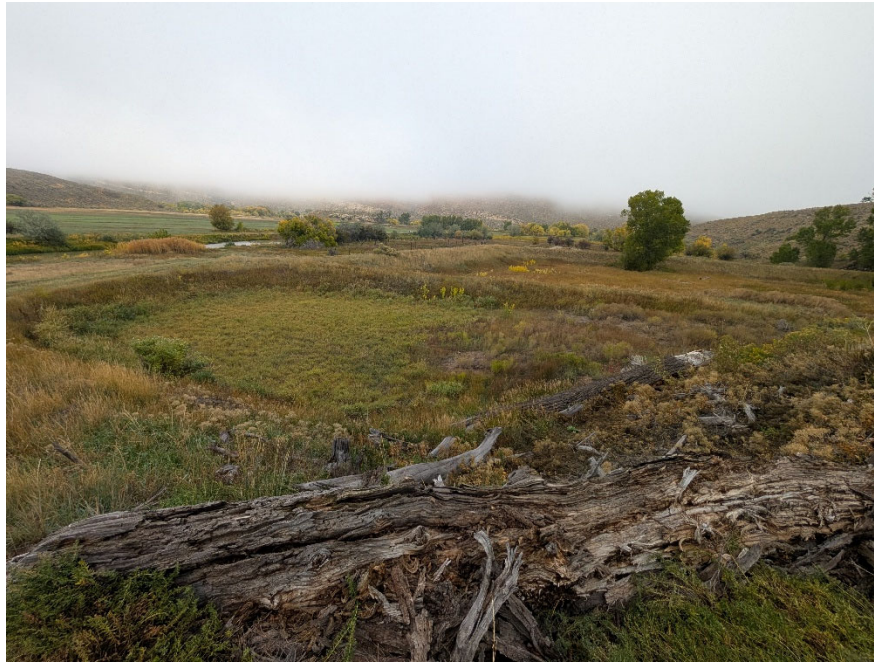
Photo 4: Ponds HR-P1a and P1b observed on the north end of the site.

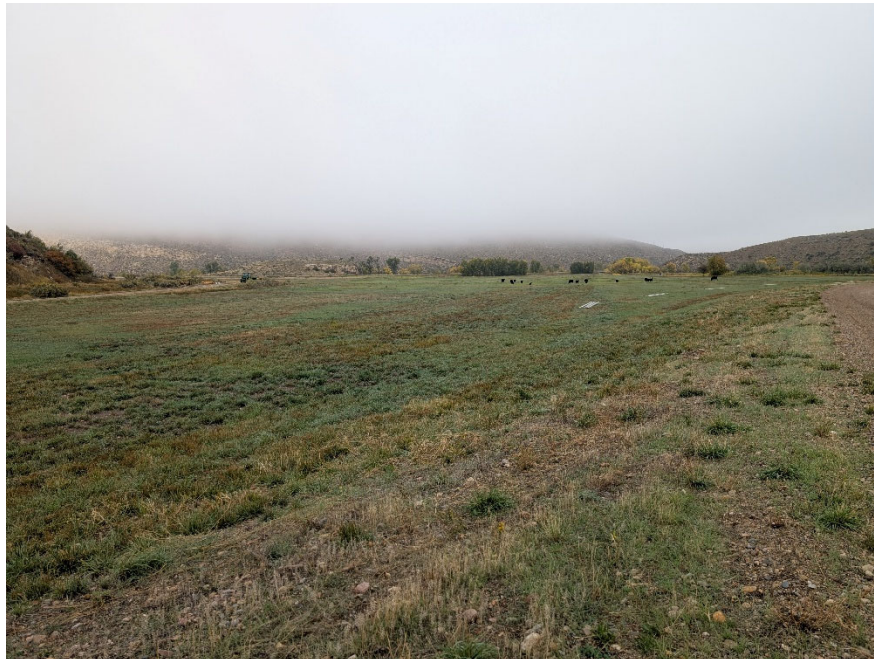
Photo 5: Looking northwest at cropland in the RR Spur area.

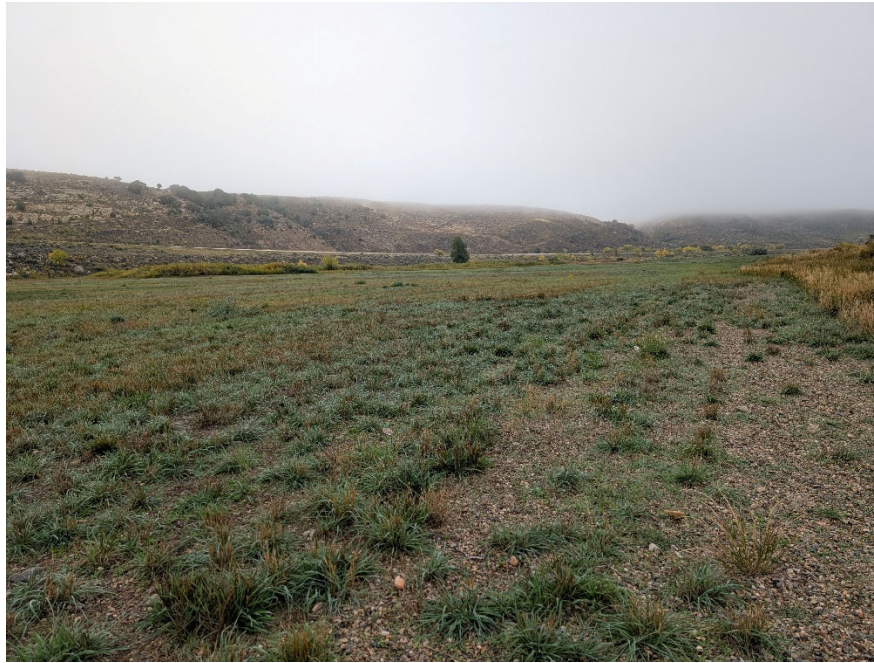
Photo 6: Looking northwest across Cropland near the #5 Portal/Shop area.

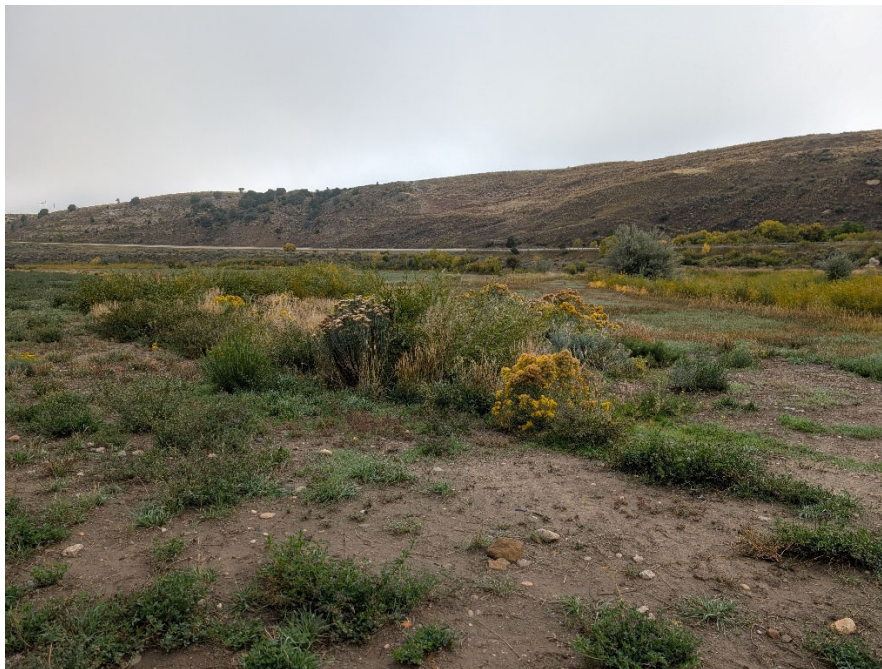
- Stream buffer zone along the Williams Fork River was marked.
- The Division observed the drainage ditch that runs north/south through the cropland. **In the area of the reclaimed silo, sediment was observed around the drainage ditch indicating water is pooling outside the ditch. The operator needs to excavate the ditch in this area to restore the drainage channel.**

Photo 7: Ditch on the east side of the #5 Portal/Shop area. Water and sediment appear to pool in this area.

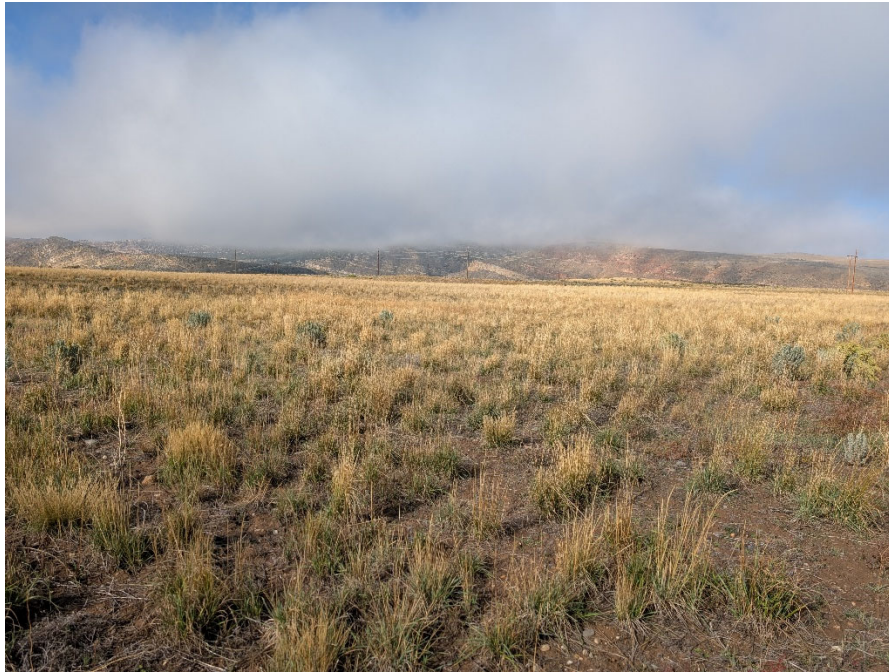
- The revegetated refuse pile appears stable with no significant rills or gullies forming.
- Desired grasses are growing uniformly across the area.
- A large area of yellow sweet clover was observed on the northeast side. Isolated patches of cheat grass were noted. **The Operator will need to continue to spray the noxious weeds according to the weed management schedule.**

Photo 8: Looking west across the refuse pile reclamation

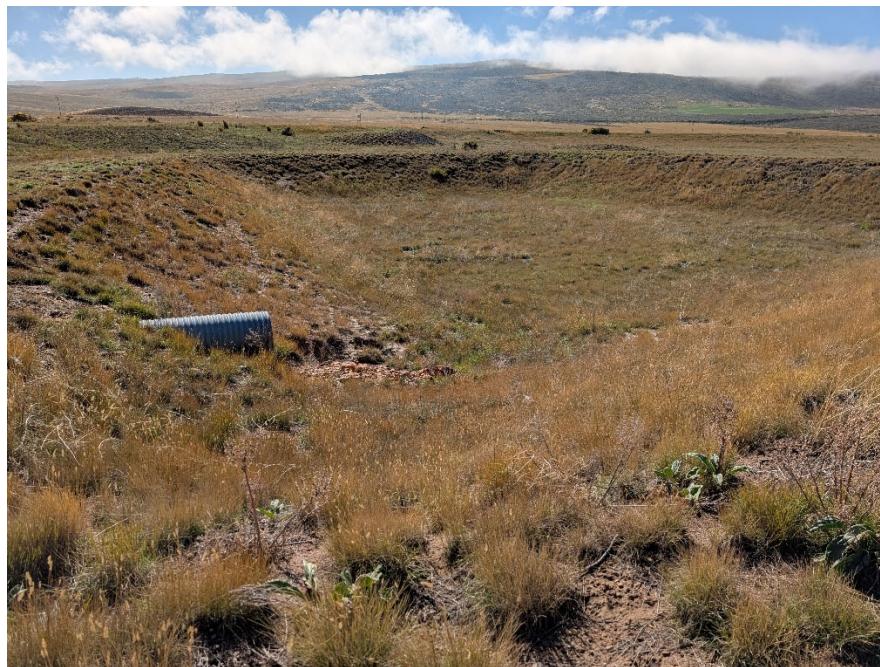
Photo 9: Pond 9-P6 on the east side of the site, well vegetated and stable.

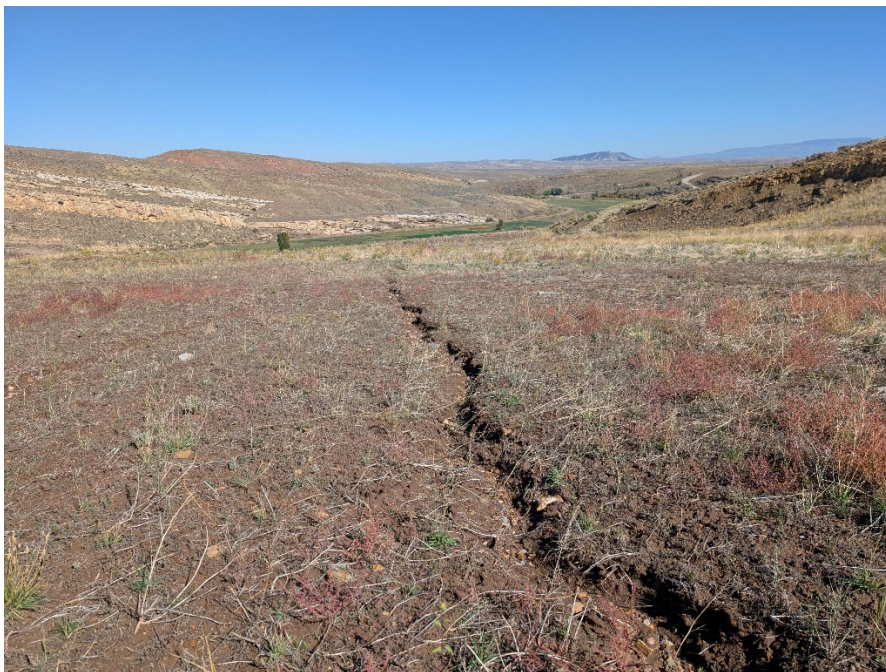
- #5 Portal /R.R. Spur/Shop areas along the west side are revegetated to cropland. Desired hay species were observed, including alfalfa and wheat plants. The field was last harvested in July 2025.
- 5A Portal area slopes are revegetated and stable and no erosion rills were noted.
- The slope below the service building, adjacent to the 5A portal, is vegetated with russian thistle and some desired grasses are filling in. Bare ground was also noted here. **A large erosion rill was observed on the slope leading to Pond 5A-P1. The Operator will need to monitor this and repair the rill.**

Photo 10: Erosion rill noted in slope below the #5A Portal and Service building.

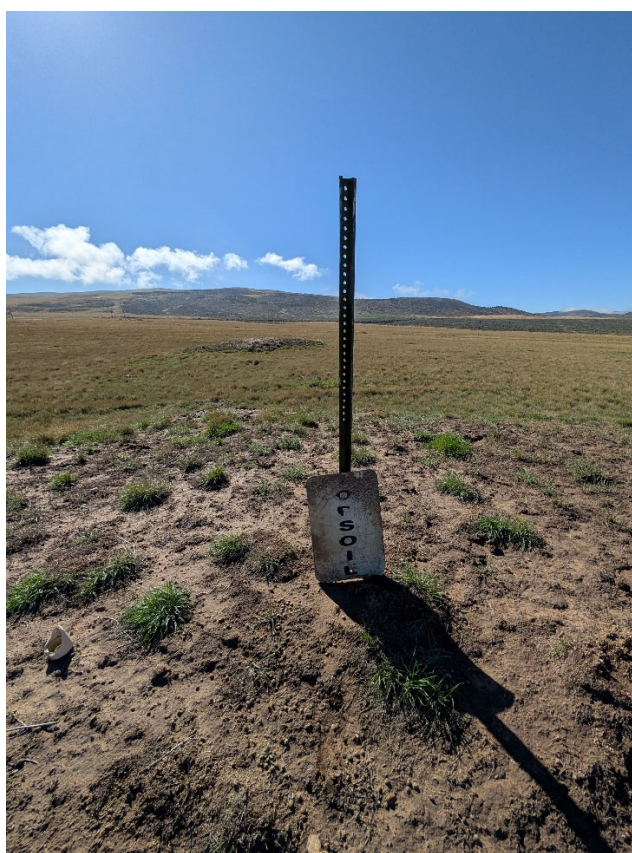
Photo 11: Topsoil pile marked with t-post and sign. Sign has fallen off the stake.
