**PERMIT INFORMATION**

| <b>Permit Number:</b> C-1981-015<br><b>Mine Name:</b> Fruita No 1 & 2<br><b>Operator:</b> Dorchester Coal Company<br><b>Operator Address:</b><br>Greg Lewicki<br>9054 South Forrest Drive<br>Highlands Ranch, CO 80126 | <b>County:</b> Mesa<br><b>Operation Type:</b> Underground<br><b>Permit Status:</b> Revoked<br><b>Ownership:</b> Private |

**INSPECTION INFORMATION**

| <b>Inspection Start Date:</b> September 30, 2025<br><b>Inspection Start Time:</b> 11:10<br><b>Inspection End Date:</b> September 30, 2025<br><b>Inspection End Time:</b> 12:05 | | <b>Inspection Type:</b> Coal Complete Inspection<br><b>Inspection Reason:</b> Normal I&E Program<br><b>Weather:</b> Clear | |

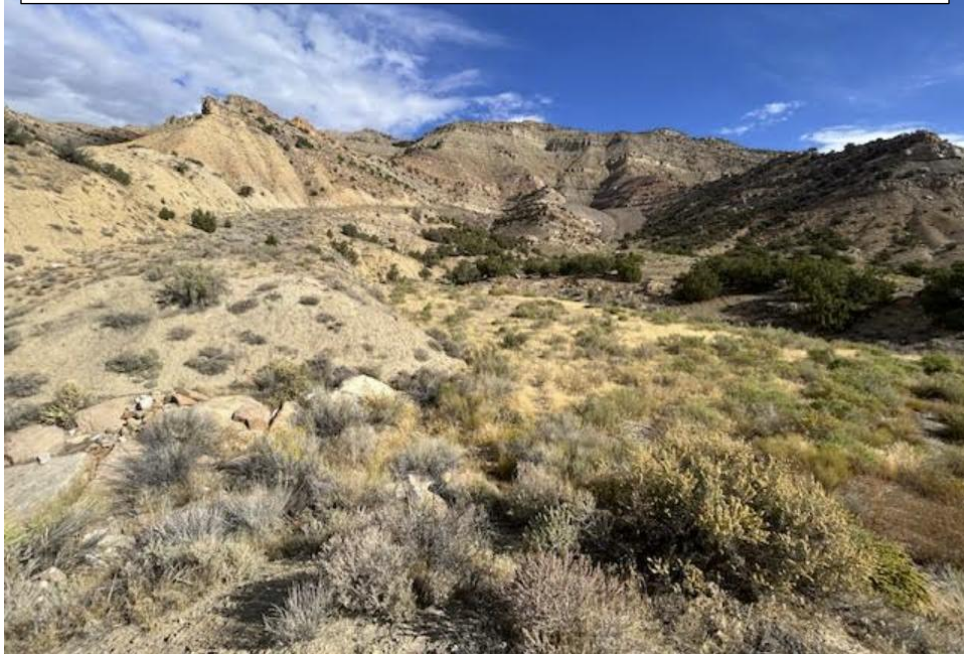
Located in the southern portion of the permit area, is the sediment pond. The pond was dry at the time of the inspection (Photo 1). The embankment was stable with vegetative cover (Photo 2). There were no indications of erosional features or animal burrows observed. The outlet for the pond is located on the west side of the pond. The outlet is lined with riprap. The outlet was stable with no blockages. The riprap was in good condition.

Photo 1: The north end of the sediment pond.

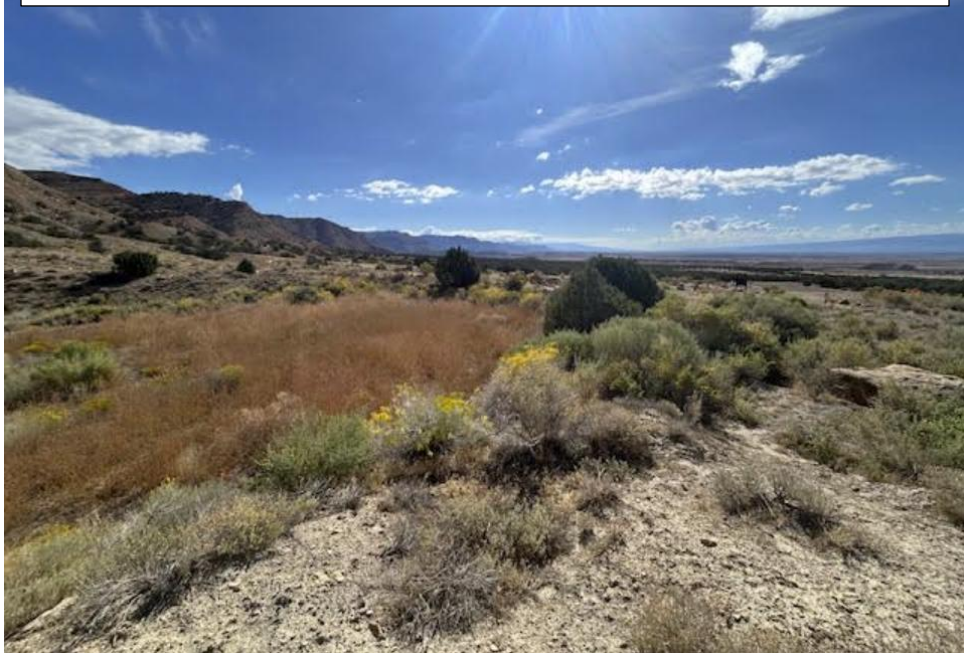
Photo 2: The embankment of the sediment pond.

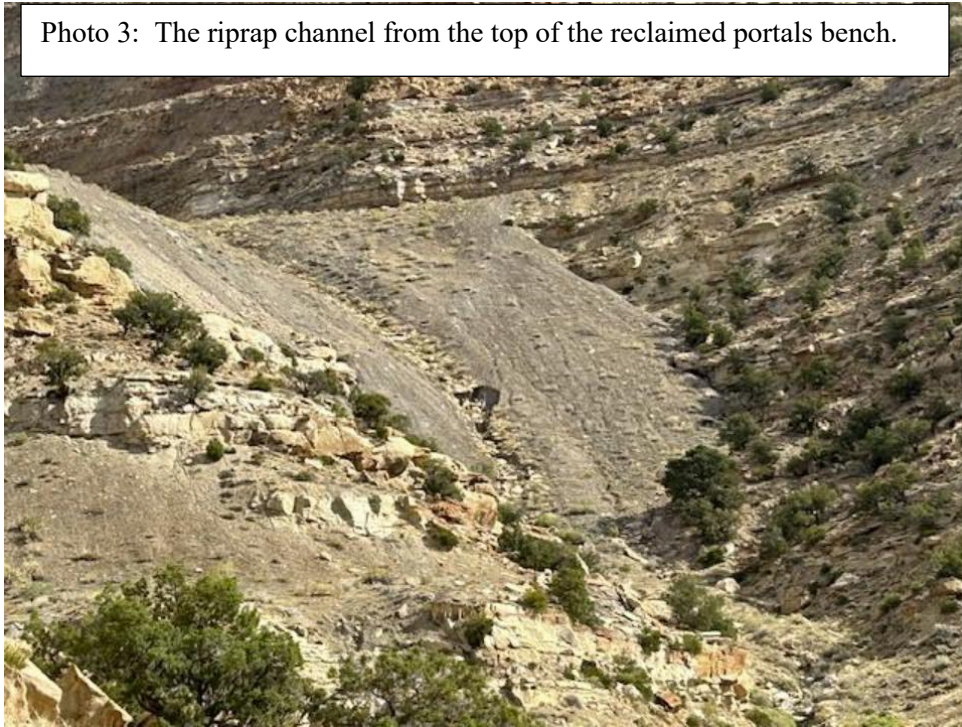
There is a riprap lined channel that extends from the reclaimed portals bench to the drainage above the sediment pond. The riprap channel was dry and appeared to be in the same condition as previous Division Inspections (Photo 3). The channel was stable and there were no new erosional features identified. The same erosional rill on the east side of the channel remained but did not appear to have enlarged from previous Division inspections. No obstructions were observed in the channel.

Photo 3: The riprap channel from the top of the reclaimed portals bench.

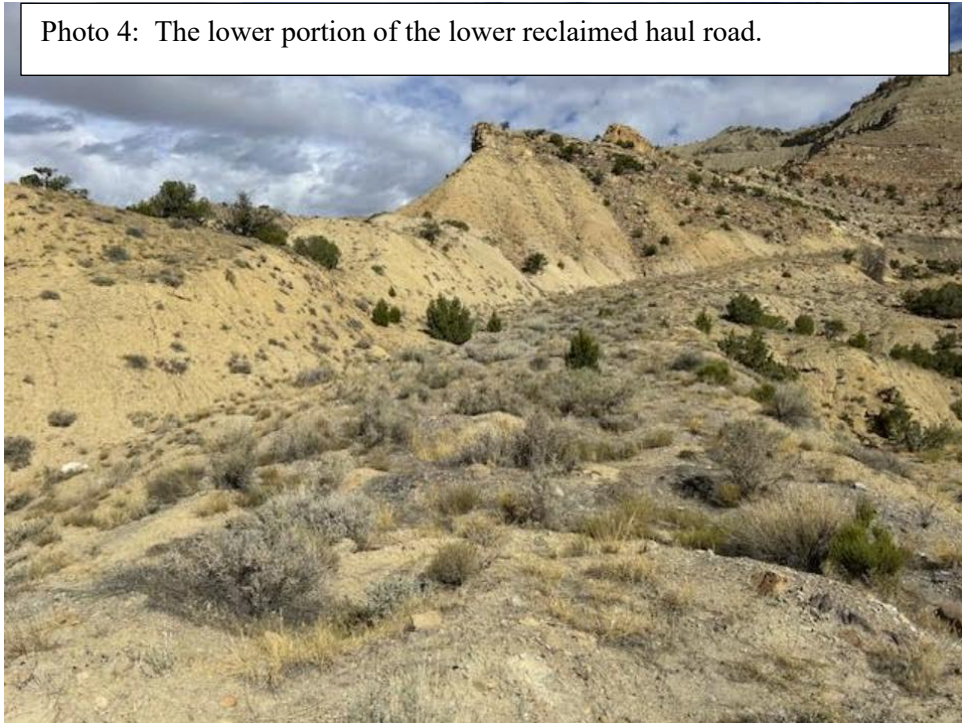
The reclaimed haul road extends from the southern portion of the permit area to the north at the reclaimed portals bench. The lower portion of the haul road was stable with vegetative cover (Photo 4 and 5). There were no new

Photo 4: The lower portion of the lower reclaimed haul road.

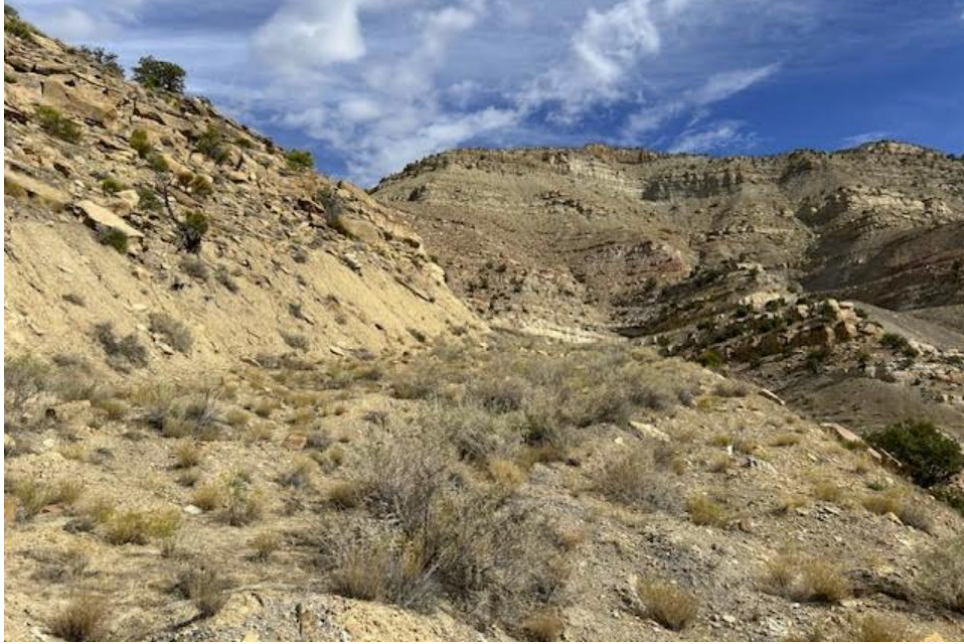
Photo 5: The upper portion of the lower reclaimed haul road.

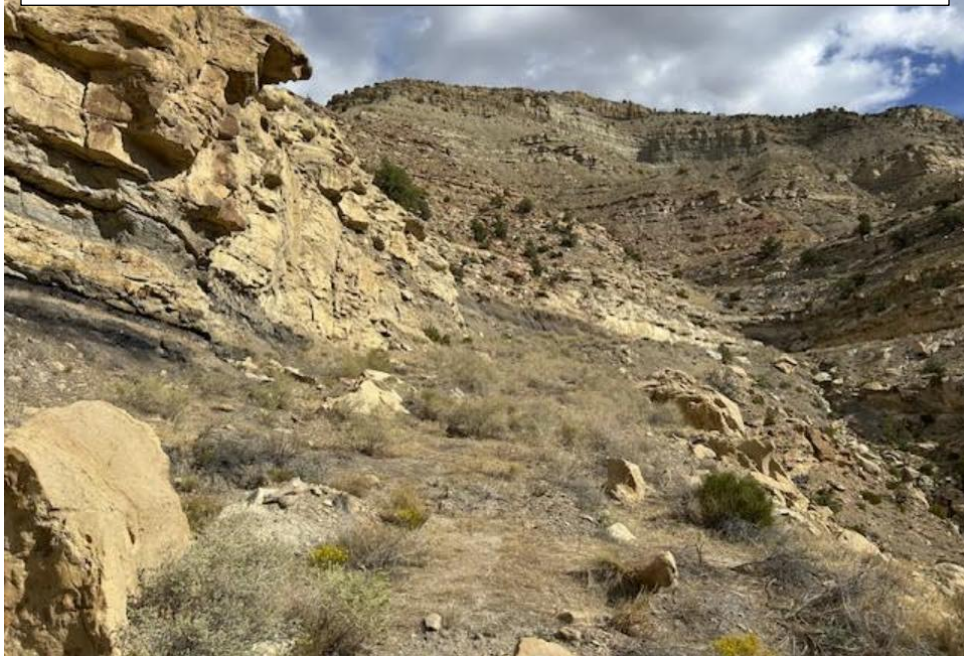
erosional features identified during the inspection. The old rills on the lower part of the reclaimed haul road remained stabilized and had not enlarged. The middle portion of the reclaimed haul road was also vegetated and stable (Photo 6). Here were no indications or erosional features. The upper portion of the reclaimed haul road was stable with no erosional features (Photo 7 and 8). The reclamation was covered with vegetation. The cut and fill slopes of the reclaimed haul road were stable and there were no erosional concerns identified.

Photo 6: The middle portion of the reclaimed haul road.

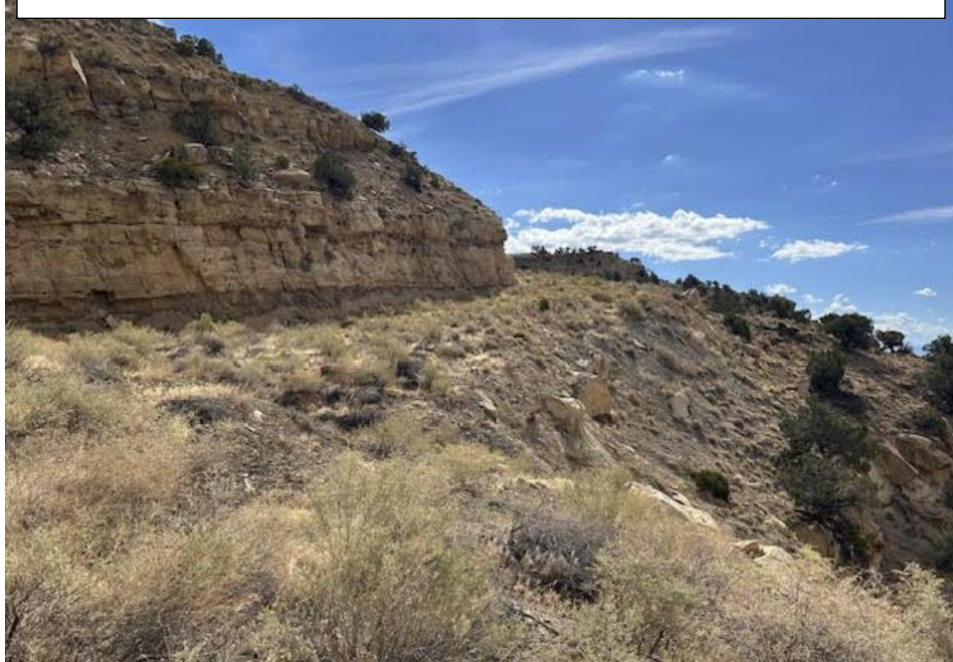
Photo 7: The lower portion of the upper reclaimed haul road.

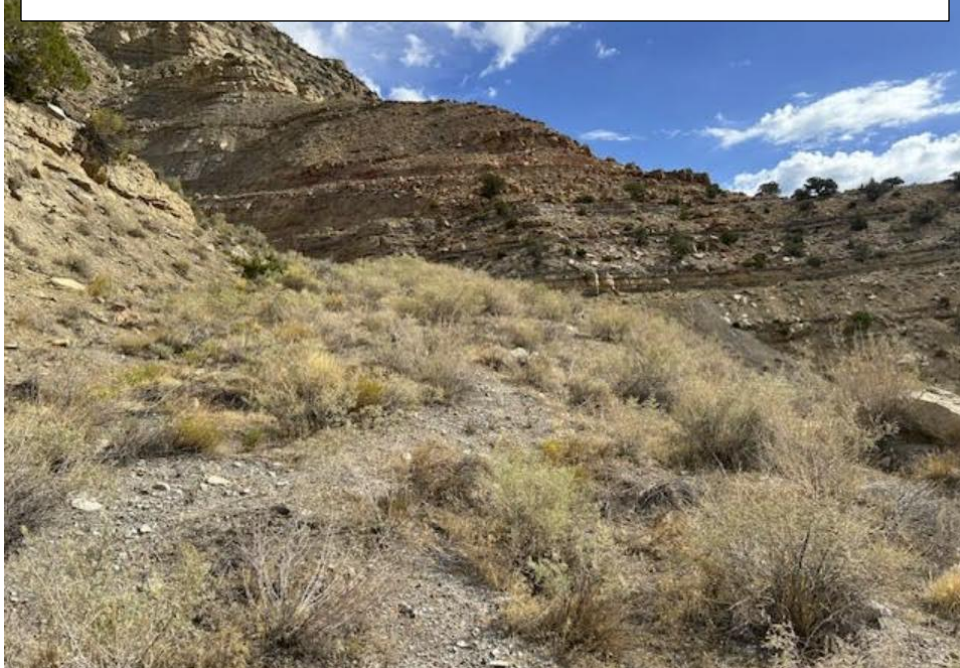
Photo 8: The upper portion of the upper reclaimed haul road.

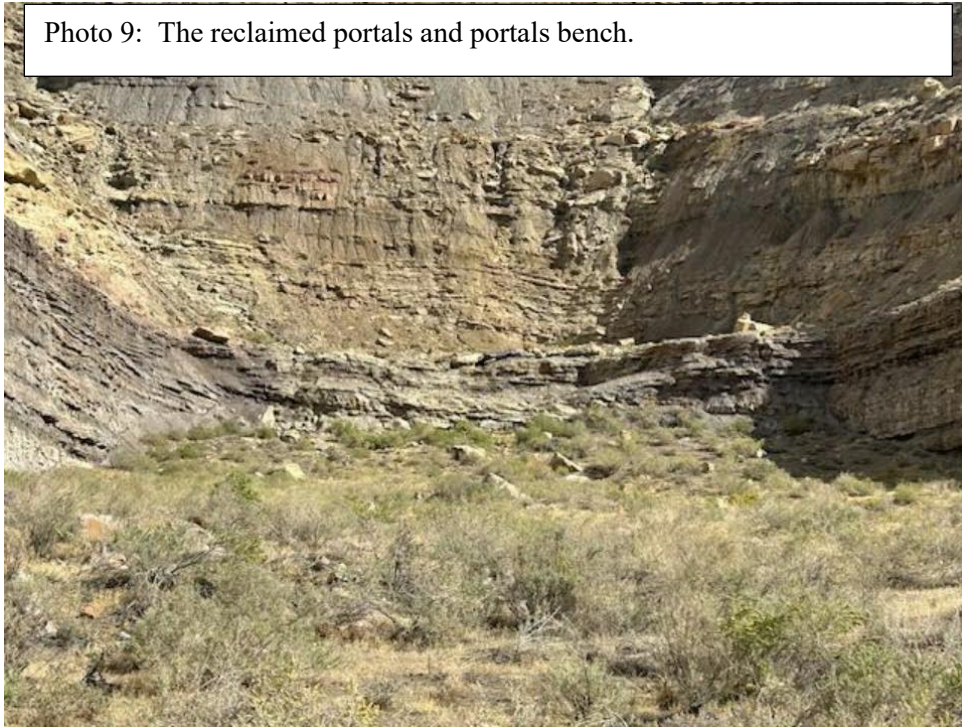
The reclaimed portals bench was vegetated and stable during the inspection. No erosional features were observed. The reclaimed portals are on the north side of the bench. The reclaimed portals were covered with vegetation and stable (Photo 9). There were no indications of erosional features.

Photo 9: The reclaimed portals and portals bench.
