**MINERALS PROGRAM INSPECTION REPORT**  
**PHONE: (303) 866-3567**

| <b>MINE NAME:</b><br>Pikeview Quarry | <b>MINE/PROSPECTING ID#:</b><br>M-1977-211 | <b>MINERAL:</b><br>Limestone (general),<br>granite gneiss and do | <b>COUNTY:</b><br>El Paso |
| <b>INSPECTION TYPE:</b><br>Surety Release Inspection | <b>WEATHER:</b> Raining / Inclement weather | <b>INSP. DATE:</b><br>September 29, 2025<br>& October 3, 2025 | <b>INSP. TIME:</b><br>10:00 am |

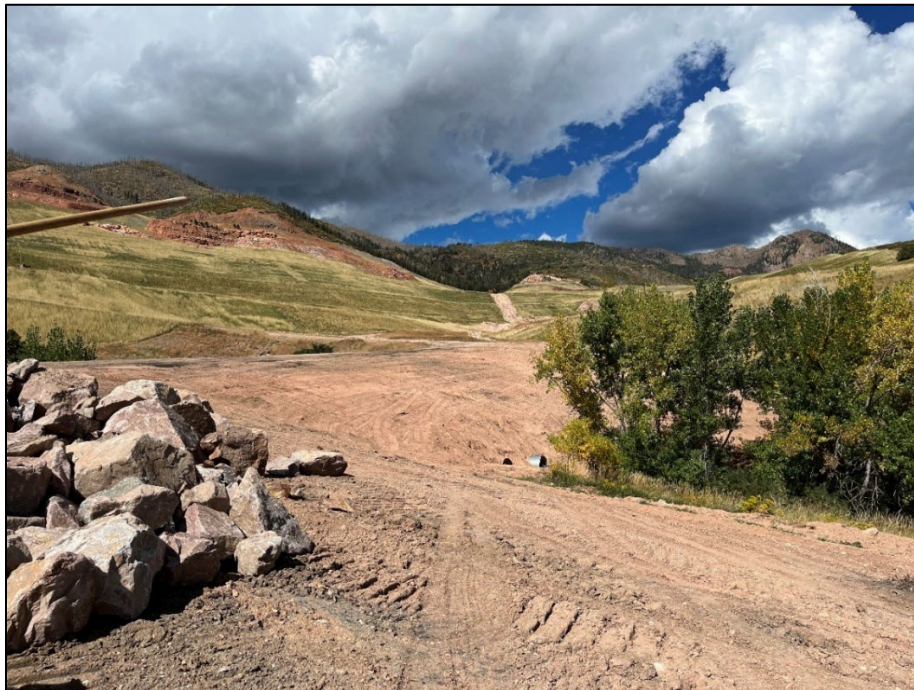
At the time of inspection, the partial landowner, the City of Colorado Springs, was continuing work on a trail system in the Blodgett Open Space adjacent to the Pikeview Quarry Site (Photo 3), which included the grading of a gravel parking lot area (Photo 2) and drainage grading for the site access road (Photo 1). The City of Colorado Springs currently owns a portion of the Pikeview Quarry boundary to the east. Following final release, all areas of Pikeview that are not on USFS land will be donated to the City of Colorado Springs. On October 3, 2025, the Division approved Technical Revision No. 26 (TR-26) at the Pikeview Quarry which clarified the reclamation plan map to include these updated disturbance areas and listed all permanent structures / equipment to remain onsite post-reclamation as part of the site donation to the City. The TR also included a signed letter from David Deitemeyer, representing the City of Colorado Springs, clarifying that all current disturbance at Pikeview has been directed and completed by the City and is independent of the reclamation work completed by the Permittee. A full list of these activities includes: "Minor grading and parking lot surface improvements, trailhead plaza construction, trail improvements and trail bridge installation at the trailhead, signage installation at the trailhead and in the parking lot, drainage improvements/swale stability along the access drive from Allegheny Dr to the trailhead, and reseeded and restoration of previously disturbed areas around the trailhead".

**Photo 1: View west of the access road and recent drainage work.**

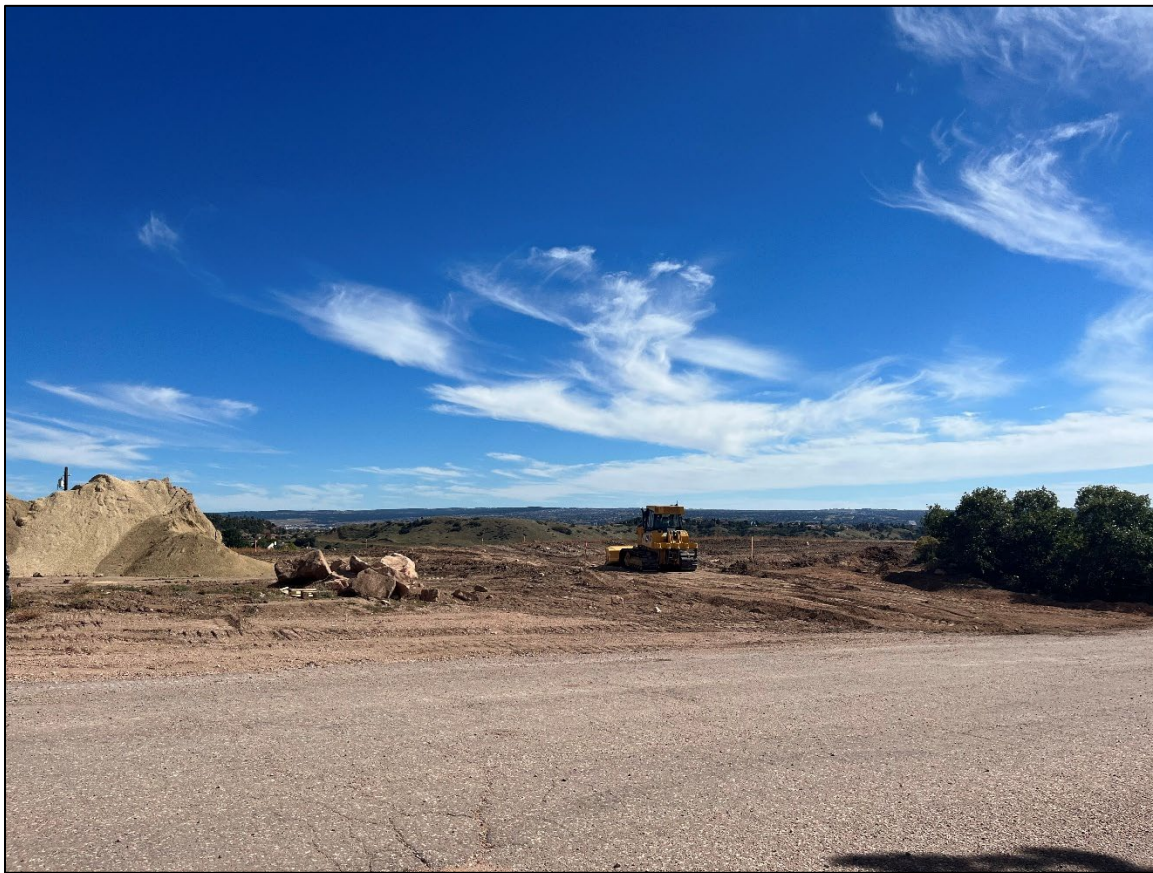
**Photo 2: Grading conducted by the City of Colorado Springs for the future gravel parking lot.**

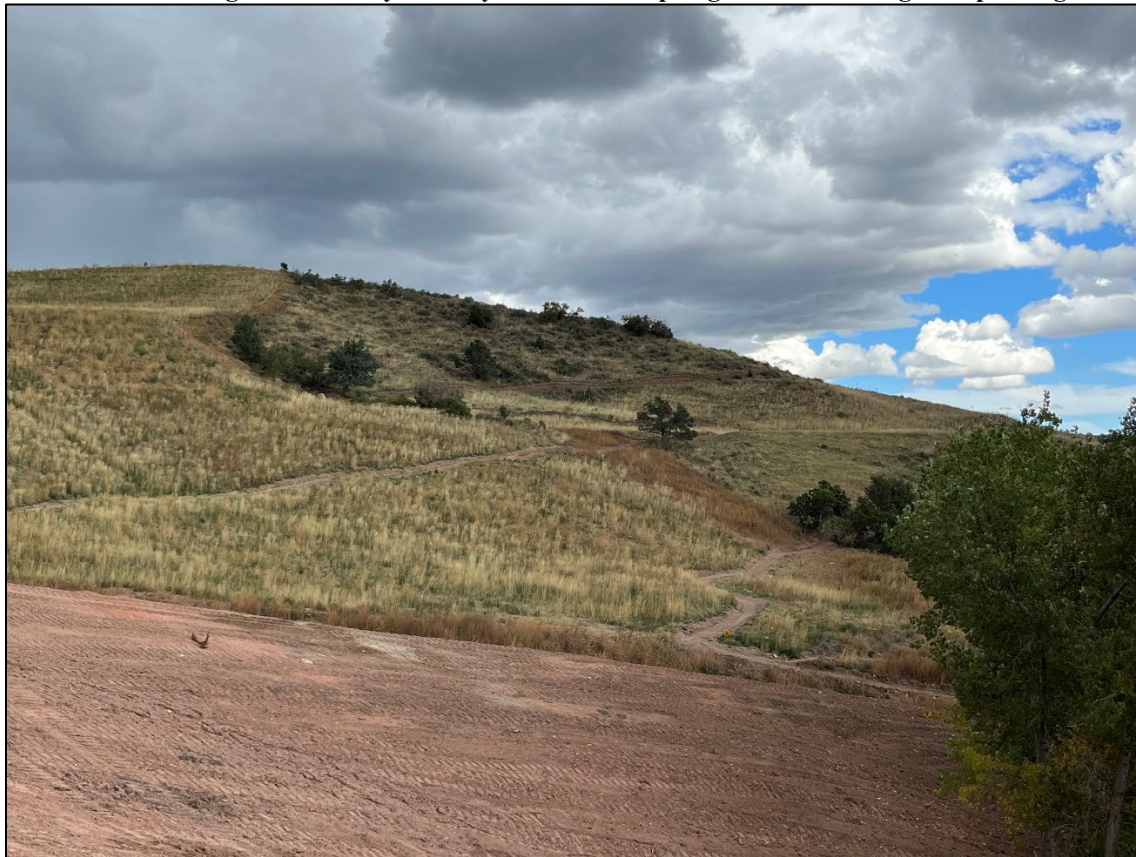
**Photo 3: View north of trail work in the adjacent Blodgett Open Space.**

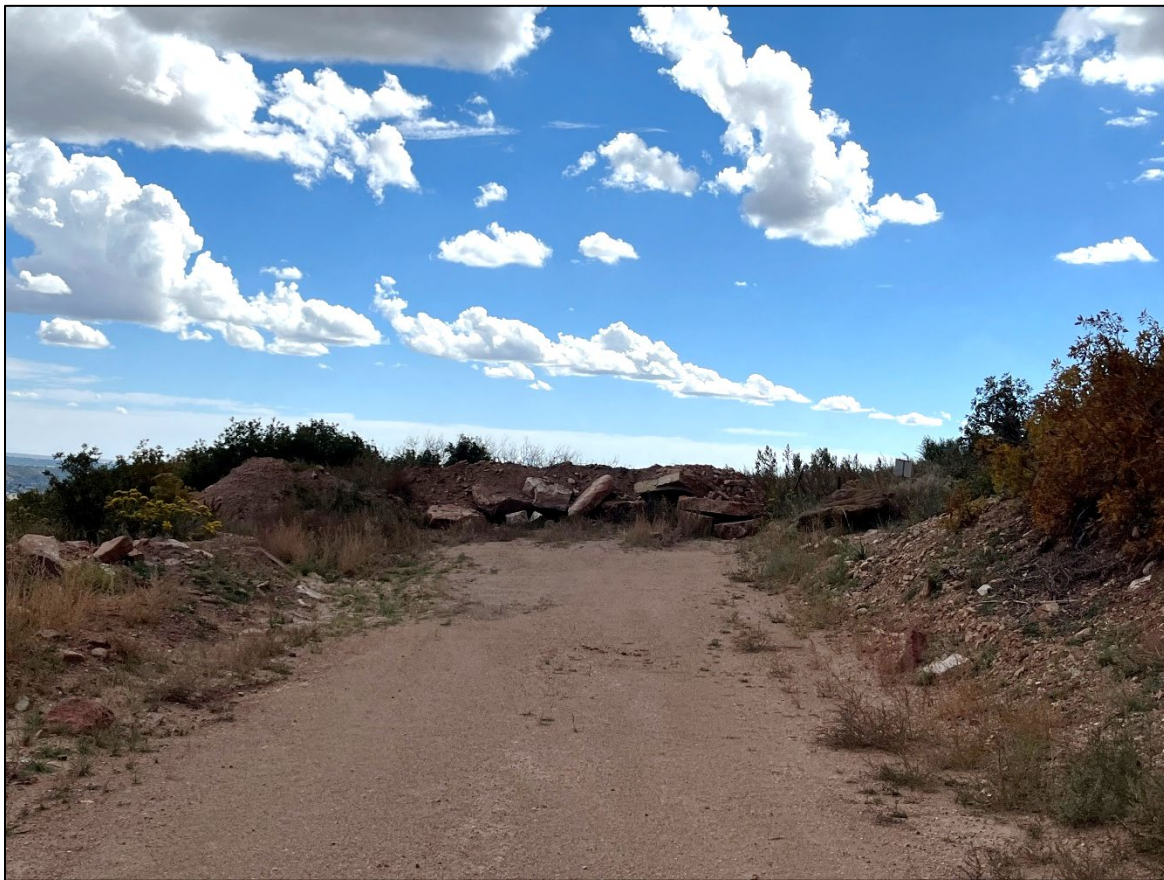
**Photo 4: View south of the rock barrier placed on USFS land.**

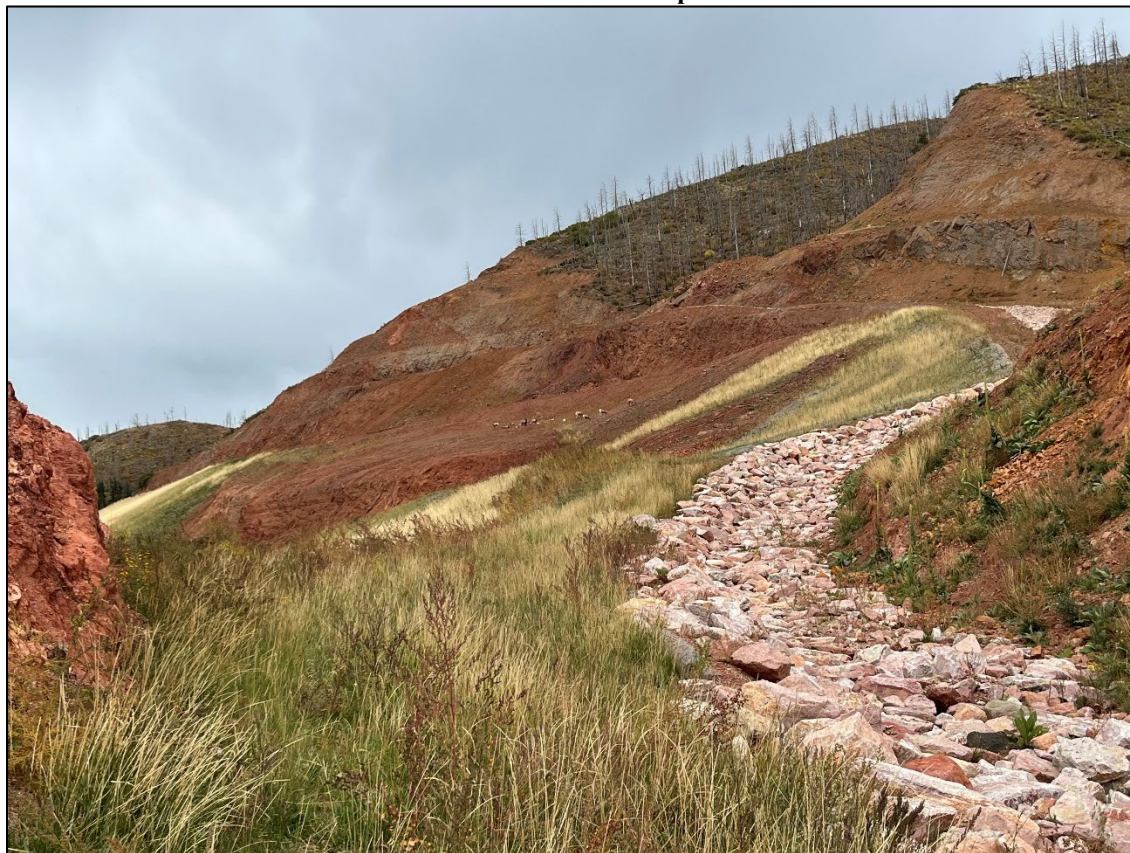
**Fish and Wildlife:** No negative impact on wildlife was observed. A herd of Bighorn was spotted on the upper levels of the buttness (Photo 5). Colorado Parks & Wildlife has been active on site, tracking the herd and occasionally tagging several rams for research and management. Various small birds, foxes, raptors, rattlesnakes, and bugs have been observed on site throughout prior and current inspections. This suggests that reclamation at Pikeview is supporting a multi-leveled and well-rounded ecosystem.

**Photo 5: View of the upper slopes and Bighorn herd observed.**

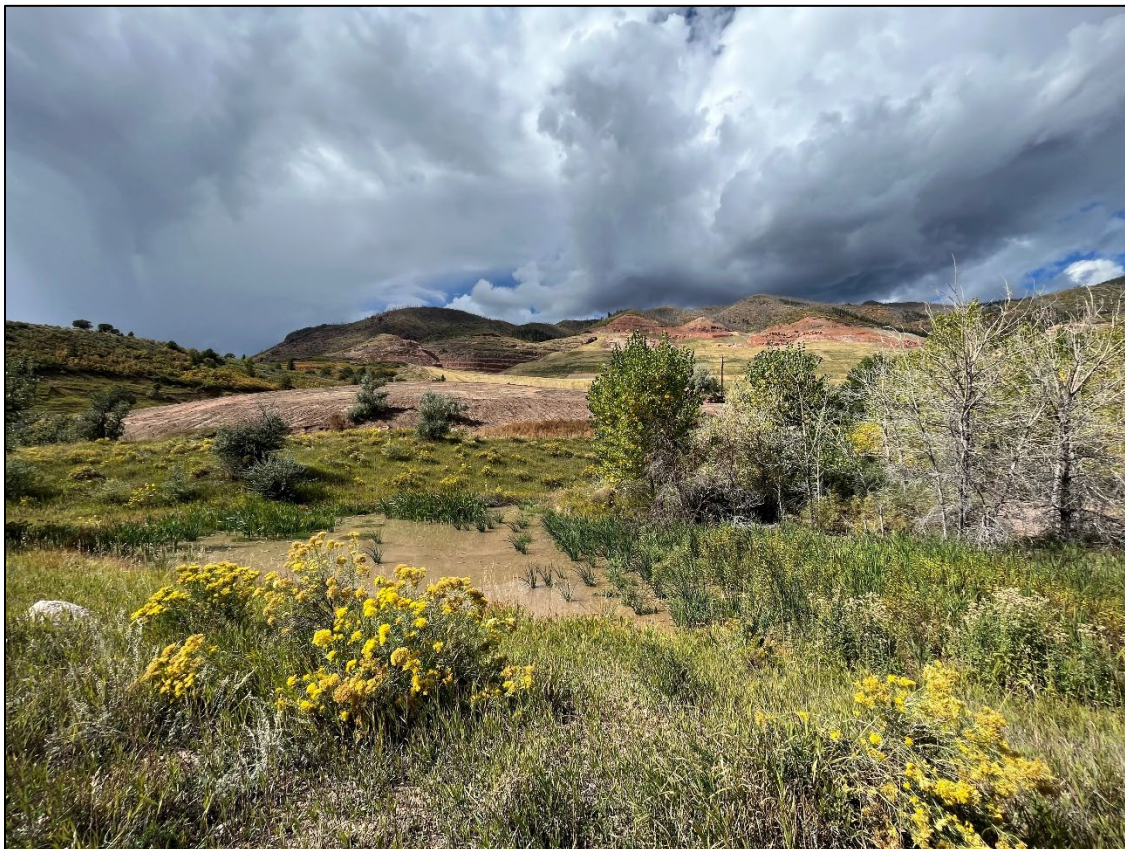
**Photo 6: Retention pond located on the eastern edge of the permit's boundary, collects and clarifies underdrain water.**

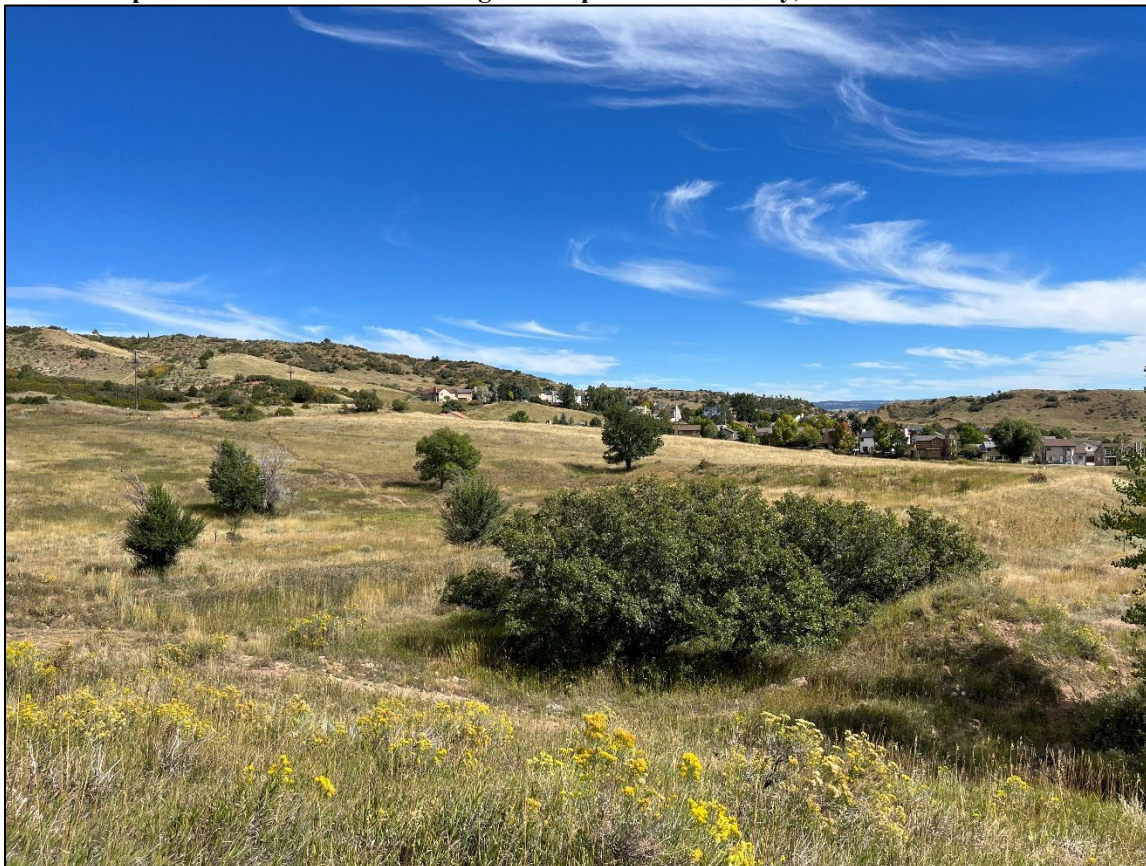
The engineered slope at Pikeview includes several underdrains which direct water away from the slope and out towards the eastern end of the site. Large culverts in this area of the site daylight any collected water, pipe it across the access road, and towards a retention pond. Grading of this underdrain standpipe outlet area is complete, and the retention pond was observed to be holding water as designed (Photo 6). In the event of an extremely heavy rainfall event, there is an additional, grassed basin to collect and retain additional surface flow in this area (Photo 7).

**Photo 7: View northeast of the extra retention area, east of the current retention pond.**

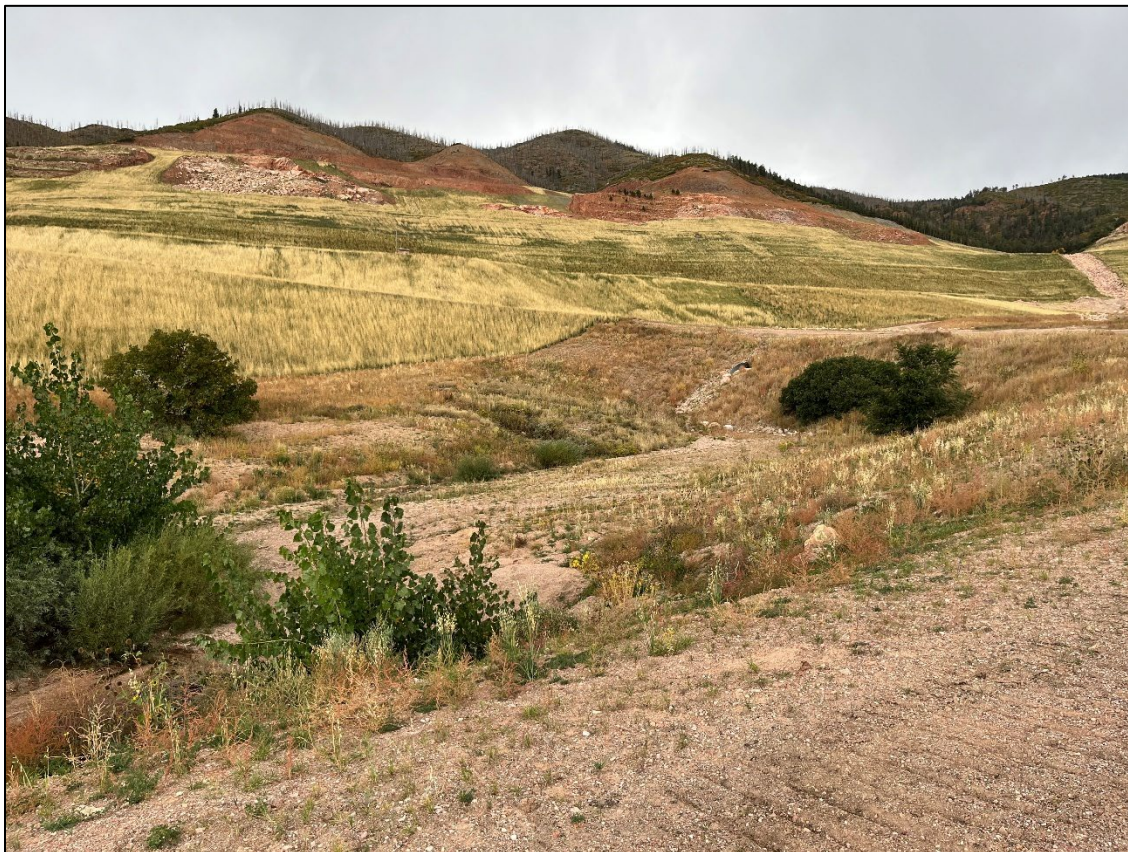
**Hydrologic Balance & Sediment Control:** The large culvert area at the eastern end of the site was noted to be diverting water successfully under the buttress as designed (Photos 8 & 9). Water is flowing consistently towards the eastern edge of the permit and into the adjacent open space, following natural waterways. The installation of safety signs near the large standpipes in this area is in progress. This will discourage public access to the area after the permit is released.

**Photo 8: View west of the underdrain outlet area.**

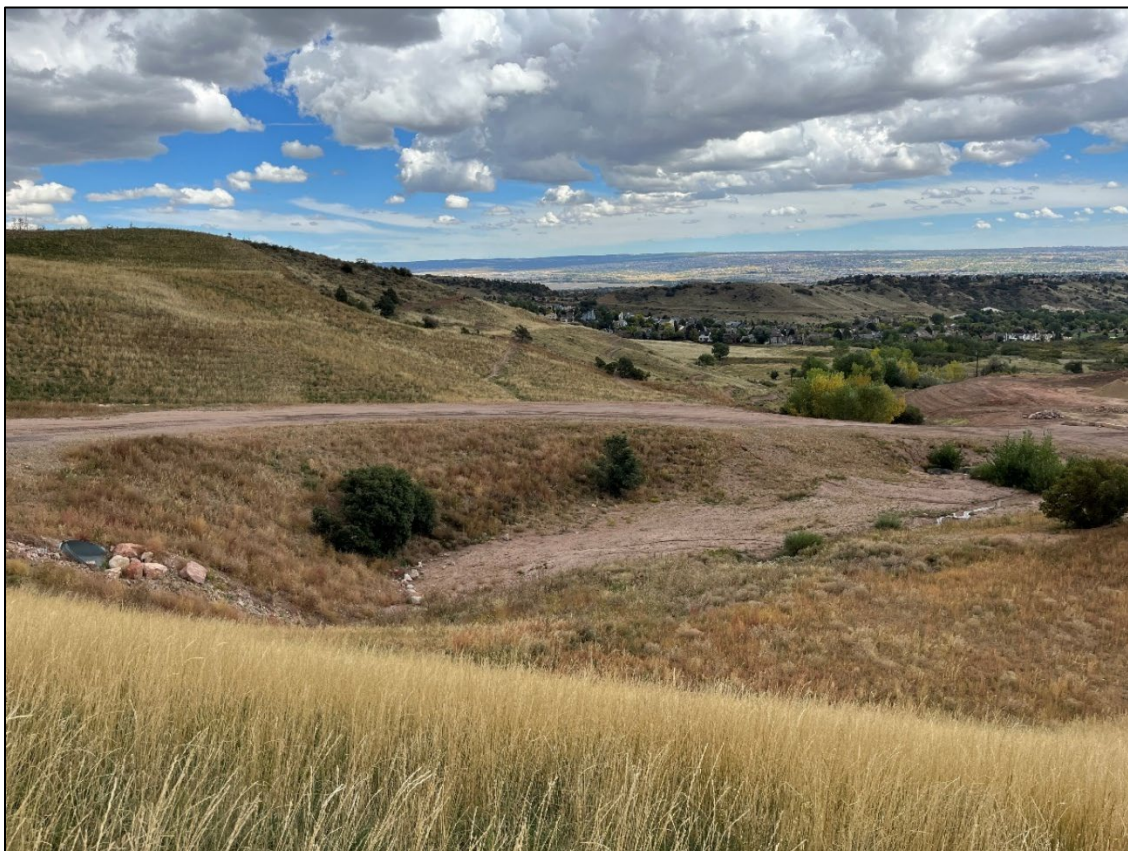
**Photo 9: View northeast of the underdrain outlet area.**

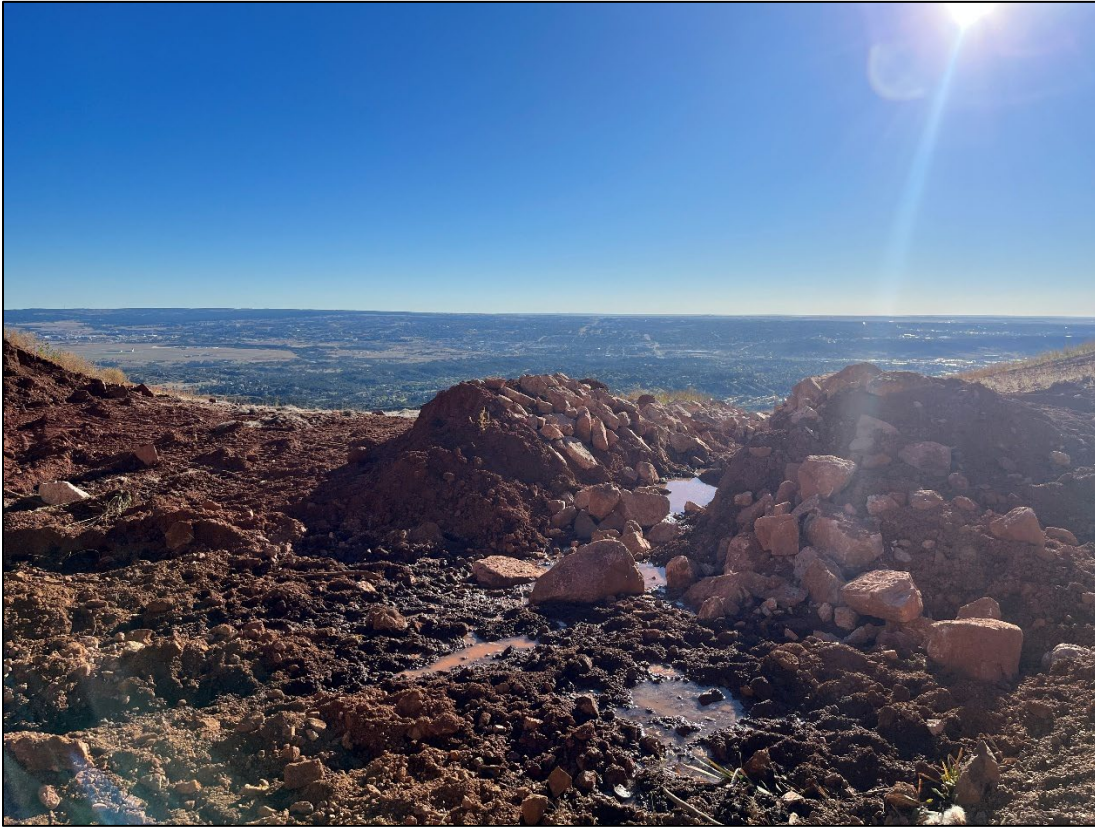
The previously called 'sheep pond' area on the upper slopes has been filled in and graded to direct the natural seeps in this area towards the designed channel system (Photo 10) and away from the buttress. Prior plans for a sheep 'guzzler' system will not be progressing at this time.

**Photo 10: View east of the old 'sheep pond' area, now filled in and graded to promote drainage of natural seeps.**

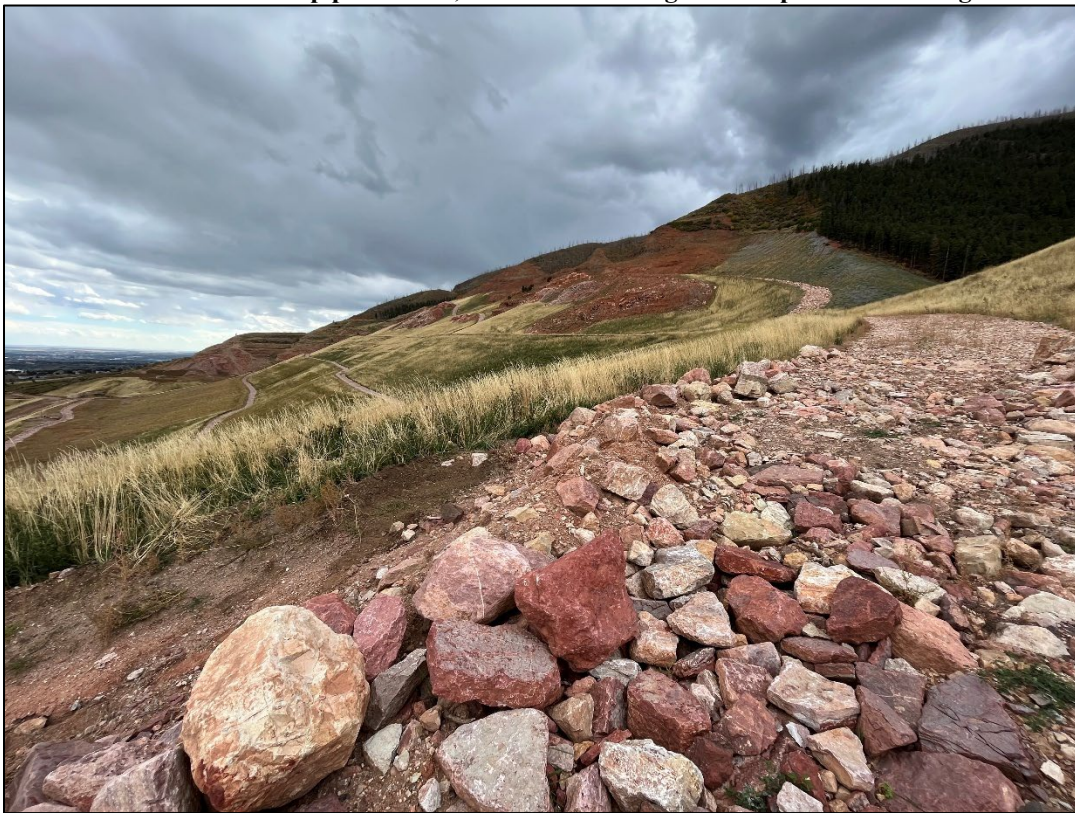
The Division's last inspection noted a few areas of minor sedimentation / erosion that required maintenance work. As the site was hiked for the inspection, these areas were inspected. The Division's photographs (11-13) show that in these areas erosion gullies and ruts have been repaired and stabilized to prevent further erosion.

**Photo 11: View southwest of the north channel, this area was observed to be the source of a few downslope erosional issues last inspection but has now been reformed to direct stormwater further into the channel.**

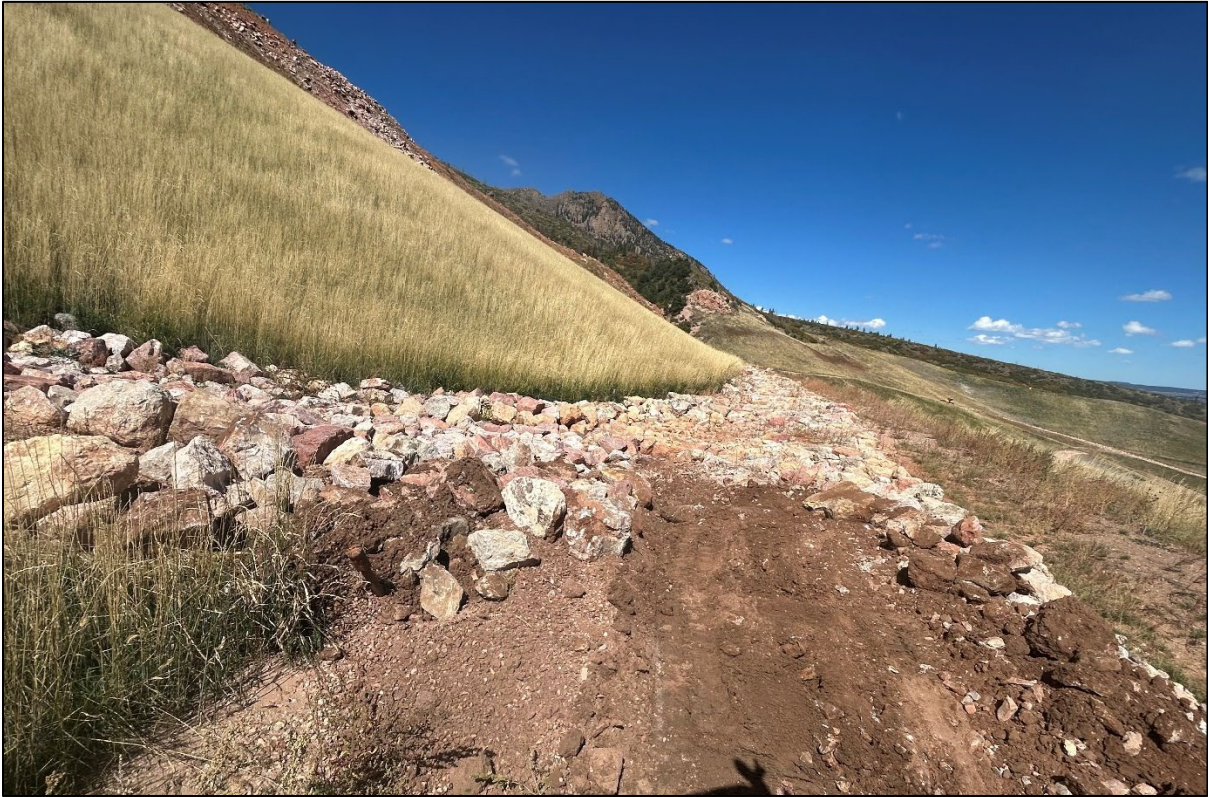
**Photo 12: Sedimentation area observed at the tie in on Channels T7 and T8 has been cleaned up and the channel re-formed to direct stormwater appropriately.**

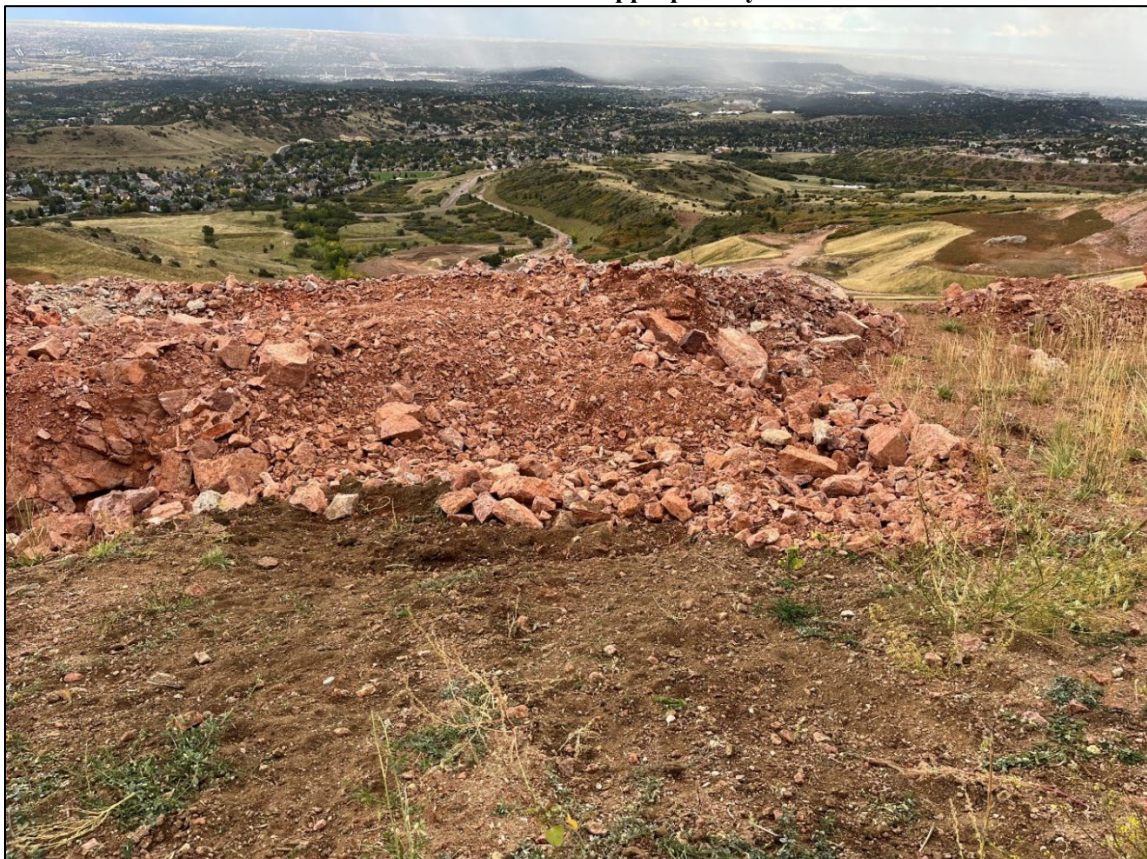
**Photo 13: Filled in hole feature previously observed near the western edge of a natural outcrop feature along the upper slopes.**

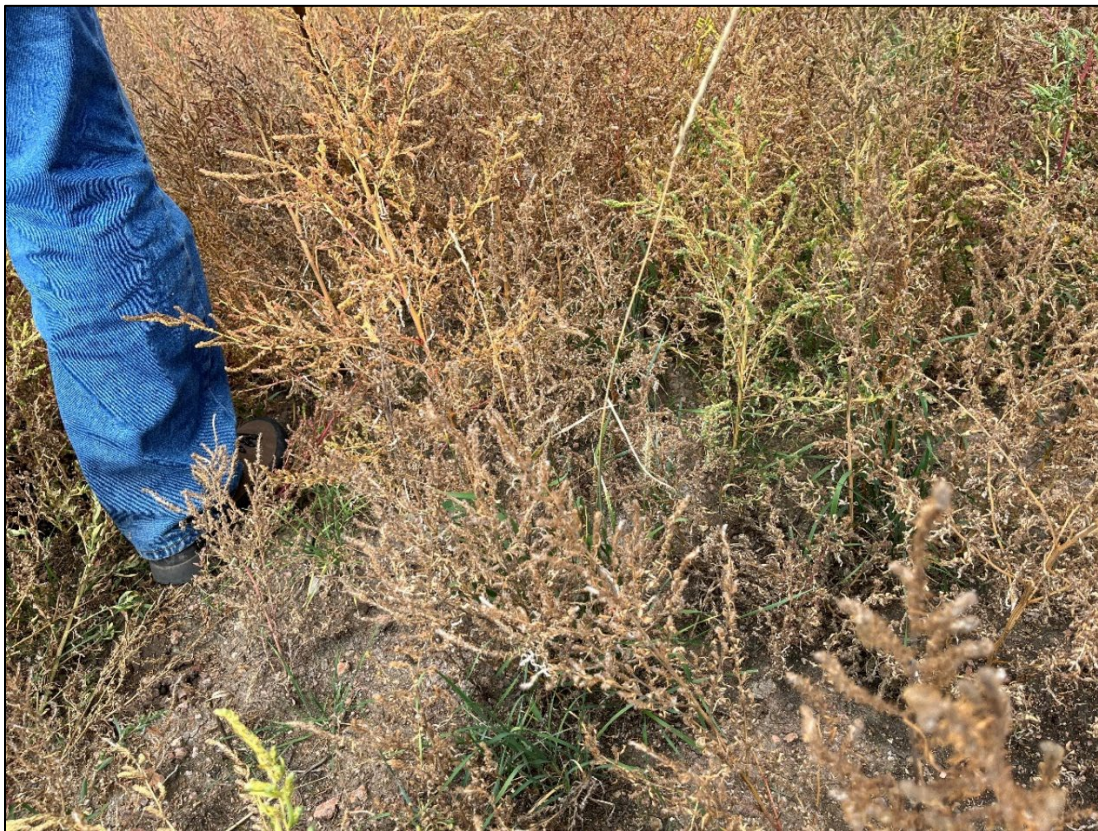
Various weed species were identified during inspection, including Russian thistle and kochia. No noxious weeds were observed at the time of inspection. However, weed spraying efforts have been vigilant throughout reclamation of the site and the observed, small populations of weeds are not representative of the site as a whole and do not pose threat to out competing the abundance of native and desirable vegetation already present across most of the site. Further, many of these weedy species are annual species, meaning that as native plant growth continues, annual weeds can more easily be out competed by more desirable species. Bunch grass and other desirable species growth was already noted to be present in these more weedy areas (Photo 14).

**Photo 14: Desirable grass species growing in weedy areas.**

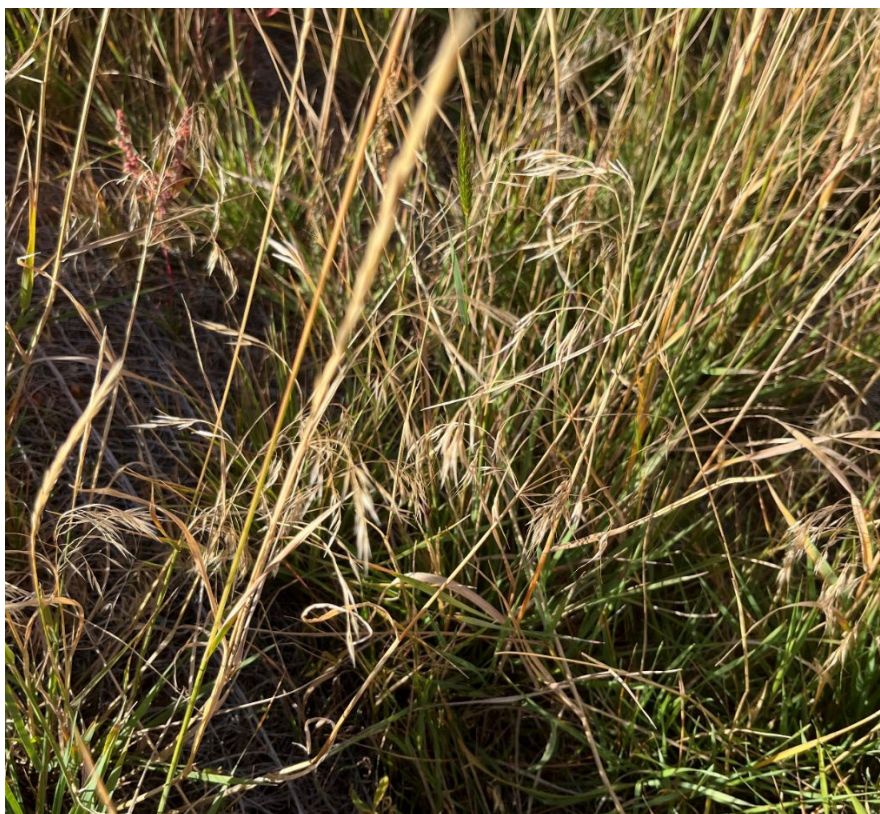
**Photo 15: Common example of a desirable bunchgrass species observed at the site.**

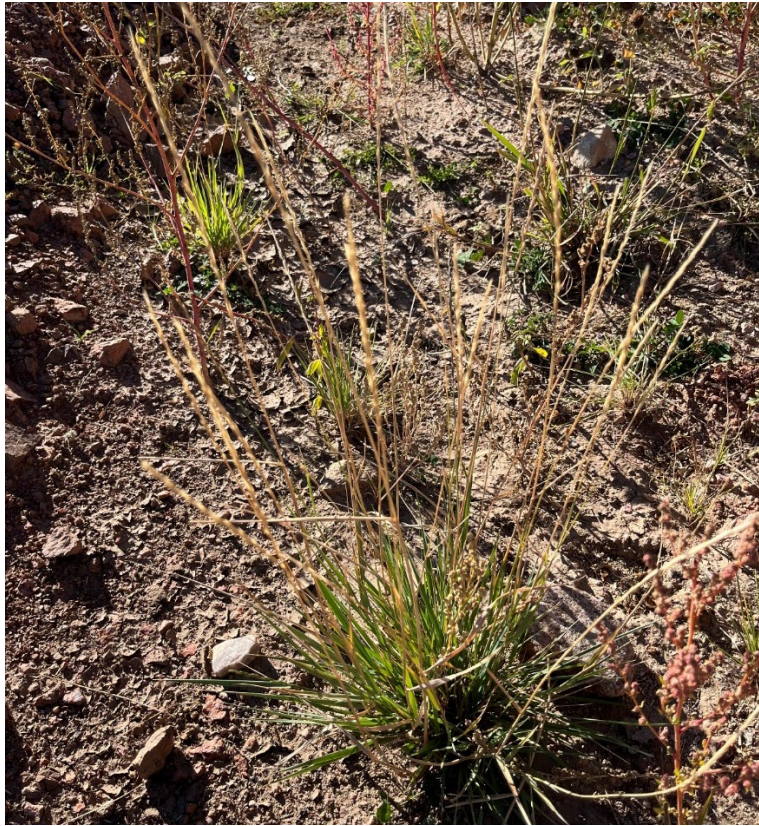
**Photo 16: Common example of a desirable bunchgrass species observed at the site.**

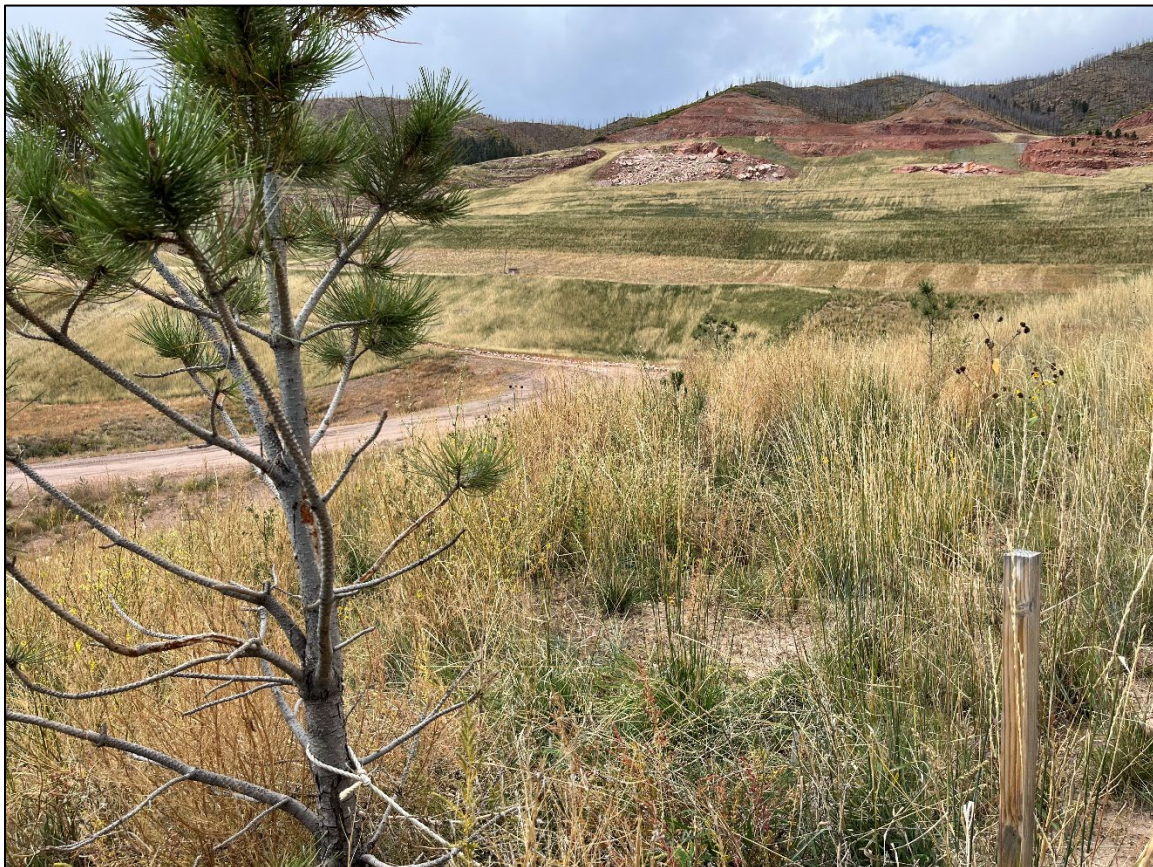
A majority of the backfilled slope areas (upper and lower) have been matted to encourage revegetation and protect against erosion. The Division observed very successful vegetation growth in these areas, with predominant vegetation made up of native and desirable species such as wheatgrasses, rice grass, oatgrass, bottlebrush, and rye grass. Desirable forbs were also observed, including but not limited to alfalfa, sunflowers, clover, and Cicer milkvetch. Examples of continually observed diversity of species growth are shown below in Photos 15 & 16 and shown in prior inspection report photographs. Continued growth and survival of transplanted pine trees and shrubs such as Mountain mahogany and Snowberry was also noted (e.g. Photo 17).

**Photo 17: Example of surviving patches of pine trees.**

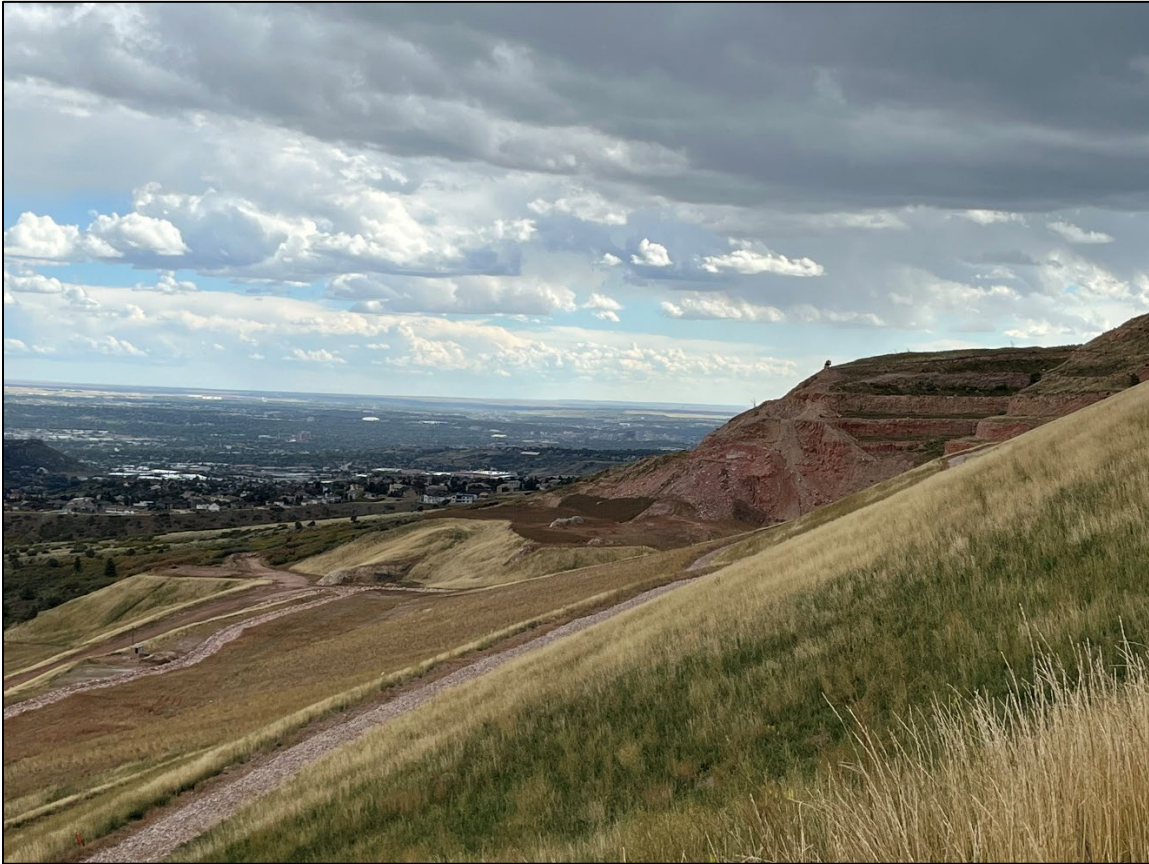
The south borrow area and USFS land to the south both appeared well vegetated, with many grasses going brown and to seed as expected in the autumn season (Photos 18 & 19). Slopes to the north, owned by both the City of Colorado Springs and USFS have improved greatly in terms of vegetation. Slopes in these areas were previously lacking in diversity but have since been reseeded and show improved diversity of species, with wheatgrasses and other forbs popping up among the preexisting alfalfa and clover plants (Photo 20).

**Photo 18: View southeast of the South Borrow area and USFS slopes.**

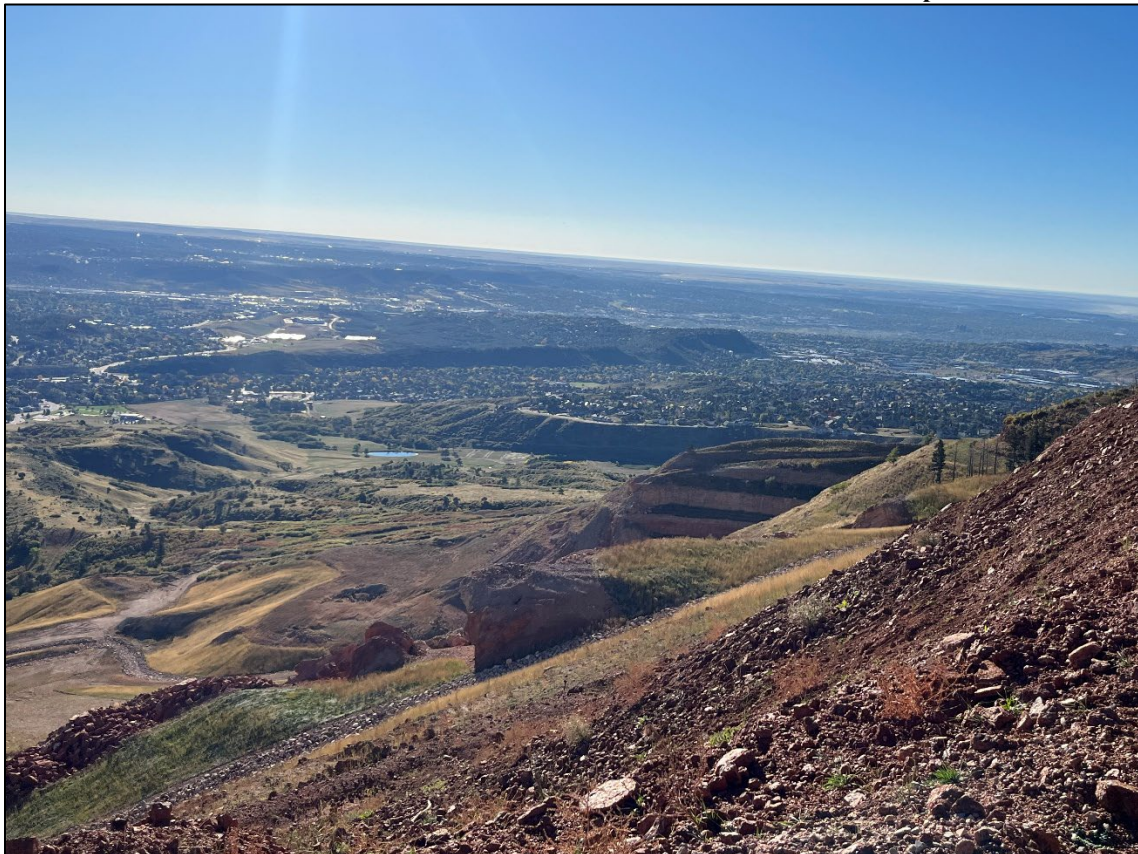
**Photo 19: View southeast of the USFS drainage area and south borrow.**

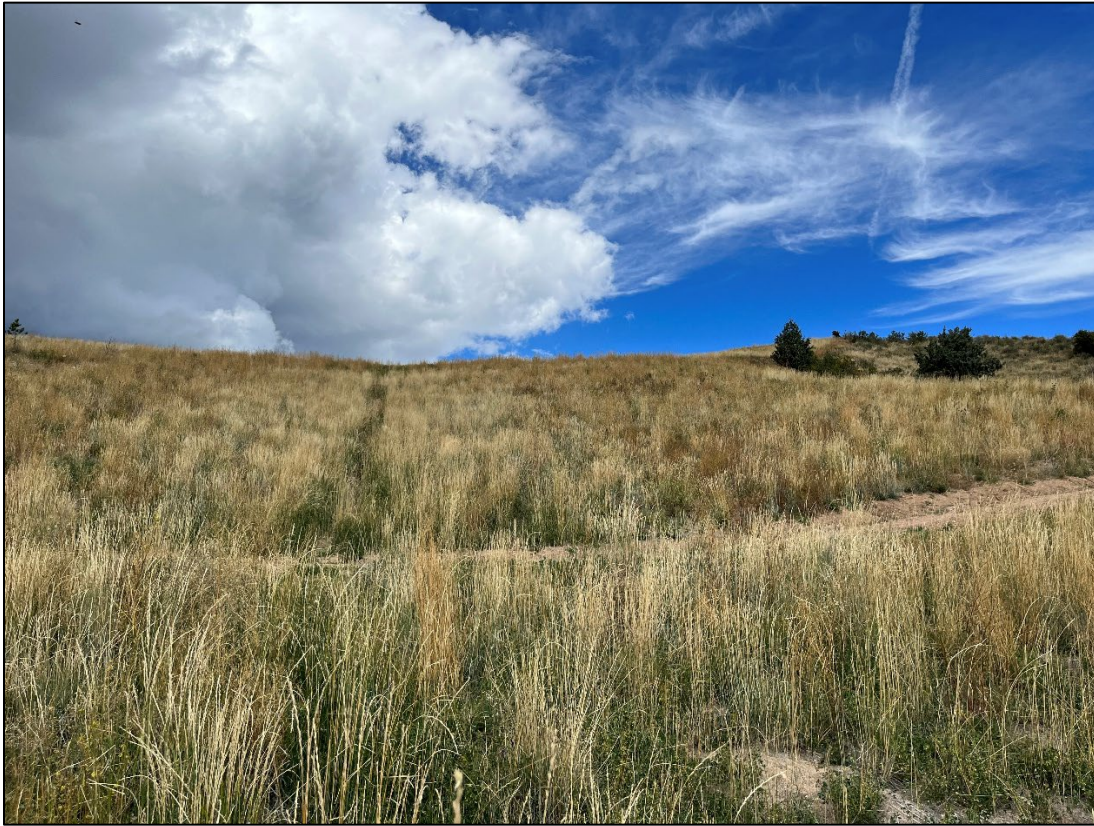
**Photo 20: View north of City & Riverbend slopes.**

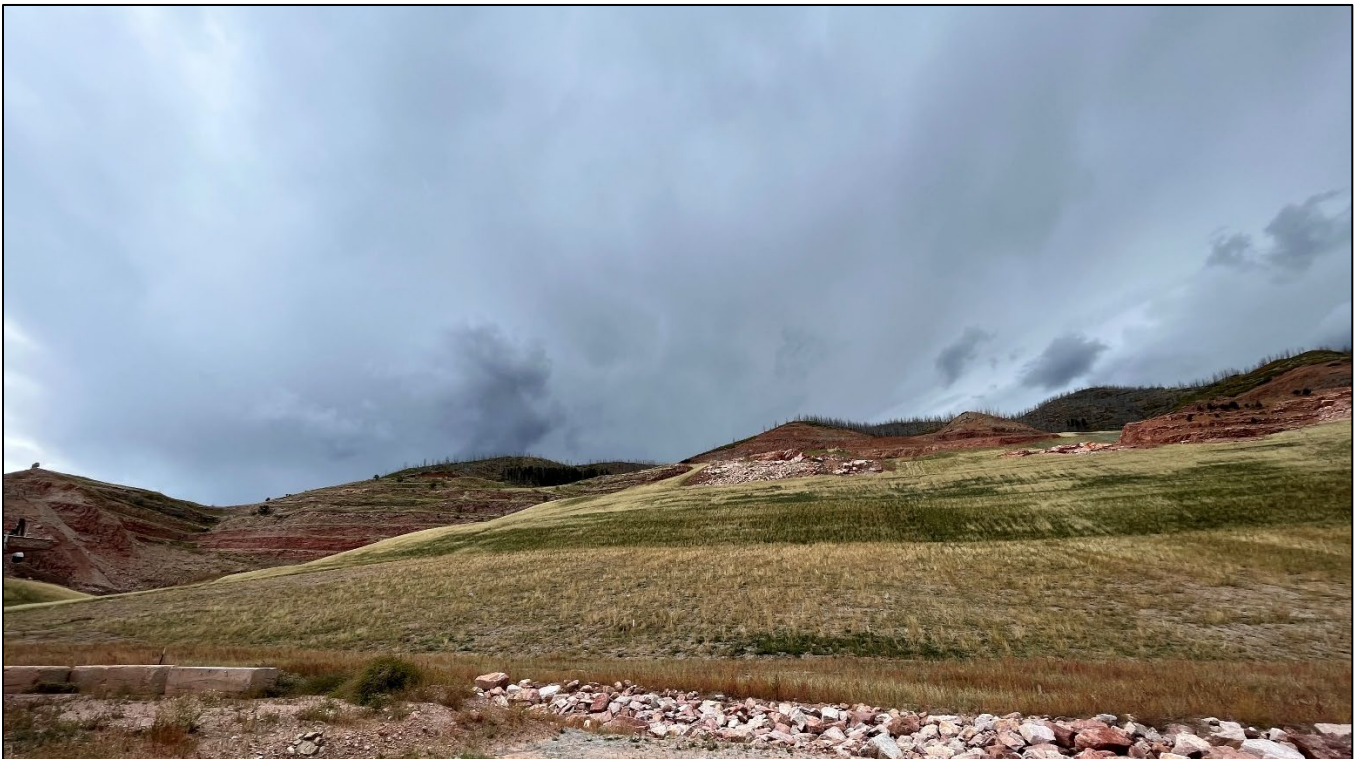
**Photo 21: View west of slopes above the Leica level.**

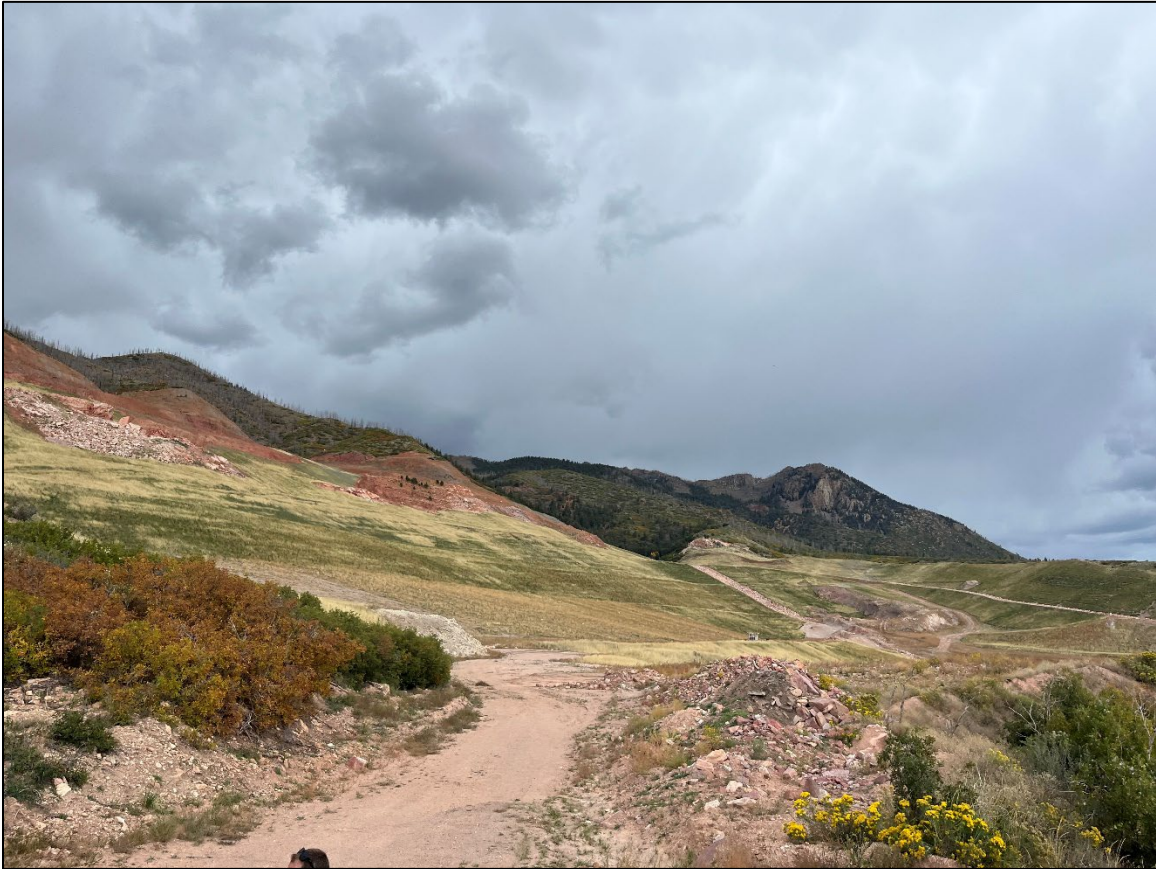
The Leica prism level bench and slopes above (Photo 22) were seeded in a similar fashion to the northern City and USFS slopes discussed above and has now been seeded a second time. The slope is already showing signs of new plant growth which will supplement pre-existing vegetation.

**Photo 22: View northwest, looking at a site overview from the southernmost edge of the permit boundary.**
