## McClane Canyon Mine, C-1980-004, September Partial Inspection of Sediment Control Structures

**McClane Canyon Mine, C-1980-004, September Partial Inspection Report\_CCW.pdf**

**INSPECTION INFORMATION**

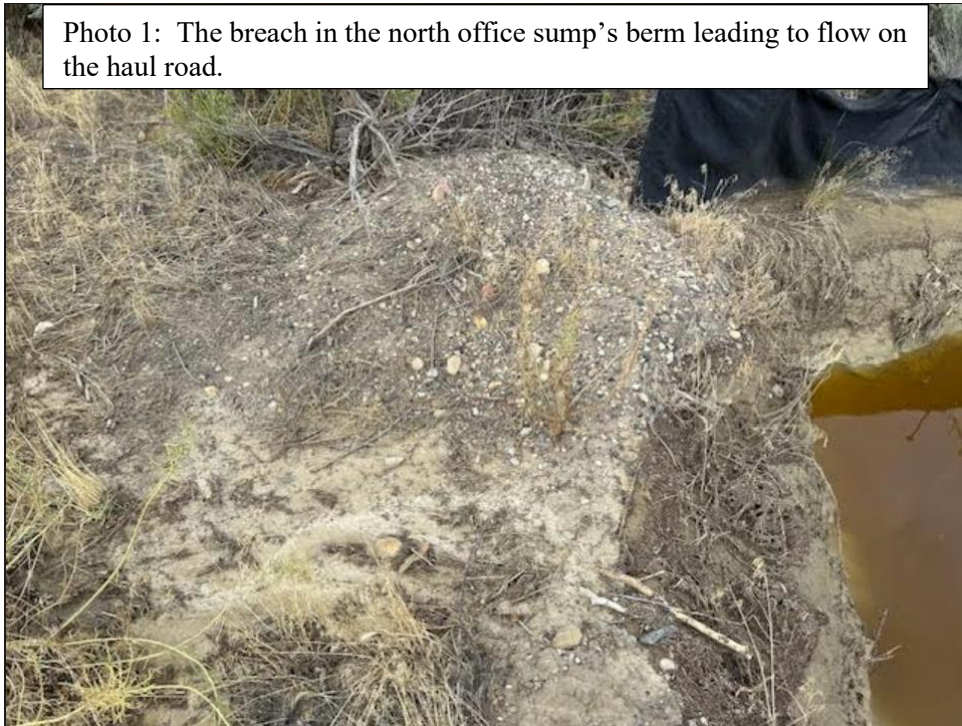
The inspection started at the mine office pad. The north office sump was observed to be holding water but not discharging (Photo 1). The embankment for the sump had been breached on the north and south sides. Evidence of water flowing out of the south embankment breach traveled down the haul road to the bridge over East Salt Creek (Photo 2). The flow path then went over the bridge and down the north side of the road into East Salt Creek (Photo 3). The northern embankment breach's flow path lead west into East Salt Creek. The sump requires cleaning and repairs.

Photo 1: The breach in the north office sump's berm leading to flow on the haul road.

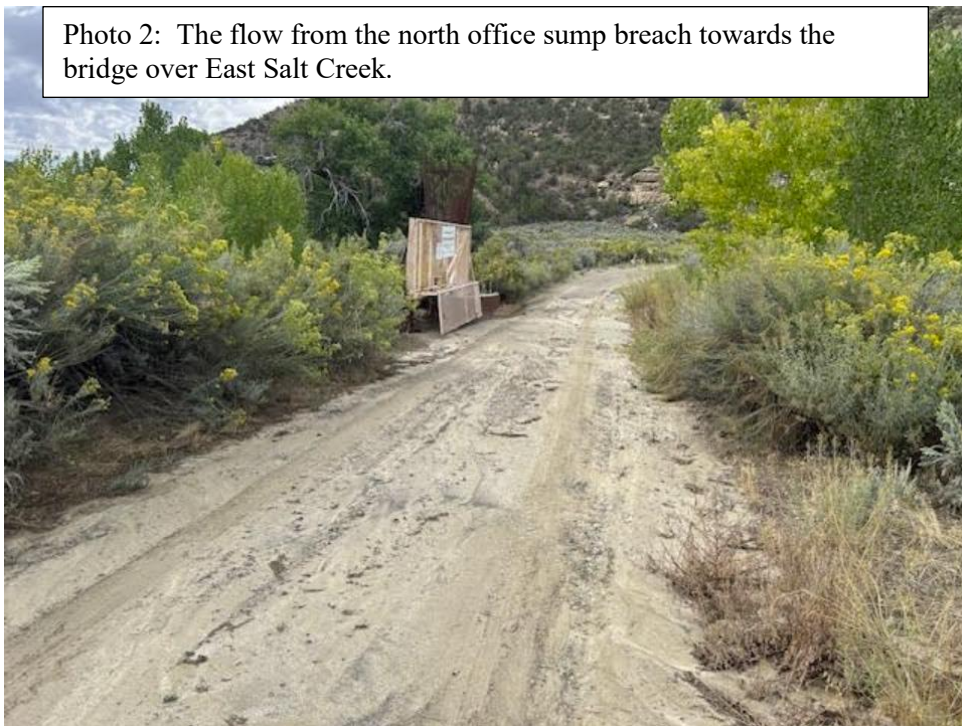
Photo 2: The flow from the north office sump breach towards the bridge over East Salt Creek.

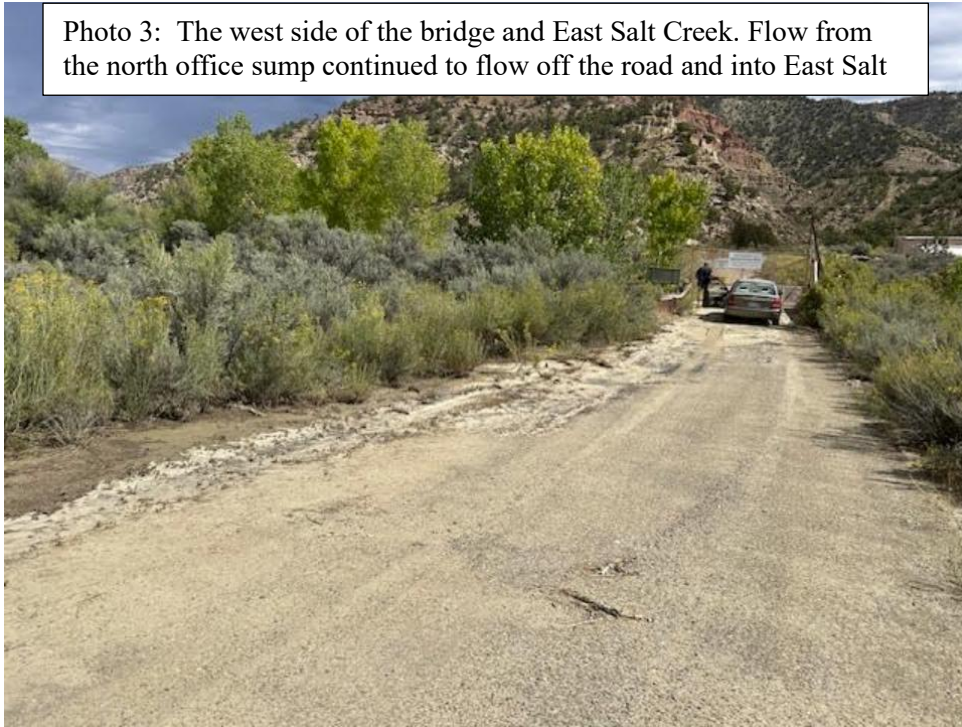
Photo 3: The west side of the bridge and East Salt Creek. Flow from the north office sump continued to flow off the road and into East Salt

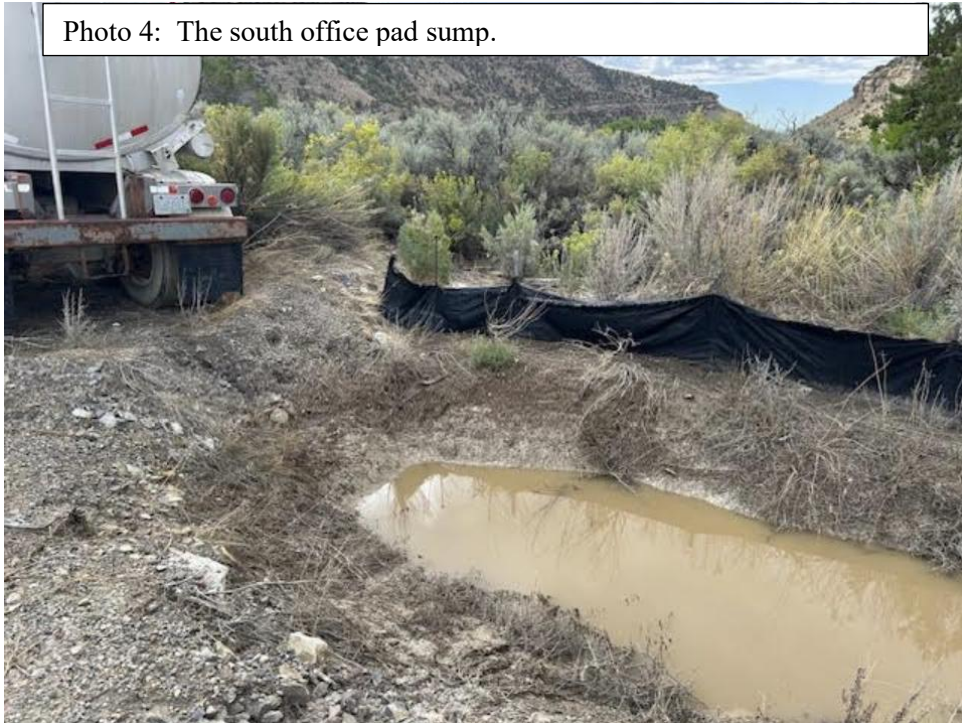
Photo 4: The south office pad sump.

The south office sump was also holding water during the inspection (Photo 4). No discharge occurred. The silt fence was intact. There was no indication that water had bypassed the outlet of the sump. No damage to the sump's embankment was observed.

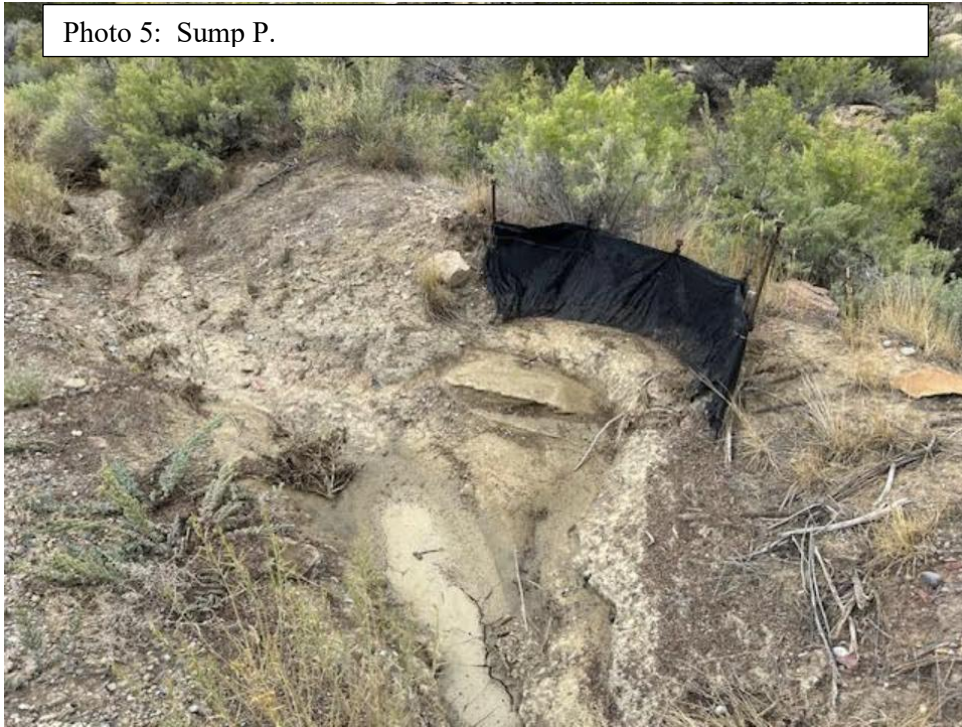
Photo 5: Sump P.

Sump P, located on the north side of the haul road in-between the office pad and Sump Q, was dry during the inspection. The silt fence was intact and the berms for the sump were stable (Photo 5).

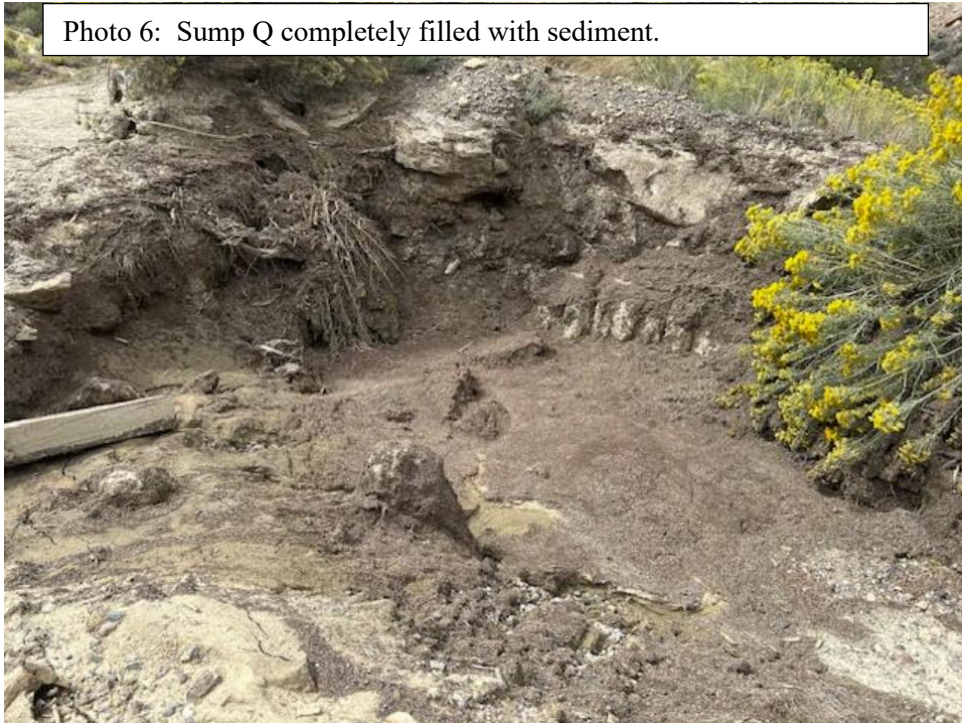
Sump Q was muddy and entirely filled with sediment (Photo 6). The discharge culvert was plugged. A breach in the southern berm was observed. The flow through the breach followed the north bar ditch for the haul road down to Sump P and the north office sump. Sump Q requires cleaning and repairs to the berm.

Photo 6: Sump Q completely filled with sediment.

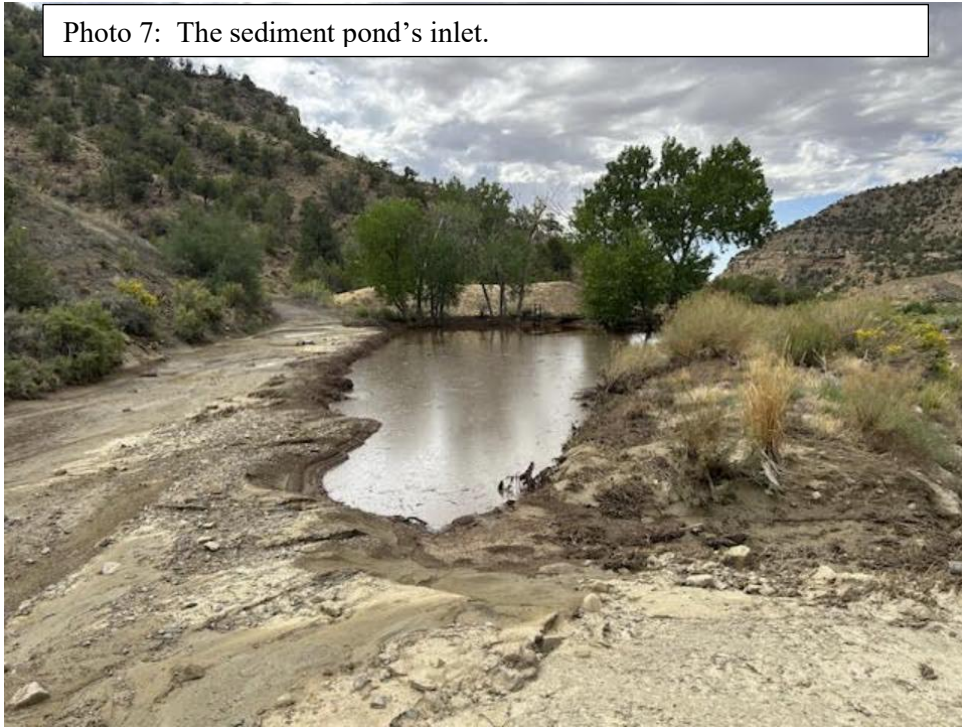
The sediment pond was holding water during the inspection (Photo 7). The level of water in the pond was at the top of the primary spillway (Photo 8). The primary spillway's valve was not open during the inspection, and no discharge was occurring. Evidence of flow through the emergency spillway was observed. The amount of water being impounded in the sediment pond from the precipitation event was too large for the emergency (Photo 9) to handle. Evidence of flow overtopping the pond's western embankment was observed (Photos 10, 11 and 12). There were no rills or gullies observed to be cut into the embankment. There was also no indication of sloughing or instability with the embankment. Water will need to be discharged to restore some of the sediment pond's capacity. The primary discharge outlet pipe's exit remained uncovered, however, debris from backflow into the

Photo 7: The sediment pond's inlet.

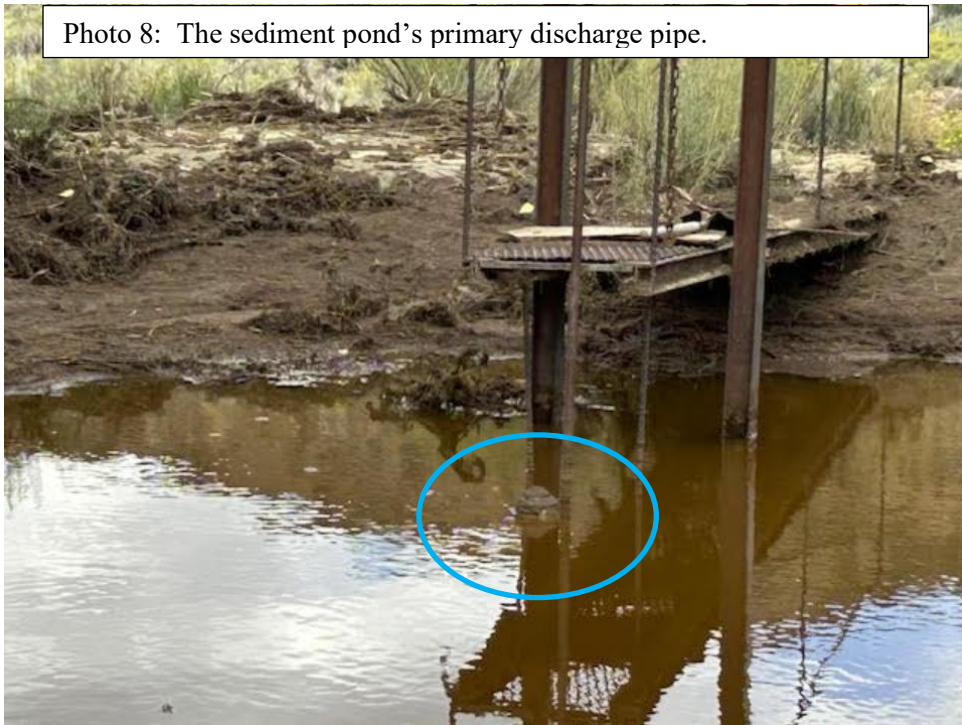
Photo 8: The sediment pond's primary discharge pipe.

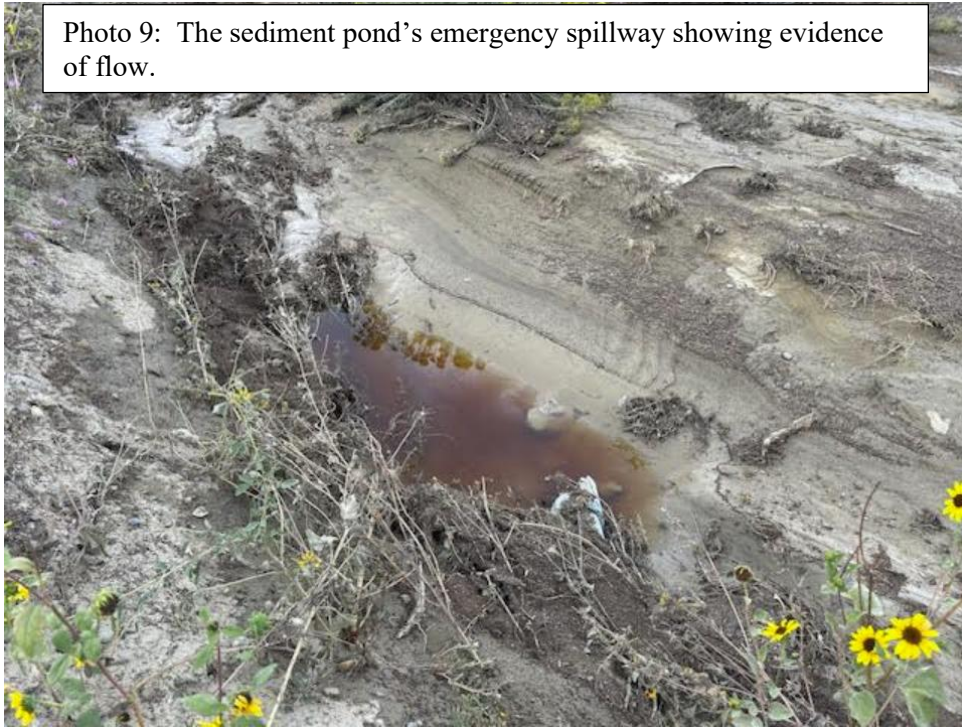
Photo 9: The sediment pond's emergency spillway showing evidence of flow.

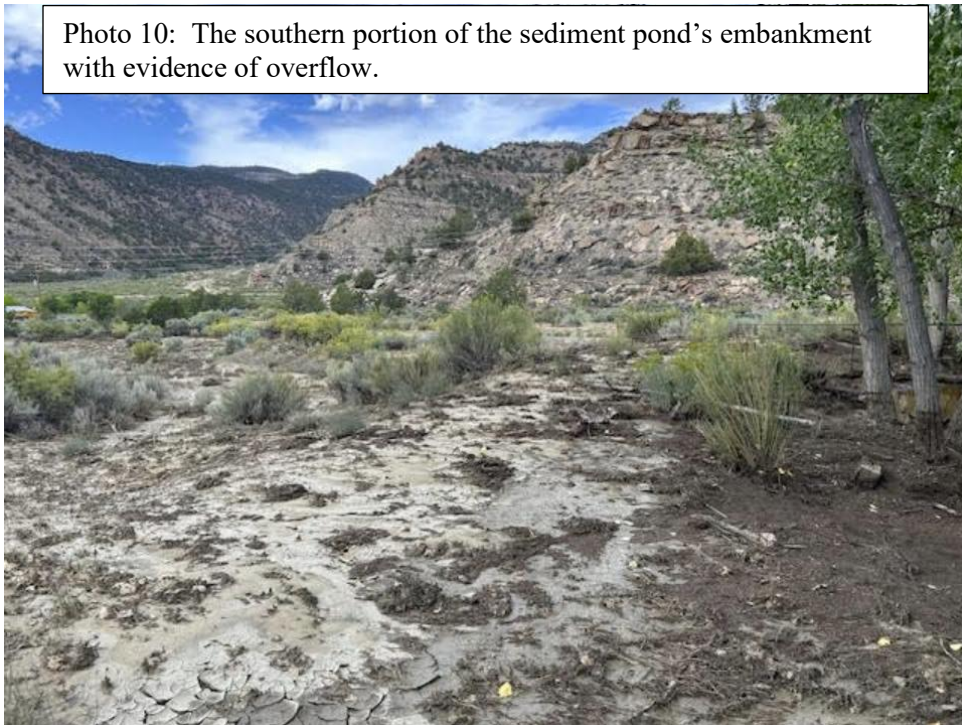
Photo 10: The southern portion of the sediment pond's embankment with evidence of overflow.

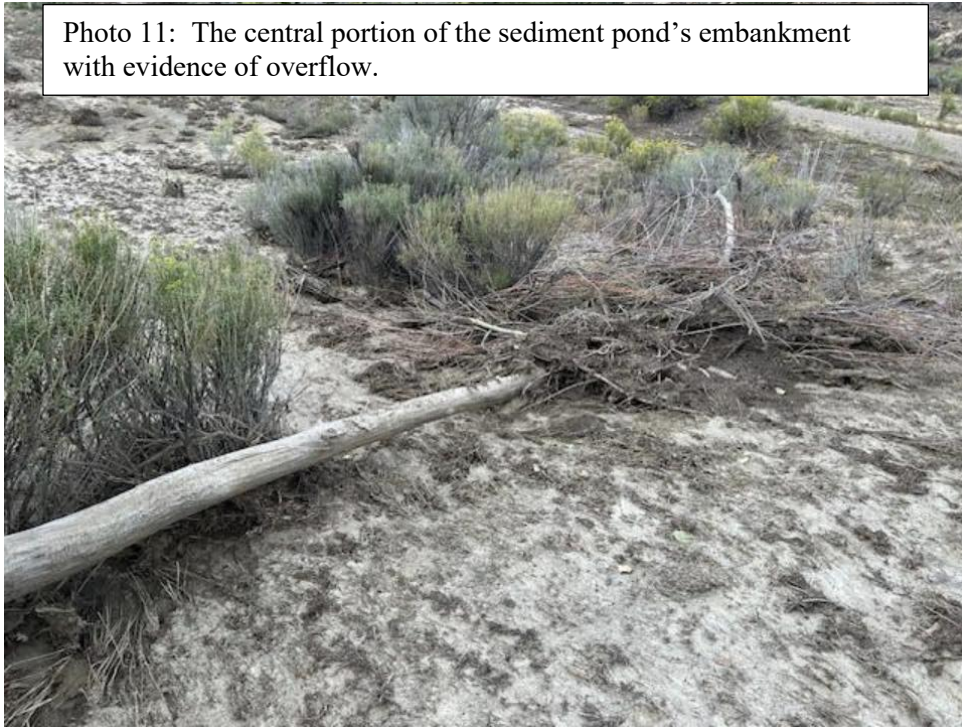
Photo 11: The central portion of the sediment pond's embankment with evidence of overflow.

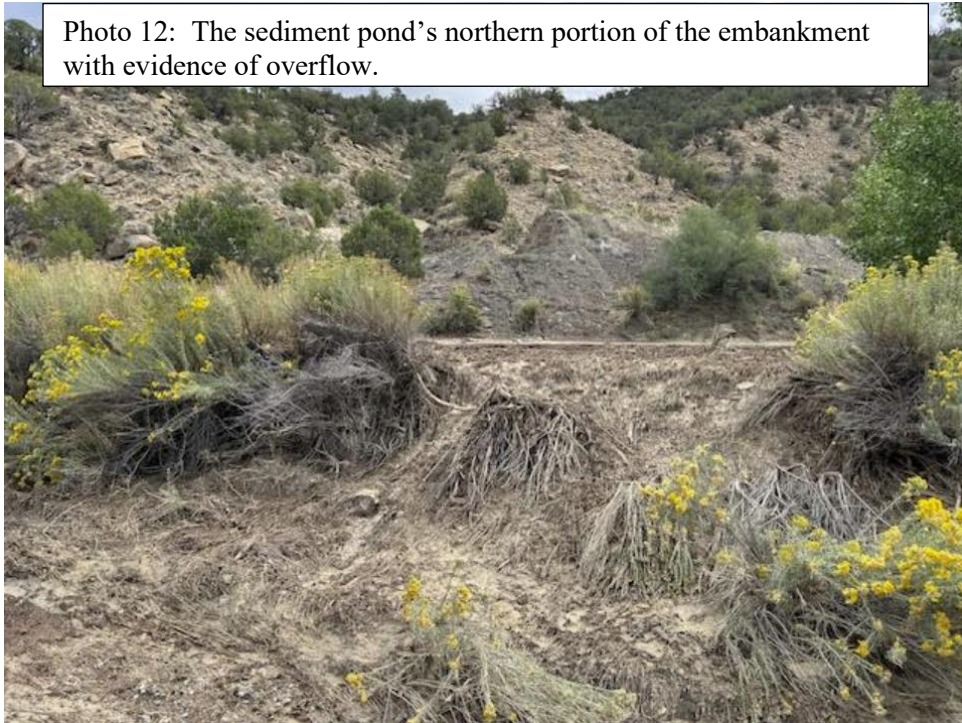
Photo 12: The sediment pond's northern portion of the embankment with evidence of overflow.

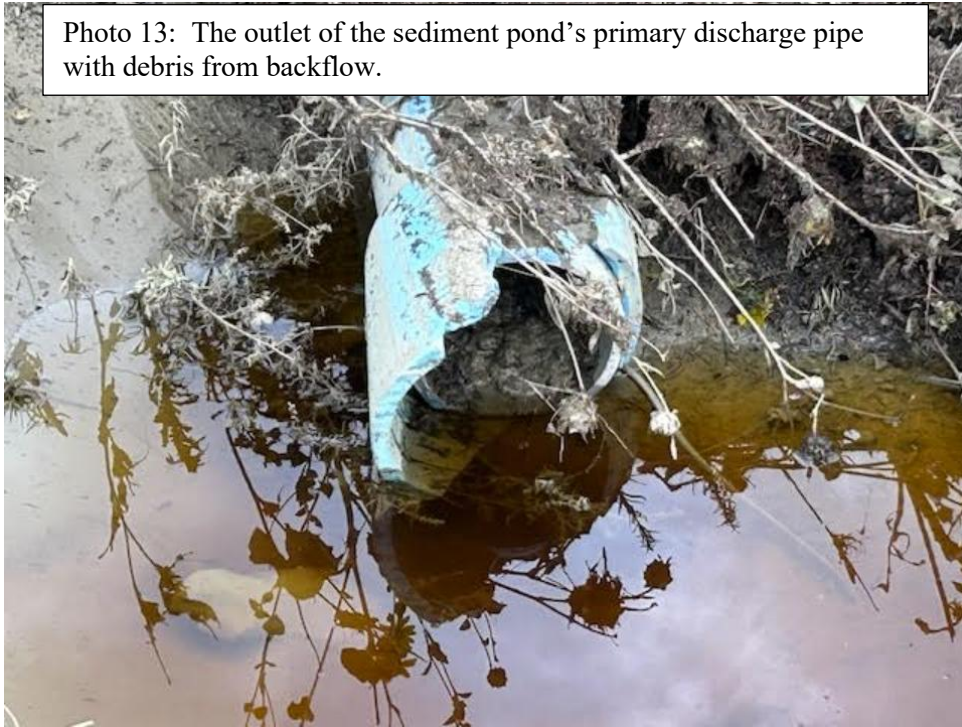
pipe was observed (Photo 13). The outlet to the pipe requires cleaning so the primary outlet can function as designed.

Photo 13: The outlet of the sediment pond's primary discharge pipe with debris from backflow.

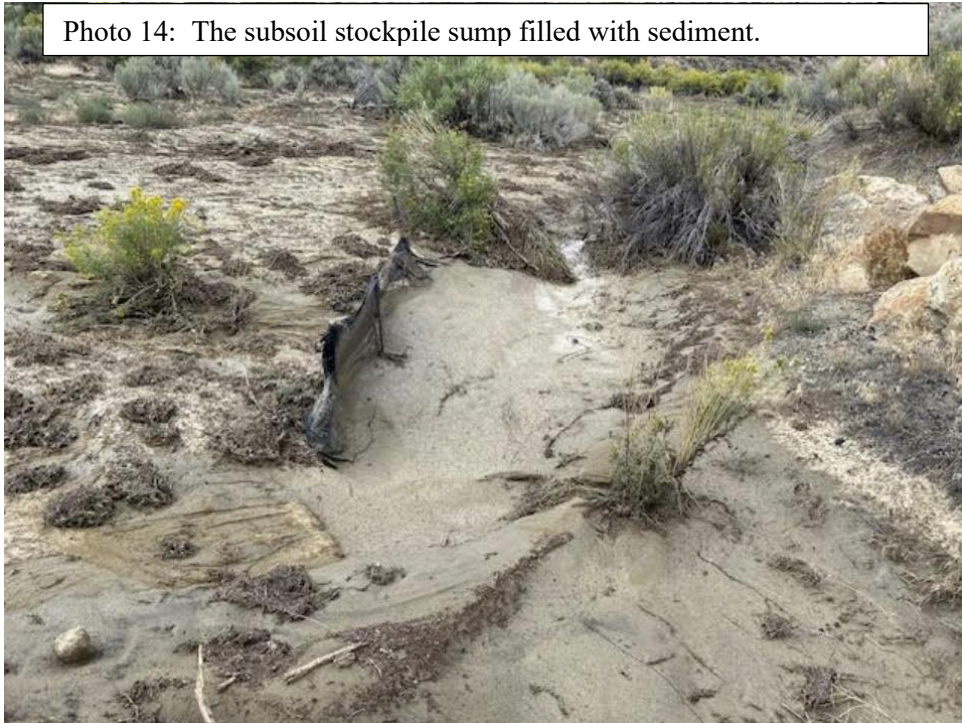
The sump for the subsoil stockpile had filled with sediment and the silt fence had been bypassed by flow during the precipitation event. The sump requires cleaning, and the silt fence needs to be repaired (Photo 14).

Photo 14: The subsoil stockpile sump filled with sediment.

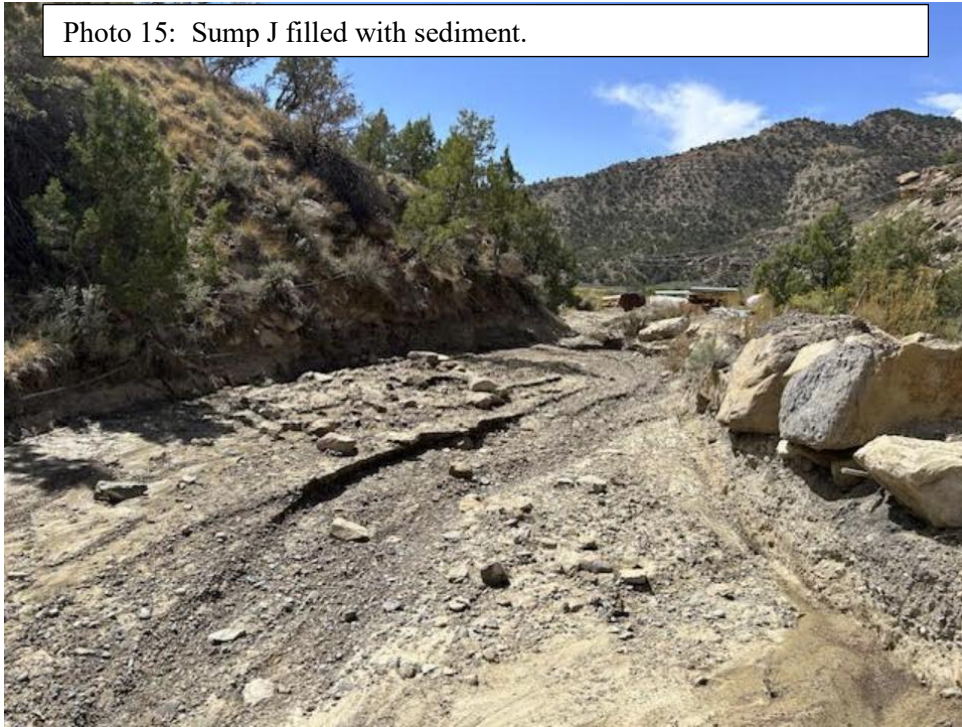
Sump J was damp and full of sediment (Photo 15). The level of sediment deposited within the sump had reached the level of the discharge outlet. Sump J requires cleaning and maintenance on the berm to restore the sump's capacity and functionality.

Photo 15: Sump J filled with sediment.

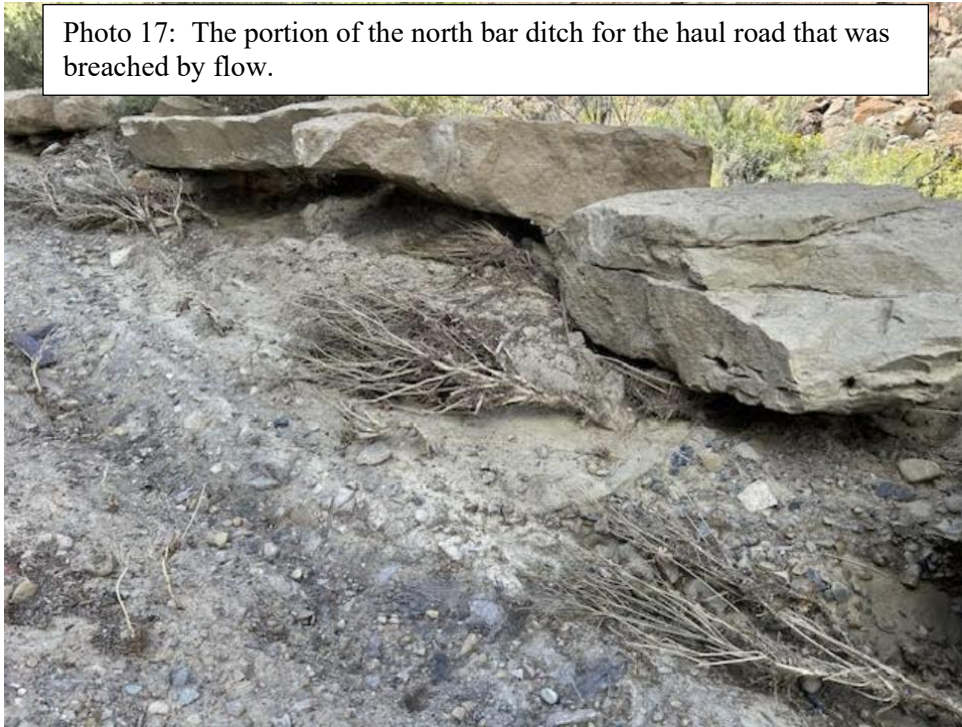
The north haul road bar ditch is composed of two main sections. The north office sump east to Sump Q and then Sump Q east to Sump I. The north haul road bar ditch was intact all the way to Sump Q from the north office sump. Evidence of flow within the ditch was observed. Some down-cutting within the ditch was observed. No breaches in this section were identified. Repairs to the down-cut sections of the ditch are required. The portion of the north haul road bar ditch from Sump Q east to Sump I was observed to have been affected more significantly than the other portion. Much of this portion of the north haul road bar ditch had been down-cut. Approximately a 10-foot section of the ditch's berm had been eroded during the precipitation event (Photo 17). This portion of the ditch was located west of Sump I. This portion of the bar ditch requires repairs to both the berm and the down-cut areas.

Photo 17: The portion of the north bar ditch for the haul road that was breached by flow.

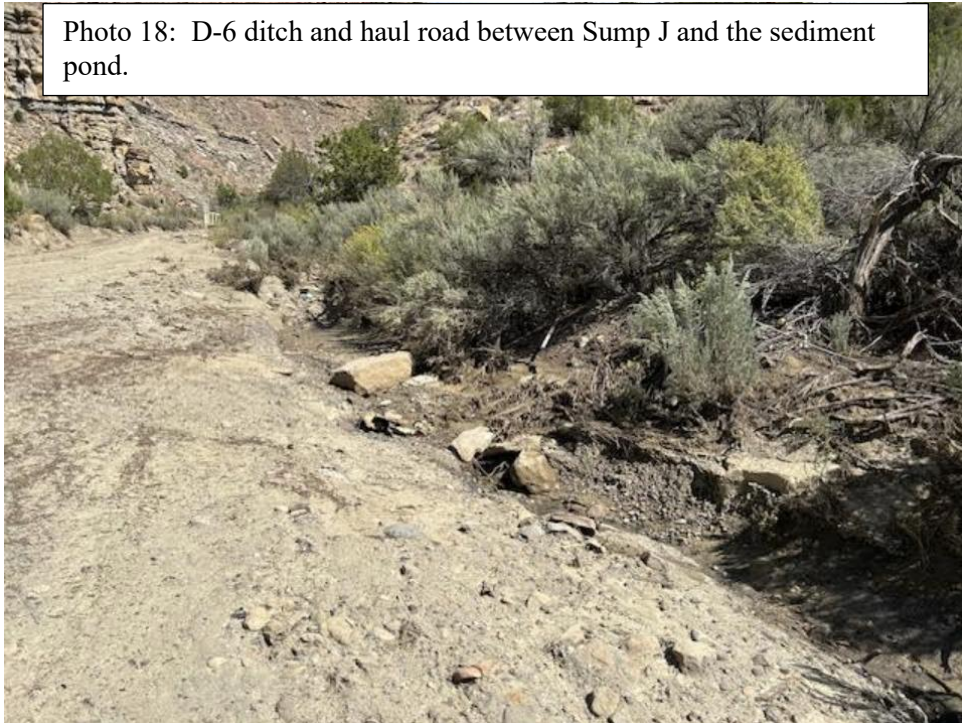
The south haul road bar ditch extends from the mine office pad to the sediment pond, then from the sediment pond to the outlet of Sump J, and from the inlet of Sump J to the base of the lower portals ditch. The portion of the ditch that extended to the sediment pond from the office had minimal erosion to it. The flow within the ditch did not breach the berm. Minor down-cutting within the ditch was observed. This section of the ditch will require minor repairs. The portion of the ditch closest to the sediment pond had downcutting within it. The portion of the ditch closer to the outlet of Sump J had filled in with sediment. This section of the ditch requires repair and cleaning (Photo 18). The remaining portion of the south haul road bar ditch, from Sump J to the base of the portals lower bench was intact but had been down-cut by the flow of water. This section of the bar ditch requires repair.

Photo 18: D-6 ditch and haul road between Sump J and the sediment pond.

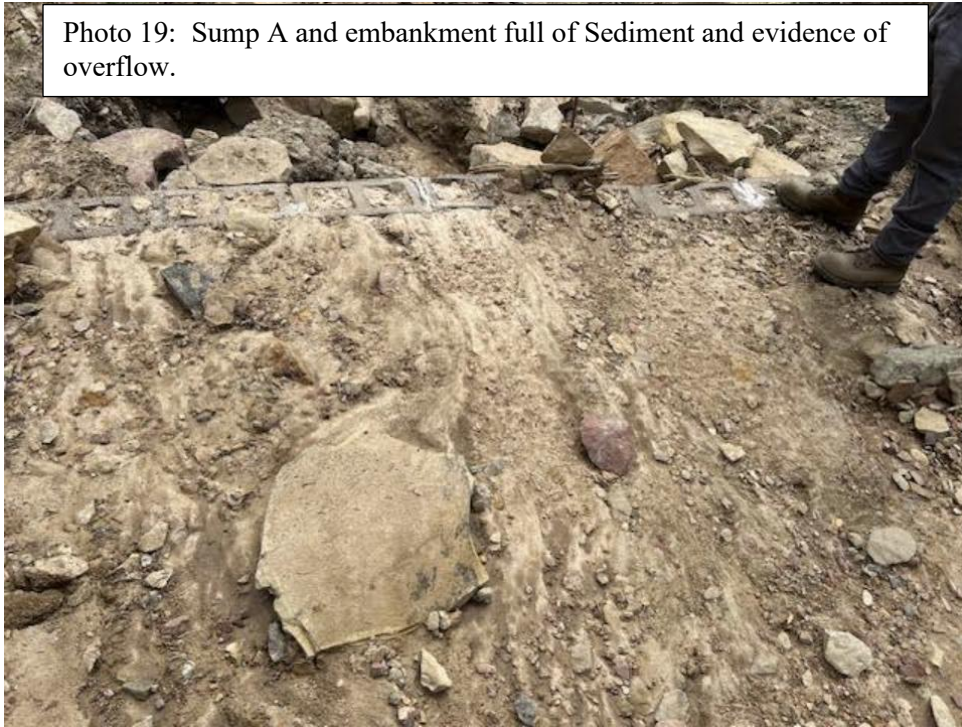
Sump A was observed to be completely filled in with sediment (Photo 19). The embankment for the sump had overtopped. Evidence of flow down the slope behind the embankment was observed. The flow down the hill eroded the material covering Sump A's culvert and had exposed the culvert (Photo 20). Sump A requires cleaning and the hillside behind the sump's embankment needs to be repaired.

Photo 19: Sump A and embankment full of Sediment and evidence of overflow.

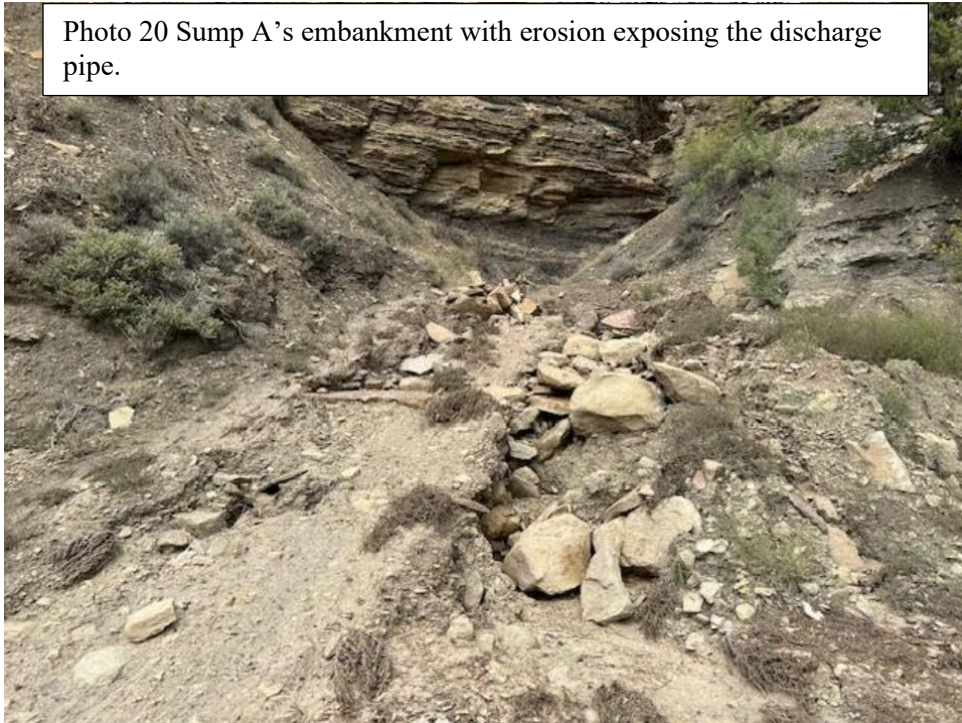
Photo 20 Sump A's embankment with erosion exposing the discharge pipe.

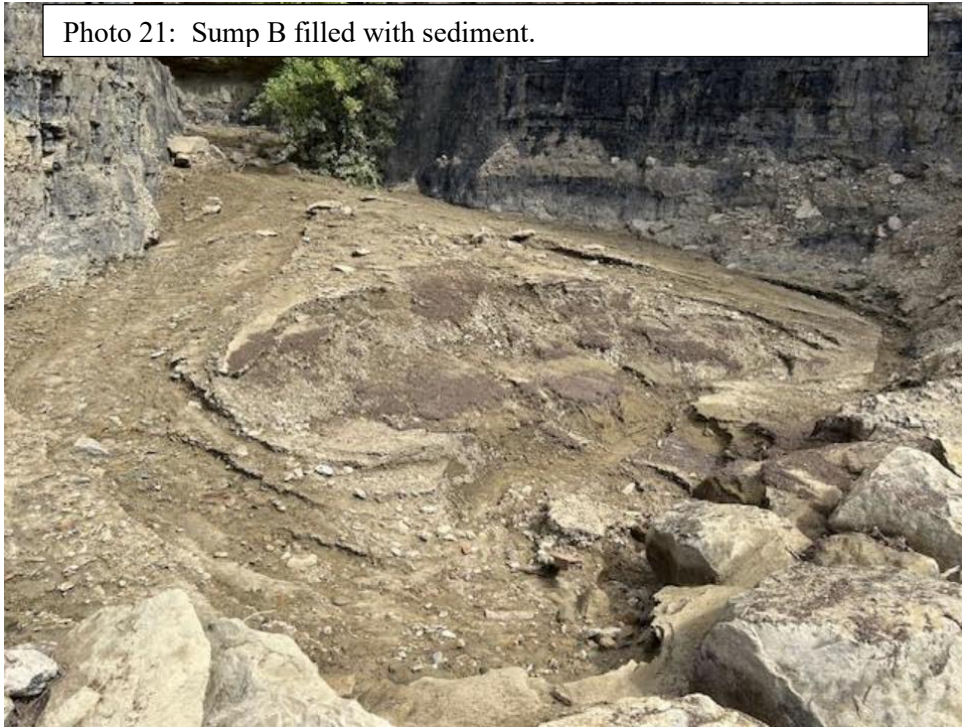
Sump B was also filled entirely with sediment (Photo 21). Indications of flow over the sump's embankment was identified. Sump B requires cleaning.

Photo 21: Sump B filled with sediment.

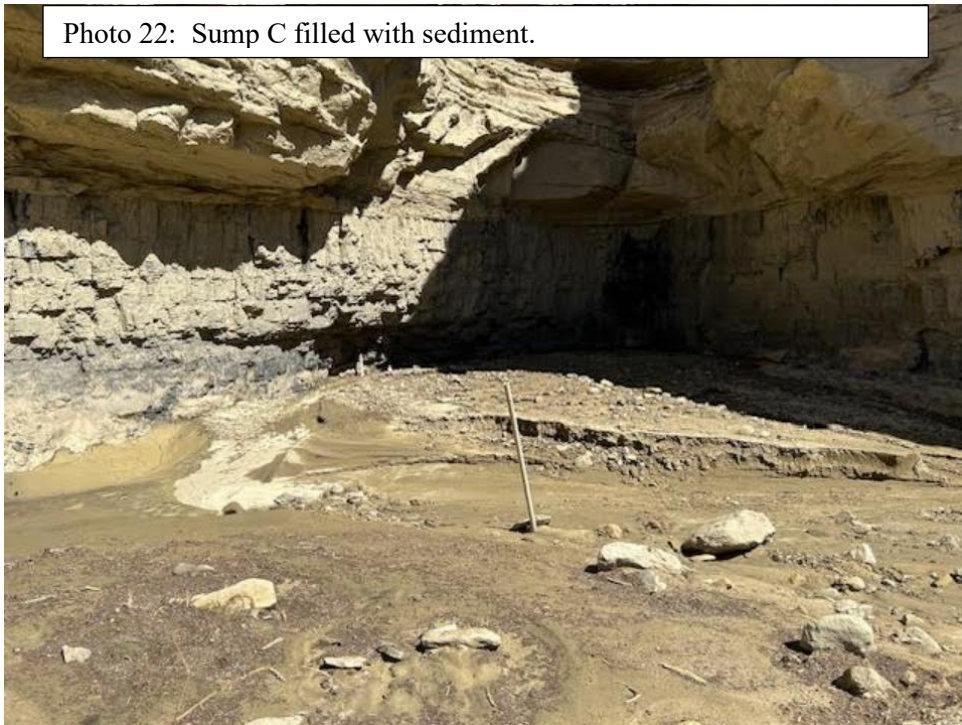
Sump C had filled to the top with sediment (Photo 22). The sump was muddy during the inspection. Evidence of flow over the sump's embankment was observed. Sump C requires cleaning.

Photo 22: Sump C filled with sediment.

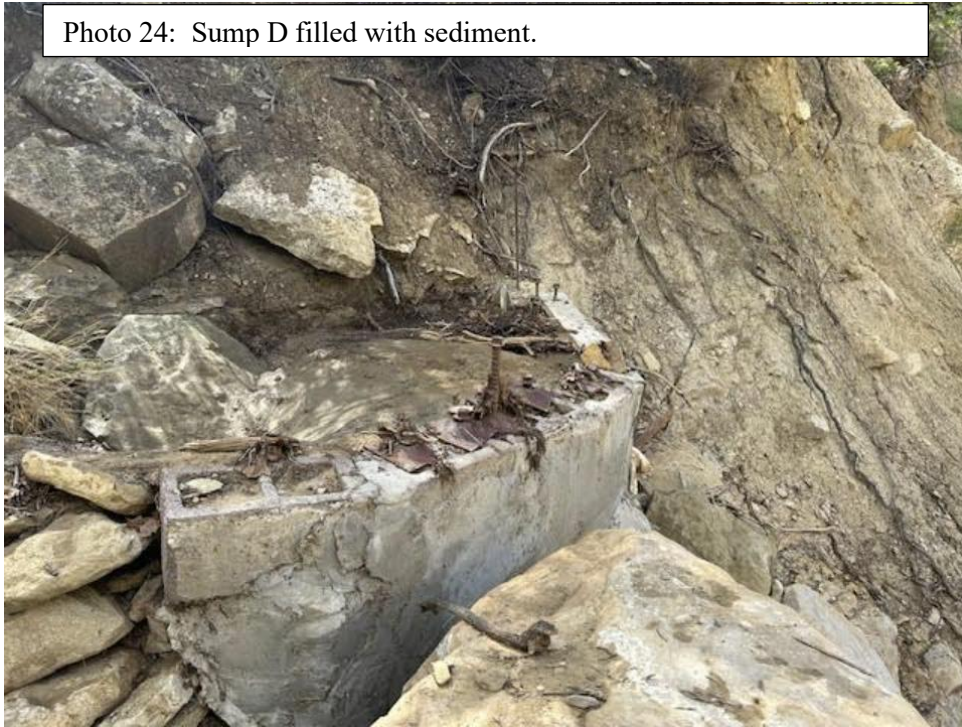
Sump D was filled up to the top with sediment (Photo 23). Flow had overtopped the sump's embankment and flowed down the hillside behind the embankment. Minor erosion on the hillside had occurred (Photo 24). The sump needs to be cleaned and the hillside behind the embankment requires maintenance.

Photo 24: Sump D filled with sediment.

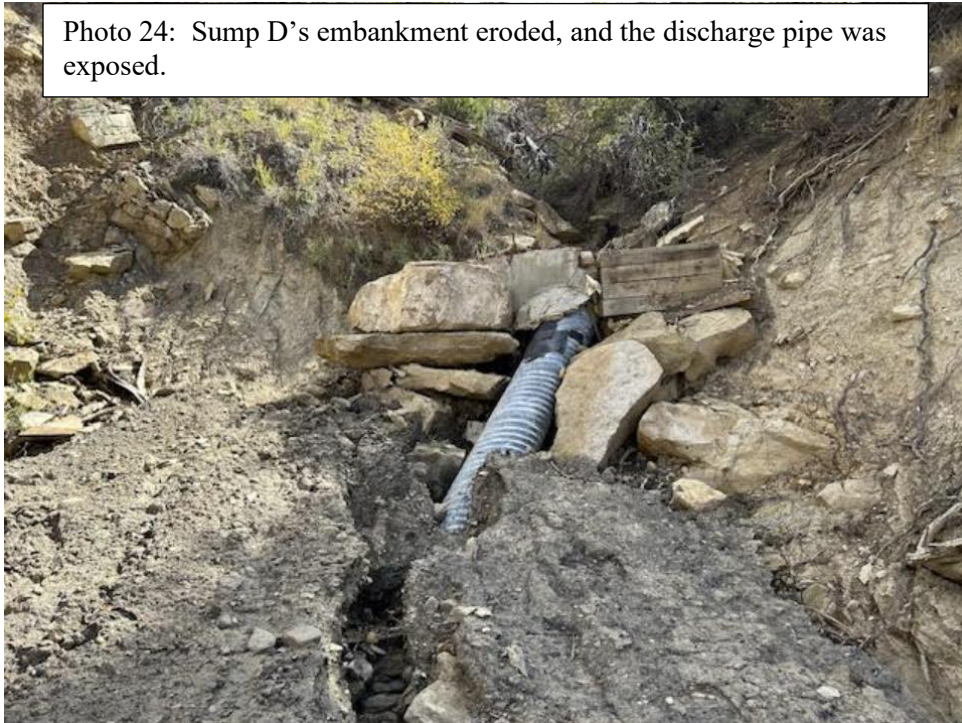
Photo 24: Sump D's embankment eroded, and the discharge pipe was exposed.

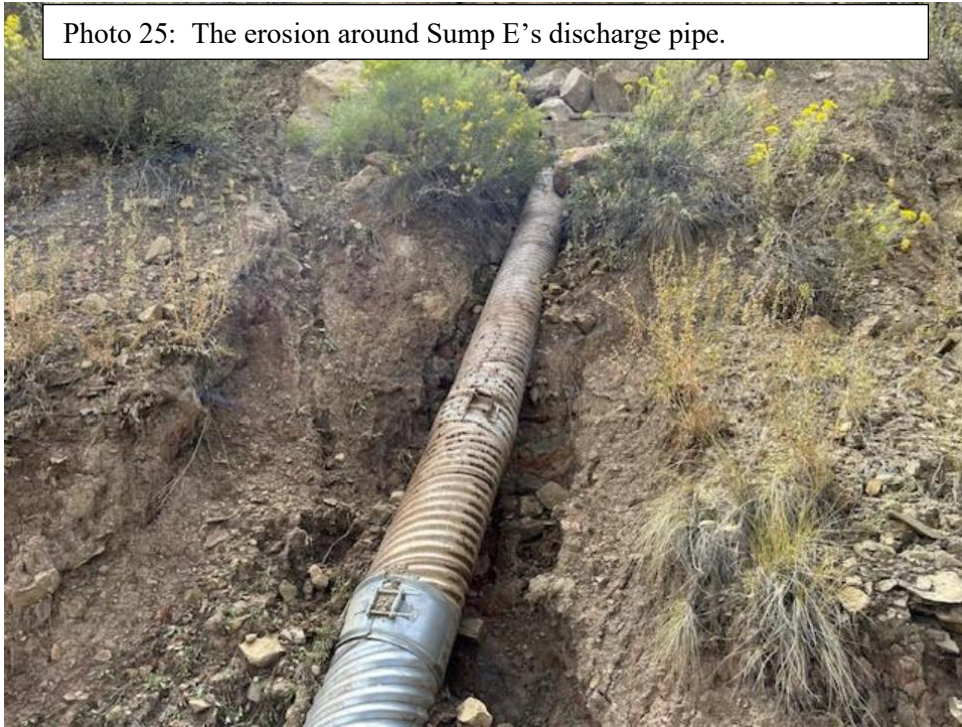
Sump E is located on the hillside adjacent to the southeast of the shop. Sump E had filled with sediment and the hillside below the sump had been eroded around the sump's culvert (Photo 25). Sump E needs to be cleaned and the hillside surrounding the culvert requires repair.

Photo 25: The erosion around Sump E's discharge pipe.

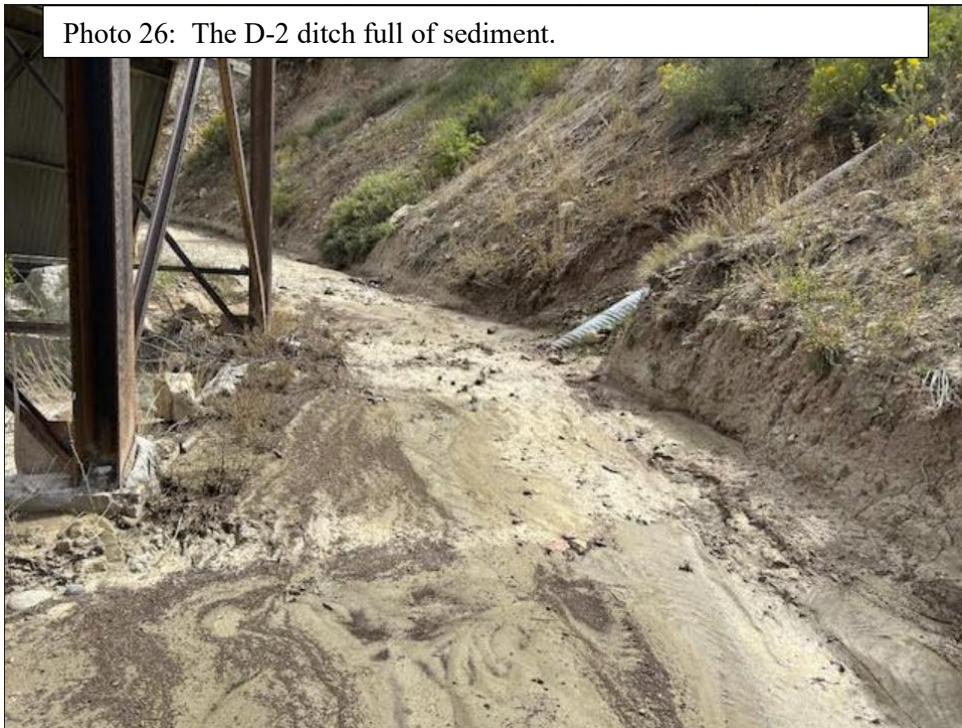
The D-2 Ditch on the upper portals bench had filled with sediment (Photo 26). The ditch will require cleaning. The open culvert extending down from the upper portals bench to the D-3 Ditch had been under-cut (Photo 27 and 28). The adjacent clearwater culvert to the open culvert had also been eroded underneath. The hillside under these two culverts requires repairs to support the culverts.

Photo 26: The D-2 ditch full of sediment.

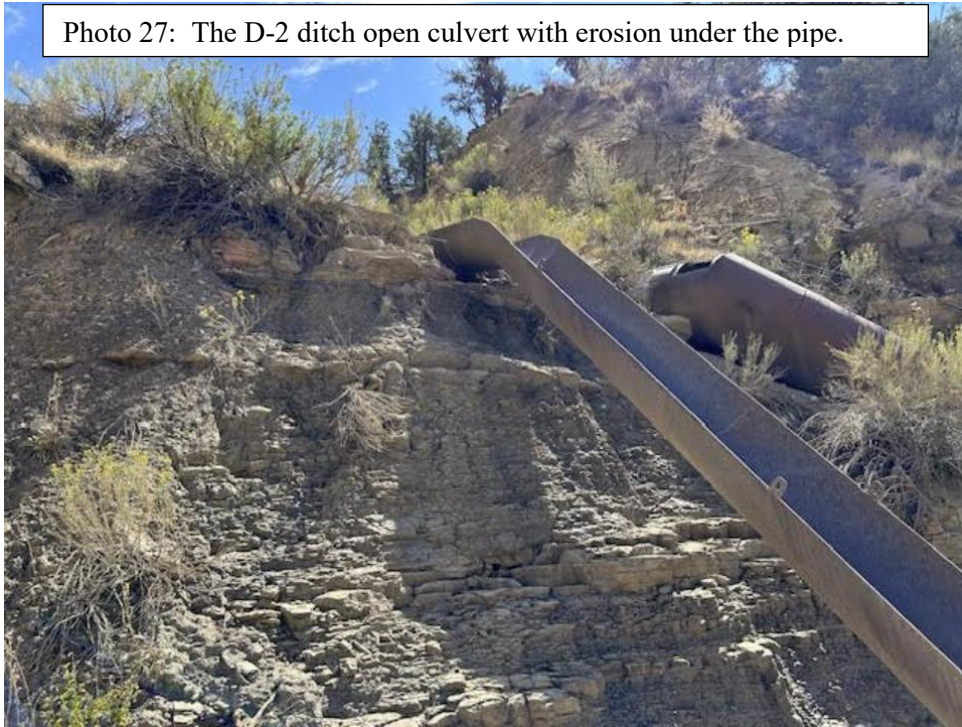
Photo 27: The D-2 ditch open culvert with erosion under the pipe.

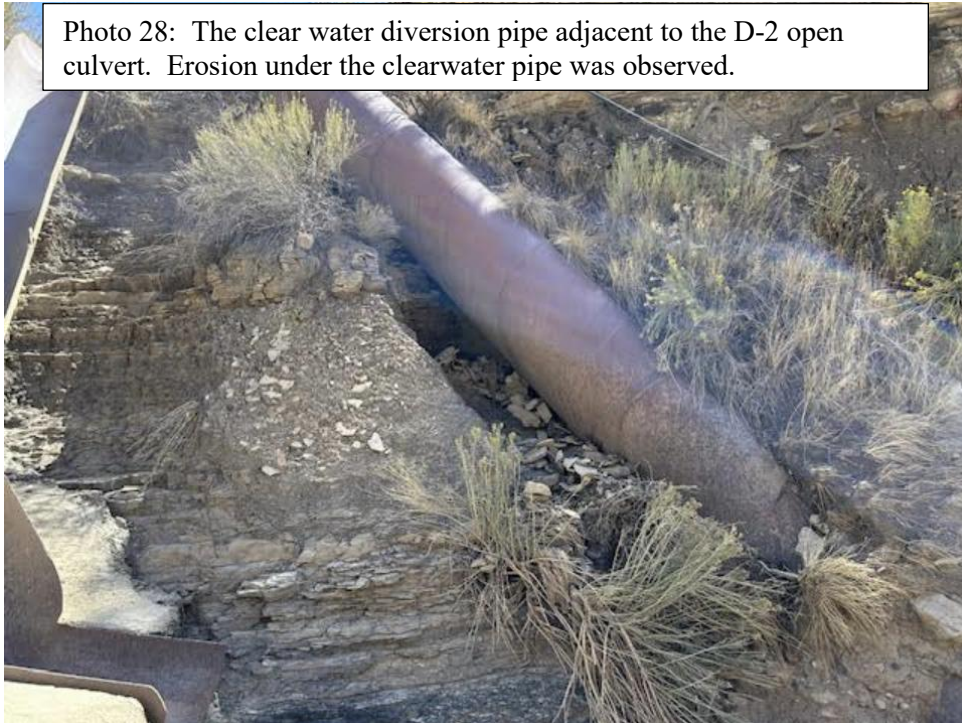
Photo 28: The clear water diversion pipe adjacent to the D-2 open culvert. Erosion under the clearwater pipe was observed.

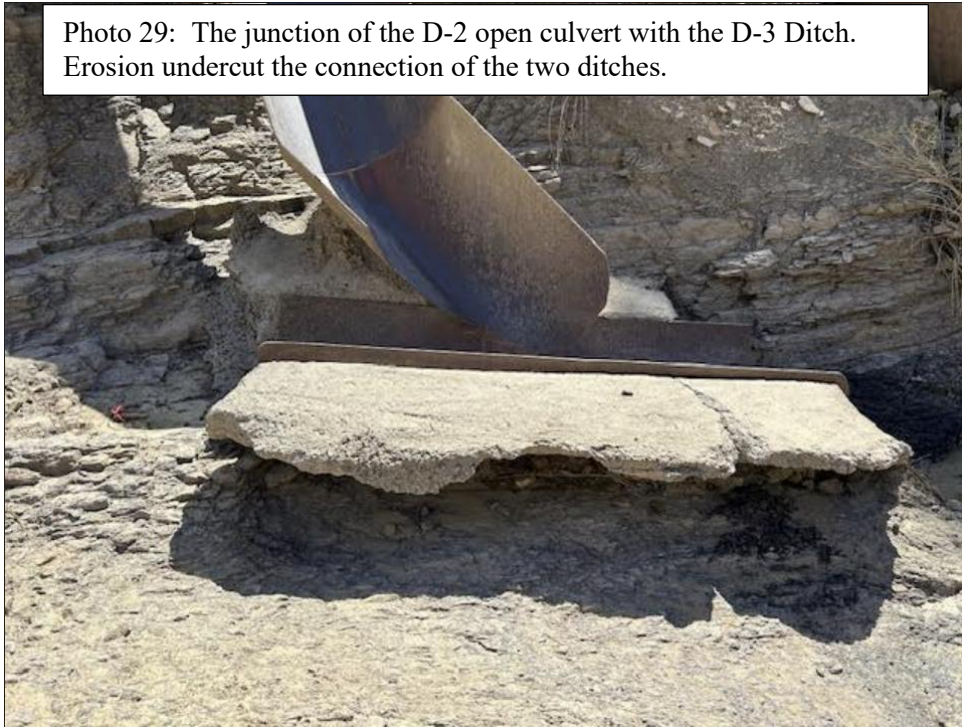
The D-3 connects the upper portals bench to the south haul road bar ditch. The D-3 Ditch had been down-cut from the precipitation event. The connection of the D-2 open culvert and the D-3 Ditch had been completely exposed (Photo 29). The concrete base was intact but all the rocks surrounding the concrete base had been removed by the water flowing within the ditch. The D-3 Ditch requires repairs.

Photo 29: The junction of the D-2 open culvert with the D-3 Ditch. Erosion undercut the connection of the two ditches.

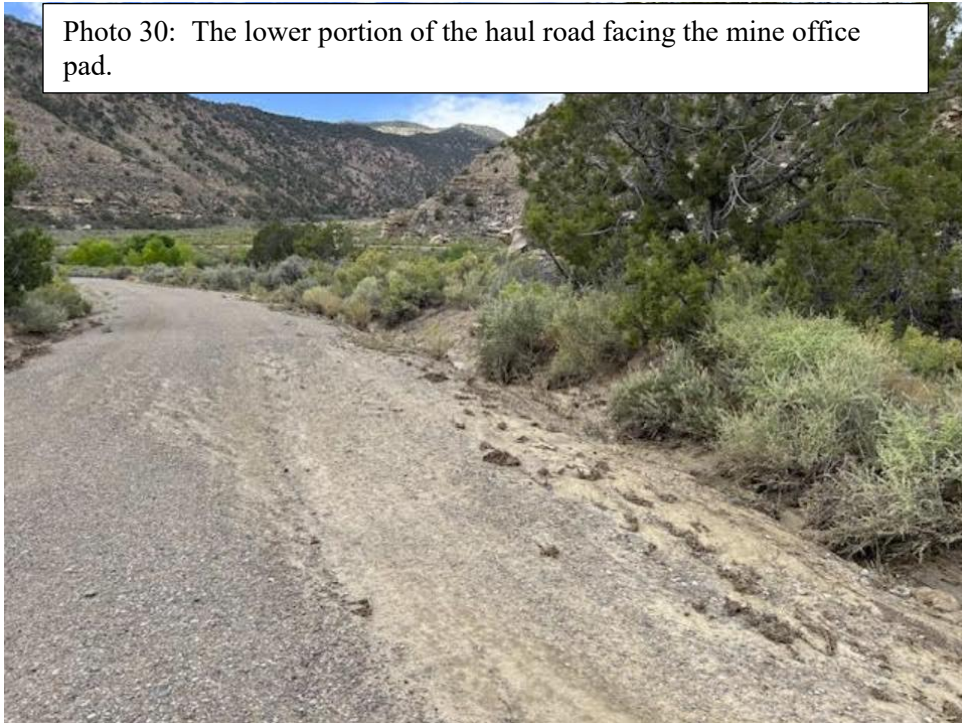
Several portions of the haul road had the road surface eroded due to water flow (Photo 30 and 31). Evidence of water flowing down the haul road was observed. The haul road bar ditches had more water flowing in them than what could be contained within the ditches. Water flowed onto the road as a result. The haul road needs to be resurfaced west of the sediment pond and from the lower portals bench south towards Sump J.

Photo 30: The lower portion of the haul road facing the mine office pad.
