## McClane Canyon Mine, C-1980-004, September Partial Inspection of Sediment Control Structures

**McClane Canyon Mine, C-1980-004, September Partial Inspection Report\_CCW.pdf**

**INSPECTION INFORMATION**

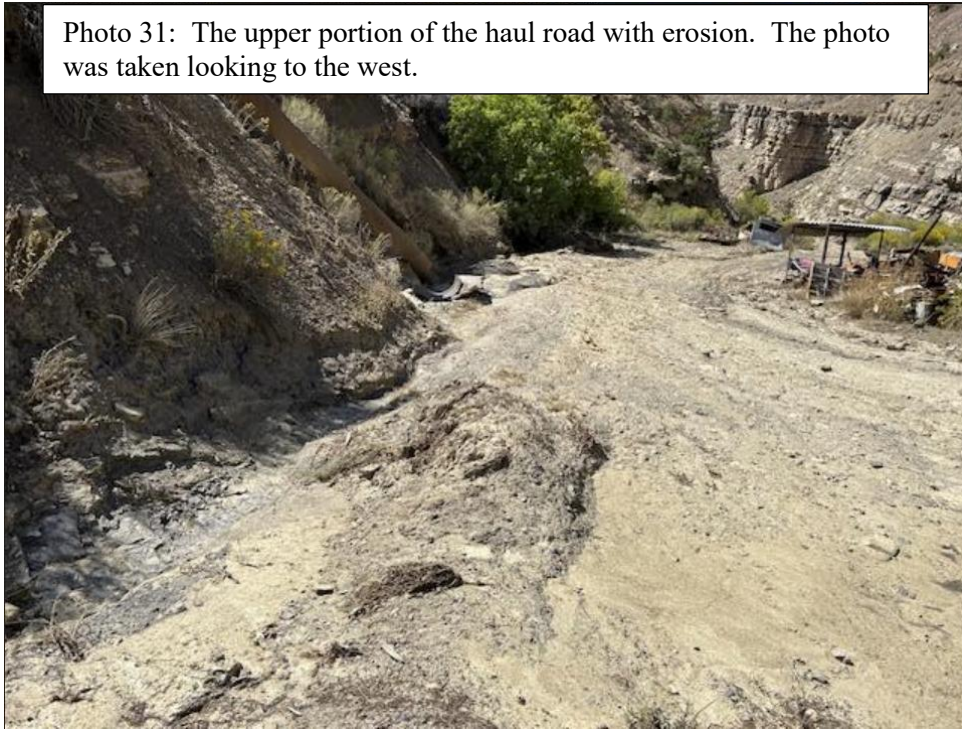
Several portions of the haul road had the road surface eroded due to water flow (Photo 30 and 31). Evidence of water flowing down the haul road was observed. The haul road bar ditches had more water flowing in them than what could be contained within the ditches. Water flowed onto the road as a result. The haul road needs to be resurfaced west of the sediment pond and from the lower portals bench south towards Sump J.

Photo 31: The upper portion of the haul road with erosion. The photo was taken looking to the west.

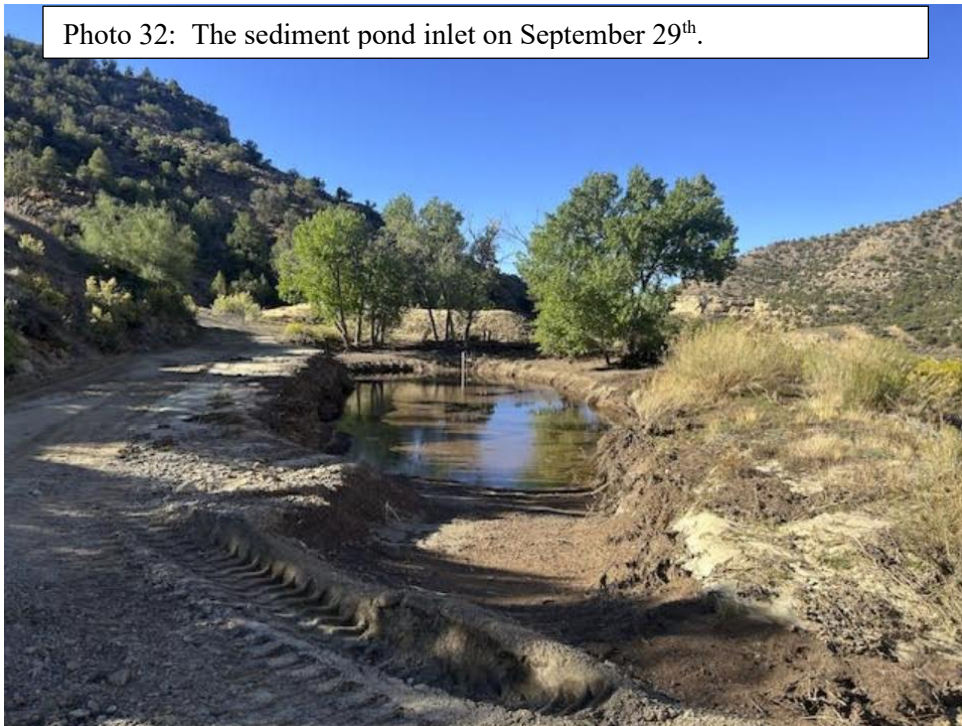
During the inspection, the sediment pond was holding significantly less water than the September 16<sup>th</sup> inspection (Photo 32). Water was discharged through the primary spillway until the level of water impounded in the pond was below the primary spillway. There was approximately 2-3 feet of water still impounded within the pond. The operator used a pump to discharge water further on September 29<sup>th</sup>. The level of water within the pond appeared to be about 1 foot deep. The sediment level deposited in the pond during the precipitation event on September 12, 2025, precipitation event could be evaluated during the inspection. Sediment deposited within the pond was at a

level that requires cleaning. Approximately a third to a quarter of the pond's original capacity was available for storage. The pond's embankment was stable and there were no indications of seepage, sloughing or erosion at the time of the inspection. The primary discharge outlet was clear of debris and able to function as designed. The emergency spillway was clear of debris and stable. The removal of sediment from the pond will progress as the material in the pond dries out. Equipment is likely to get stuck in the soft mud as material approaches the center and southern areas within the pond if the equipment is placed on top of this material before it has dried.

Photo 32: The sediment pond inlet on September 29<sup>th</sup>.

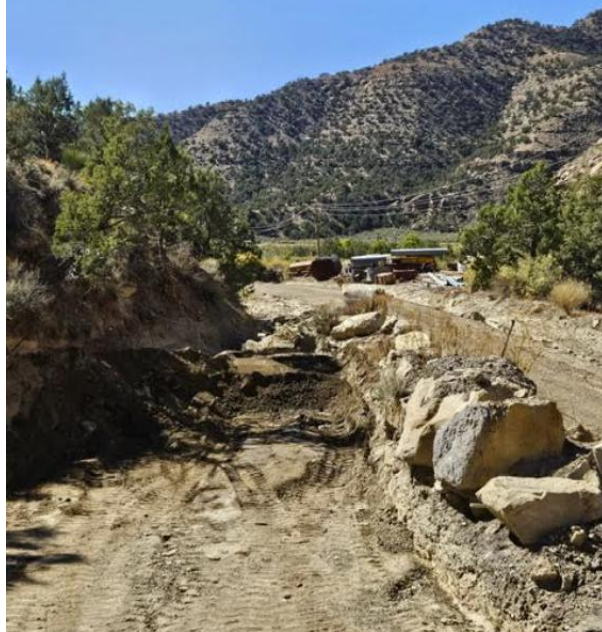
Sediment from Sump J was observed to have started to be removed (Photo 33). The sediment deposited in the sump is still damp and soft in the middle. Mr. Selingo has been removing sediment from the sump as it dries out to avoid the risk of getting the equipment stuck in soft mud. A significant portion of the sediment deposited in the sump still remained in the sump. Sump J requires further cleaning and repairs to the sump's embankment have not yet been completed.

Photo 33: Sump J on September 29<sup>th</sup>.

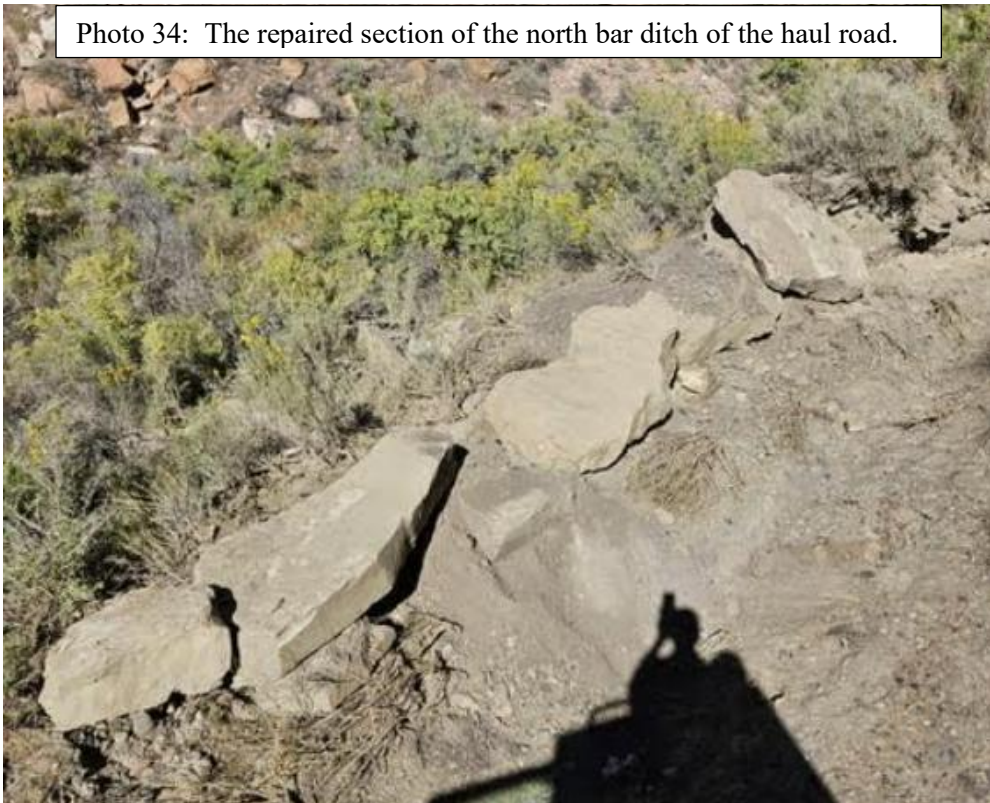
The 10-foot section of the north haul road bar ditch was repaired on September 29<sup>th</sup>, 2025 (Photo 34). Material was replaced on the ditch embankment to return the berm to the original design. No other portions of the north or south haul road bar ditches had the down-cutting repaired.

Photo 34: The repaired section of the north bar ditch of the haul road.

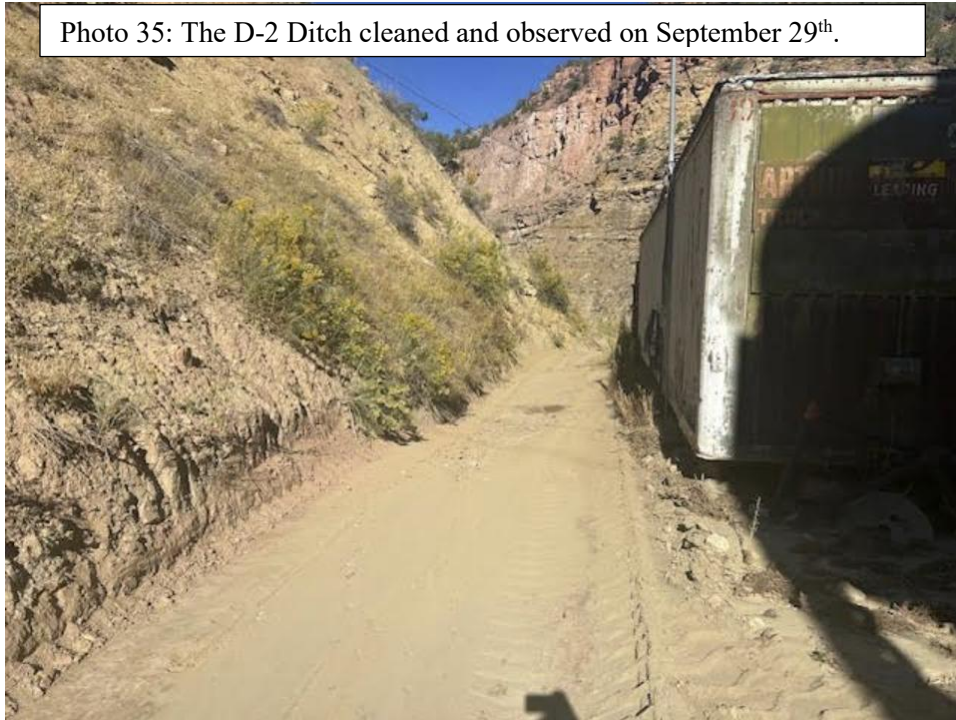
The middle portion of the D-2 ditch had been cleaned (Photo 35). The ditch was clear of debris and stable. The upper-most portion of the D-2 ditch required further cleaning. Mr. Selingo plans to complete the cleaning of this portion of the ditch when an excavator is on-site. The open culvert at the end of the ditch remained in the same condition as on September 16, 2025.

Photo 35: The D-2 Ditch cleaned and observed on September 29<sup>th</sup>.

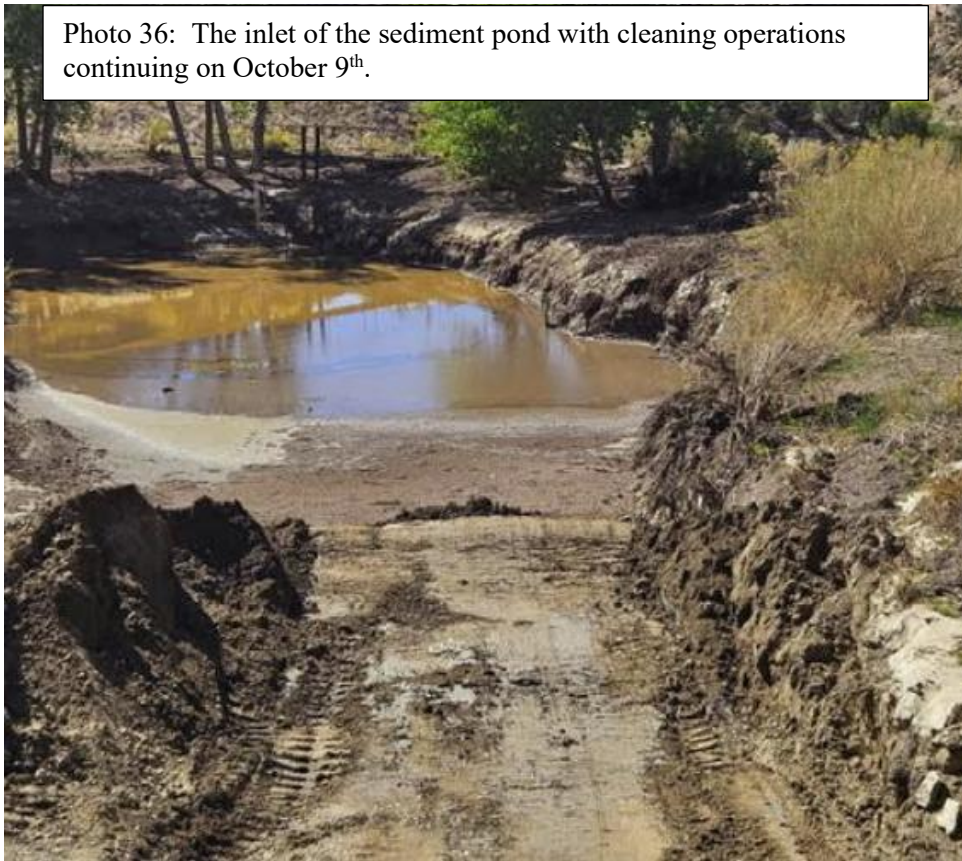
The Division received Photographs from Mr. Selingo showing updates to the work being conducted at the McClane Canyon Mine with regard to the maintenance and repairs of the sediment control structures. Photos were provided to the Division showing additional progress had been made since the September 29, 2025 inspection. Sediment had started to be removed from the northeast end of the sediment pond (Photo 36). Water was still impounded within the pond. The level of the water was below the primary discharge outlet.

Photo 36: The inlet of the sediment pond with cleaning operations continuing on October 9<sup>th</sup>.

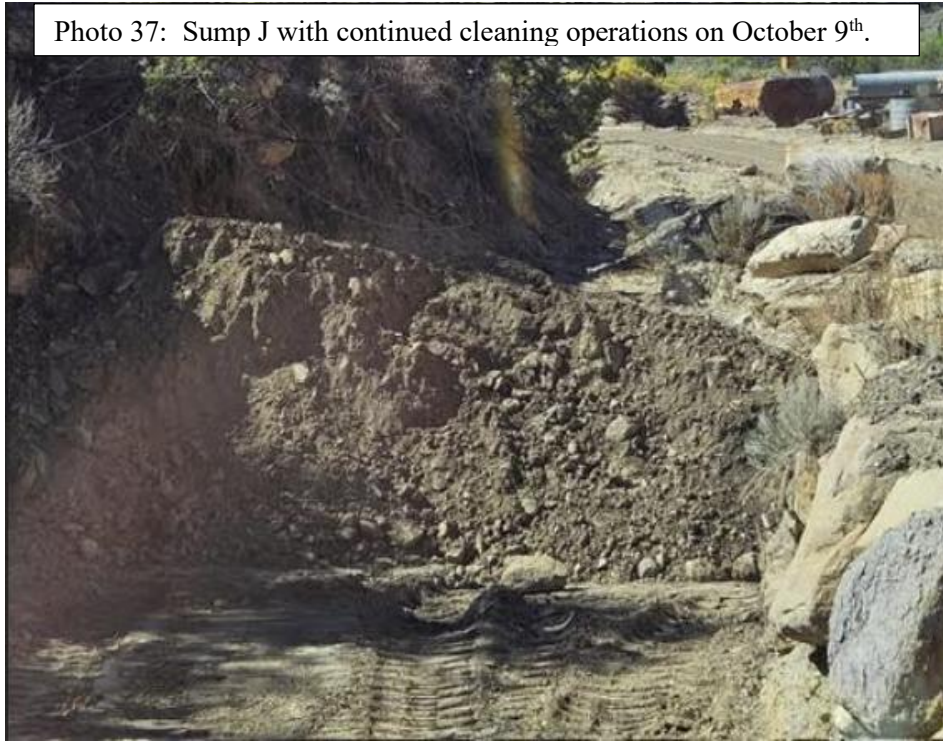
Sediment had started to be removed from Sump J (Photo 37). The amount of sediment deposited within the sump requires further cleaning. Similar to the sediment pond, Sump J will be cleaned in phases to allow sediment to dry and then be removed. Equipment used by the operator is likely to get stuck in the sump if the sediment is still saturated.

Photo 37: Sump J with continued cleaning operations on October 9<sup>th</sup>.

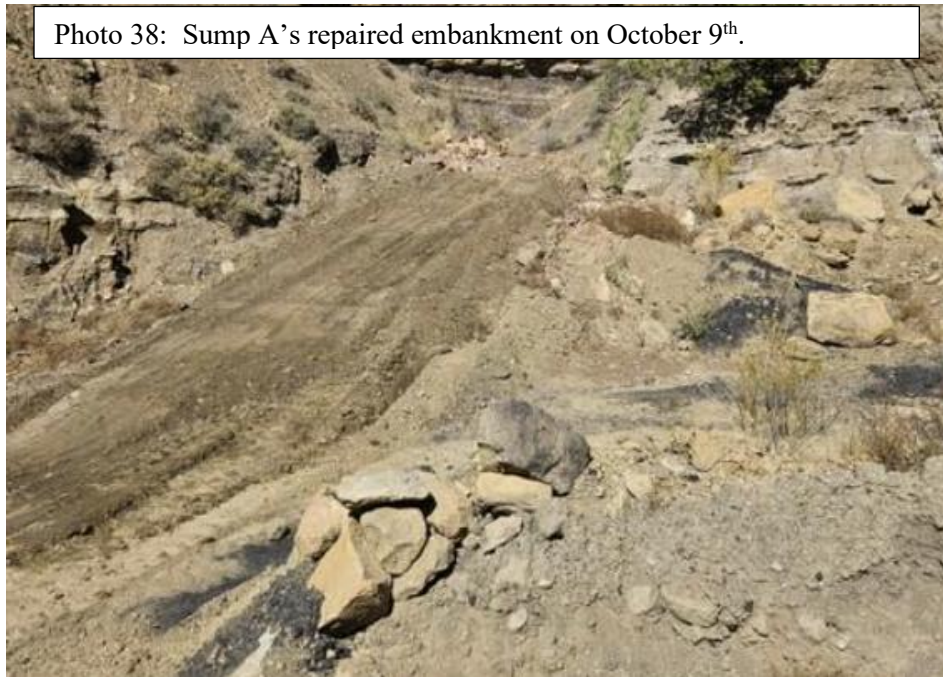
The hill slope behind Sump A's embankment had been repaired (Photo 38). The culvert outlet for the sump was covered and buried. There were no erosional issues on the hill slope.

Photo 38: Sump A's repaired embankment on October 9<sup>th</sup>.
